# **Infrared Thermography Inspection on Potential Failures of Rotating Equipment**

Bachelor of Engineering (Hons)  
(Mechanical Engineering)

A project dissertation submitted to the  
Mechanical Engineering Programme  
Universiti Teknologi PETRONAS  
in partial fulfillment of the requirement for the  
BACHELOR OF ENGINEERING (Hons)  
(MECHANICAL ENGINEERING)

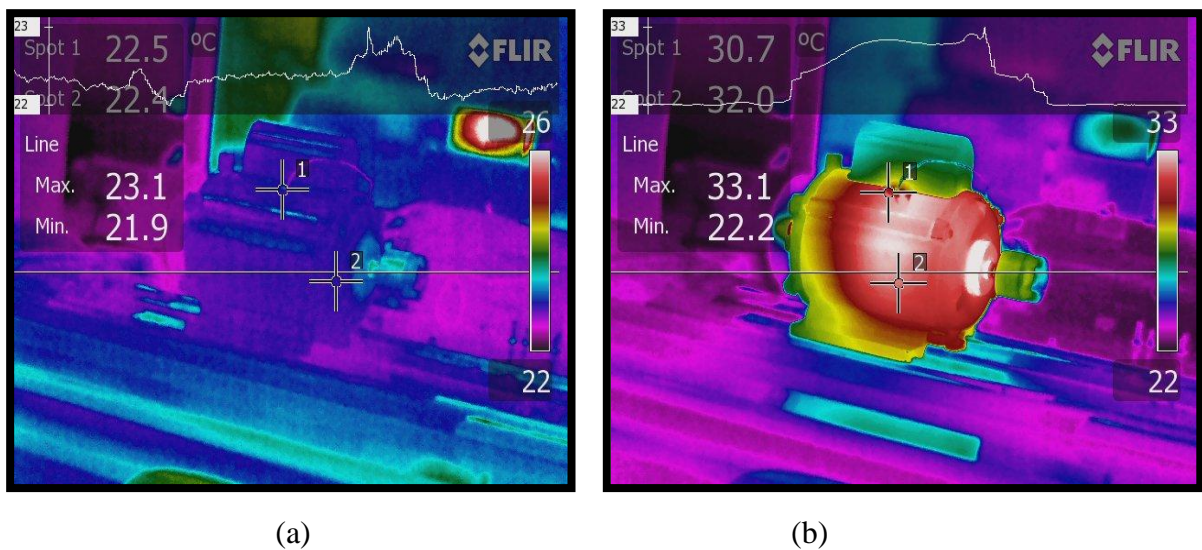
**Figure 20: The IR Images under Normal Operating Condition,**

**a) The Temperature of Motor at the First minutes of Operating, b) The Temperature of the Motor after 3 hours of Operating.**

Figure 20 shows the motor operating under normal condition. From the IR images it can be interpreted that, the color of infrared image represents the temperature distribution of the motor and determines the condition of the object.

Different colors of the infrared represent different thermal distribution. The figure 25a shows the temperature when the motor start operating while the figure 25b shows the condition of the motor after three hours operating. The condition of the motor is justified by the value of  $\Delta T$ , by comparing the temperature difference between spot 1 and 2. The value of  $\Delta T$  is based on the standard from International Electrical Testing Association. Based on the motor above, the value of  $\Delta T$  is determined as below:

According to the standard provided by NETA in Table 1, the value of  $\Delta T$  is justified as the normal since the value of  $\Delta T$  is less than 10 which is  $1.3^\circ\text{C}$ .

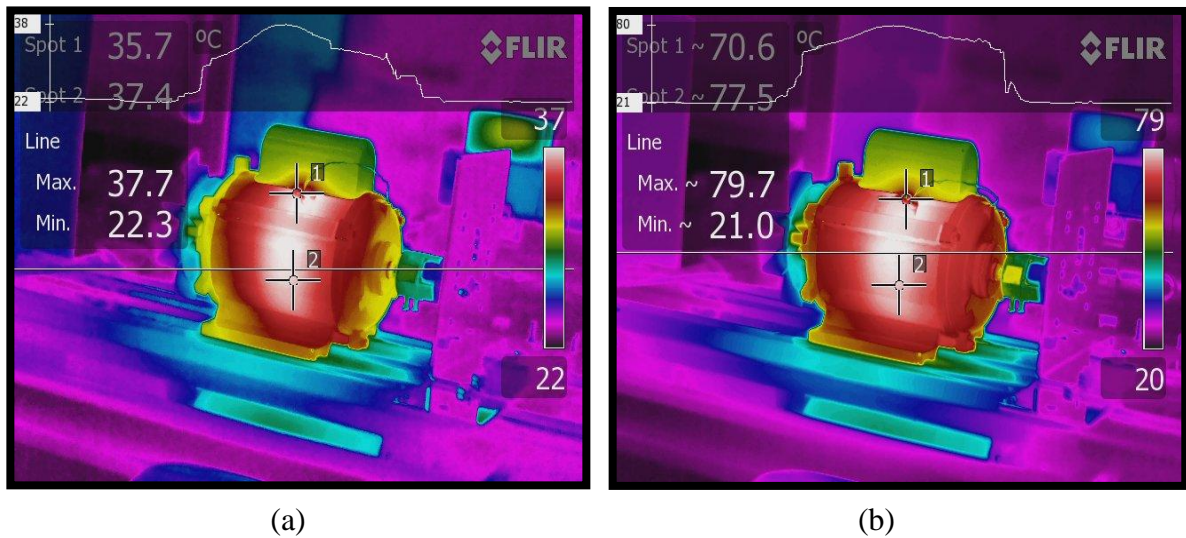
**Figure 21: The IR Image under Overload Condition**

**a) The Temperature of the Motor at the First minutes of Operation, b) The temperature of Motor after two hours under overload condition.**

The Figure 21 shows the IR image under overload Condition. The temperature increased from 35.7 to the 70.6 within 30 minutes. To determine the condition of the motor, the value of  $\Delta T$  is calculated.

Based on the standard of NETA, the motor is in the phase of possible deficiency as the value of  $\Delta T$  is less than 10.

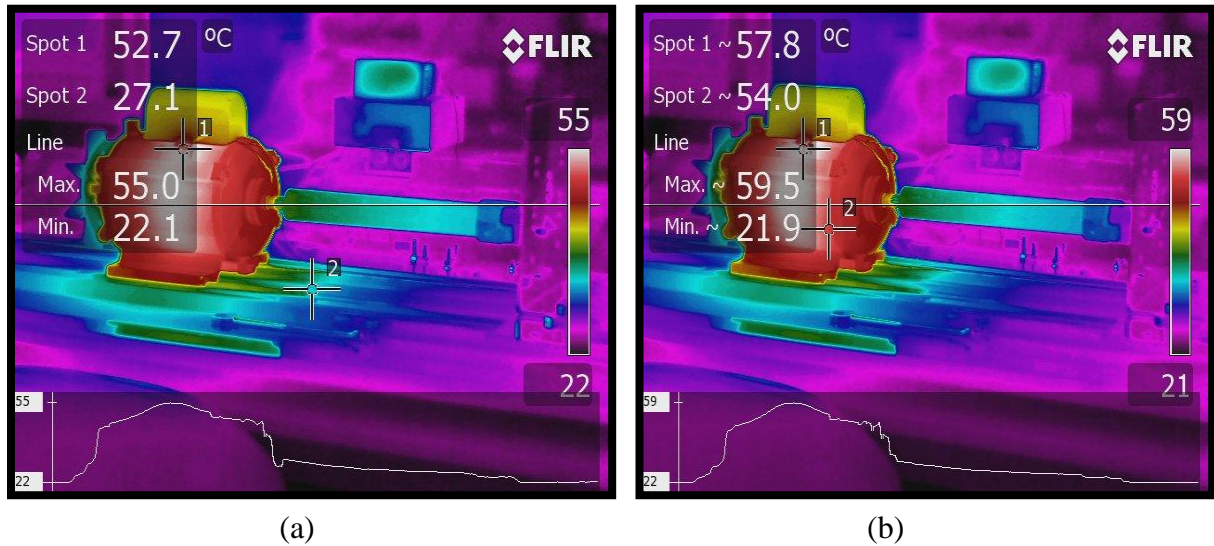
Figure 22: The IR Images under Misalignment Condition

The Temperature of the Motor at the early stages of Operation, b) The Temperature of motor after an hour.

The figure 22 shows the IR image under misalignment condition, the temperature increased throughout the testing. To determine the condition of the motor, the value of the  $\Delta T$  is calculated.

Based on the standard of NETA, the motor is in the phase of possible deficiency as the value of  $\Delta T$  is less than 10.

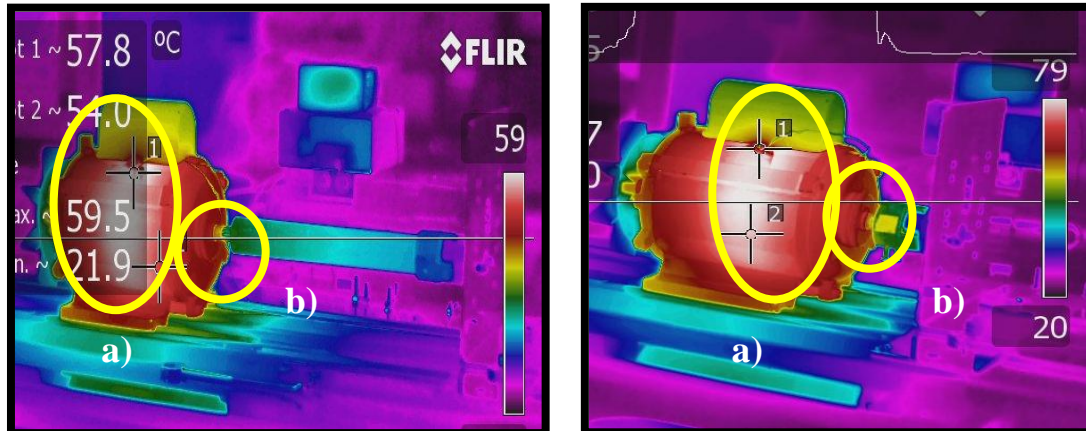
**Figure 23: IR Images subjected to Bearing and Winding Possible Failure**

From the figure 23, the misalignment and overload condition show the possibility to lead to the bearing and winding. The circle a) represents the potential failure at stator winding. From the both images, the highest temperature is captured around the winding area. This situation interpreted the deterioration in thermal happen when the motor is subjected on the misalignment and overload. The circle b) represents the potential failure of bearing. The bearing experience the increasing in temperature due to the friction produced from misalignment and overload condition. In brief, the friction created, affect the deterioration of thermal stress and finally lead to the failure of the motor.
