CHAPTER 1

1.1 Background of Study

- a) to carry out failure analysis for the failed seal used at the condensate booster pump

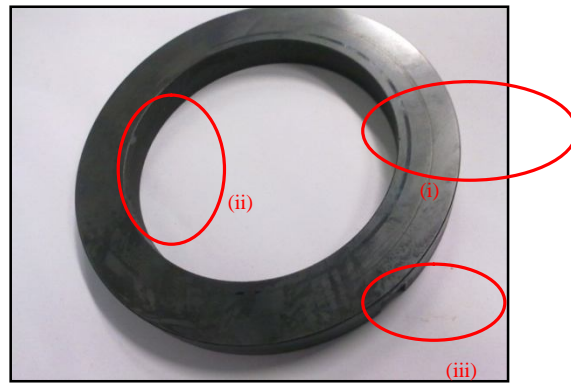
Figure 4.12: Stationary face seal of P-5156

Tag no	Type of failure	Possible causes
(i)	Grooving along the seal faces	a)Dry running due to insufficient or no liquid between the seal mating faces
(ii) & (iii)	Scratches and chips at ID and OD	a)Mishandling during manufacture, storage, assembly or installation b)Dirt trap between seal faces c)Edge chipping from slamming together during operation when pump cavitates or fluid vaporizes at seal faces d)Excessive shaft run-out e)Excessive shaft deflection f)Misalignment of the seal

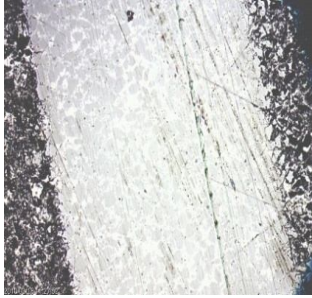
Figure 4.16:Picture 1	Grooving and scratch	-there are changes on the microstructure of the material -the thickness of the face seal was changed -there is recorded lines at the face seal -it may lead to face failure (leakage)

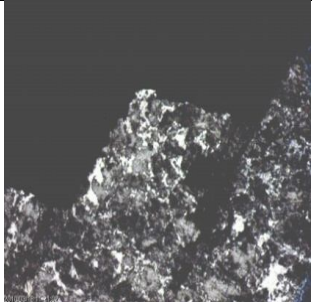
Figure 4.18:Picture 3	Edge Chipping at OD (Outer dimension)	-there are changes at the microstructure of the material -the strength of the material may be depleted -there are fracture line that can be seen where it may be the weak point of the material -it may lead to face failure (leakage)

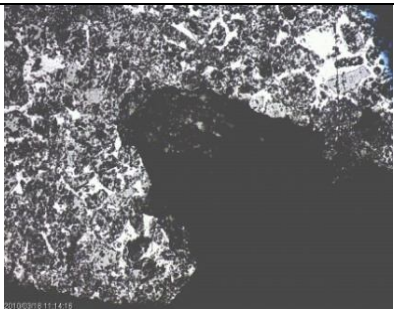
<p>Figure 4.19:Picture 4</p>	<p>Edge Chipping at ID (Inner Dimension)</p>	<p>-there are changes at the microstructure of the material</p> <p>-the strength of the material may be depleted</p> <p>-it may lead to face failure (leakage)</p>

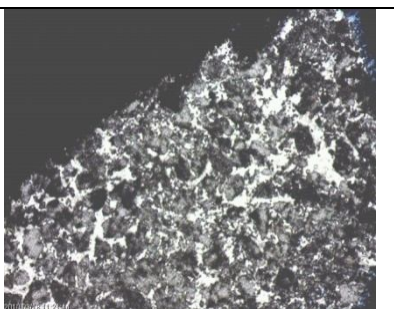
<p>Figure 4.20:Picture 5</p>	<p>No failure</p>	<p>-the microstructure is still in good condition where the atoms are still bond with each other</p> <p>-the edge of the seal is still in good condition</p>
