# **Failure Analysis of a Heat Exchanger Tube**

Dissertation submitted in partial fulfillment of

Universiti Teknologi PETRONAS

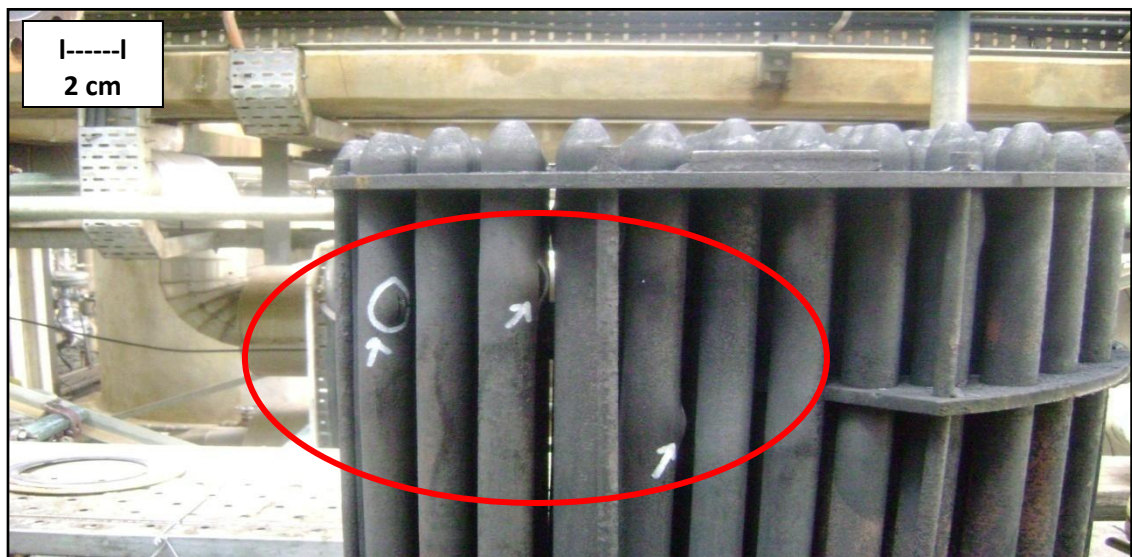
The bulging and burst of this heat exchanger tube is a first time occurrence since commissioning in 1991. The leakage of this heat exchanger tube happened during plant cold start-up period of approximately 8 days in March 2009 in conjunction with the plant emergency shutdown. This heat exchanger operated in a vertical position. It was suspected leak due to the condensate steam carry over into the hydrocarbon system. All defect tubes were at top portion of the tube and some of tube also found bulging without crack as shown in Figure 1.1 and 2.1. 35 out of 138 total tubes found bulging and burst with vertical crack after the vessels were opened. The heat exchanger tubes failure sample material is SA-179 low carbon steel. SA-179 carbon steel types referred to the specification material for seamless cold-drawn low-carbon steel that being used widely in industry for heat-exchanger and condenser tubes.

Figure 1.1: Bulging and burst tube at the top portion of the heat exchanger

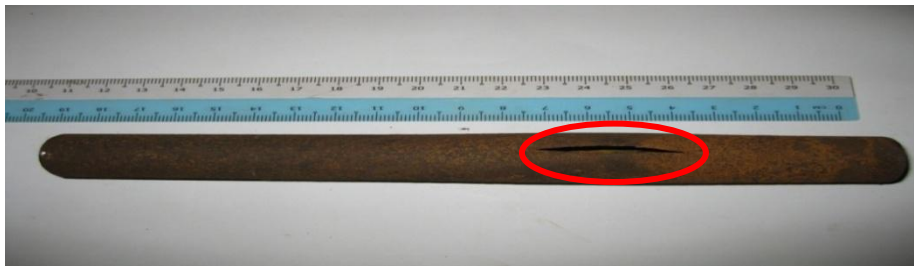
Table 2.1 and Figure 2.2 shows heat exchanger data sheet and schematic drawing. Heat exchanger tube bulging and burst with narrow longitudinal split as shown in Figure 2.1.

Figure 2.1: Heat exchanger tube fail sample

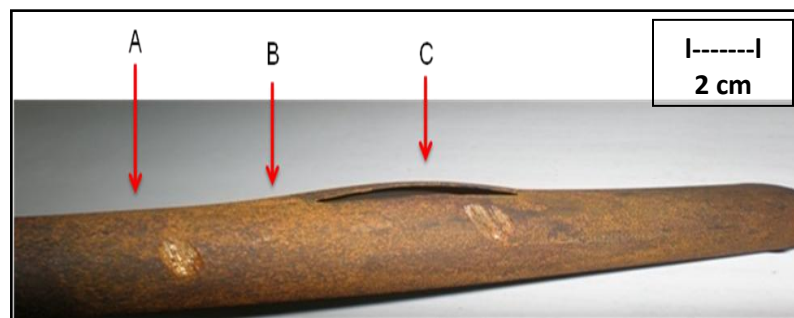
- Outer diameter shows thin loose corrosion product with reddish and brownish in color as shown in Figure 4.1
- Inner diameter shows black dark in color, clean surface with no deposit/scale
- Narrow longitudinal split, 25 mm length and 3.1 mm widest opening of the burst area

Location	Diameter (mm)	
	Outer	Inner
A (away from burst area)	25.4	21.4
B (near burst area)	26.5	23.6
C (burst area)	31.5	27.5

Figure 4.1: Heat exchanger tube for sample measurement

Based on the diameter measurement on the heat exchanger tube sample that has been measured, there is a huge increment number of diameter measurement at the burst area compare to the normal one as shown in Table 4.3 and Figure 4.1. These phenomena happened due to the bulging effect take place before the heat exchanger tube burst thus the diameter measurement increase rapidly. Besides that, the thickness measurement of the tube wall at the burst area reduces rapidly as shown in Table 4.4 and Figure 4.2. Here, the thinning effect occurred at the tube wall as well as the diameter tube increased. This bulging and thinning process run simultaneously until exceed certain allowable load and force that cannot be sustained by tube wall before this heat exchanger tube burst. These processes affect size and shape of the tube wall grain boundaries.

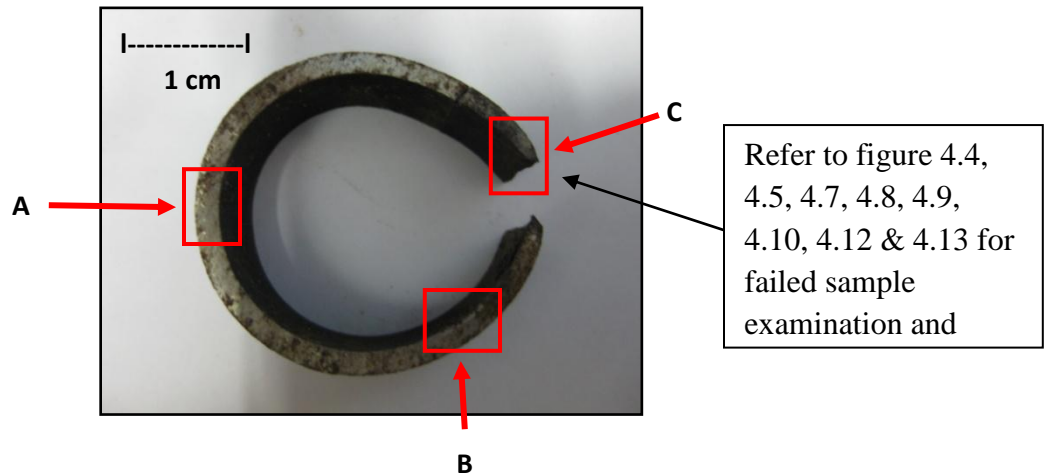
Location	Thickness (mm)
A(away from burst area)	2.10
B (near burst area)	1.65
C (burst area)	1.10

Figure 4.2: Cross section of the burst tube

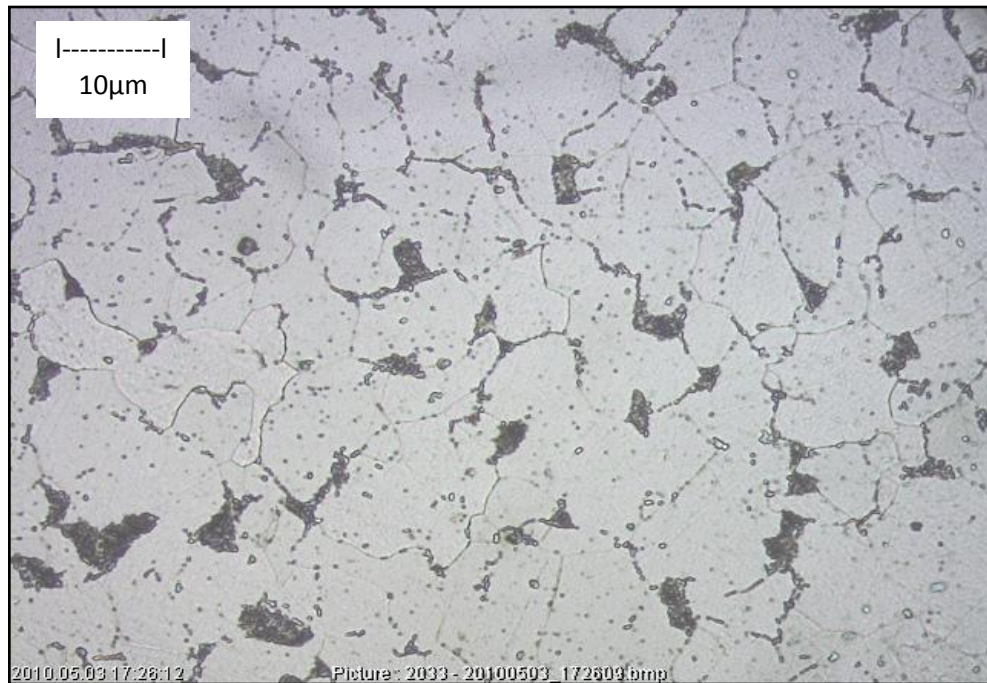
There are huge different comparisons of microstructure in between 2 samples, normal ones and failed area after being examined by optical microscope (OM). With referring to Figure 4.3, the normal sample seems to have a consistent in grain boundaries sizes and shape compared to the failed sample. The pearlite seems to agglomerate and precipitated along grain boundaries for both samples. The failed sample was observed to elongate and formed closer to grain boundaries but different in size and shape as shown in Figure 4.4 & 4.5. The elongations of grains form the long horizontal grain with a thin size. This point is a weak point due to loss of grain boundaries bonding strength. The indication of the heat exchanger tube microstructure plastic deformation has been observed.

Figure 4.3: Away (normal) area by optical microscope with 50X magnification

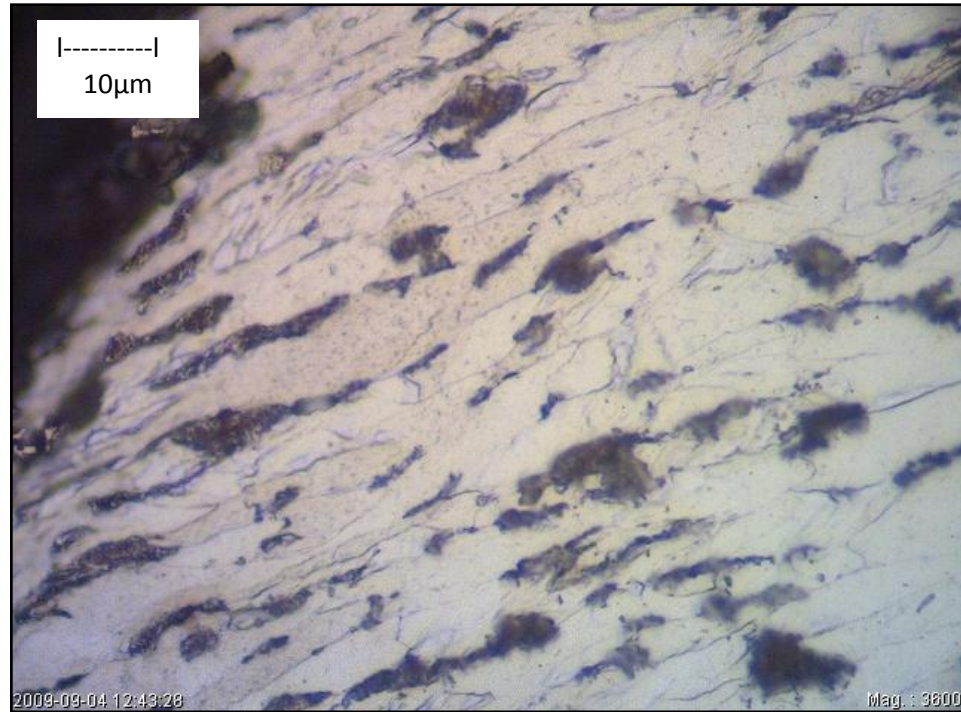
Figure 4.4: Elongated deform grain (failed area) by optical microscope with 50X magnification

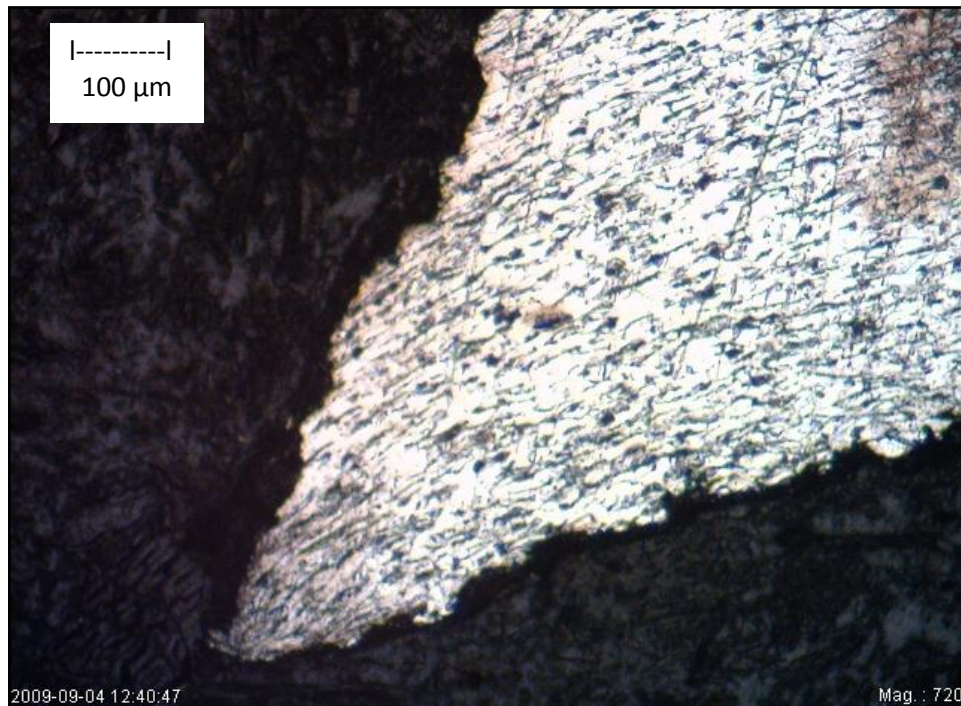
Figure 4.5: Elongated deform grain (failed area) by optical microscope with 10X magnification

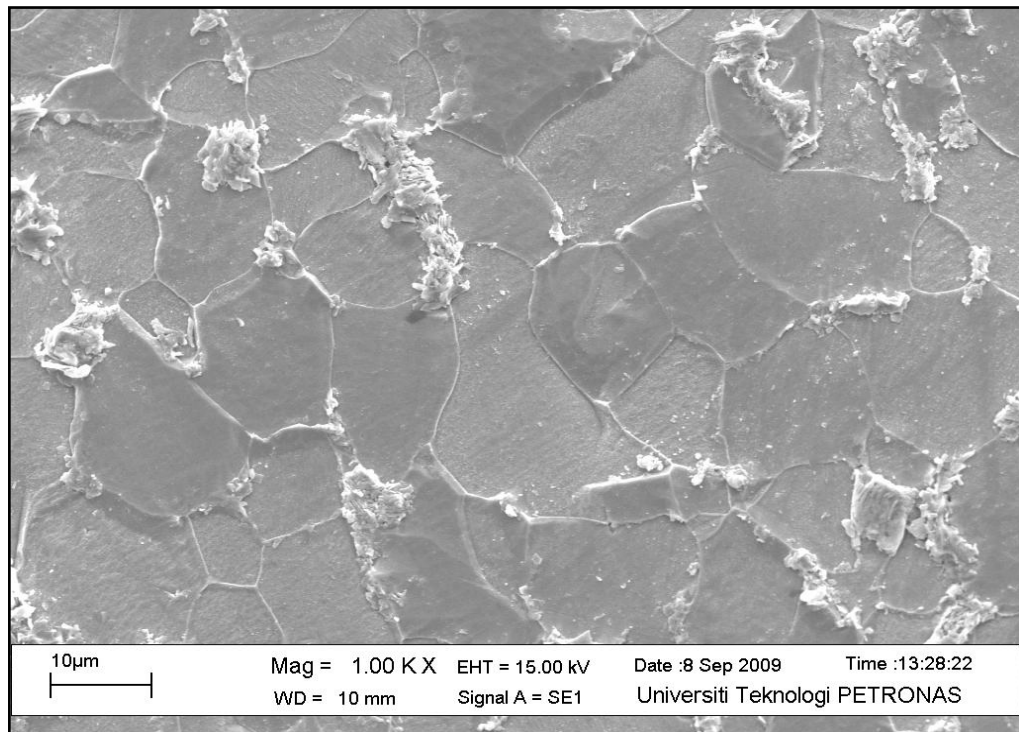
Metallographic sample examination has been performed by scanning electron microscope (SEM). The normal area observed to have consistent shape and size of grain boundaries as shown in Figure 4.6. There is no indication of affected grain. Pearlite seems to agglomerate and precipitate along the grain boundaries for both normal and failed sample. For the failed area, the grains observed to elongate and form the long horizontal shape in a thin size together with the occurrence of plastic deformation indicate by Figure 4.7. The grain observed to move towards and become closer to each other. Recrystallization of the grain / microstructure has been pragmatic. Besides, the micro voids and cavities formation along the grain boundaries has been observed as express in Figure 4.8 & 4.9. These micro voids and cavities formation revealed the indication of creep failure. Nucleation and growth of cavities to coalescence increase the rate of creep failure.

Figure 4.6: Away (normal) area by SEM with 1000X magnification

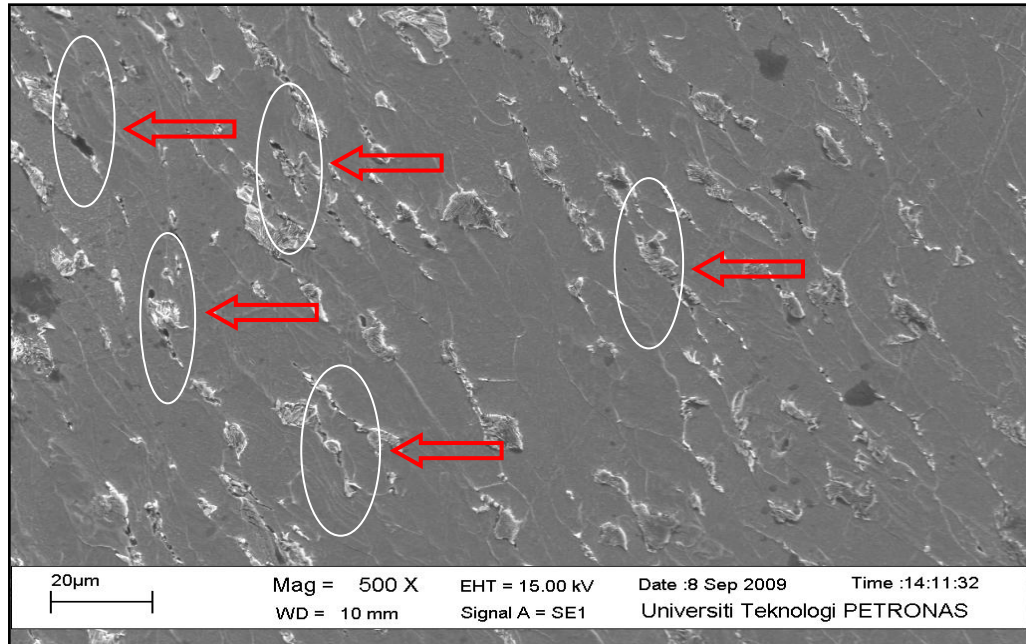
Figure 4.7: Micrograph showing elongated deformed grain and formation of micro voids (failed area) with 500X magnification

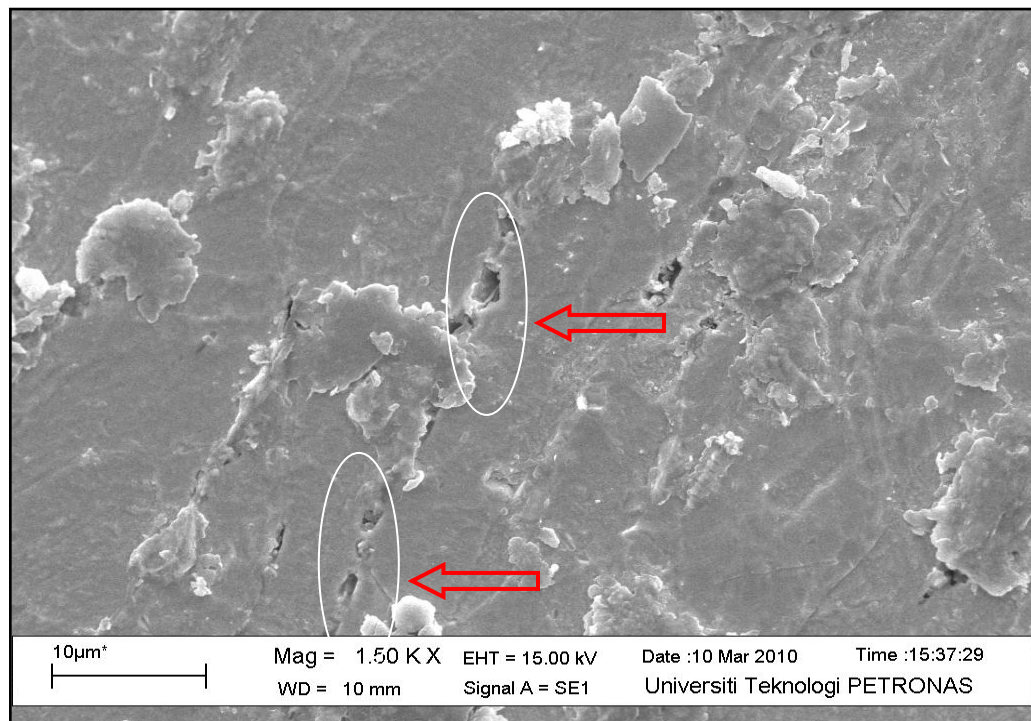
Figure 4.8: Micrograph showing elongated deformed grain and formation of micro voids (failed area) with 1500X magnification

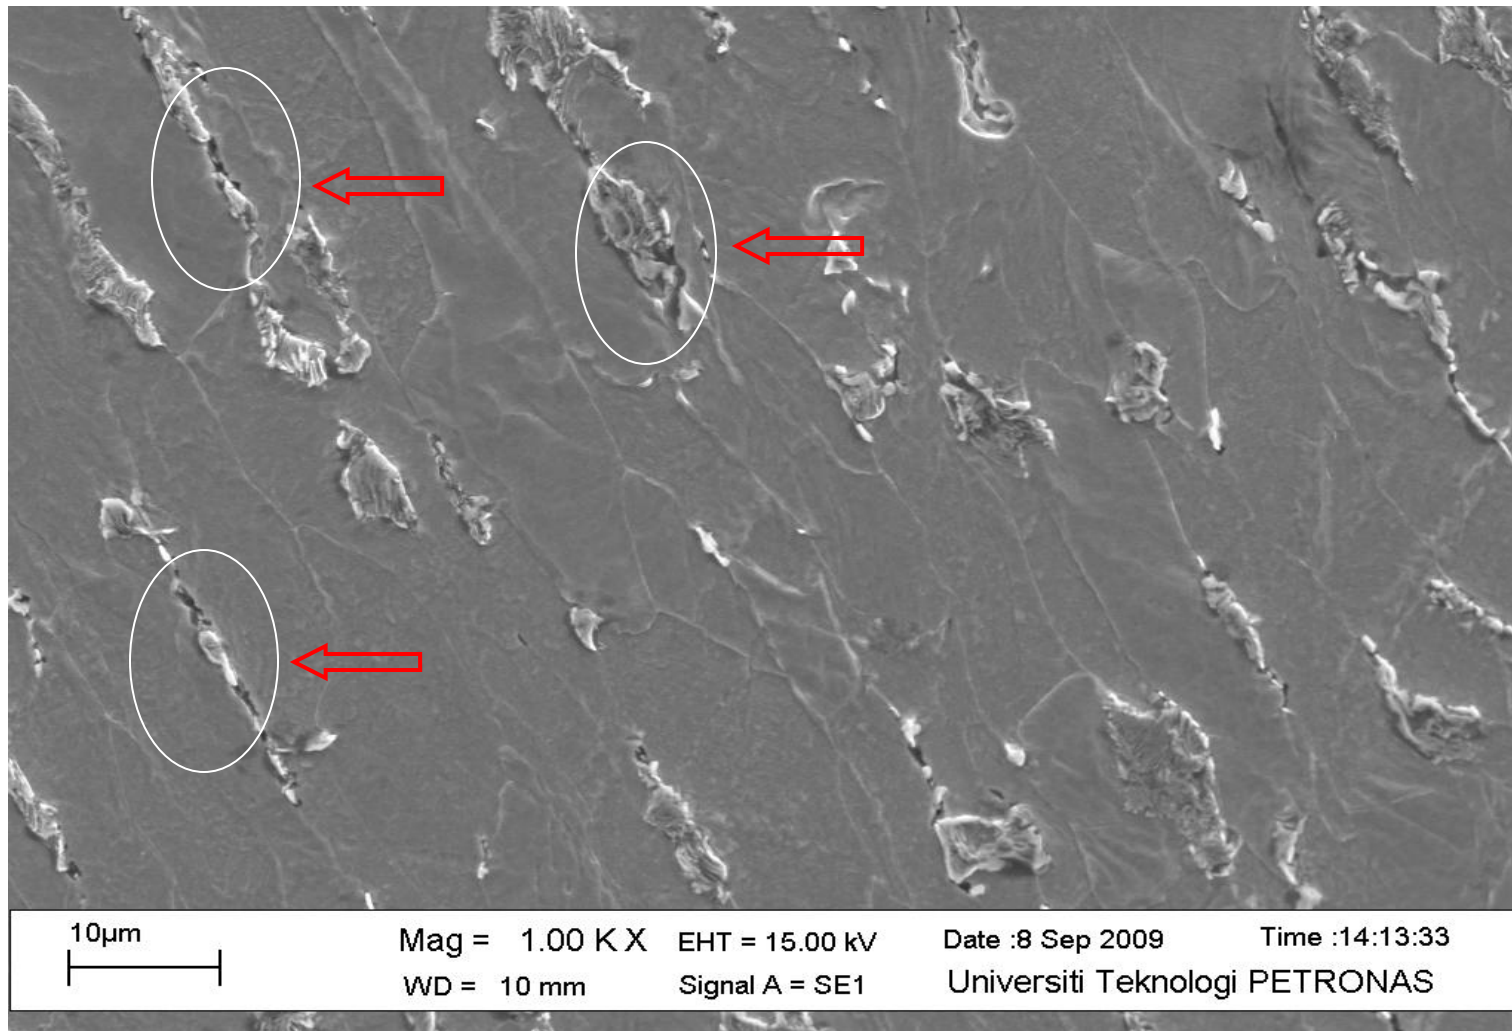
Figure 4.9: Close-up view of elongated deformed grain and micro voids formation (failed area)

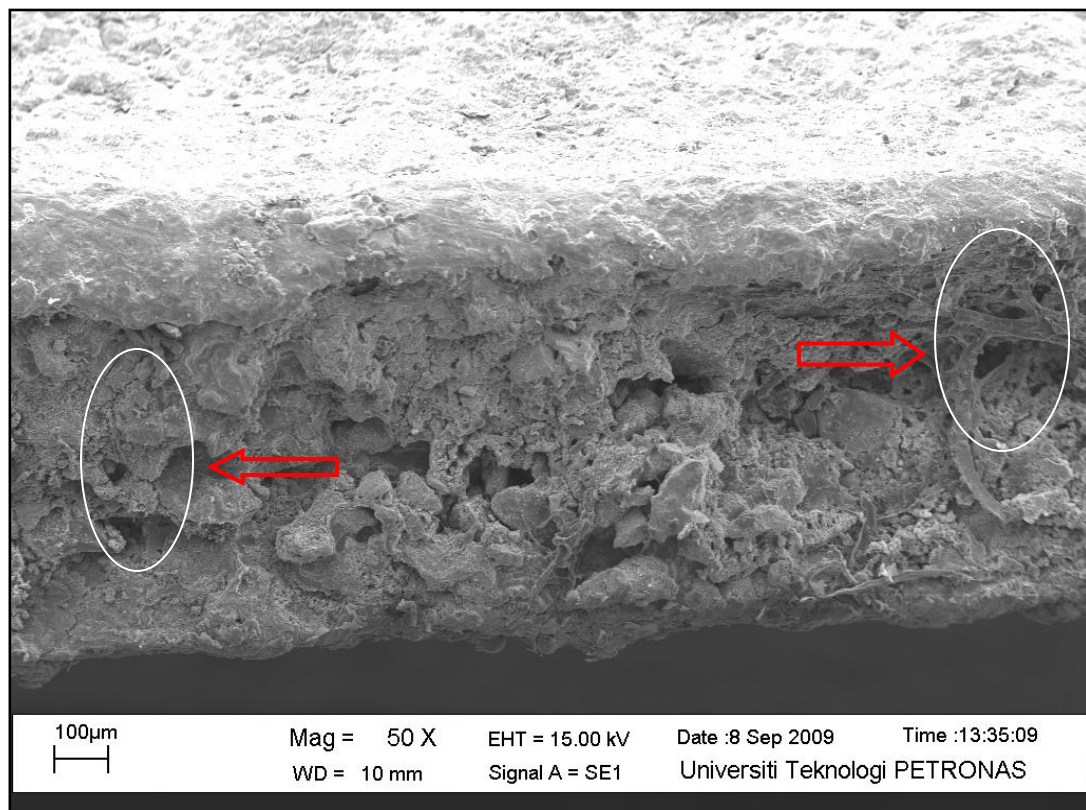
For the fractographic analysis, the failed area observed to have ductile fracture modes. This analysis was supported by the appearance of the dimple, cavities and micro pores at the fracture surface together with mode of ductile fracture. Micro voids or dimples elongated in direction of loading and cross section is reduced by necking. Besides, failure area with higher magnification of scanning electron microscope divulges the intergranular crack criterion. This phenomenon occurs due to coalescence and lining of cavities and voids to form intergranular cracks as shown in Figure 4.10 below.

Figure 4.10: Fractographic of fracture surface by SEM showing the intergranular crack, dimples and micro pores

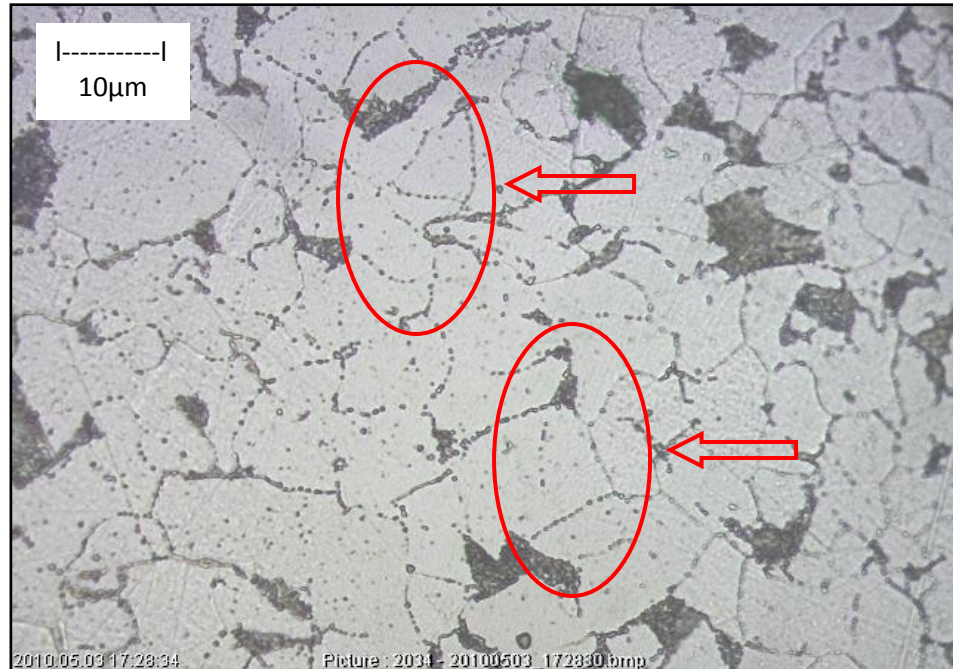
Creep results in slow plastic deformation and ultimate coalescence of micro cavities in metal during overheating revealed evidences of creep damage and rupture as indicated by lining of creep cavities to form intergranular cracks. In polycrystalline metal subject to creep at elevated temperatures, the nucleation and growth of cavities to coalescence also play a major role in the failure process. With referring to Figure 4.11, rounded voids are formed by the coalescence of vacancies at grain boundaries in diffusion creep that increase with time constraint. Figure 4.12 shows tertiary creep is associated with the formation of cavities and voids along the grain boundaries. Micro cracks are formed as the voids and cavities coalescence become connected and propagate along grain boundaries leading to intergranular fracture as demonstrated by Figure 4.13.

Figure 4.12: Tertiary creep stages with a formation of voids and cavities

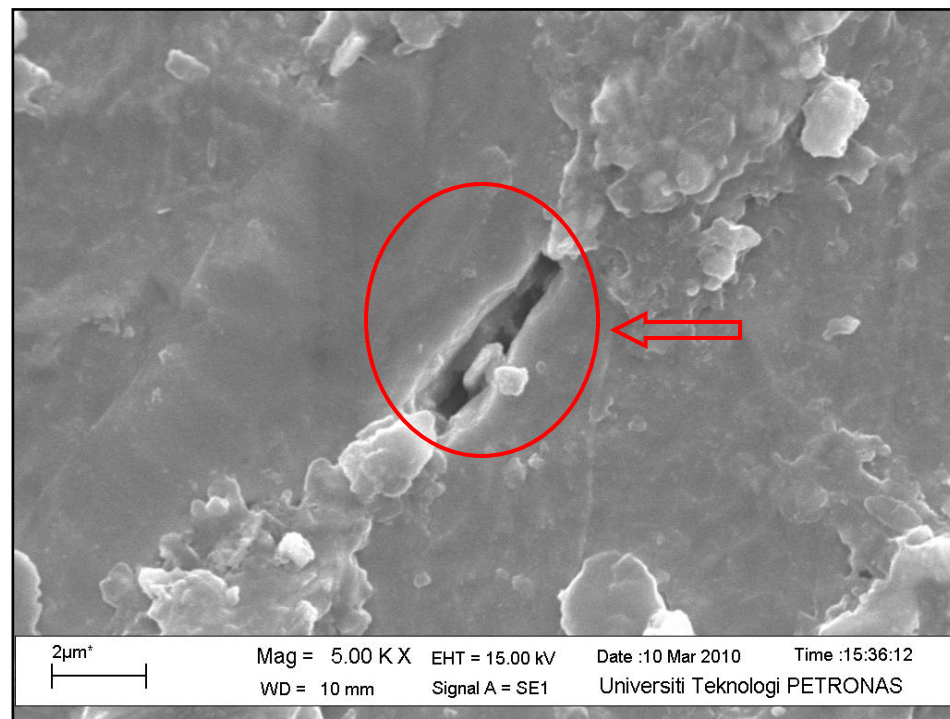
Figure 4.13: Void and cavities lining and connected to form intergranular crack

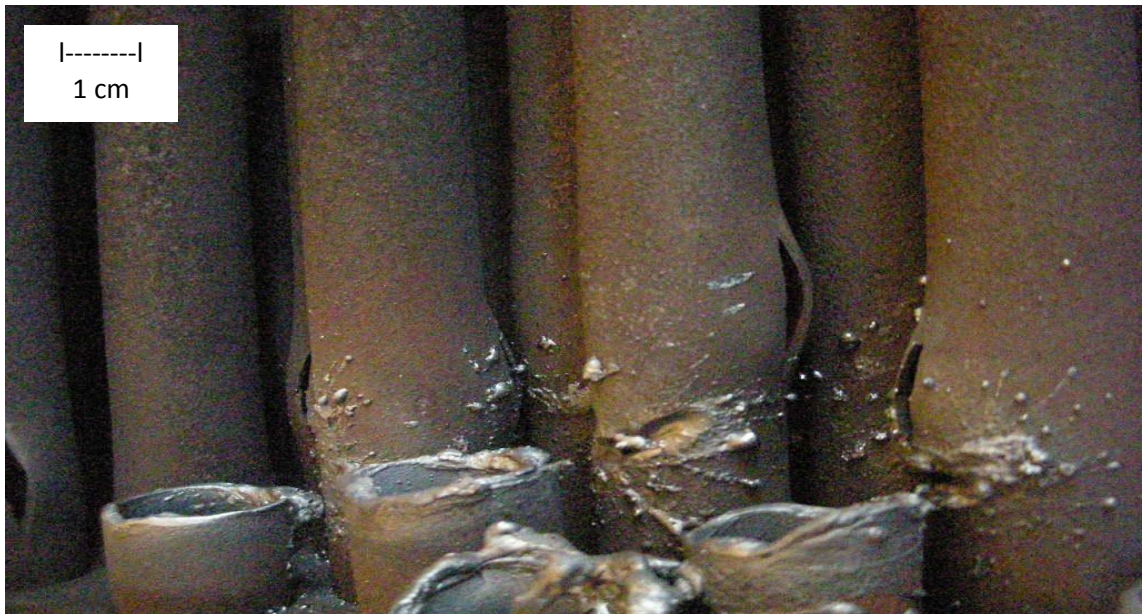
Appendix 1: Bulging and burst tube

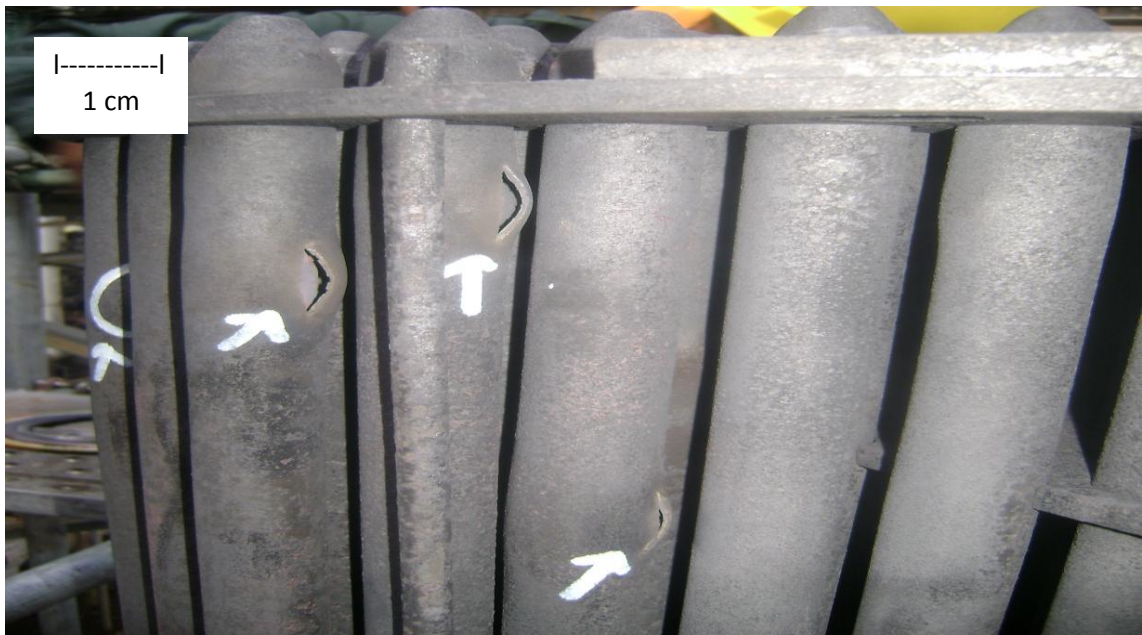
Appendix 3: Heat exchanger tube failure position

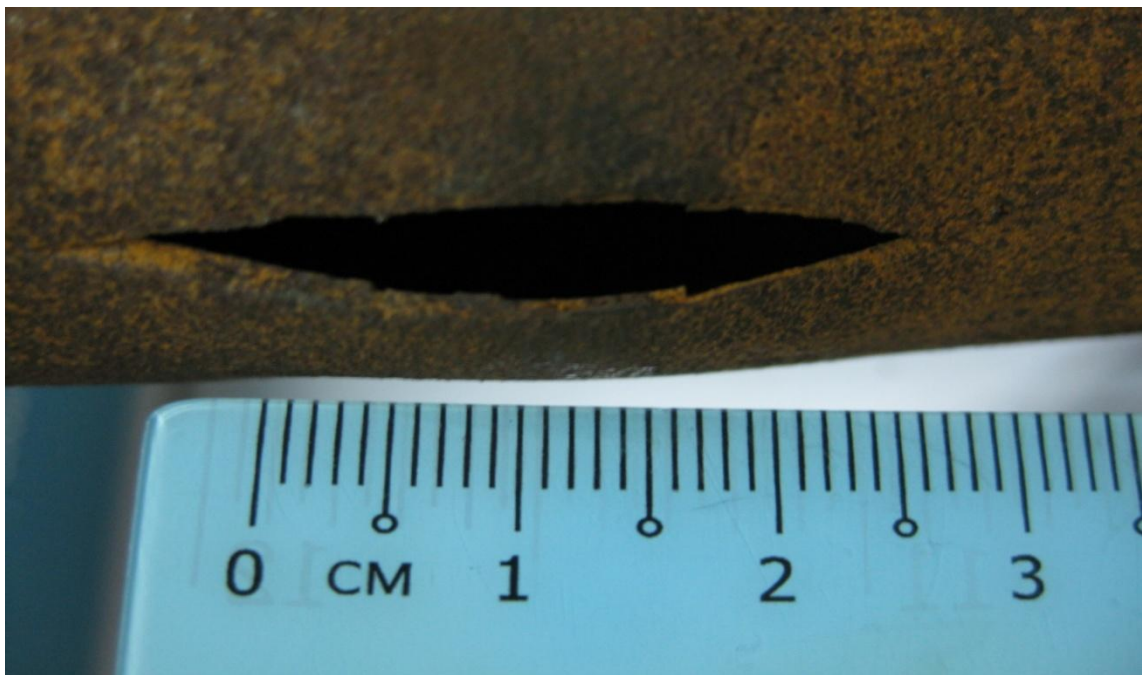
Appendix 4: Close up view of the burst heat exchanger tube

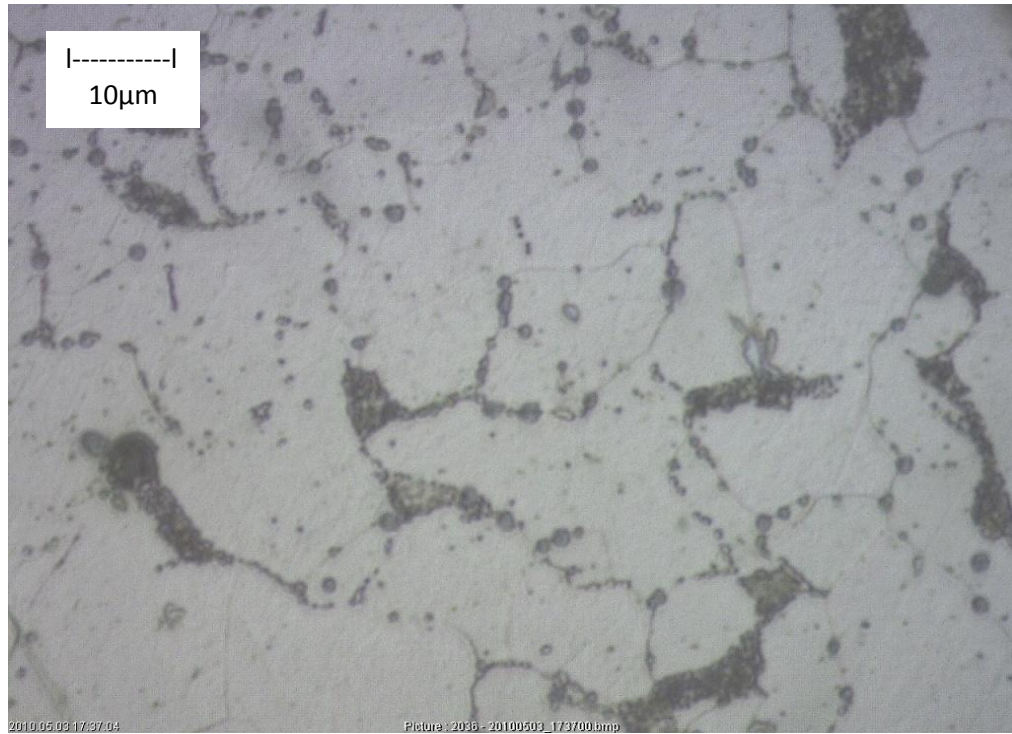
Appendix 6: Cavities and micro voids formation along grain boundaries

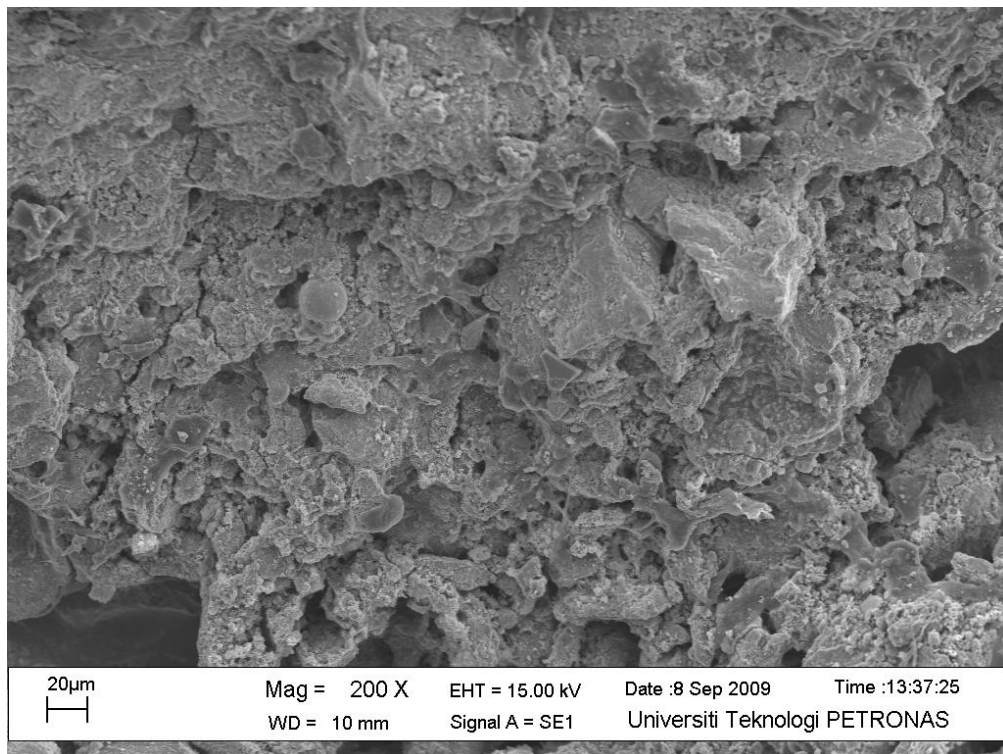
Appendix 7: Fracture surface on failed area
