Furnaces at Ethylene (M) Sdn Bhd is ethane cracking heater which are used to crack ethane to produce ethylene gas and other useful byproduct which is mainly fuel hydrogen gas. The cracking heater is gas fired and the fuel gas is hydrogen and methane-off gas. ^[1]

Furnace tube prematurely failed after 1 years of operation. Total replacement of furnace tubes are scheduled after 6 years of operation. The last total replacement of the tubes was done in June 2008. The tube experienced bulging and cracks, suspected due to overheating. Failure analysis to identify the causes of failure is to be done.

General Information		
Plant	Ethylene (M) Sdn Bhd	
Tag Number	ET-O-F-105 (Coil 6)	
Design Code	API 530/ ASME VIII Div 1	
Design Parameters		
Material	Nickel based alloy (25-35 CrNi)	
Design Life	100,000 hours	
Design Operating Temperature	1100°C	
Operating Temperature	692 °C (Outlet), 841°C (Inlet)	
Tube thickness	6.55 mm	
Manufacturing Information		
Manufacturer	Schmidt-Clemens	
Manufacturing process	Casting	
Failure Information		
Component maintenance history	major	Total radiant tubes replacement conducted in 2003 and 2008. Replacement of furnace linings carried out in 2006.
Date of failur

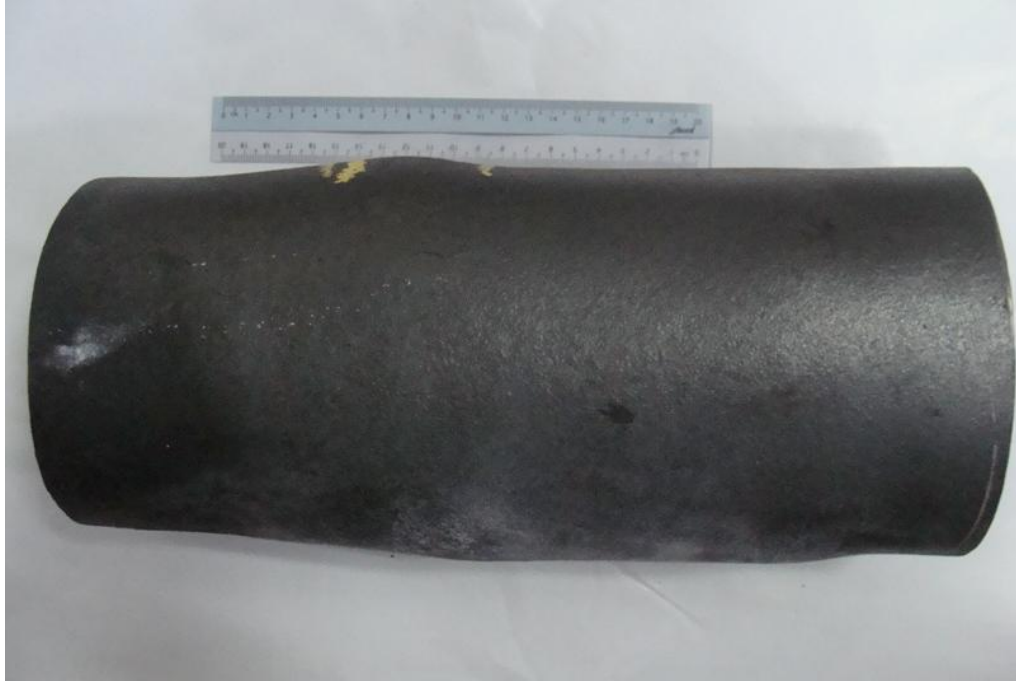
Figure 4.1: Tube bulge as received sample (1)

Figure 4.1 shows the actual bulge and rupture of as received sample. Figure 4.2 shows tube diameter is now increased and elliptical. This is a big amount of deformation. It is

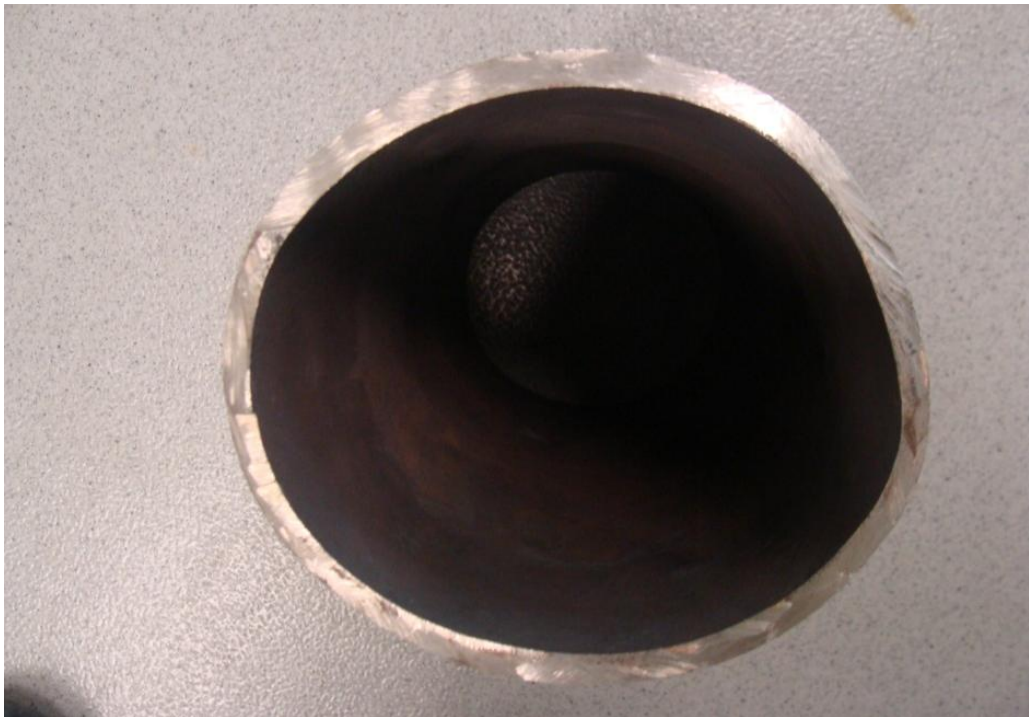
Figure 4.2: Furnace tube from upper view

consistent, however, with a tube that has operated at higher than normal temperatures for short periods.

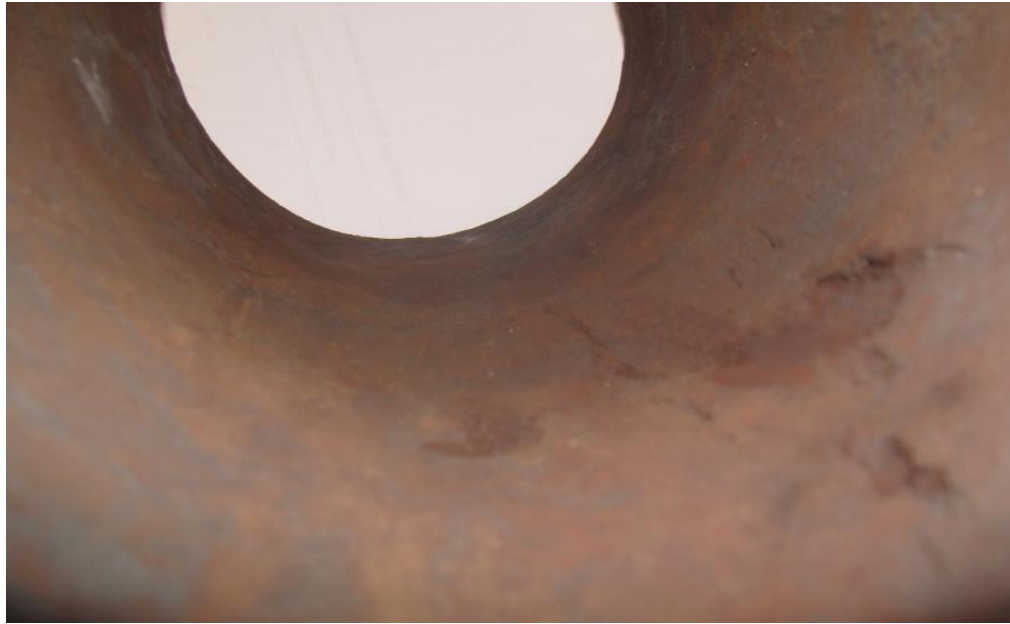
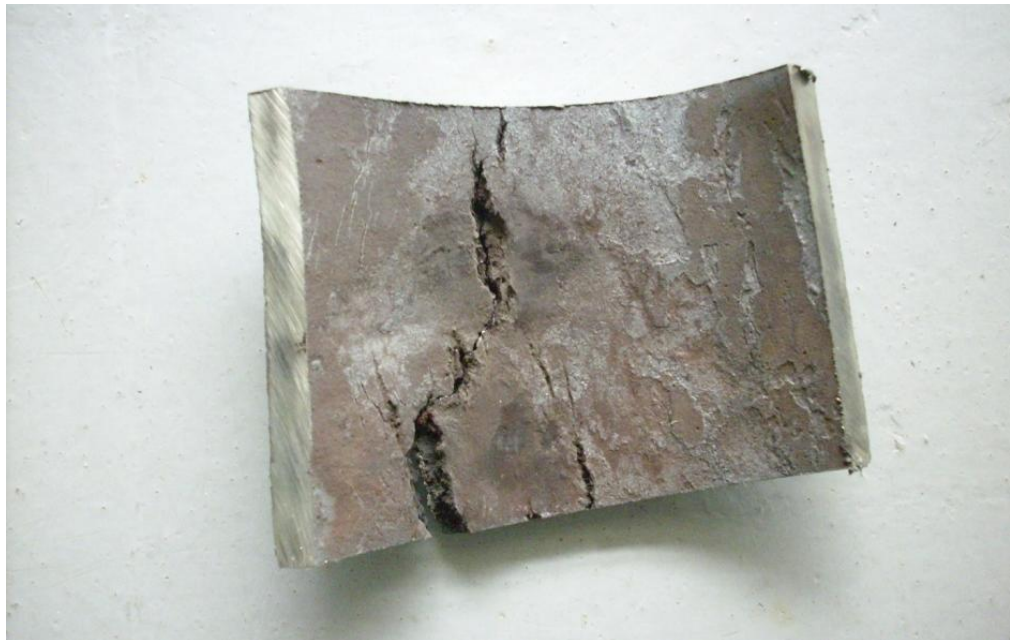
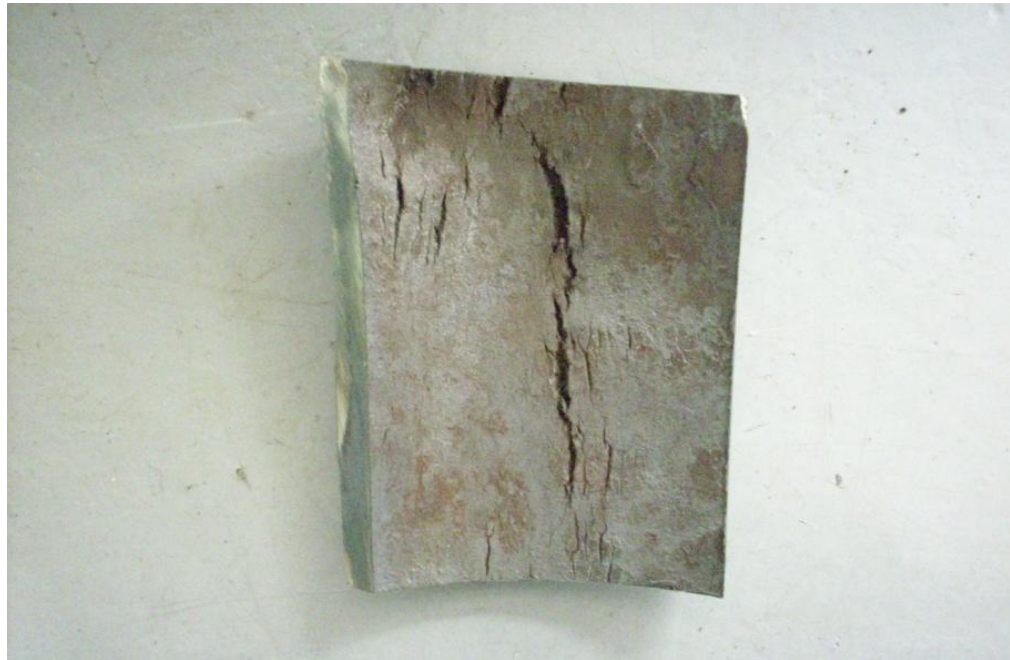
Figure 4.3: Internal cracks

Figure 4.4: Internal cracks

Figure 4.5: Internal cracks

Figure 4.3, 4.4 and 4.5 shows the crack viewed on the tube inner surface. The crack is discontinuous in inner surface.

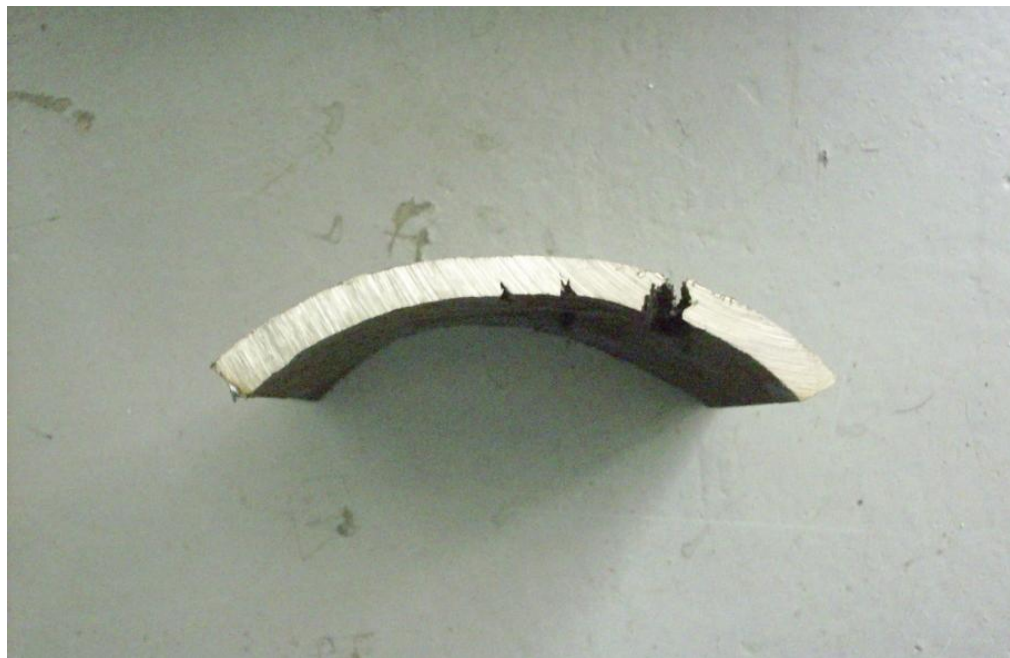
Figure 4.6: Penetrated internal crack

Figure 4.6 shows penetrated internal crack. The penetrated crack is longer and bigger in inner surface than that in outer surface which indicates the crack originated from inner surface. There is no indication of any localized damage in the form of pits. No wall thinning and plastic deformation is observed near the crack which reveals that the crack is brittle in nature.

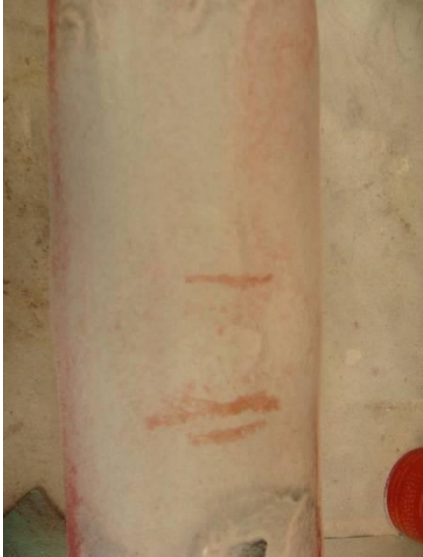
No crack detected at one side of the tube even though minor bulging is detected at this side of tube.

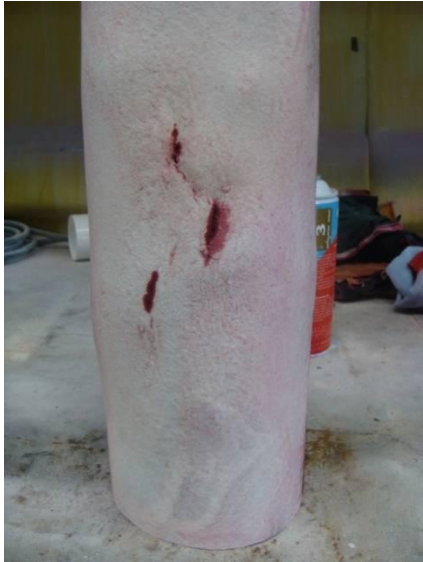
Three cracks detected at the other side of the furnace tube where major bulging is detected. The cracks' lengths are about 3.0-3.5 cm. No minor cracks detected at other part of the furnace tube.

The result of this test concludes that the cracks originated from the inner surface and penetrated to the outer surface at some point where the failure is most severe.

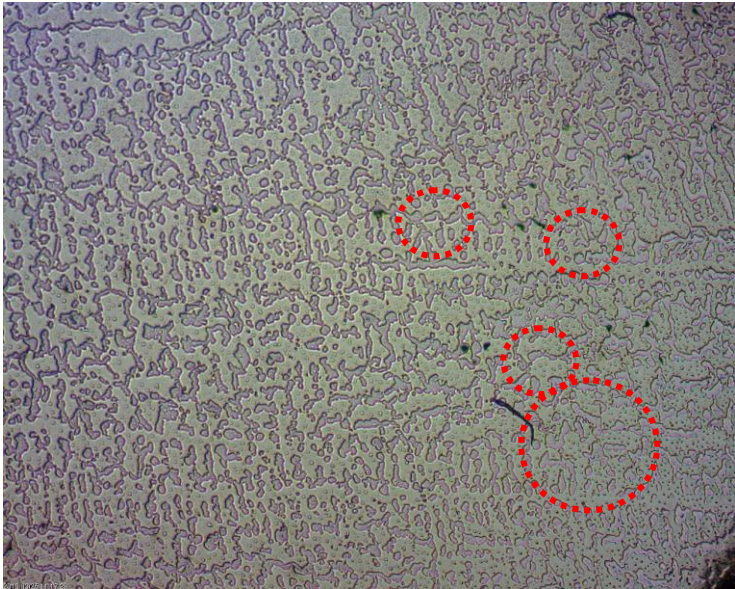
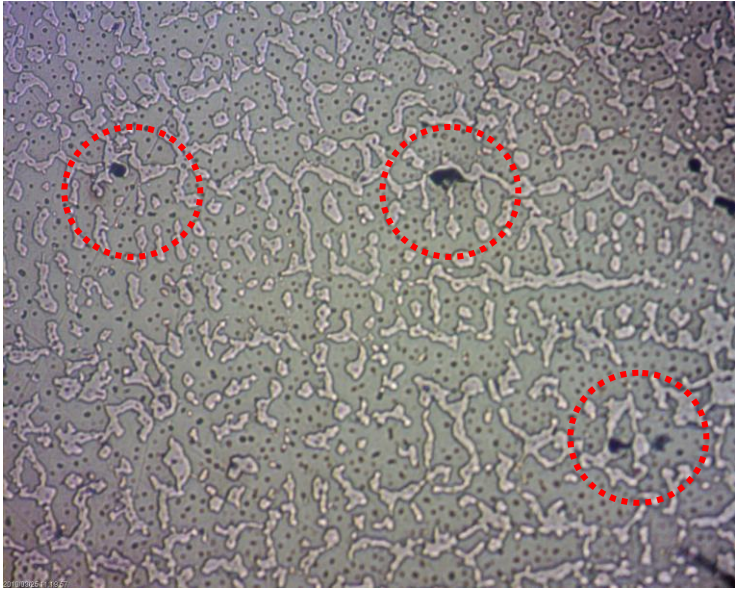
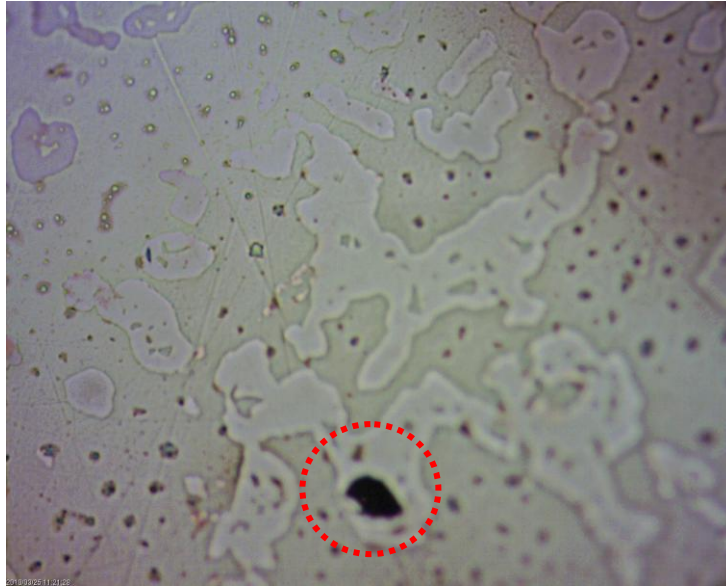
Figure 4.7: Microstructure of failed tube

Figure 4.7 (a), (b) and (c) shows austenite matrix and a network of primary carbide of the tube, which is typical microstructure of as-cast materials of alloys with high chromium and nickel contents. However, precipitates of small blocky type are found in the austenitic grains as shown in the circles. Carbides are obviously coalesced and blocky which indicates overheating. This is in line with initial tests which lead to overheating caused by carburization.

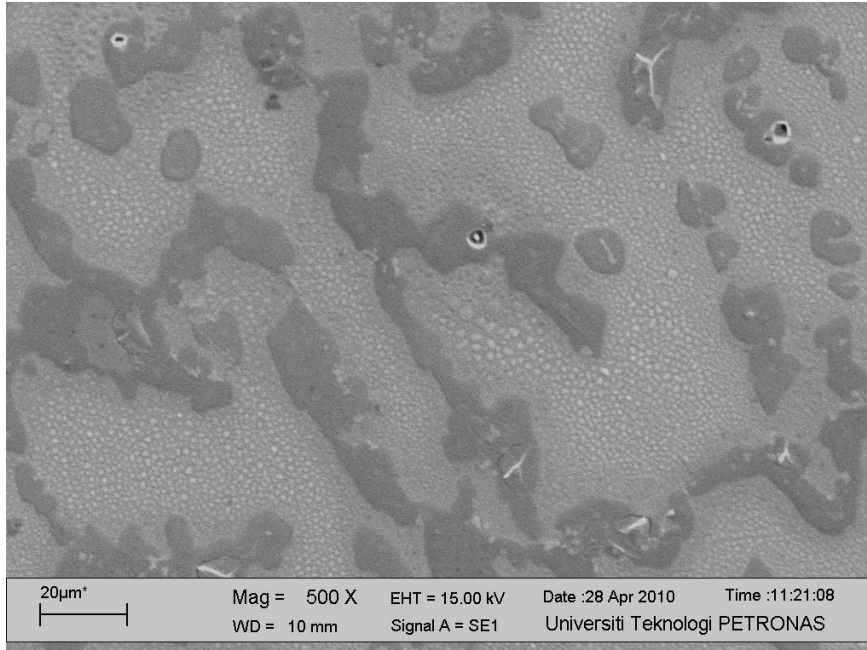
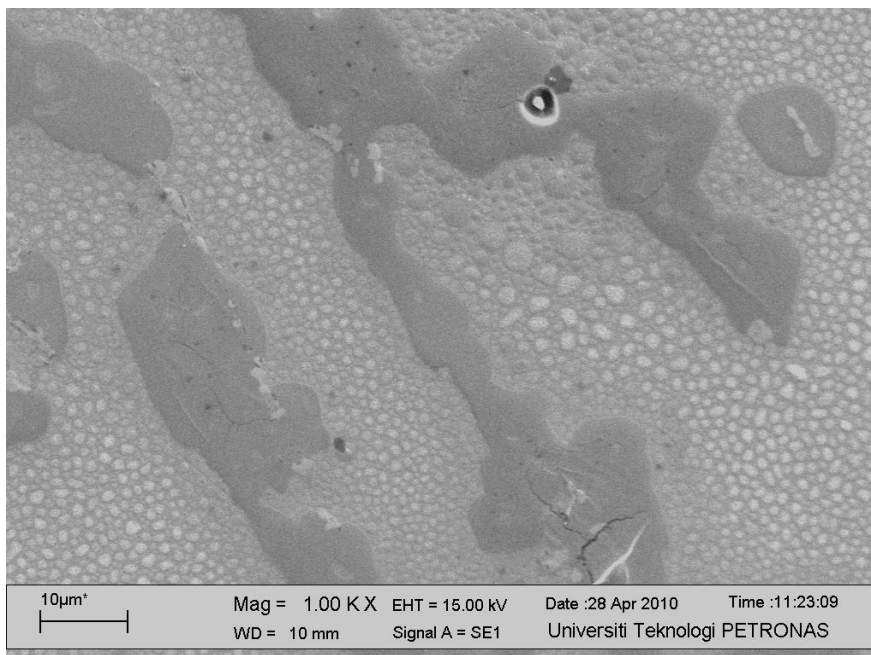
Figure 4.8: SEM image (500X magnification)

Figure 4.9: SEM image (1000X magnification)

Figure 4.8 and Figure 4.9 show SEM image from the failed tube sample. The carbide precipitation appears relatively coarse both at the austenite grain boundaries and within the matrix itself. The dark grey area is confirmed to be chromium-rich carbides from EDX analysis.

The sample shows a high degree of carbide precipitation at the grain boundaries and blocky carbide particles in the matrix compared to the uncarburized Nickel-Chromium alloy. Massive carbide precipitation at the austenite grain boundaries (forming a continuous lattice) and the presence of carbides as coarse blocky particles within the matrix indicate the exposure of the furnace tubes to an excessively high temperature that leads to heavy carburization.

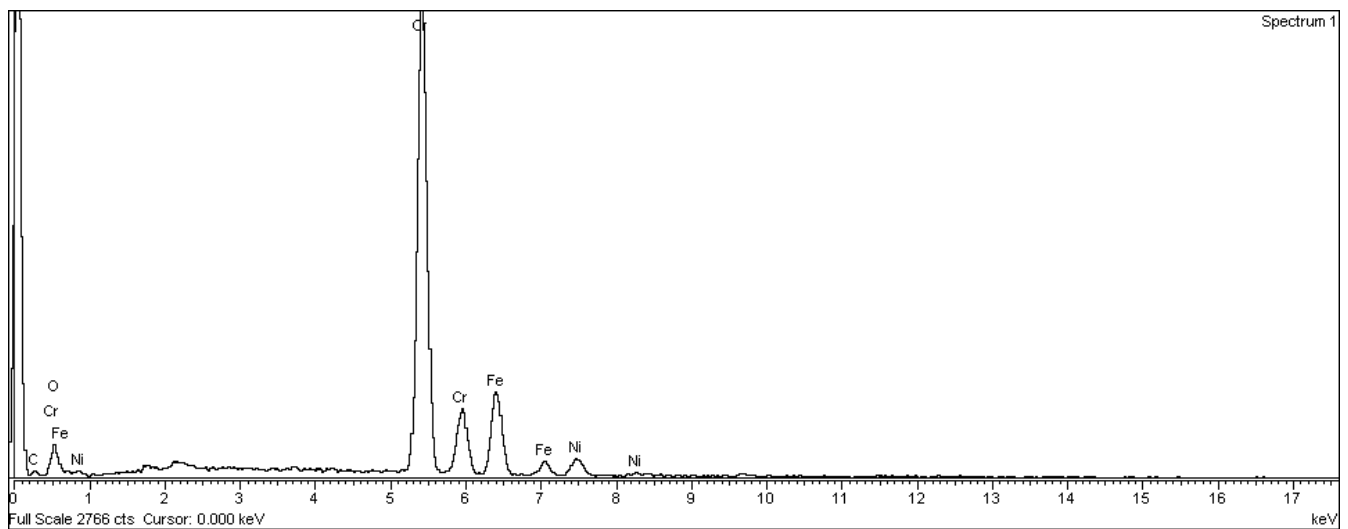
Figure 4.12: Energy dispersive X-ray spectra obtained from dark grey region

The Energy dispersive X-ray result shows large peak for Chromium. Chemical composition shown in Table 4.5 shows that the dark grey precipitates are chromium-rich precipitates.

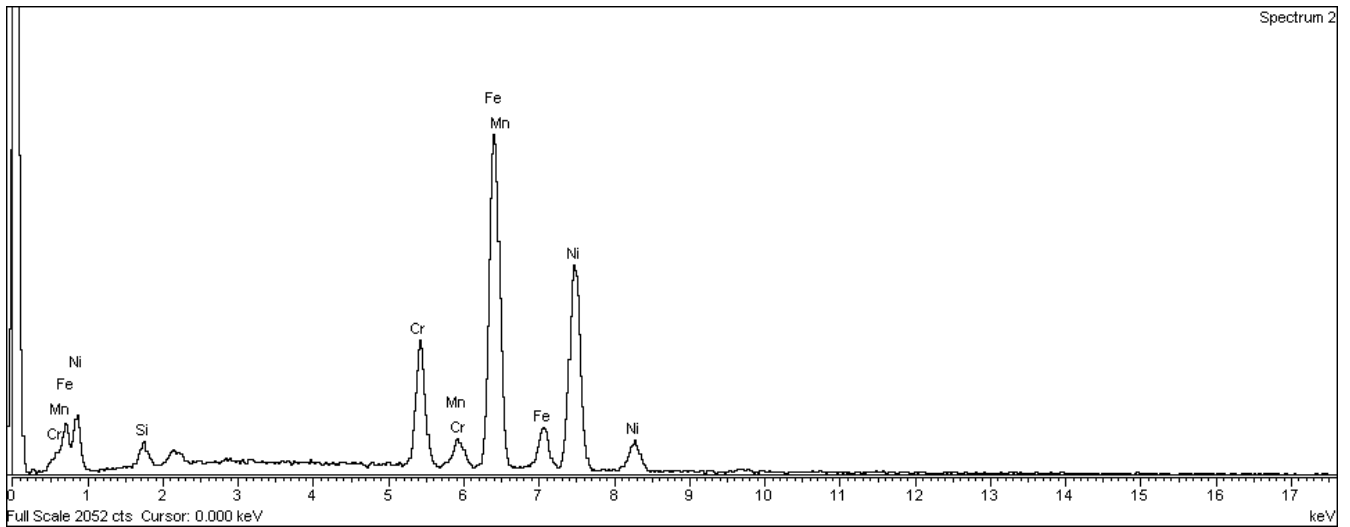
Figure 4.13: Energy dispersive X-ray spectra obtained from light grey region

The Energy dispersive X-ray result shows large peak for Ferum. Chemical composition shown in Table 4.5 shows that the dark grey precipitates are Ferum-rich precipitates.

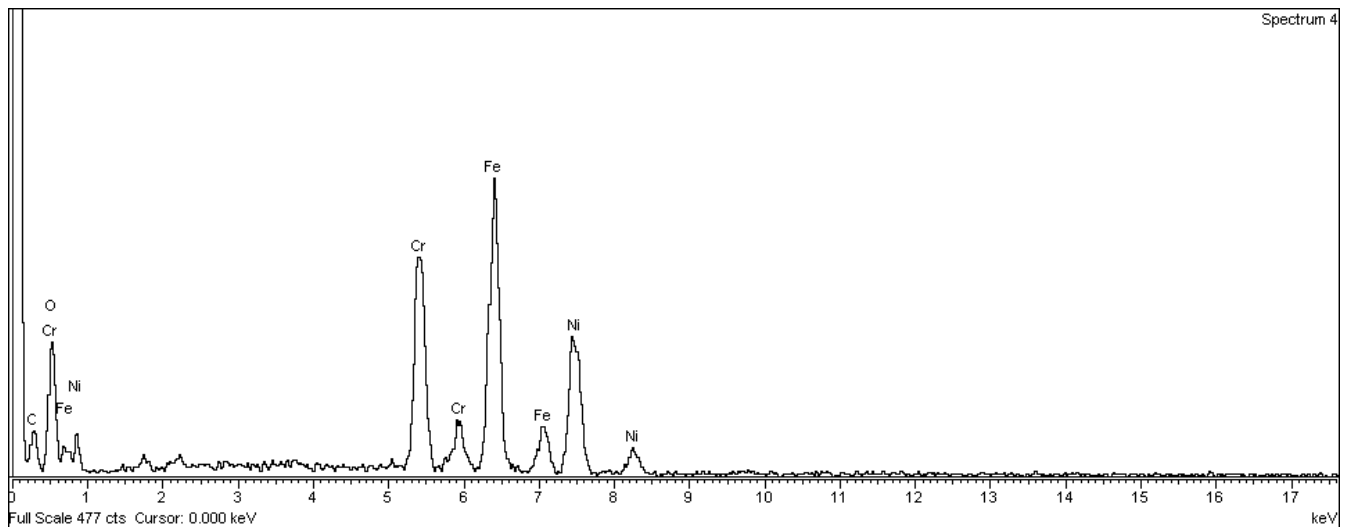
Figure 4.14: Energy dispersive X-ray spectra obtained from surface of the sample

The Energy dispersive X-ray result shows the presence of Carbon. Comparing to chemical composition of the tube from the manufacturer, Carbon's percentage is much higher for the sample which is 15.03% compared to 0.40-0.45% as informed by the manufacturer.

This proved carbon's involvement in the reaction at the surface of the tube.

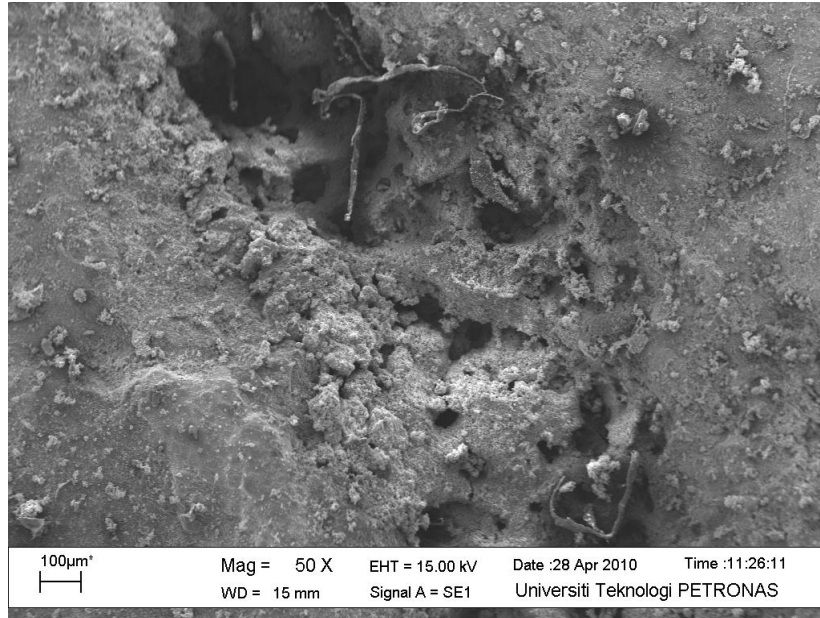
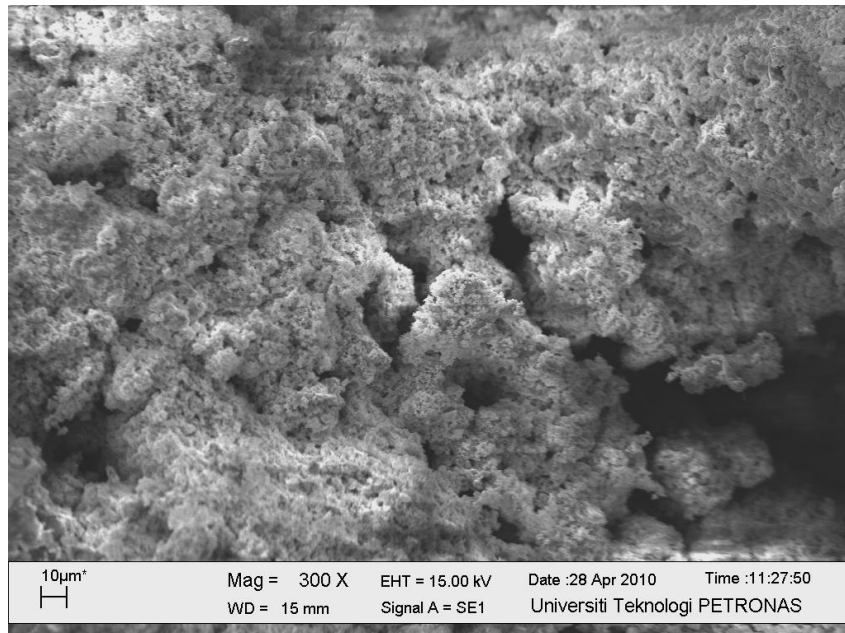
Figure 4.15: SEM image of fracture (50X magnification)

Figure 4.16: SEM image of fracture (300X magnification)

Figure 4.11 and Figure 4.12 present the fractography of the crack. The fracture mode was found to be intergranular crack.

Intergranular fracture can exclusively occur by creep deformation. However, it is accelerated by carburization attack which reduces the ductility of the material. If the material becomes unable to strain harden during the initial creep stage (primary creep), e.g., by intergranular cracking due to carburization, the creep rate is accelerated. ^{(4) (7)}

It can be concluded that the mode of failure of the radiant furnace tube was a combination of creep damage and carburization attack.

The temperature of the furnace should be monitored and controlled closely, in order to avoid over-heating during ethylene production and decoking.

It is recommended for Ethylene (M) Sdn Bhd to review all the parameters involved to make sure no overheating occur during process. Decoking process should also be reviewed in term of its frequency to control the deposition of coke. Decoking process which is done too frequent will could accelerate creep deformation, while in the other hand, without decoking process, coke formation will occur and disturb the process parameters.

As a long term solution, it is also recommended for Ethylene (M) Sdn Bhd to replace Nickel-Chromium alloy with an Al_2O_3 -forming alloy. Most evidence points out that there is a correlation between the protective nature of the surface oxide scale developed by the alloy and its resistance to carburization.⁽⁷⁾ Alloys that develop Al_2O_3 -base scale are found to be considerably more resistant to carburization in comparison with CrO_3 -forming alloys. It is believed that an Al_3O_2 -base scale impedes carbon diffusion into the alloy, which considerably reduces the extent of carburization.⁽⁷⁾
