CHARACTERIZATION AND PROPERTIES INVESTIGATION
OF AUTOMOTIVE STEEL EXHAUST PIPING FAILURE

MUHAMAD FIKRI BIN KHAIRDDIN

MECHANICAL ENGINEERING
UNIVERSITI TEKNOLOGI PETRONAS
JANUARY 2017

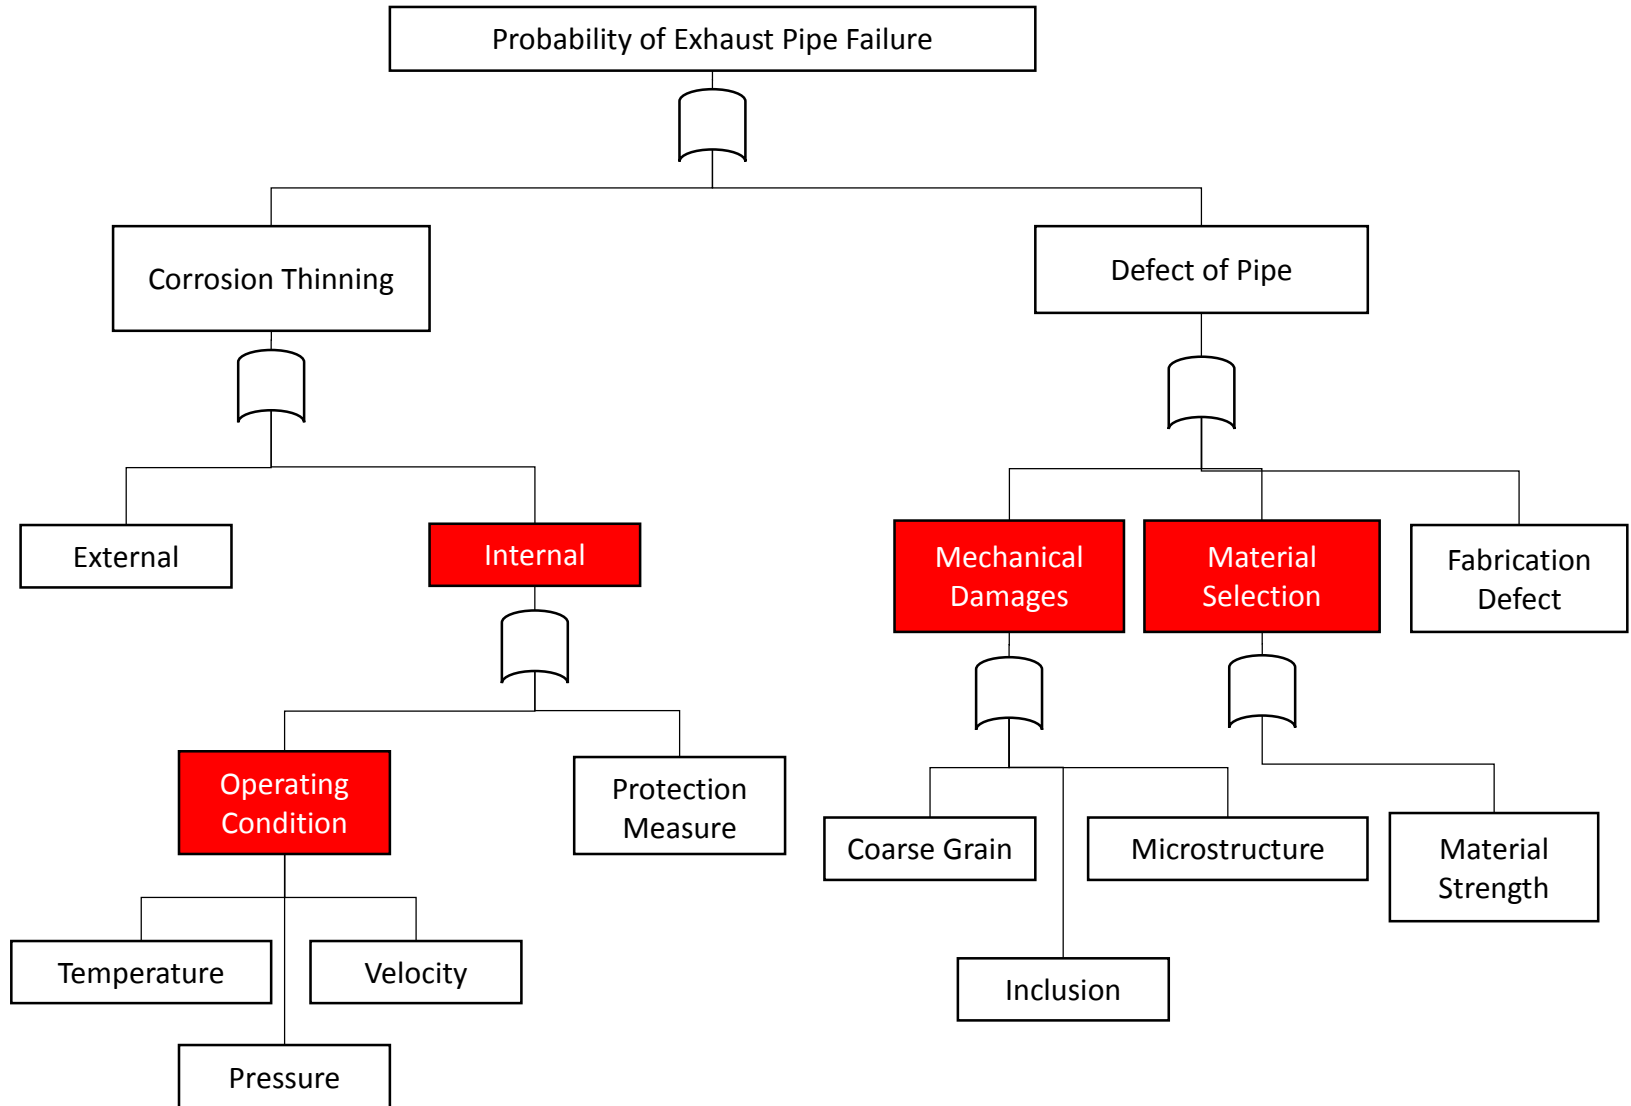
Figure 4.1: Fault tree analysis (FTA)

Further observation discovered a large portion of the exhaust pipe affected and damaged by corrosion. The inner surface of the exhaust pipe was strongly affected by the corrosion problem. Some sediments and corrosion products removed from entire inner surface of the pipes indicates that corrosion is occurred uniformly along the pipe. Several pits formation with different sizes and depths were observed in few areas leads directed to serious corrosion problem which leads to leakage occurred from the inside out of the pipe. In addition, some failures of the system's components, mainly at pipe elbows, appeared to be directly correlated to impingement due to extreme fluid flow during service life. Fault tree Analysis (FTA), shown in Figure 4.1 was used as one of Root Cause Analysis (RCA) tools to pinpoint possible failures in the exhaust pipe.

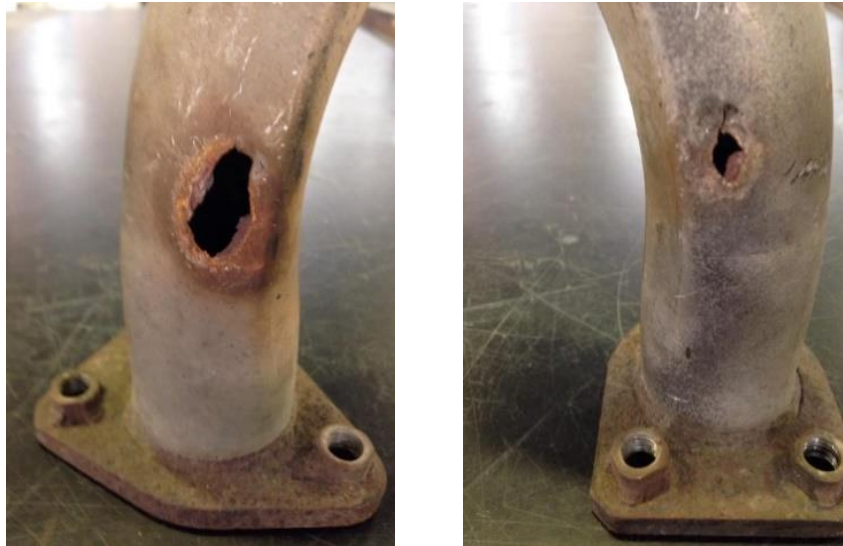
Figure 4.2: Condition of exhaust pipe studied

Figure 4.2 show the impairment incidents at the elbow of exhaust pipe. The exhaust system was disassembled after the failure occurred. Visual inspections were completed and it was observed that there are a number of leakages along the exhaust pipe especially at the elbow of the pipe. The largest hole was found at the bottom of the elbow exhaust pipe. Wall thinning phenomena can be found in the same area around midline direction of the exhaust pipe. Preliminary data of the exhaust pipe are tabulated in the Table 4.1.

- a) The exhaust pipe has the largest hole at the elbow of the pipe situated at the outer of the pipe measuring 23mm x 48mm (length x width).
- b) Internal corrosion indicated as scale and deposit were found on the inner surface of the exhaust pipe.
- c) A significant wall thickness thinning was observed at the failed area with hyperbolic shaped hole at the elbow of the pipe as illustrated in Figure 4.7.

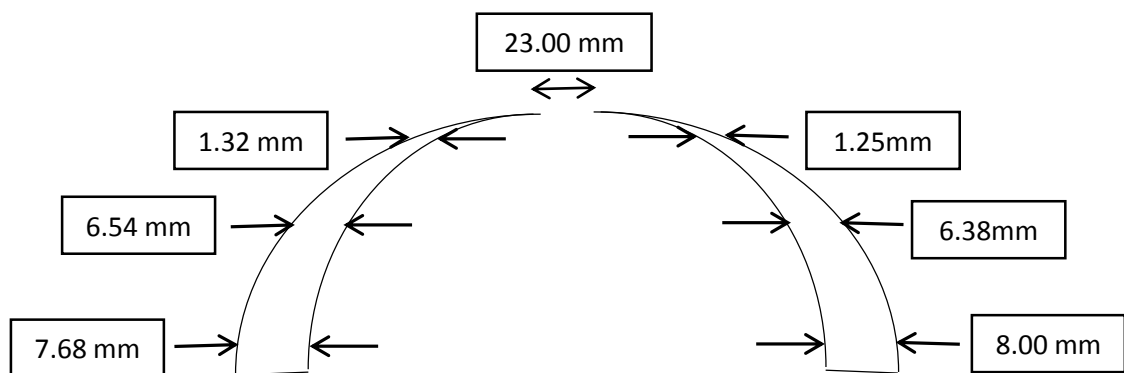
Figure 4.7: Schematic diagram thickness reduction of exhaust pipe

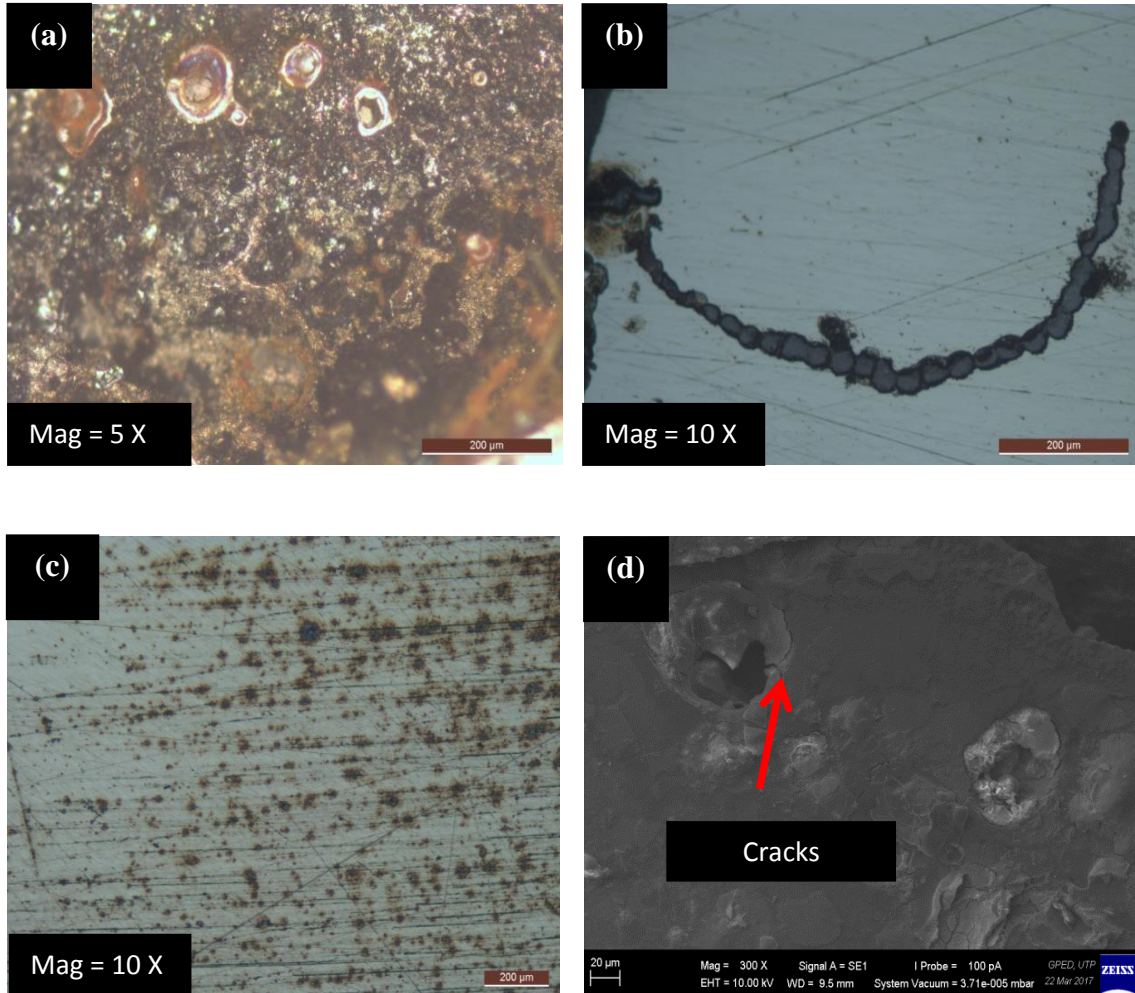
Figure 4.8: (a) Surface morphology of exhaust pipe (b) Linking of pits (c) Various size of pits formation (d) Crack propagation between pits

Figure 4.8(c) indicates various irregular shaped pits of unequal sizes randomly scattered. Frequently observed occurrence of cracks forming caused by sustained load or cyclic load shown by linking of pits in Figure 4.8(b). Formation of cracks is vaguely observed as link pitting formulated which lead to several site impairments. Localized corrosion process shown in Figure 4.8(a) causes propagation of microscopic holes linking to one another on steel surface. The initiation of pitting corrosion is due to the presence of local defects at the metal surface such as flaws in the oxide or segregates of alloy elements, and the presence of aggressive chlorides in the environment [33]. Crack propagation between the pits could be seen in Figure 4.8(d) under a high magnification. This initiates an opening thus leads to surface perforation.

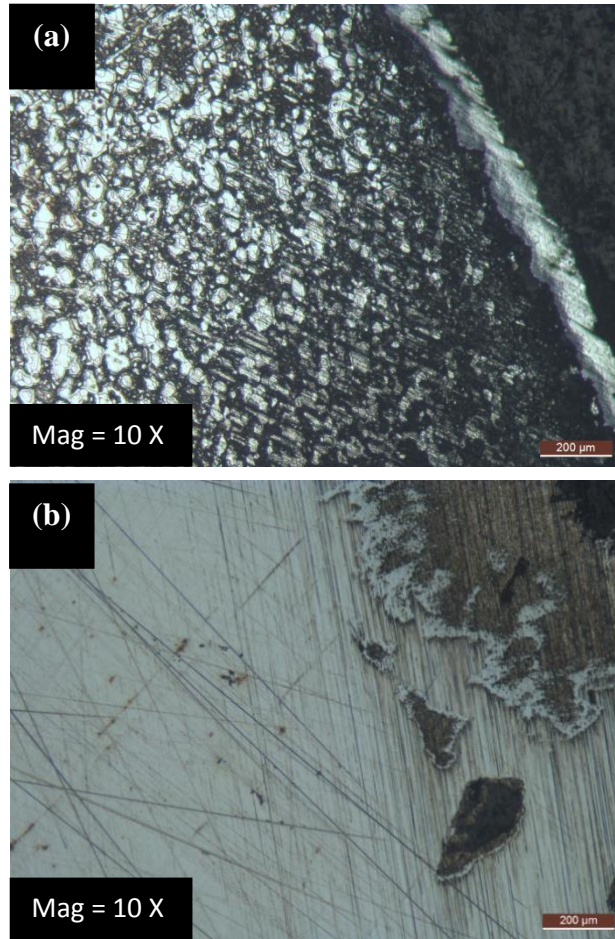
Figure 4.9: (a) Surface oxidation (b) Decarbunisation

Figure 4.9(a) shows surface oxidation or also known as scaling. Phenomenon known as high temperature oxidation observed due to effect of hydrogen on aluminium alloys [34]. Formation of oxide rich scale causes the material lost which reduce the thickness of pipe wall and the strength of the exhaust pipe. Some cracks existed across the scale and voids were present along the scale interface. High temperature oxidation caused by elevated-temperature atmosphere affects the surface layer of the exhaust pipe. Moisture contamination in the atmosphere stimulates surface oxidation and sometimes aggravated by Sulphur [35]. Decarbunisation of the exhaust pipe shown in Figure 4.9(b), caused the excavation of the material at the surface and a resulting porosity. Decarbunisation initiates with graphite subtraction on the surface due to the carbon-oxygen reactions producing carbon monoxide or dioxide resulting in poor wear resistance and low fatigue life.

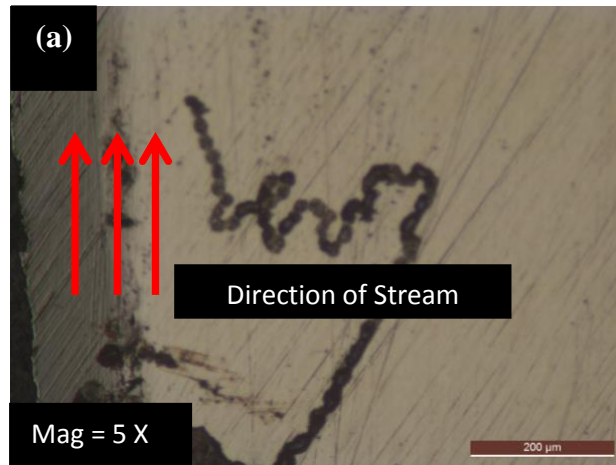
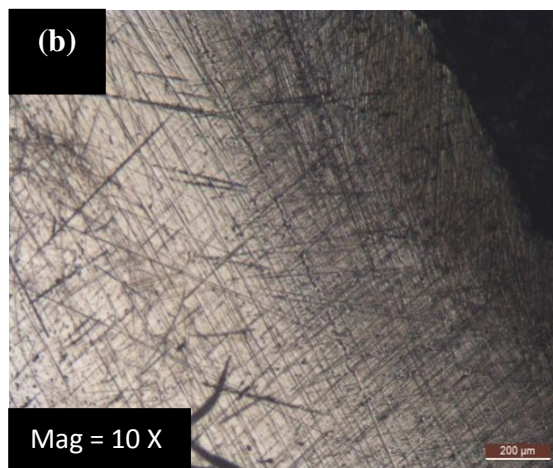
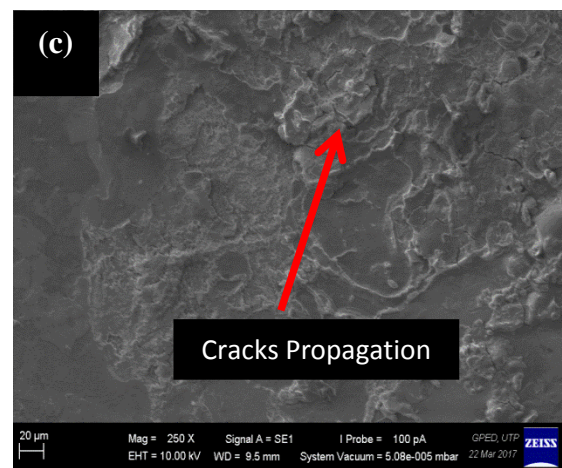
Figure 4.10: (a) Direction of gas stream flow (b) Erosion-corrosion traces (c) Surface cracks

Morphology of erosion site formed at high velocity area for the exhaust pipe steel is shown in Figure 4.10(a). The crack propagation formed suspected creates lumps at the surface of exhaust pipe thus lead to perforation. Figure 4.10(b) and Figure 4.10(c) were taken at the edges of leakage of exhaust pipe and sharp polishing area became relatively blunt and flat. Relative high velocity of fluid flow in the exhaust pipe leaving distinct erosion-corrosion traces. Rough surface features with directional pattern on the metal surface shows the direction of flowing fluid. From the Figure 4.10(b), observed the severe eroded or partly eroded lumps as well as the formation linking of pits. Occurrence of corrosion on the surface become worse due to high fluid velocity and high pressure as surface cracks formed as illustrated Figure 4.10(c).

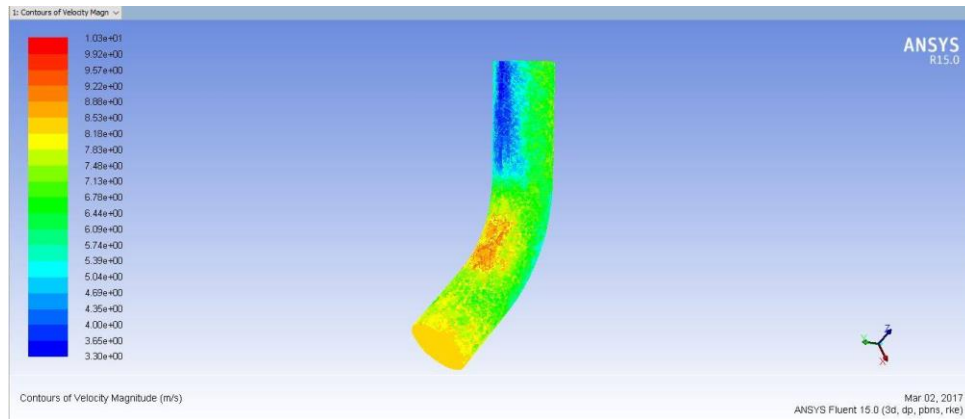
Figure 4.13: Velocity contour

Velocity values obtained vary between 3.30 m/s and 10.26 m/s as observed in the exhaust pipe. The velocity reduced as expected after passing over the elbow region. The velocity which is about 7.48 m/s at inlet becomes 3.30 m/s in some regions especially at elbow towards the outlet of the pipe. As shown in the Figure 4.14, the high-speed airflow zone of bend exhaust pipe area is mainly concentrated in the middle of inner pipe before the pipe elbow. At the same time, the inner velocity and outer velocity are greatly different one another at the elbow pipe region as illustrated by Figure 4.13.

High fluid flow introduced in Figure by exhaust system leads to erosion-corrosion damage. Perforations of exhaust pipe caused by erosion-corrosion failures allow exhaust leaks in internal components. Besides, solid particles in exhaust gas can rigorously cause erosion damage thus lead to the reduction of wall thickness of exhaust pipe. Corrosion failures may not affect the entire thickness of the pipe but reduces the thickness through pitting corrosion which allows premature fatigue or even a tensile failure.

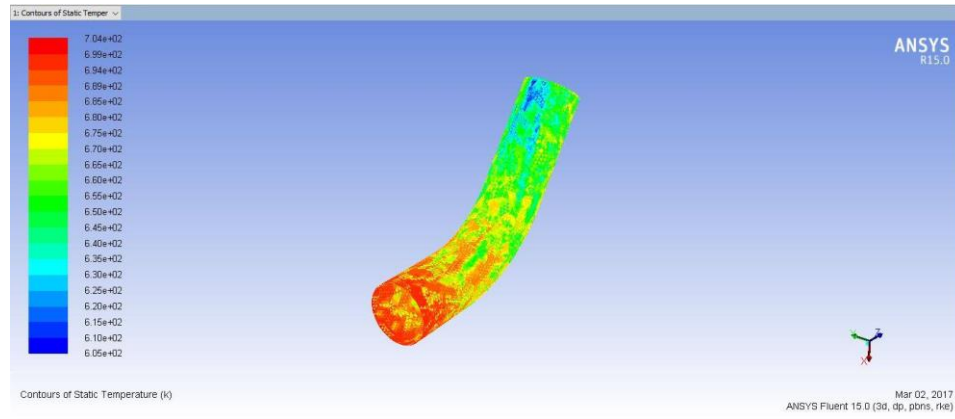
Figure 4.15: Temperature contour

Heat transfer between exhaust gas and pipe wall playing important role in determining the root cause of exhaust pipe failure. Throughout the research, the temperatures were recorded at inlet and outlet of the exhaust pipe. The temperature values of the pipe wall vary between 604K and 704K. It is observed that the temperature in the eroded pipe wall is higher than that in the surrounding areas. High loads in the pipe are expected as a result of rapidly fluctuating exhaust gas pressures, and turbulent hot fluid flow at a high flow rate as illustrated in Figure 4.15.

Exposed to high temperature distribution lead to thermal fatigue cracking consists of oxidation penetrating the pipe surface and creates crack opening. During sustained periods at high temperature, creeps deformation is one of degradation mechanisms in steels accelerated, where tensile stresses experienced is prone to fracture. Tensile failure which is also known as ductile failure occurred as the material failed to sustain the stress imposed. Cyclic exposure at high temperature cause acceleration in diffusion mechanisms that modified the original microstructure of the material prone to decarburization and carburization of pipe surface thus affect the wall thickness of pipe.
