During internship period at Petrochemical Plant in Terengganu, author had an opportunity to face a real case study, which is regarding the Heat Exchanger Tube leakage. During planned shutdown in November 2010, it is found that one of the heat exchanger tube bundles available in the plant was leak. The affected heat exchanger is a type of shell-and tube heat exchangers used to cool down ethylene gas after it being compressed by the compressor. The ethylene gas is the main gas used in the plant as it will be processed to become Low Density Polyethylene (LDPE).

The project will begin with identification of the problem. In this project, the main problem is; one of the heat exchanger tube bundles (E-105) available in a petrochemical plant got leakage and this lead to plant shut down on 8 November 2010. The problem is keep reoccurring since Turn Around in 2005. The project methodology will explain in detail on failure analysis methodology of old tube bundle and new tube bundle.

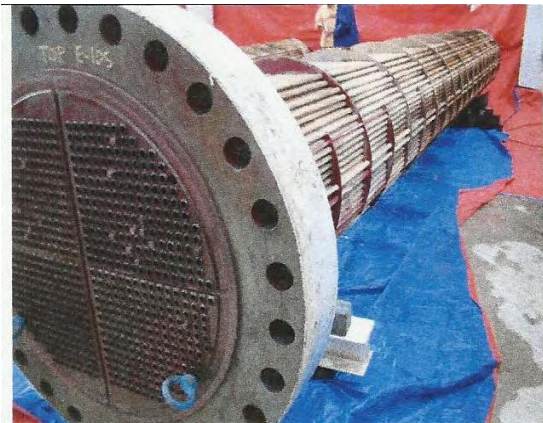
Petlin Inspection report on April 2005 reported that upon removal of the heat exchanger from the shell, it is observed that heat exchanger (E-105) are heavily fouled with brownish deposit covering most of the tube external and blackish deposit/slime collected

at the tubing and baffle plate intersection/crevice. Sign of corrosion, pinhole leak and coating degradation/blister were also observed. [6]

Figure 3.1: E-105 after being removed from the shell [6]

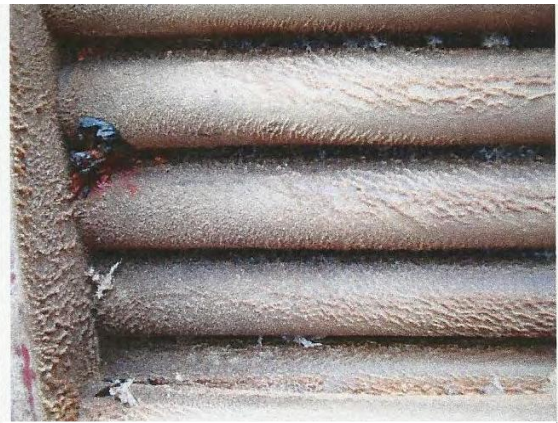
Figure 3.2: Thick brownish/slimy deposit/fouling observed next to tubing and baffle plate intersection [6]

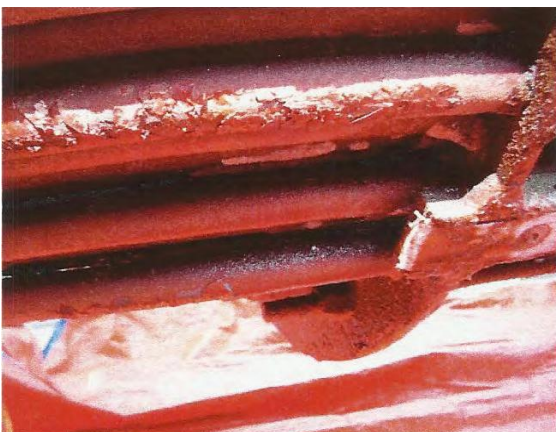
Figure 3.3: Coating damage and blister observed on E-105 tubing [6]

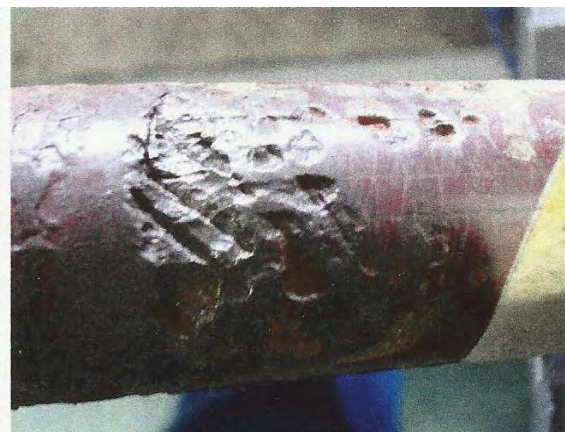
Figure 3.4: Close-up of E-105 localized corrosion/pitting and groove/mechanical damage near baffle plate to tube intersection [6]

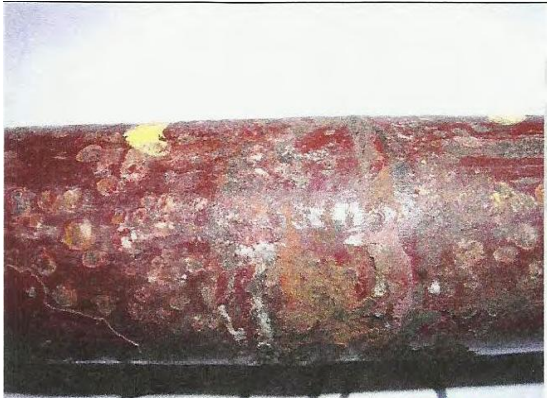
- i) E-105 shows the sign of coating damage along the tubing surface. Probable reason for coating blisters could be inadequate surface preparation, dirty/dusty and trapped solvent or air bubbles.
- ii) Compared to E-104 tubing, E-105 has more corrosion sites and the extent of corrosion pits is concentrative over a small area adjacent to the baffle plate to tubes intersection.
- iii) Mechanical damage i.e. long narrow groove is observed at one of the sites as shown in figure below.
- iv) Trough wall pitting is observed. Probable cause for high concentration of pitting at adjacent area of baffle plate to tubing intersection could be crevice corrosion and under deposit corrosion as this is the area where no flow to low flow condition prevails.

Figure 4.1: As received E-105 with coating damage/blister on tubing external [6]

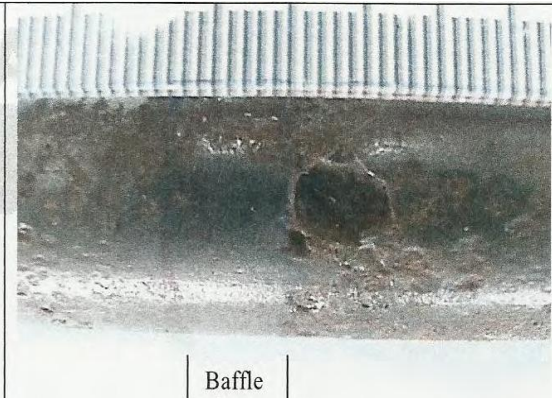
Figure 4.2: E-105 with trough wall pitting 5mm x 6mm located next to baffle plate and tubing intersection. Smaller size pits observed in adjacent area. [6]

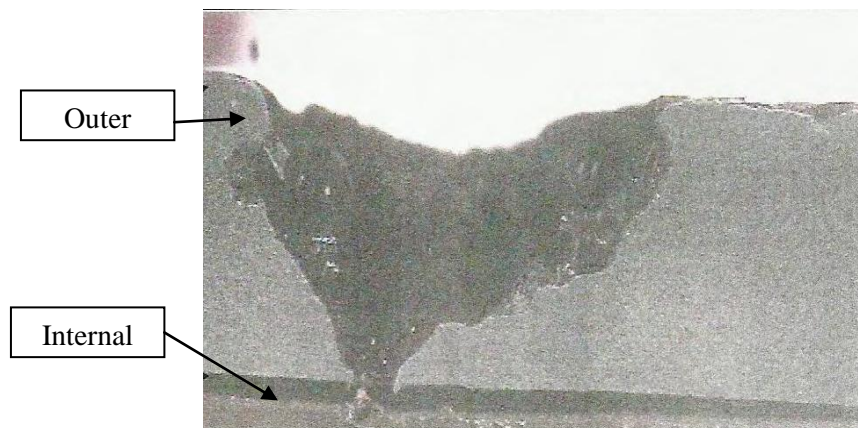
Figures 4.3 below show that the pit size was larger at external surface compared with internal surface of the tubes. This means that the corrosion originated from the external surface and penetrated into the tube wall. Both pits surfaces were covered with oxides/layer of corrosion deposit. [6]

Figure 4.3: Cross-section view of E-105 through wall pit [6]

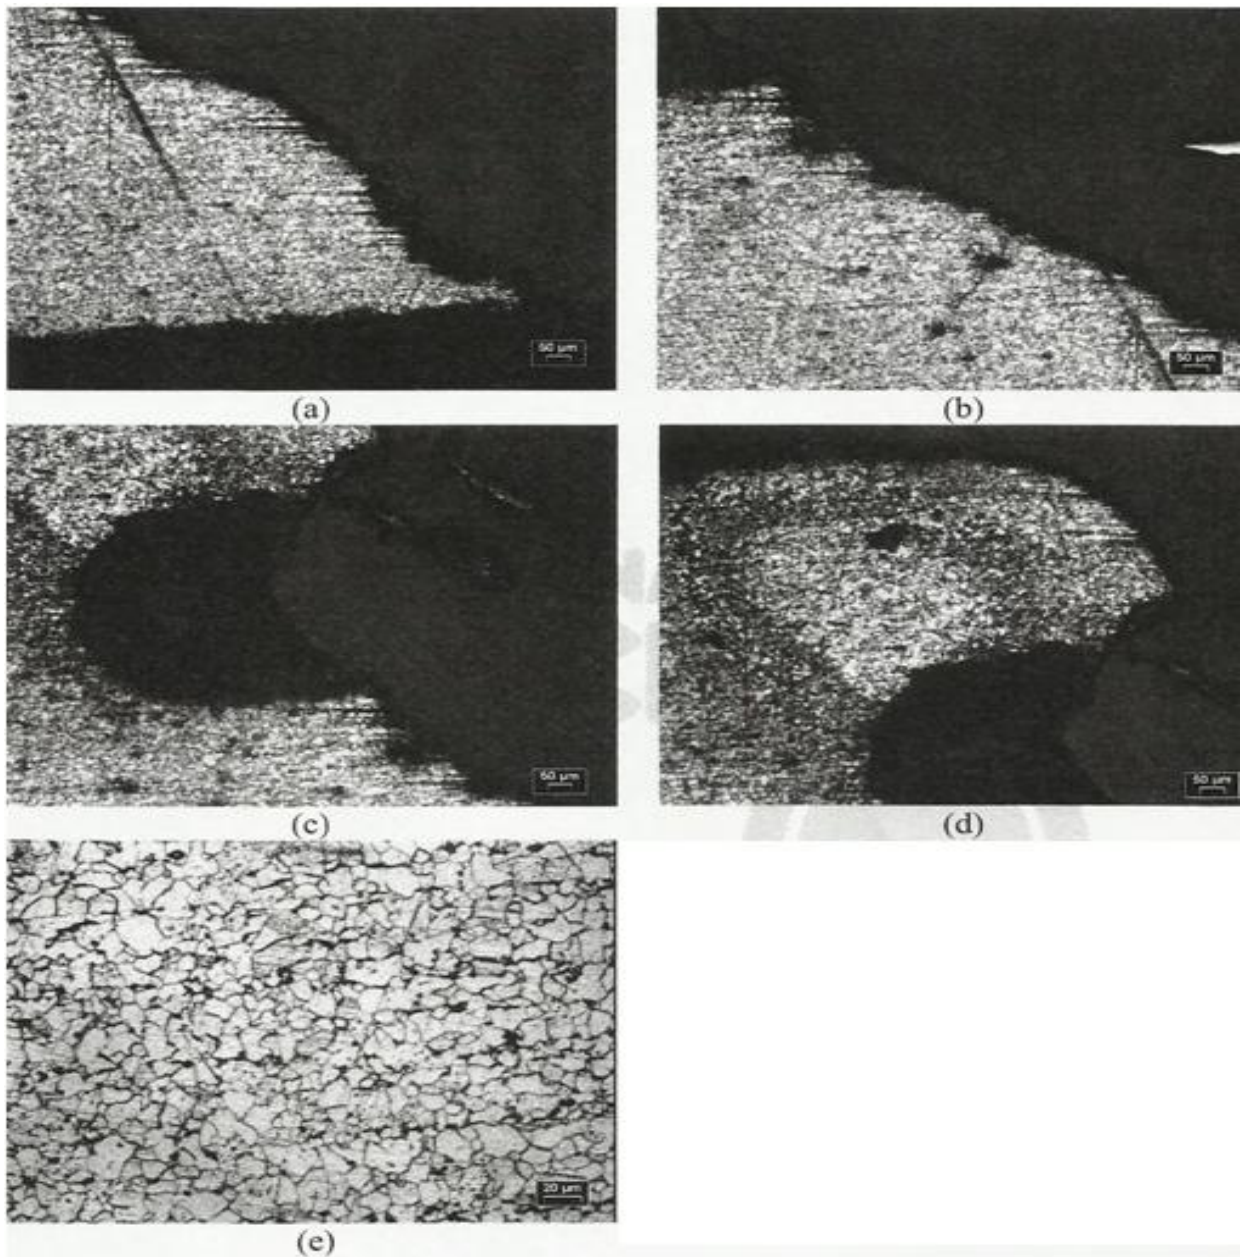
Typical microstructure is observed in E-105 tube sample consisted of large equiaxed grains; indicating that tubes were in the annealed condition and not over stressed. No grain growth, grain deformation or microcracks is observed on both tubes, and corrosion attack is along the grain boundaries. [6]

Figure 4.4: Microstructure photo of tube E-105 taken from pit internal to external surface (d) and close-up view (e). [6]

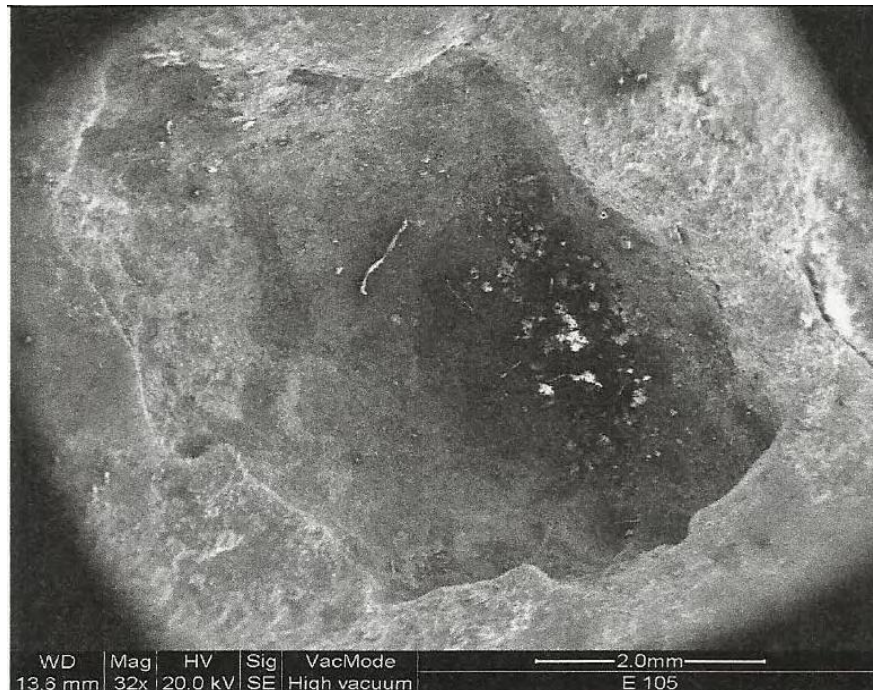
It is observed that a large proportion of the corrosion product consists mainly of iron oxides. Trace element of chloride was again detected which means that an acidic corrosion cell was present/active. [6]

Figure 4.5: SEM photo from top surface E-105 pit hole [6]

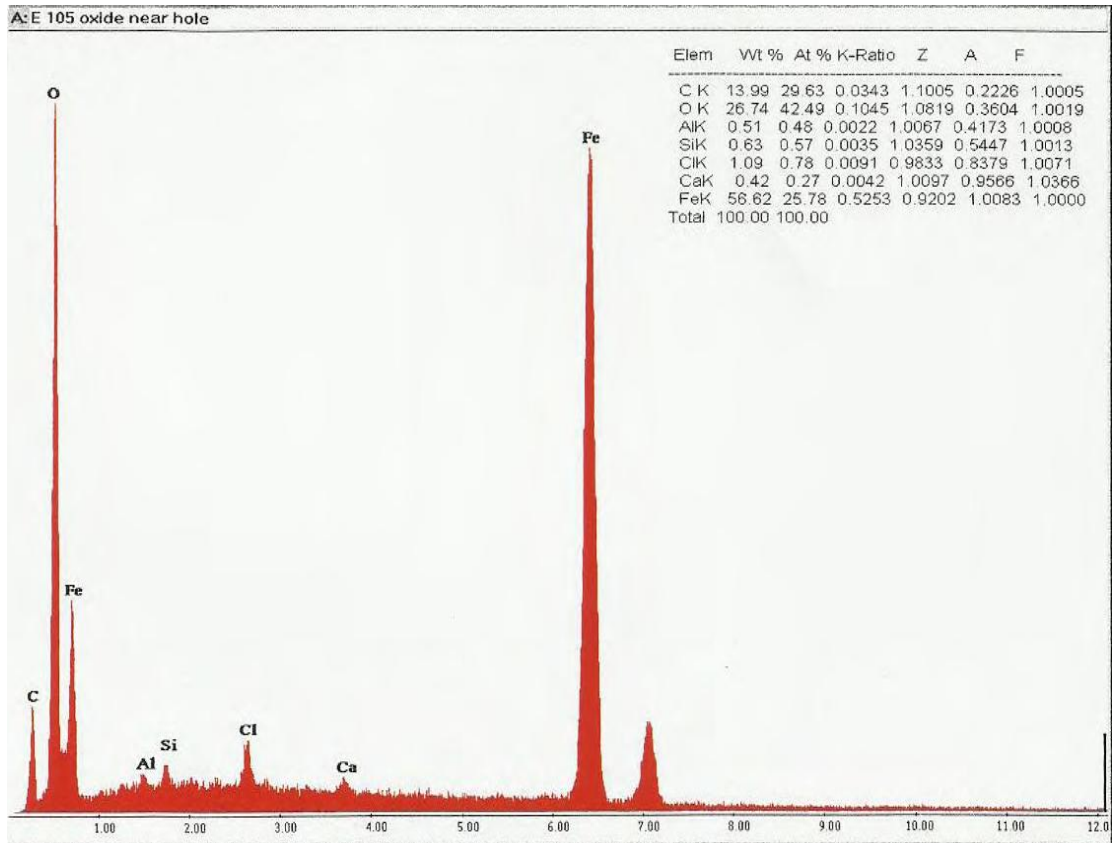
Figure 4.6: EDX analysis on corrosion product of E-105 tube [6]

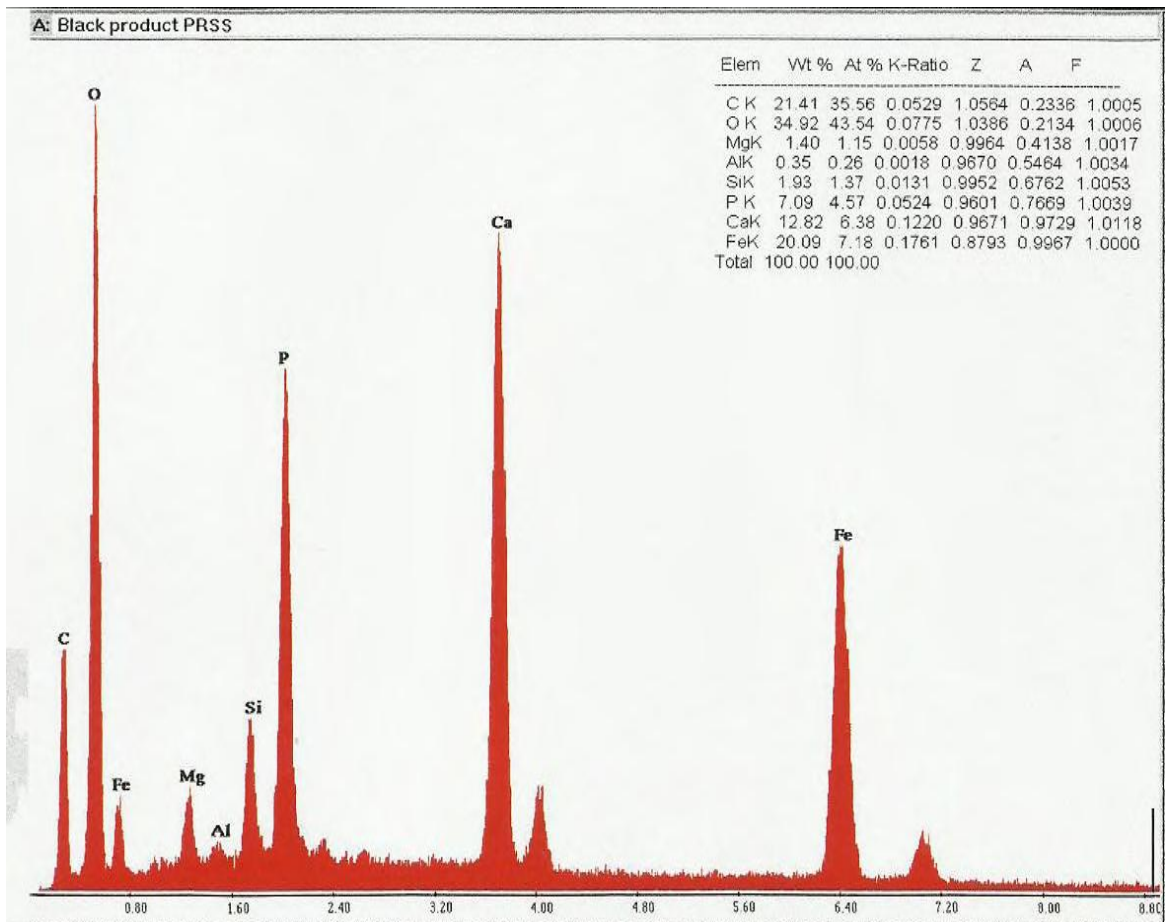
It is observed that a large proportion of the black deposits consist of calcium carbonate, phosphate, iron oxides and trace elements of silica, magnesium and aluminum. This is reflective of corrosion product from the metal itself and deposition product from the cooling water treatment.

Figure 4.7: EDX analysis on black deposit [6]

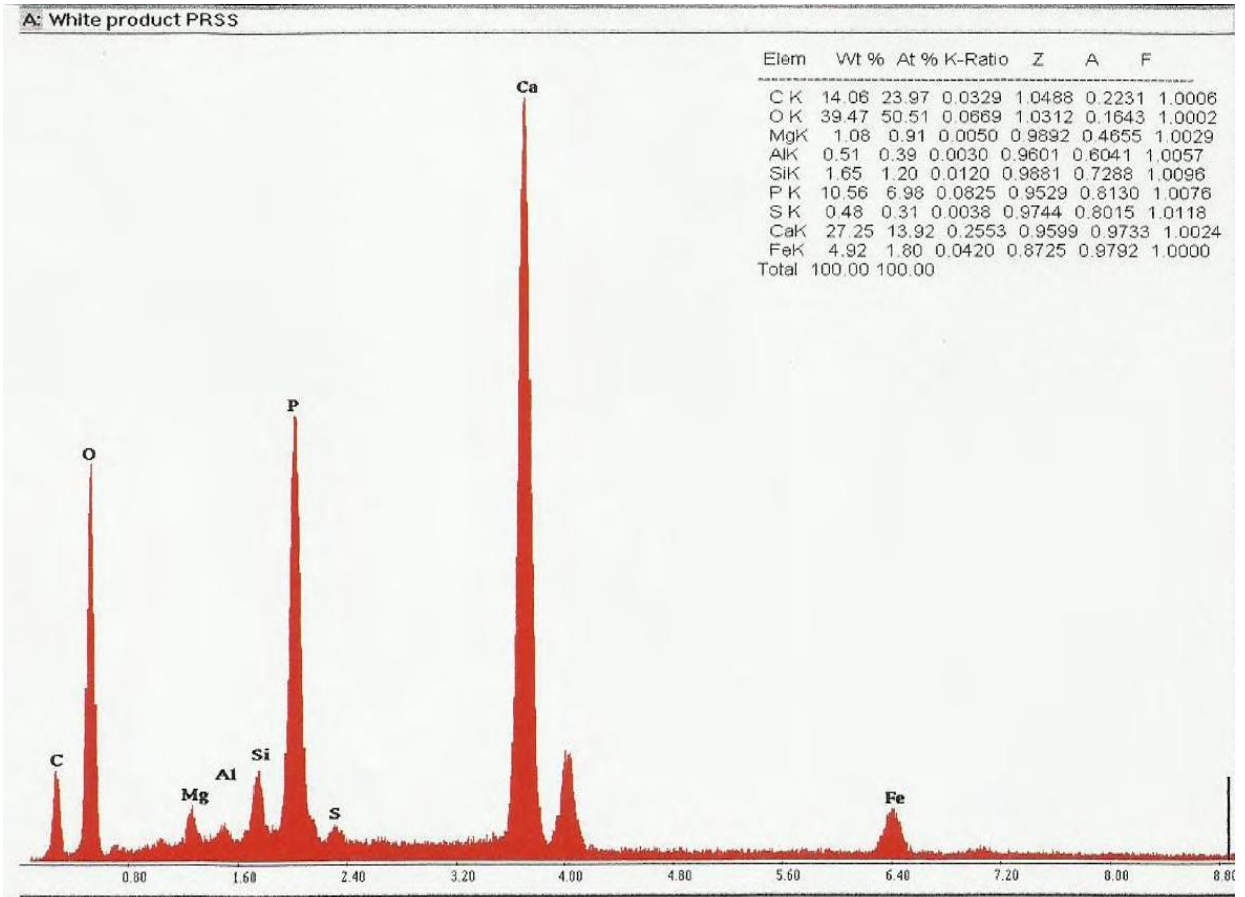
As for the white deposit, it is observed that a large proportion of the deposit consist of calcium carbonate, phosphate and trace elements of iron oxides, silica, magnesium and aluminum. This is reflective of corrosion product from the metal itself and deposition product from the cooling water treatment. A trace amount of sulfur is also founded suggesting that MIC could be present/active. Figure 4.7 and Figure 4.8 show the EDX Analysis on black deposit and white deposit respectively. [6]

Figure 4.8: EDX Analysis on white deposit [6]

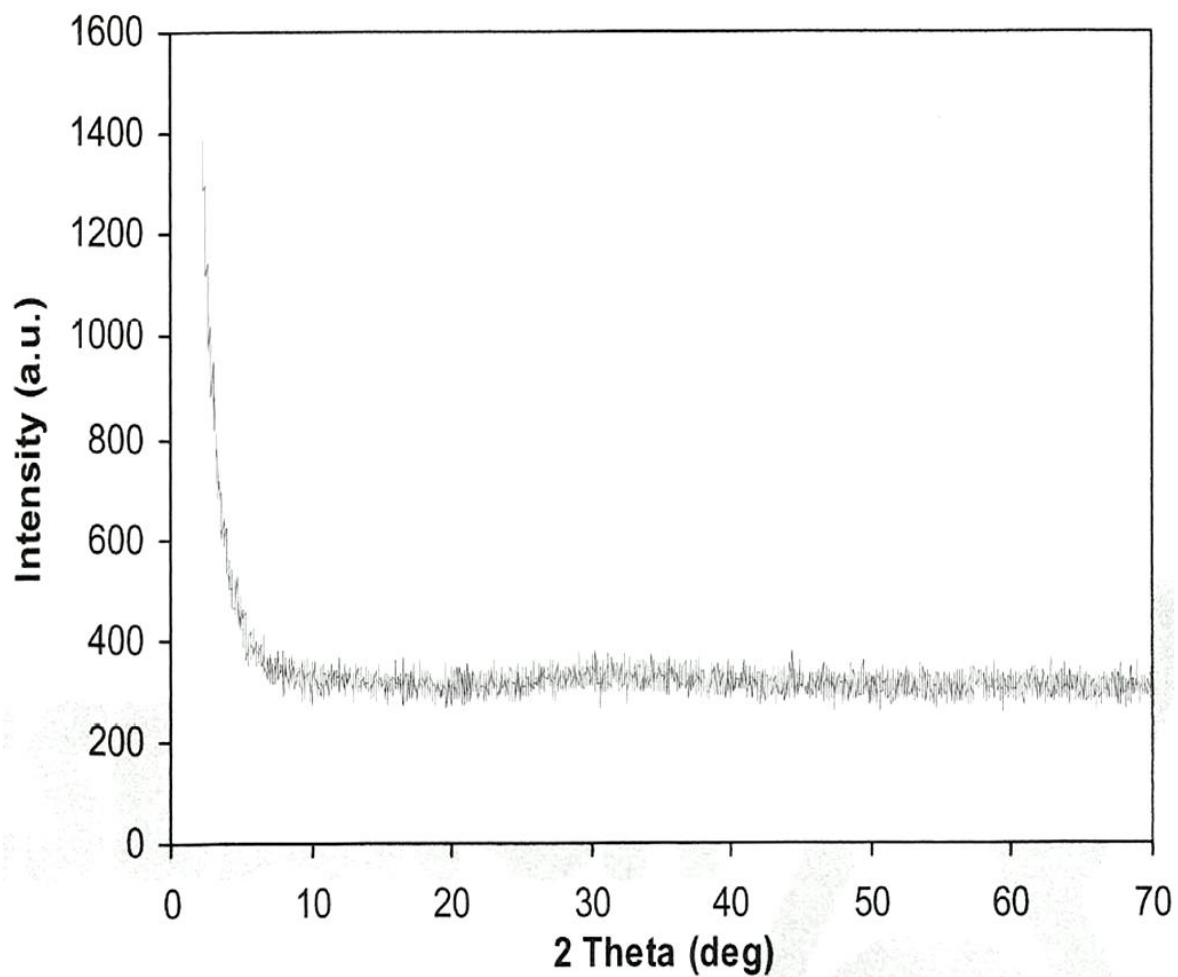
The XRD analysis result does not show any peak for both deposits as indicated in Figure 4.9 and 4.10 respectively. This means that both deposits are of amorphous material/powder that does not contain any crystalline. [6]

Figure 4.9: XRD on black deposit [6]

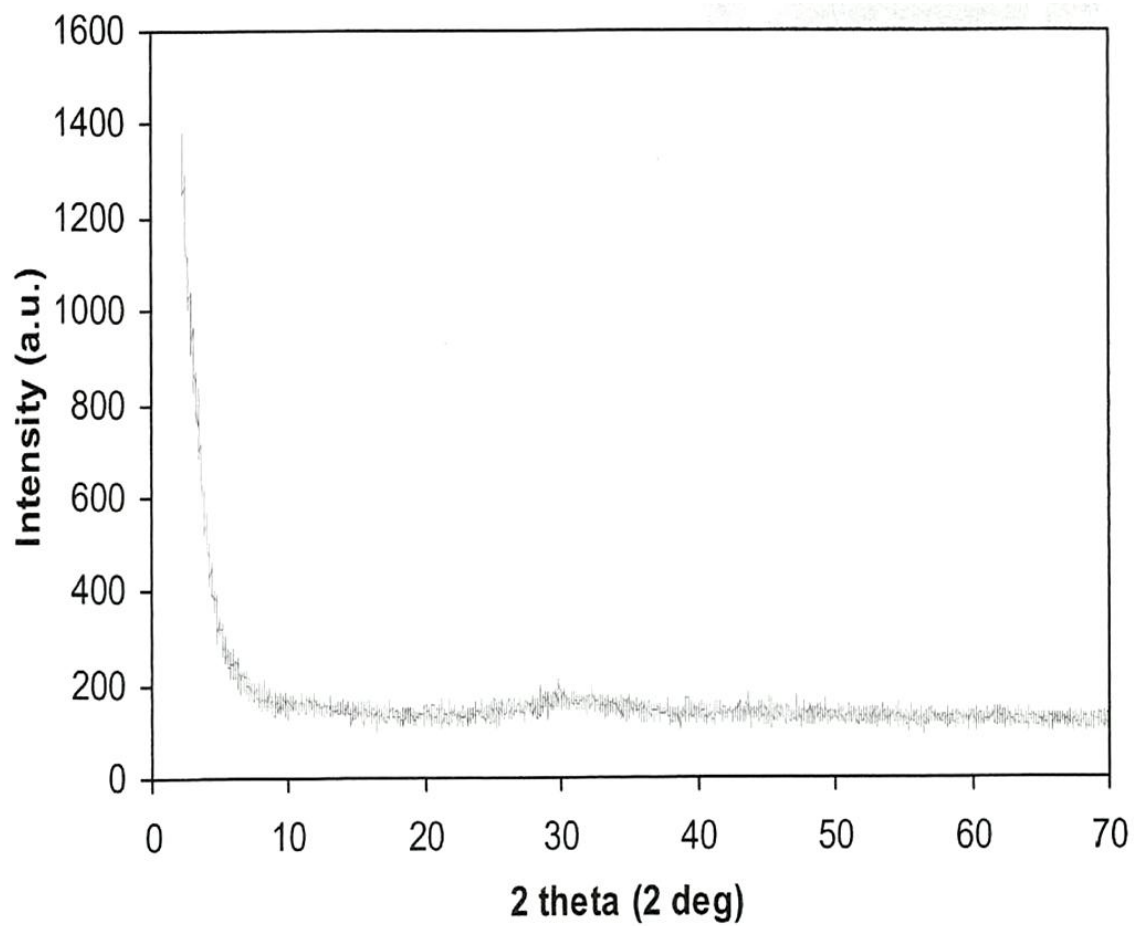
Figure 4.10: XRD on white deposit [6]

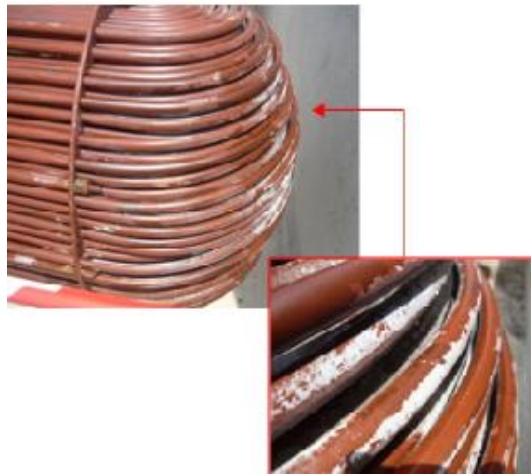
Figure 4.11: Layer of deposits scale found at tubes and mostly accumulate at U-bend area [12]

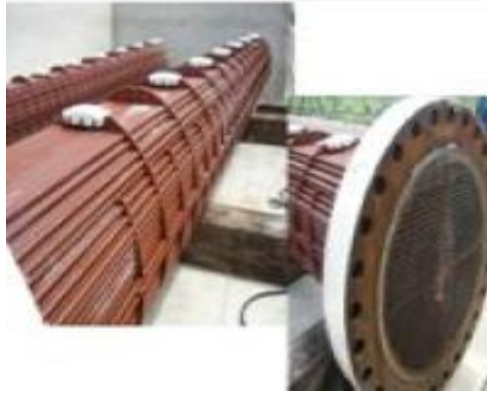
Figure 4.12: View of tube bundle noted in satisfactory condition. No sign of any abnormalities observed [12]

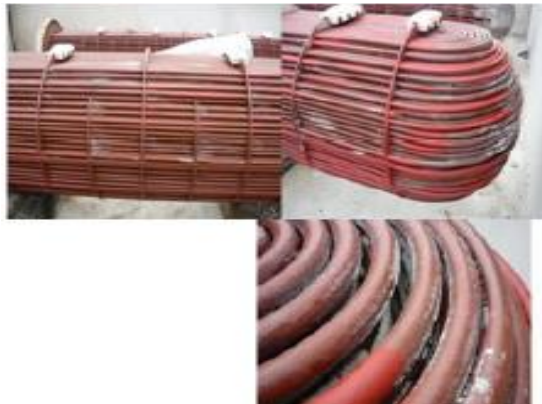
Water jetting done at external of the tube peeled off the coating in some areas. The removal of portion of the coating exposed the base metal which is prone for solid deposits that could lead to localized deposition/pitting corrosion. Therefore, action has taken to touched-up on the accessible areas but not on the inner layers. [12]

Figure 4.13: Peeled off coating in some areas due to water jetting [12]

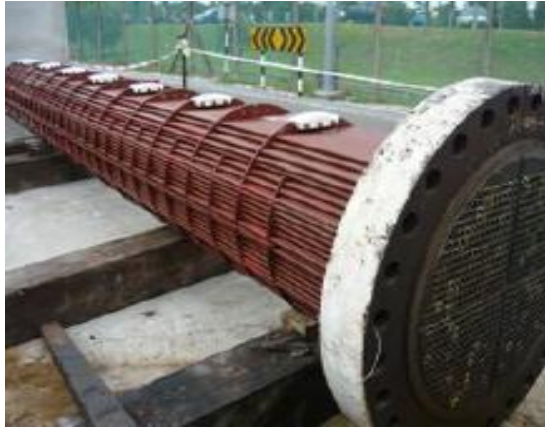
Figure 4.14: Touched-up peeled off coating after the contractor did hydro-jetting due to some damaged peeled off the existing coating [12]

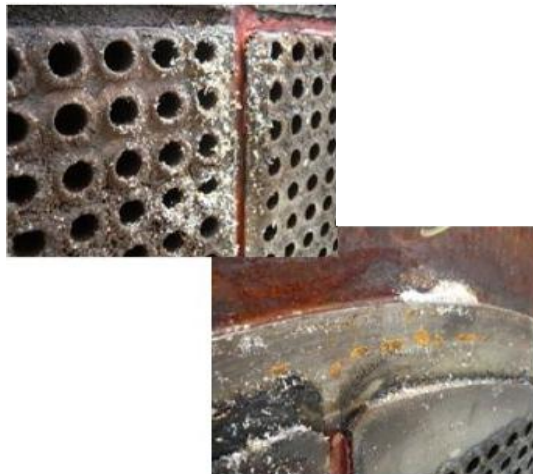
At the tube side, found a thick layer of sticky residue. [12]

Figure 4.15: View of tubes sheet found with thick layer of product residue and white residue stick at tubes sheet [12]

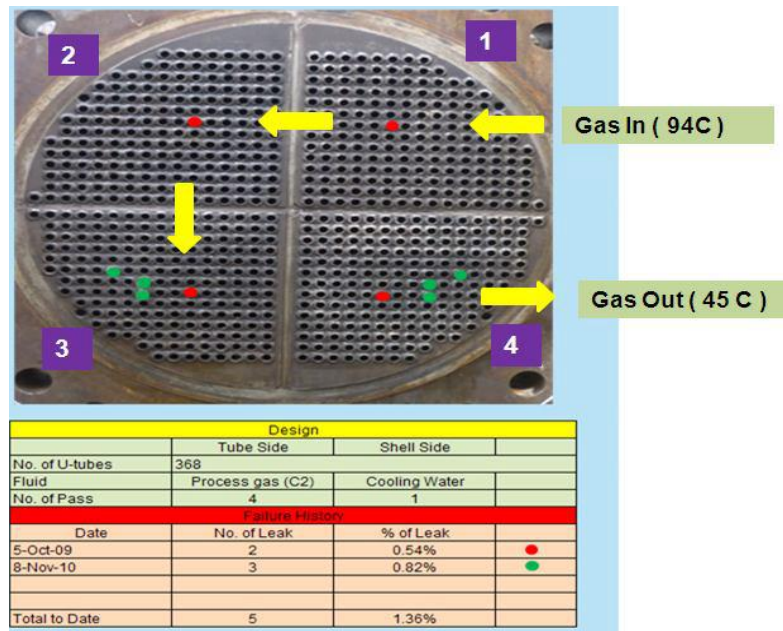
It is found that, leaking tube is more at the bottom (3/4 pass). From the Root Cause Analysis (RCA) conducted, the most probable cause is “Localized pitting in area of the tube with peeled-off coating. Refer to Figure 4.16. [12]

Figure 4.16: New E-15 Leaking Mapping [12]

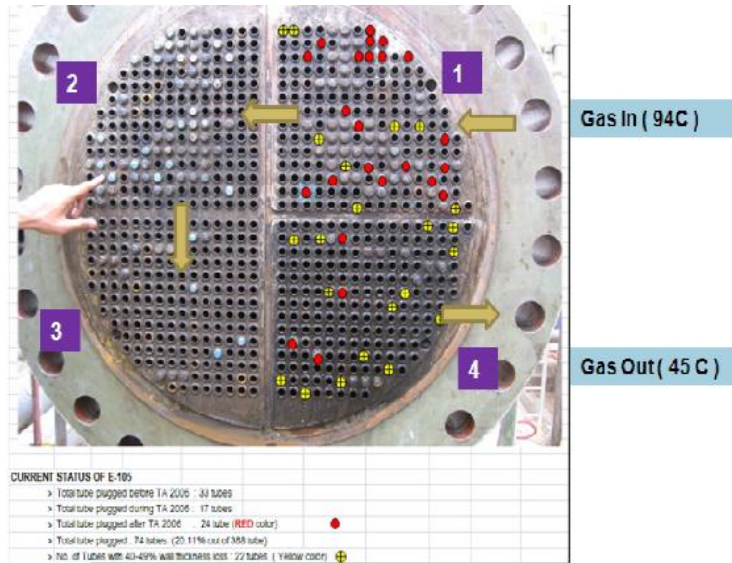
The leak pattern is more concentrated at the upper portion (1/2 pass). Higher temperature at upper portion was found where deposition/pitting corrosion is accelerated. Refer to Figure 4.17. [12]

Figure 4.17: Old E105 Leaking Mapping [12]

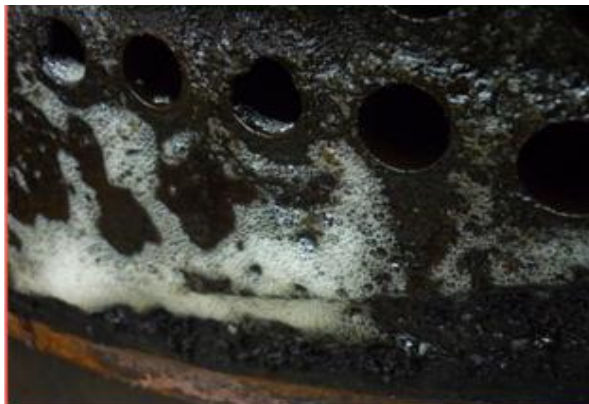
- Sticky foam was noted at the bottom section of tube sheet.
- Visual inspection was done at tube sheet face. No abnormalities noted.
- Sticky blackish deposited was noted entire tube sheet surface.
- Magnetic test were carried out at deposited surface and the deposit attract to magnet. [12]

Figure 4.18: Sticky blackish deposited noted entire tube sheet surface [12]

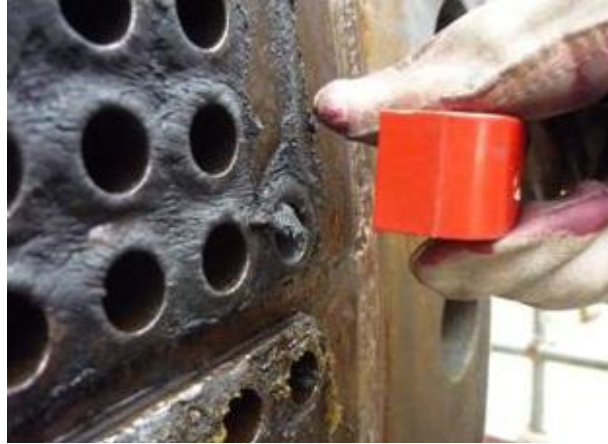
Figure 4.19: Magnetic test carried out at deposited surface [12]
