# **CHAPTER 1**

The objective of this project is to do Failure Analysis on the hot water piping system at Resak Living Quarter (LQ). The Failure Analysis processes conducted in this project is the macroscopic examination which involved the surface examination of the sample under optical microscope and the examination of microstructure of the sample under SEM (Scanning Electron Microscope). The XRF Analysis also is conducted to support the result. Data and result will be collected and further analysis will be conducted using these results to find the cause of this failure. The scope of the study focused on the microstructure analysis of the sample and how to interpret data collected from the experiment and analysis. This hot water piping system is made from copper and has been used since year 2000. All the lines are insulated with aluminium cladding to maintain the temperature of the water within the pipe. Due to the long time service, there some leaking occurs at the tube and most of the leaks are located at the distribution line along the corridor. The header and main line is still in good condition. From the survey, the leaks are due to the pitting occurring mainly at the joints

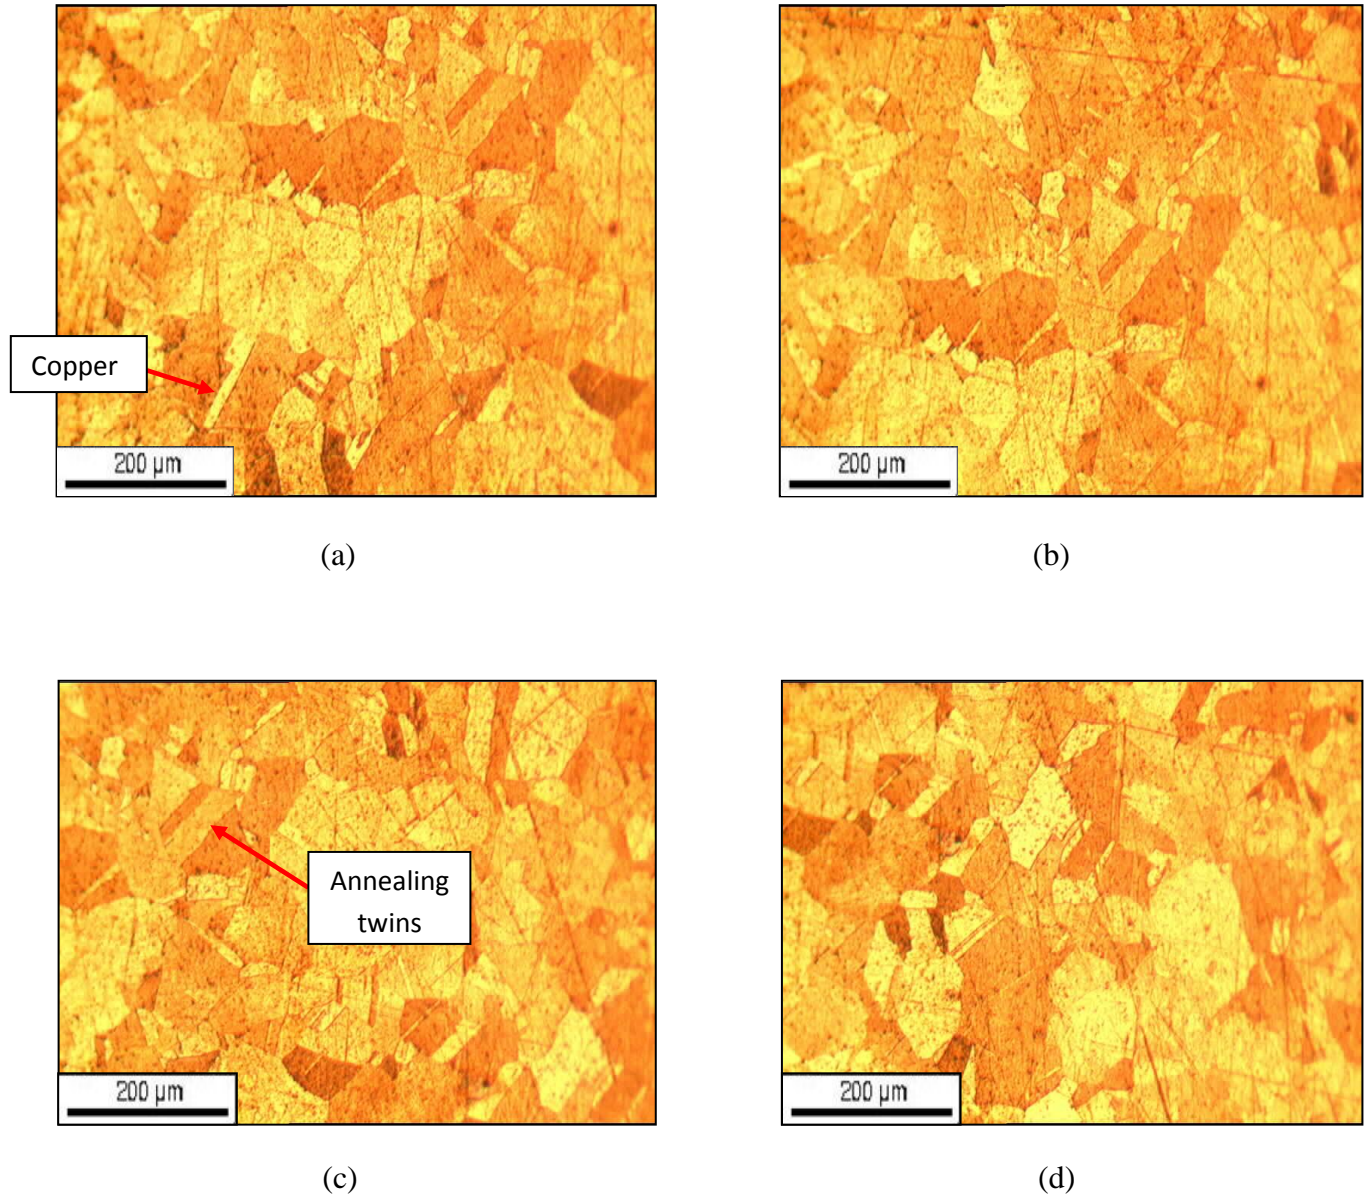
**Figure 4.1** Microstructure of the copper tube at different locations.

Copper alloy are unusual in that they may be selected to produce an appropriate decorative colour. As we can see from Figure 4.1, pure copper is red and the addition of zinc produce a yellow colour.

This copper tube has been cold worked after casting and then annealed at 300°C. The annealing heat treatment has caused recrystallisation of the high energy deformed microstructure. The straight bands crossing each grain are annealing twins and are characteristic of annealed face centered cubic metals. The recrystallised grain size is

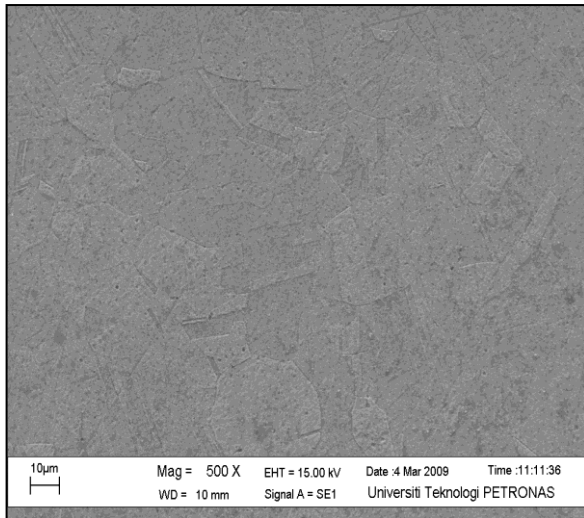
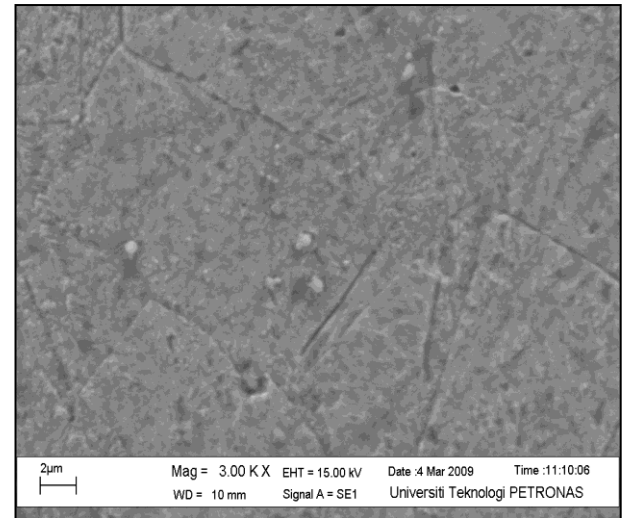
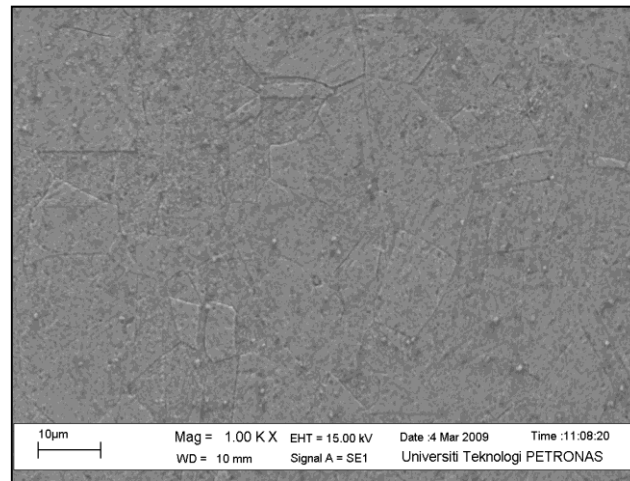
**Figure 4.2** Grain Boundary revealed under SEM

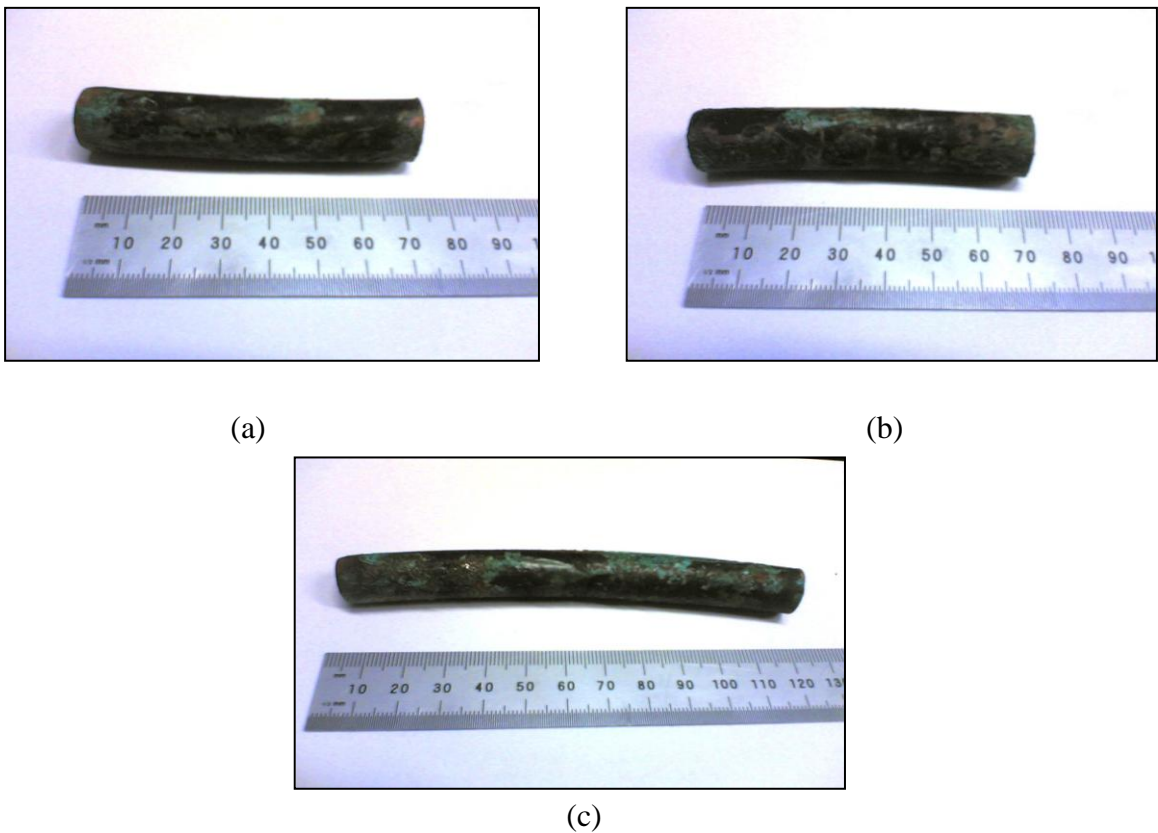
**Figure 4.3** The corroded copper tubes

The corroded copper tubes can be divided into three different areas. The blue, green and black areas. These three different areas are specifically viewed under scanning electron microscope to reveal the composition of the area.

It was concluded that the failure of the copper tubes was due to the Type I pitting attack. What exactly cause the pitting failure was not clear at this stage since particularly given the fact that pitting only became evident after 12 years service. It is may be due to the presence of foreign matter deposits introduced during installation process of the system. The presence of foreign matter in the water is a possibility if the water is not filtered. Changing in water quality or content for example resulting from mixing of the water with borehole or well waters could also lead to pitting attack.

It was therefore recommended that the copper tubes be replaced. Full attention should be given to the normal causes of Type I pitting attack. Before the tubes need to be installed, it should be ensured that all tubes be thoroughly cleaned and freed of any carbonaceous deposits. The tubes should also be clean from any foreign matter deposits and solder pastes after installation process. Water filter can be used in order to prevent the introduction of foreign matter in the water. Furthermore, the content and quality of the water should be monitored and its potential to cause pitting attack assessed. The extent of replacement or modifications to the water distribution system should follow the standard and depend on the results of such water analyses.

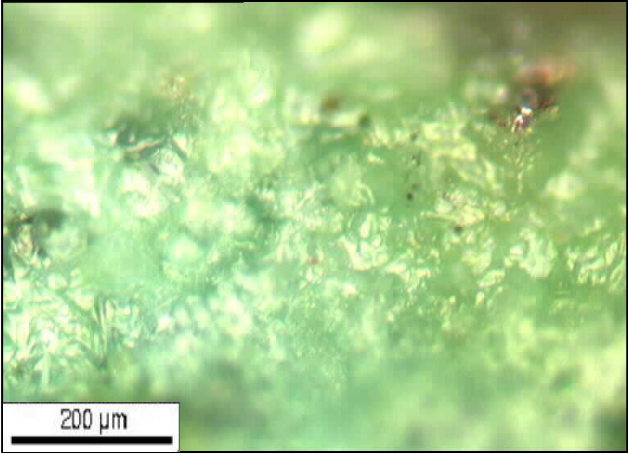
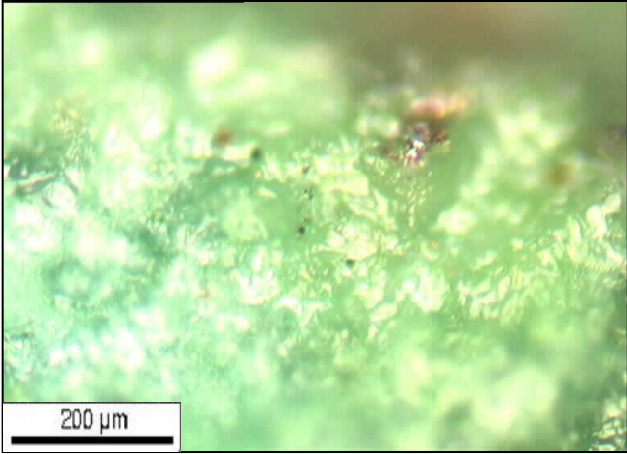
**Figure 4.4**  $\text{CuCO}_3 \cdot \text{Cu}(\text{OH})_2$ , Malachite, The green area

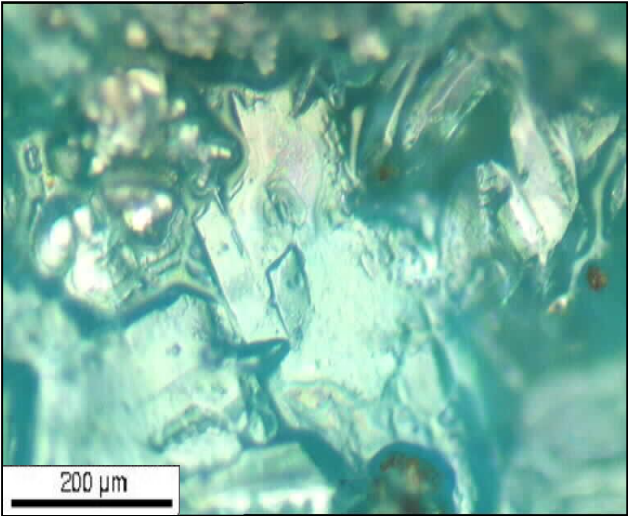
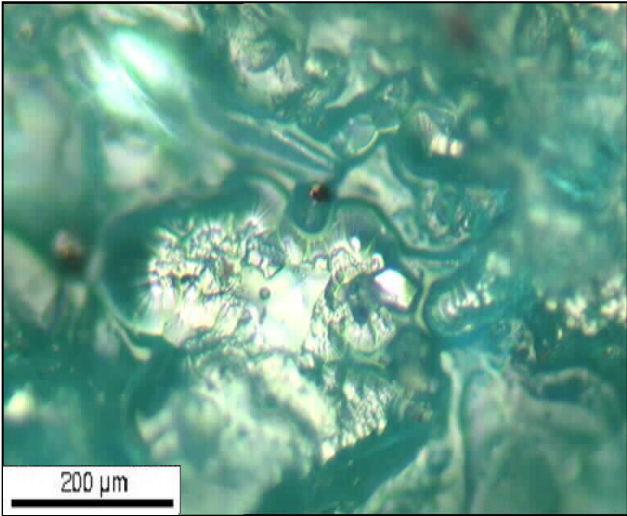
**Figure 4.5**  $\text{Cu}(\text{OH})_x(\text{SO}_4)_y$ , Copper Sulfate and Cupric Salt, The blue area

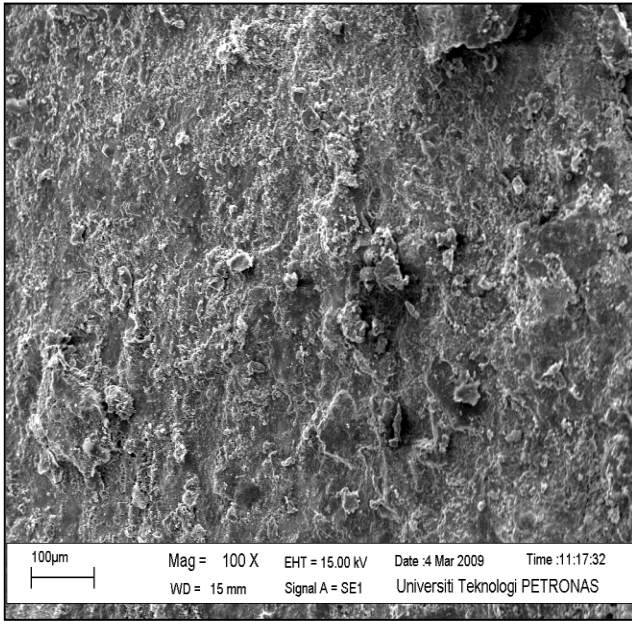
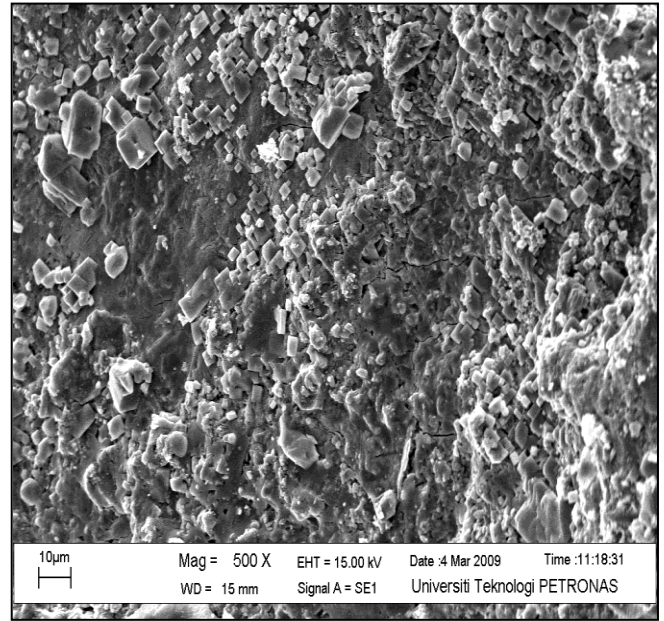
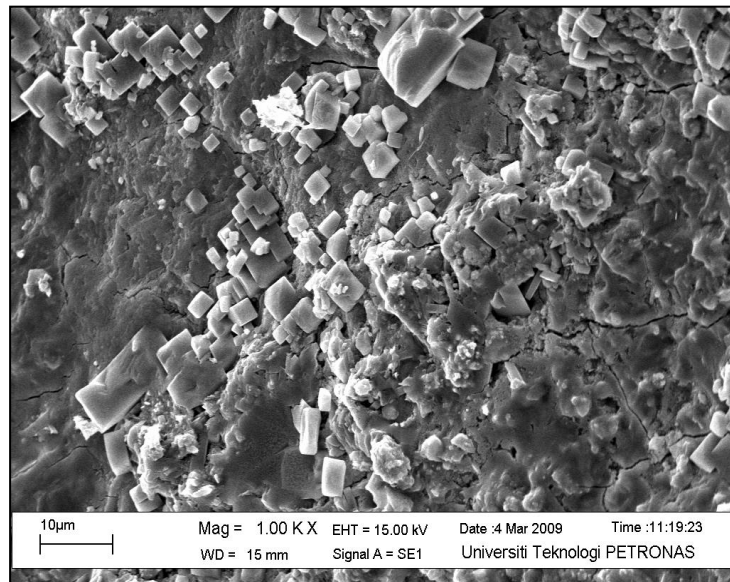
**Figure 4.6** The green/blue area of the copper tube under SEM

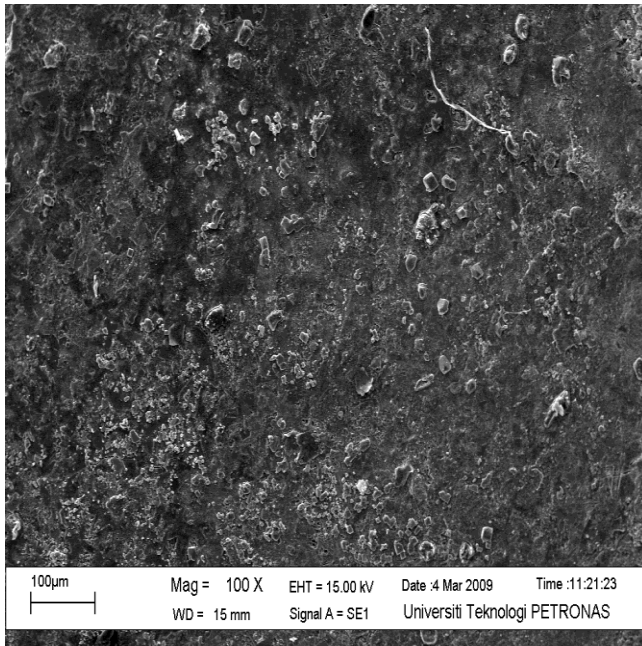
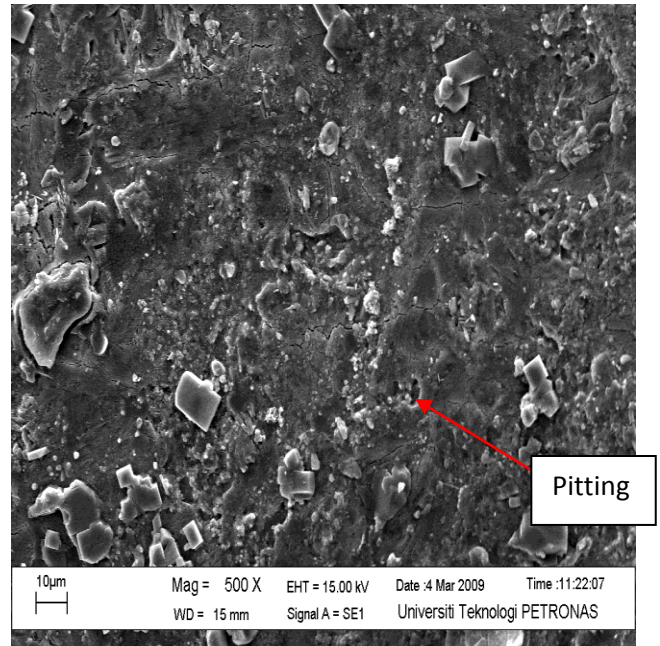
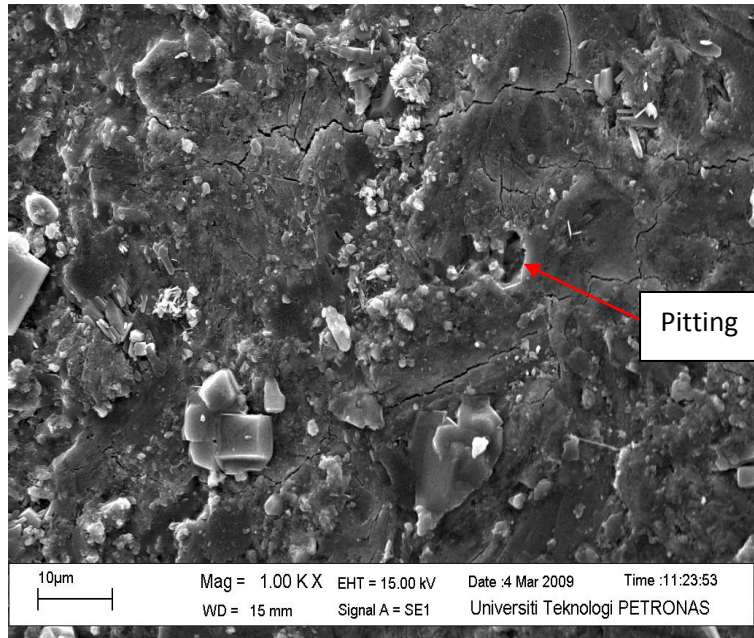
**Figure 4.7** The black area of the copper tube under SEM

The characteristics of Type I pitting are such that many pits at all stages of development can usually be found as in figure 4.7. Larger pits are generally linearly arranged along the bottom half of horizontal water lines. Tubercles can extend over a number of pits to form one long tubercle whenever pits are very close together. Although pitting has been observed in annealed, half hard and hard-drawn tube, susceptibility is generally greatest in annealed condition. The pits formed are relatively wide.

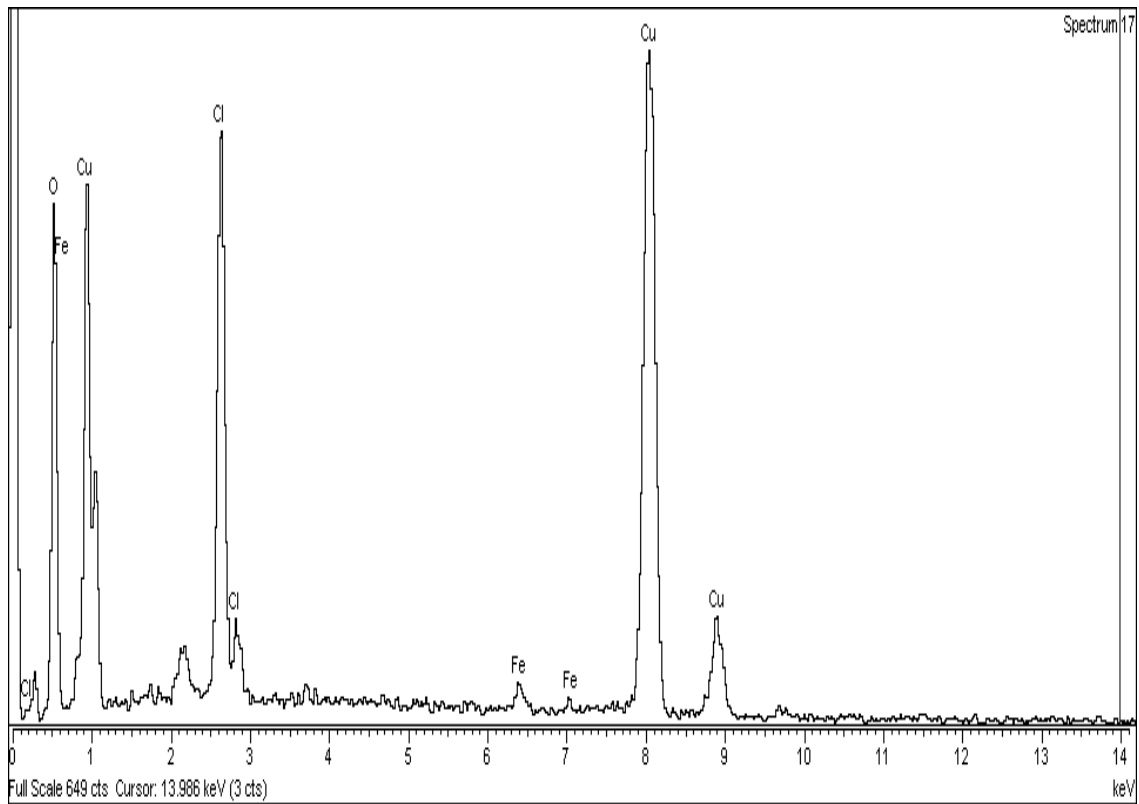
**Figure 4.8** The EDS result of the greenish deposits found on the surface of the tubes.

Sample of the tubes were examined in a scanning electron microscope (SEM) equipped with an energy dispersive spectroscopy of X-rays (EDS) facility. The results of the EDS analysis of the greenish scale found on the surface of the copper tubes are shown in figure 4.8. The large copper peak originates from the base metal. The large iron peak is due to the presence of these elements in the scale. This element is readily oxidized and therefore frequently detected in scale deposits. A major chloride peak was also detected. This ion is usually associated with pitting attack.
