Corrosion Characterization of Salvaged Subsea Pipeline

A project dissertation submitted to the
Mechanical Engineering Programme
Universiti Teknologi PETRONAS
In partial fulfillment of requirement for the
BACHELOR OF ENGINEERING (Hons)
(MECHANICAL ENGINEERING)

MAY 2012

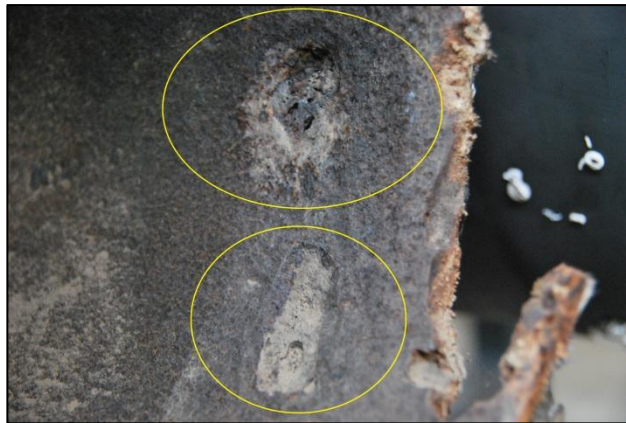
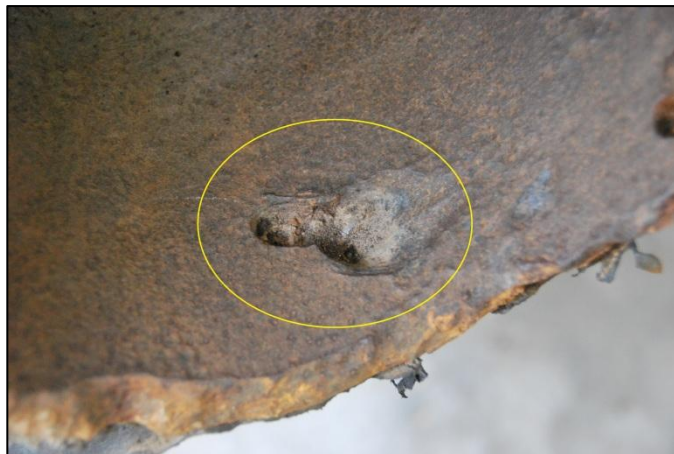
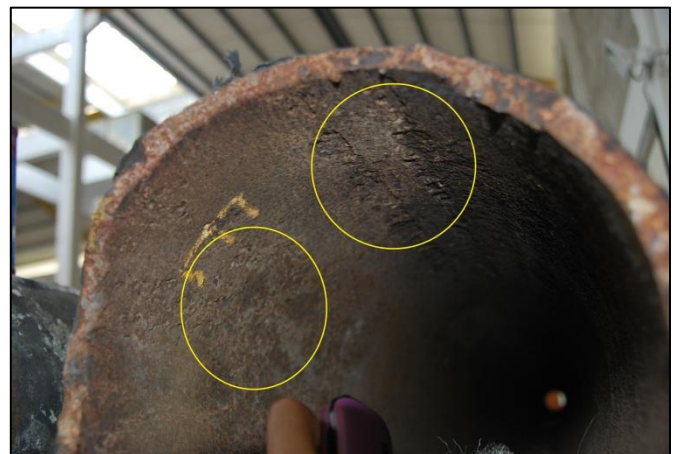
Figure 5: Samples of corroded area

The selection of samples is very important to the outcome of metallographic analysis. The component of the samples is very large which is pipeline, where it required sectioning to provide manageable metallographic samples. Samples of corroded area were taken, however samples of unaffected areas also are very important because it can reveal contrasting structures, thus distinguishing damage as shown in Figure 5.

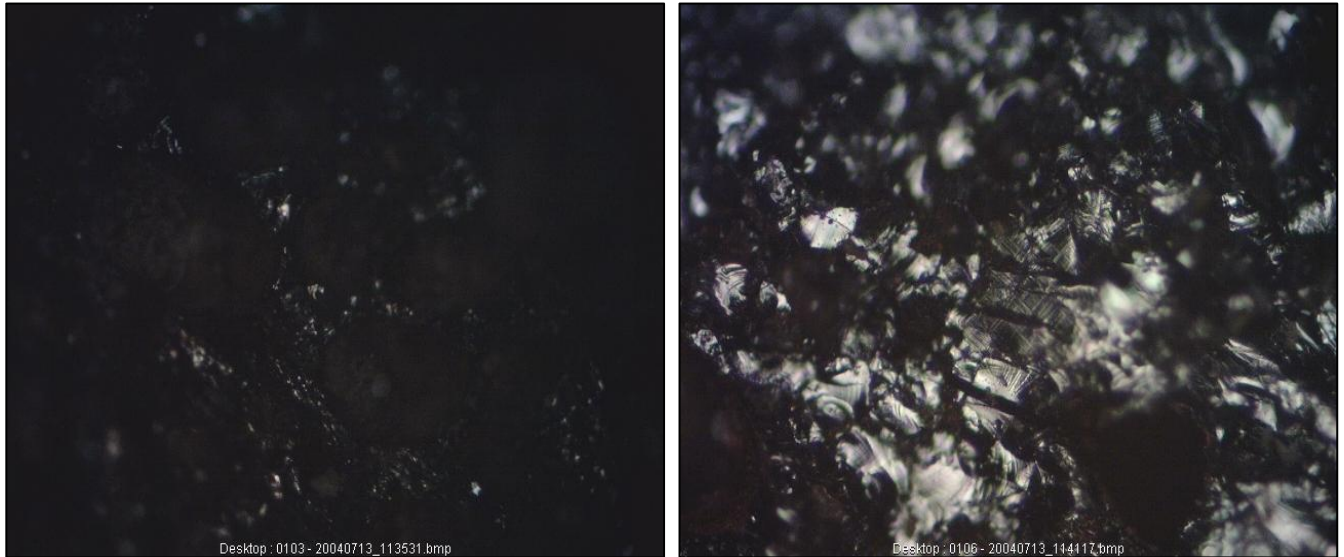
From the microstructure result, it is shown a hole type of surface on the pitting area while smooth surface on the general corrosion area. It became evident that the hole was caused by corrosion and not due to torch during the cutting process. The assumption is the inclusion and difference in elemental composition between these two areas and further analysis should be done by using SEM and EDX.

Figure 17.1: API 5L X52 microstructure (50X and 100X) pitting

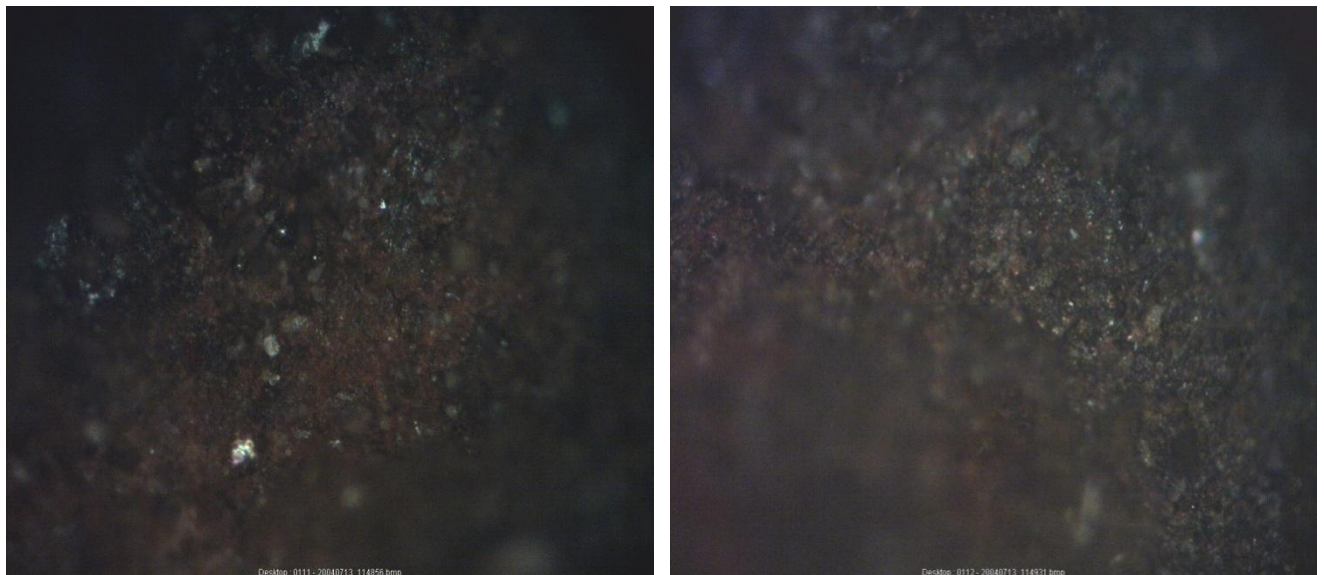
Figure 17.2: API 5L X52 microstructure (50X and 100X) general corrosion

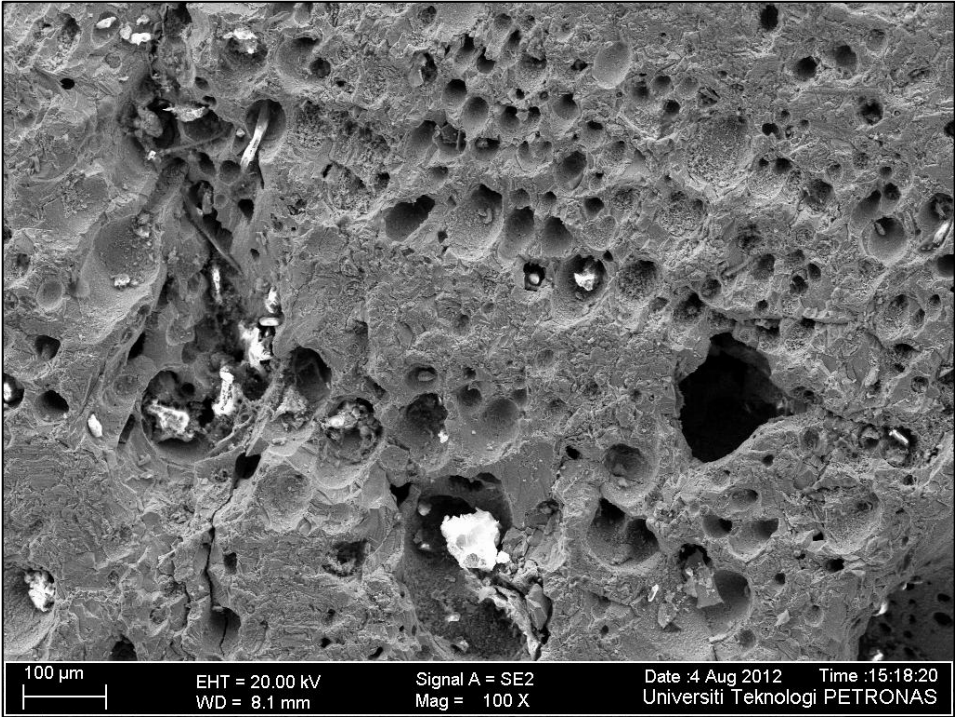
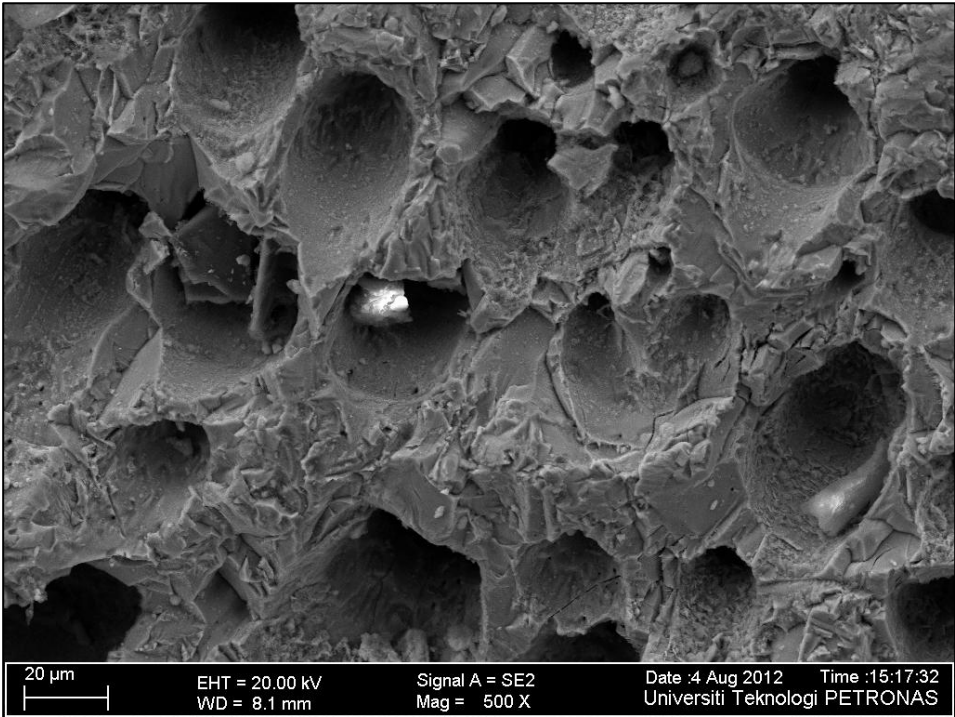
Figure 18.1: SEM image of pitting area (100X)

Figure 18.2: SEM image of pitting area (500X)

High water cut, of which in this project is 67% containing significant level of Cl⁻ (3,500 ppm max) had led to pitting whenever corrosion inhibitor availability is low (40%). However the pitting in Figure 18.1 and 18.2 is not caused by water cut but it has high probability due to the deposit or inclusion because the pitting is at different area. Below are several possible causes for corrosion in the pipeline:

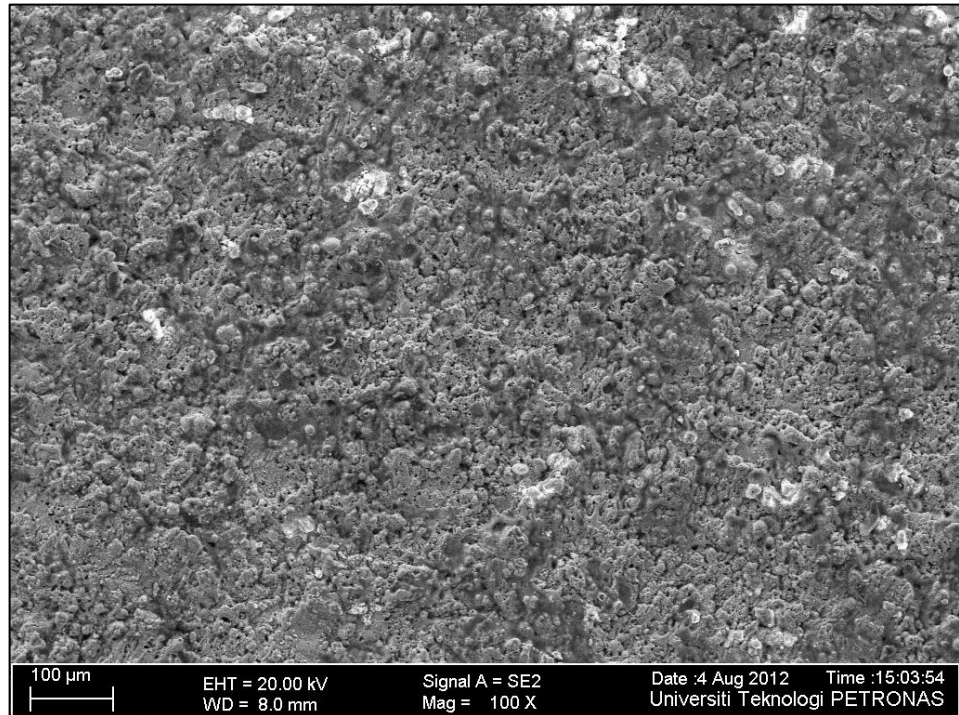
Figure 19.1: SEM image of general corrosion area (100X)

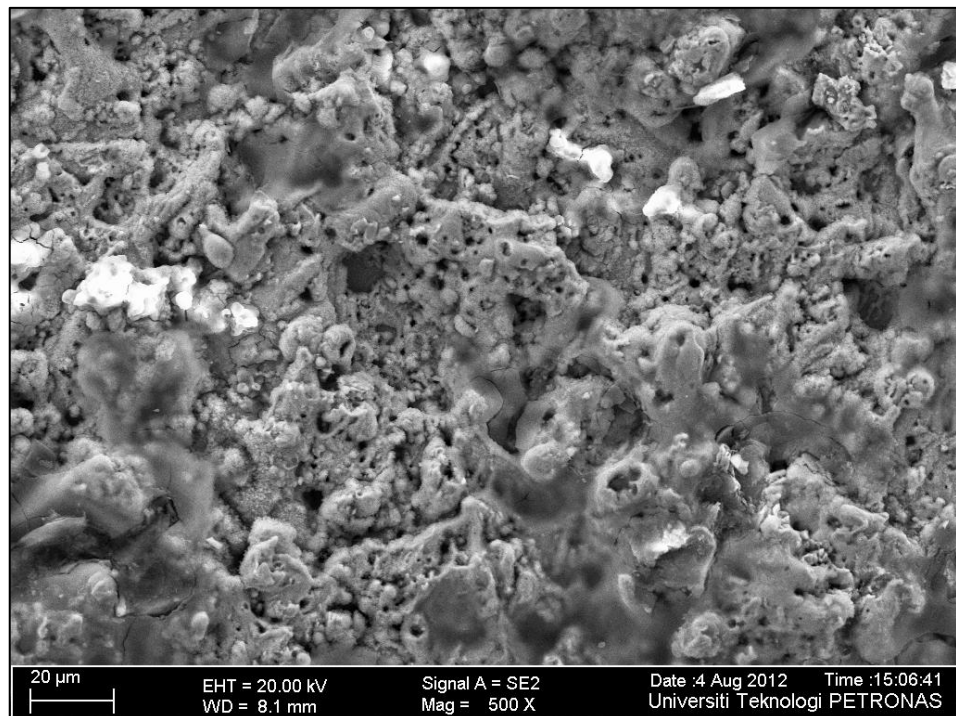
Figure 19.2: SEM image of general corrosion area (500X)

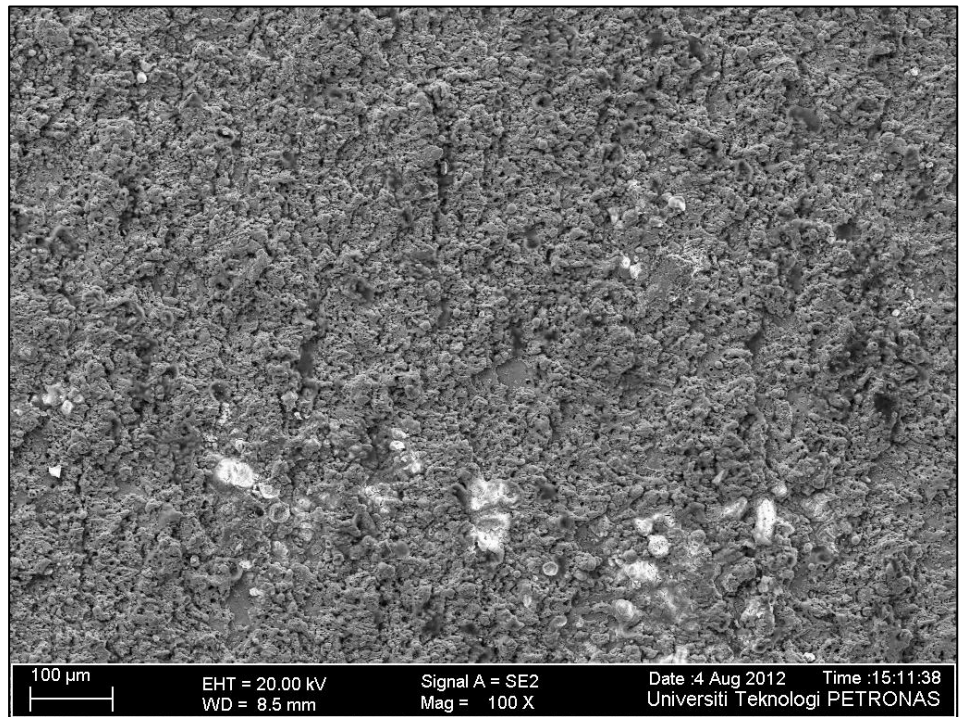
Figure 20.1: SEM image of pitting area surface (100X)

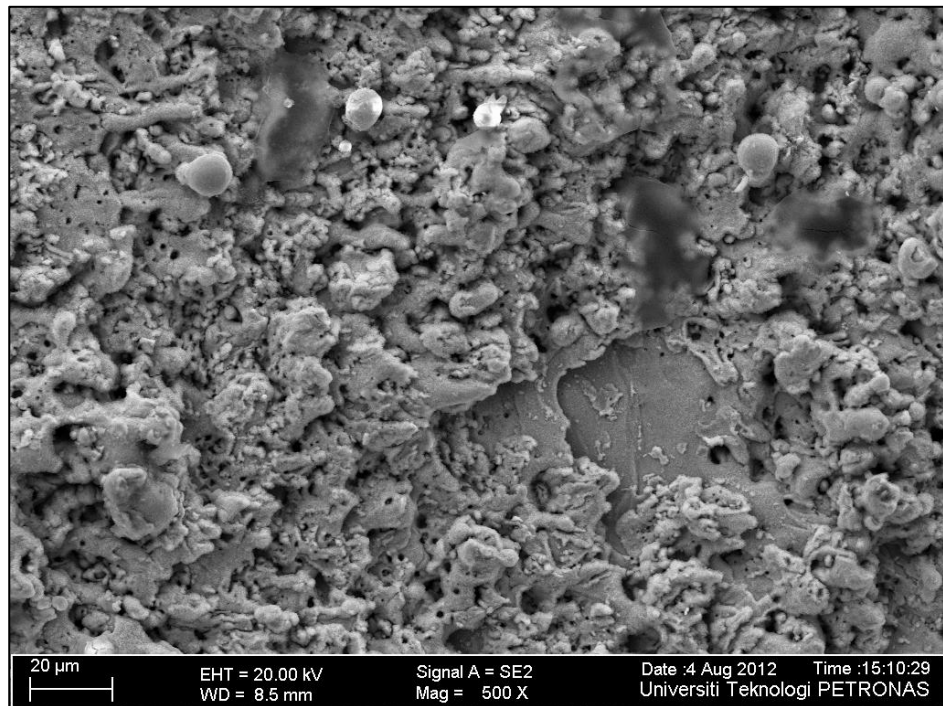
Figure 20.2: SEM image of pitting area surface (500X)

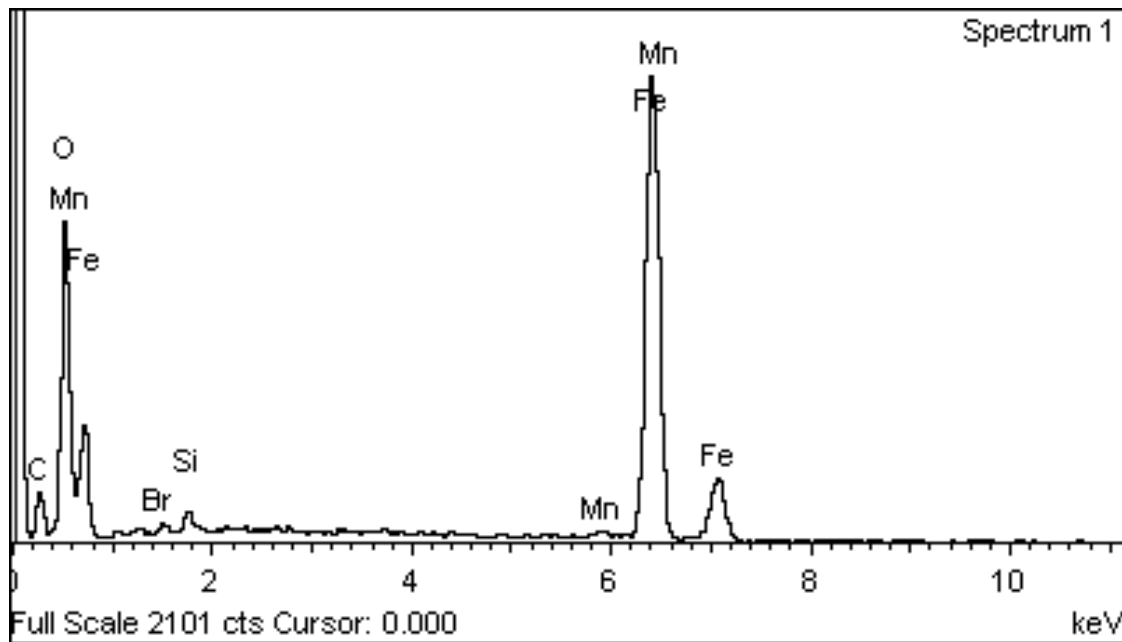
Element	Weight%	Atomic%
C K	14.29	29.97
O K	27.80	43.75
Si K	0.64	0.57
Mn K	0.56	0.26
Fe K	55.85	25.18
Br L	0.85	0.27
Totals	100.00

Figure 21: EDX image and element composition of pitting area

Elemental composition in Figure 21 and 22 shows a very small different in composition and it does not affect the corrosion rate between the sample in a long run. Besides, the difference in corrosion rates shown in Figure 24 is small and it was considered same. This suggests that the inclusions or deposit might be facilitating the pit initiation. However, there is no evidence that deposit might be the factor because the piping sample already is too old.

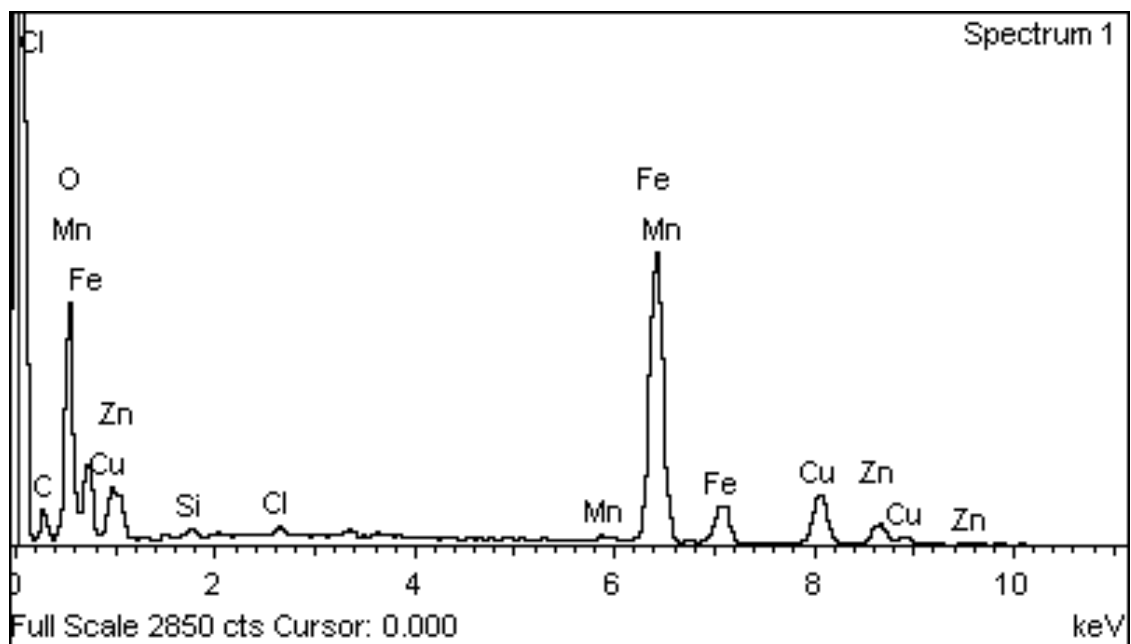
Element	Weight%	Atomic%
C K	7.14	17.59
O K	26.00	48.10
Si K	0.43	0.46
Cl K	0.44	0.37
Mn K	0.61	0.33
Fe K	43.34	22.97
Cu K	14.59	6.80
Zn K	7.45	3.37
Totals	100.00

Figure 22: EDX image and element composition of general corrosion area

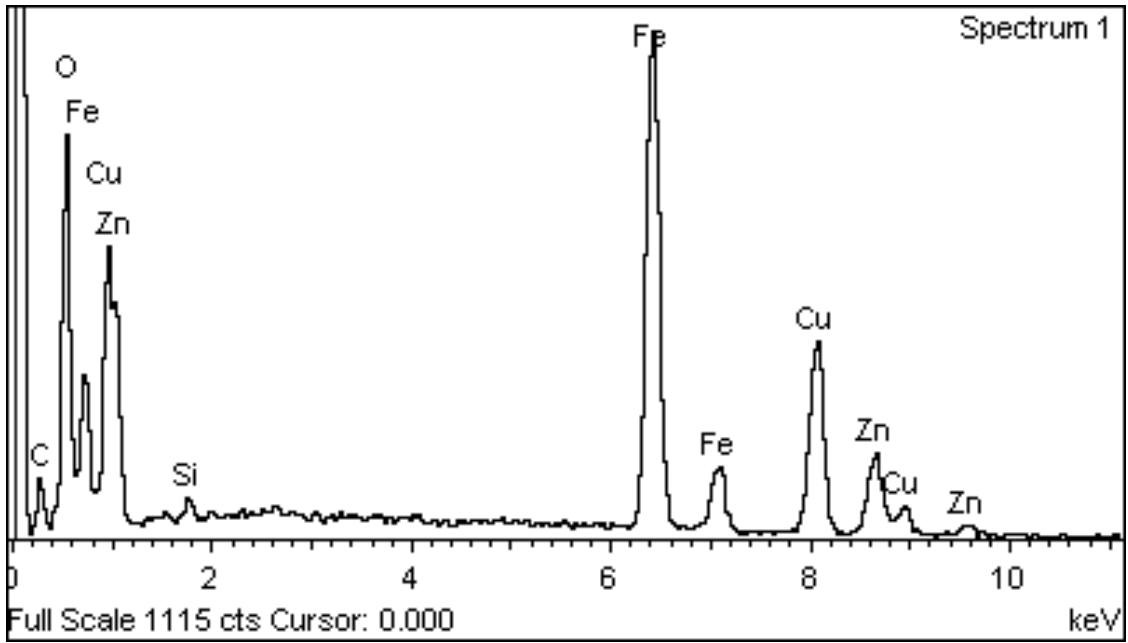
Element	Weight%	Atomic%
C K	12.78	30.33
O K	21.40	38.13
Si K	0.50	0.50
Fe K	30.26	15.45
Cu K	23.06	10.35
Zn K	12.01	5.24
Totals	100.00

Figure 23: EDX image and element composition of pitting area surface

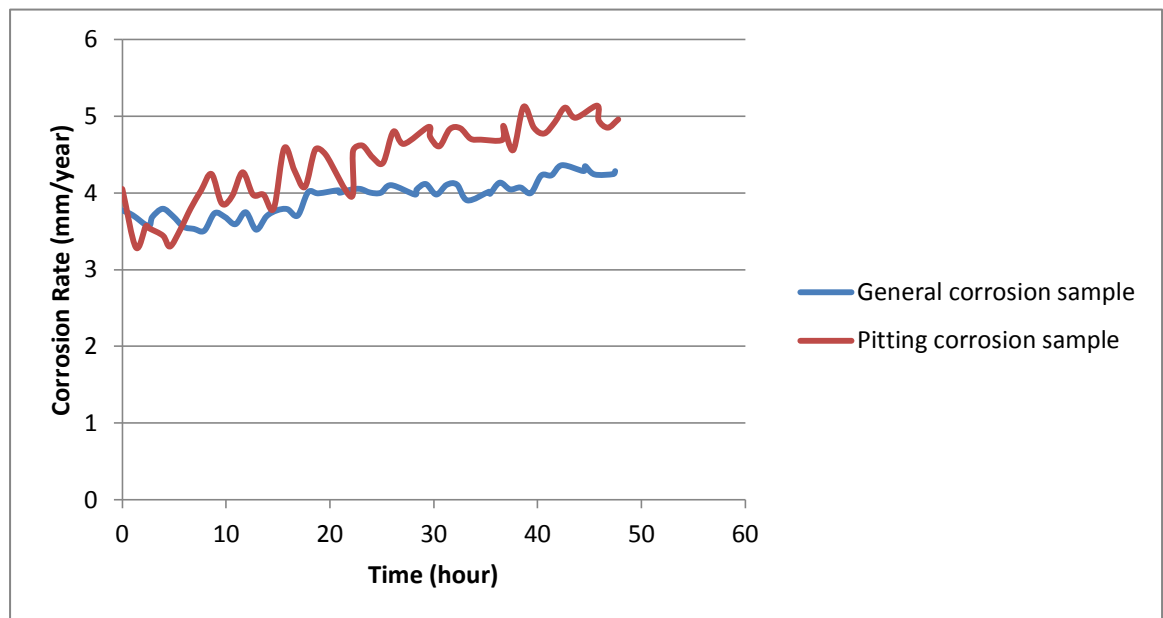
Figure 24: Corrosion rates recorded for general corrosion and pitting corrosion sample API X52 steel after 48 hours immersion at 50°C, 3% NaCl solution, 1 bar CO₂.

The corrosion rate of the two different area that obtained by the LPR test is shown in Figure 24. It can be seen that the pitting corrosion has higher corrosion rate which is 4.4 mm/yr while corrosion rate for general corrosion is 4.0 mm/yr. However, the difference in corrosion rate was relatively small and it was assumed to be the same in the industry.
