**CHARACTERIZATION OF REFORMER TUBE CREEP DAMAGE
BY ULTRASONIC ATTENUATION PATTERN AND
MICROSTRUCTURAL CHANGES**

Dissertation submitted in partial fulfillment of
the requirements for the
Bachelor of Engineering (Hons)
(Mechanical Engineering)

SEPTEMBER 2012

Universiti Teknologi PETRONAS
Bandar Seri Iskandar
31750 Tronoh
Perak Darul Ridzuan

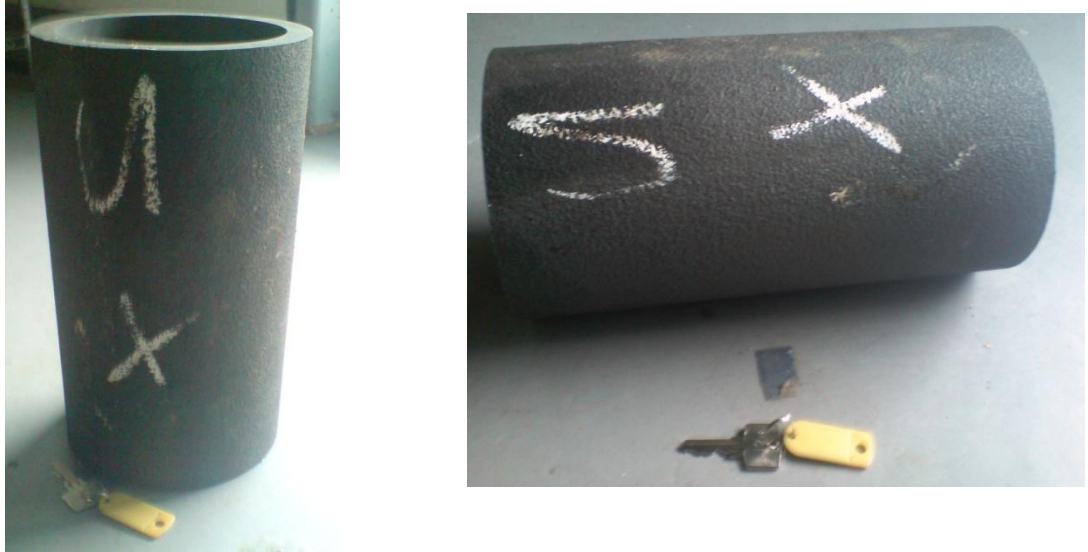
Figure 3.2: Failed catalyst tube sample from PFK [18]

After four years of service, the tube had ruptured before it reaches the theoretical life expectancy of 100,000 hours due to the formation of creep damage where the tube had then been replaced after the reformer had been shutdown. However, the issue remains where it is vital to accurately predict the remaining lives of these tubes. Among the consequences of improper assessment of creep damage can be categorized in regard of financial and safety. Financially, untimely retubing process causes unnecessary capital losses while unscheduled equipment shutdown reduces plant productivity. For safety concerns, it is clear that creeping tubes will bulge, split and rupture and in severe cases, high pressure and temperature will cause a blow down to the equipment.

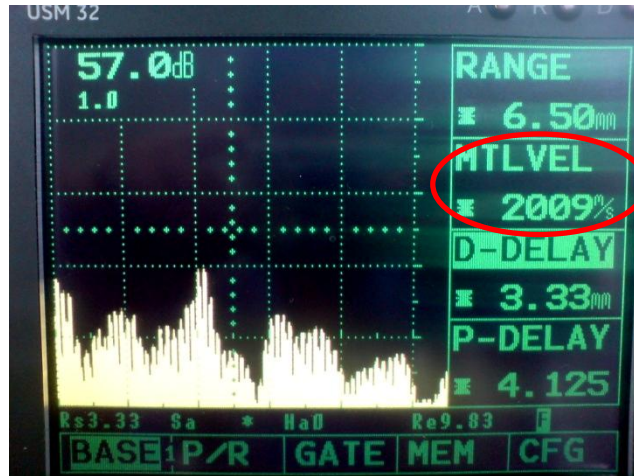
Figure 4.2: UT velocity reading on 6.5mm thickness

UT test on the internal subsurface of the tube with 6.5mm thickness yielded ultrasonic wave velocity of 2009 meter per second (m/s) as shown in Figure 4.2 below.

The values of ultrasonic velocities were found to be higher on the internal subsurface (6.5mm) of the tube, than that on the external tube surface (13.0mm). It is well known that the operating temperature environments for both these surfaces are different, where the external were exposed to much higher temperature than the other.

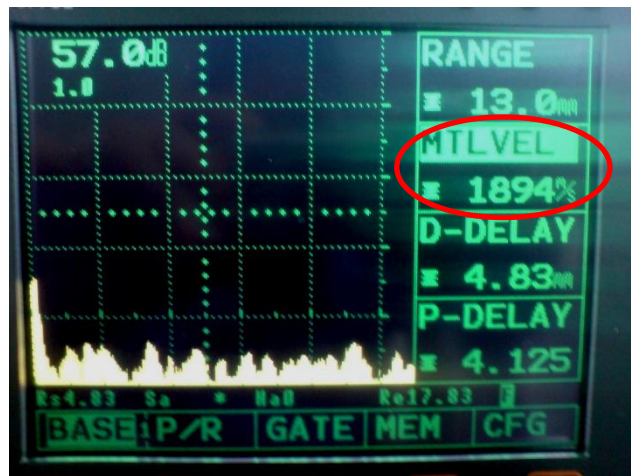
Figure 4.3: UT velocity reading on 13.0mm thickness

UT test on the external surface of the tube with 13.0mm thickness yielded ultrasonic wave velocity of 1894 meter per second (m/s) as shown in Figure 4.3 below.

Preliminary analysis suggested that the severity of creep damage is higher in the external surface of the tube than the subsurface resulted from having different temperature environment. Higher creep damage will cause the grain structure of the material to increase in size, and presence of voids will be more significant. The reduced in ultrasonic wave signaled that the path taken by the sound waves are more heavily obstructed. Therefore, tube layer with higher creep damage will produce ultrasonic wave with lower velocity. However, these analyses are subjected to confirmation via microstructure study which will be executed in accordance to the Gantt Chart provided in Chapter 3.3.

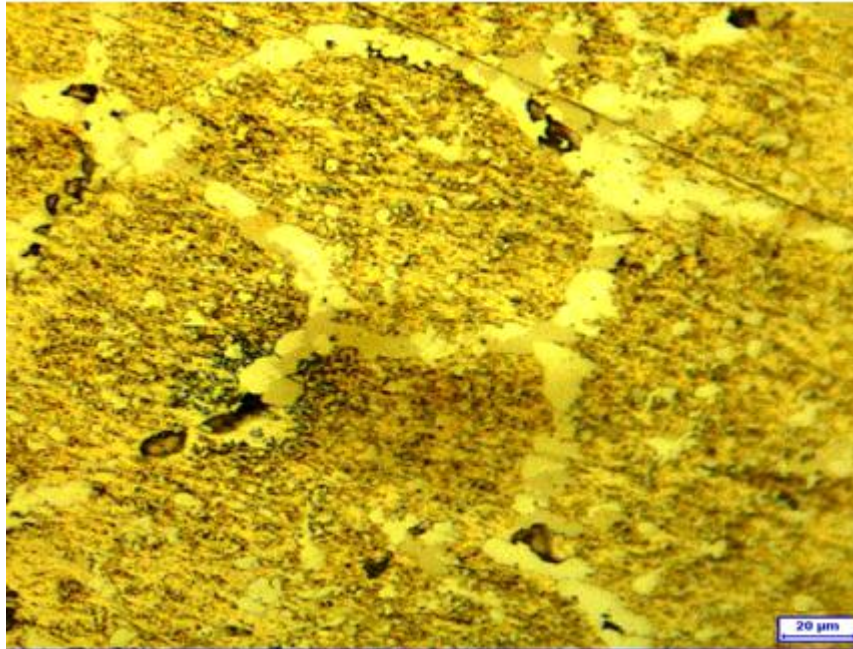
Figure 4.4: Microstructure of tube at 6.5mm thickness showing isolated voids

This part of tube section was exposed to a maximum of 773°C , which is the temperature of the product that flows on the internal surface of the tube. The grain size on this particular layer of thickness is measured to be $7.00\mu\text{m}$.

Both microstructures exhibit the structure of coagulated carbide and micro-pores at grain boundaries [20]. It is in the early stage of secondary creep, and carbides are seen to precipitate at the grain boundaries in chain-like form. With respect to time and strain, the micro-pores will further develop into micro-cavities at the grain boundaries, which will contribute to the next level of creep damage.

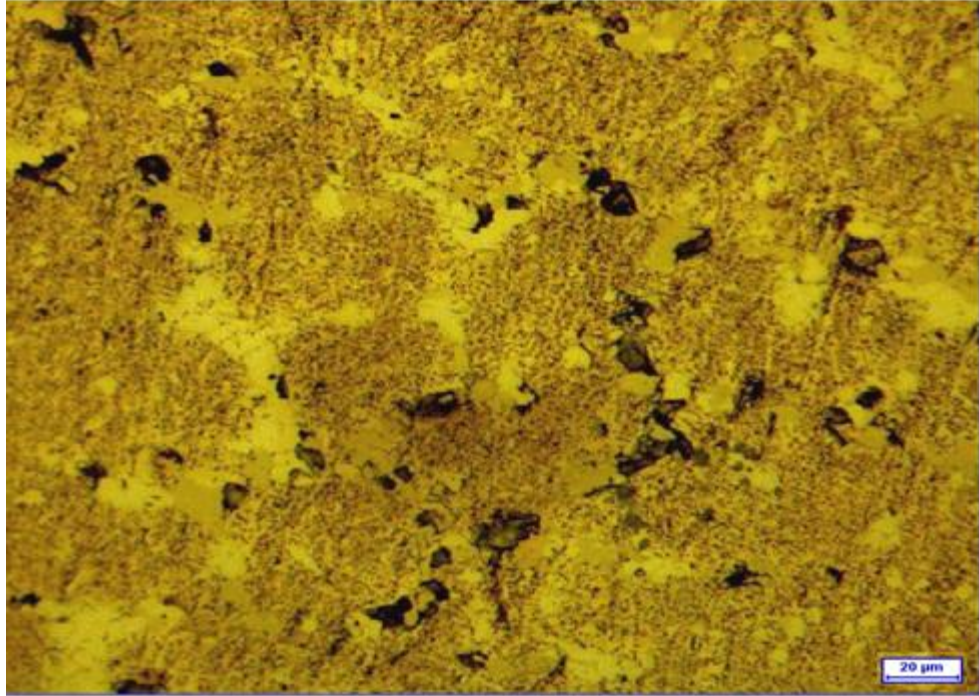
Figure 4.5: Microstructure of tube at 13.0mm thickness showing chain-like voids

This part of tube section was exposed to a maximum temperature of 910°C , which is the temperature of the heat provided by the burner onto the external surface of the catalyst tube. The grain size on this layer of thickness was measured to be $5.50\mu\text{m}$.

- 1) The ultrasonic wave attenuations had been determined, and it can be seen that the outer surface of tube which was exposed to higher temperature produced lower velocity of ultrasonic wave than the internal subsurface of the tube, which was exposed to significantly lower temperature environment.
- 2) The study of microstructure showed that the grain size of ASTM A608 steel sample decreased with increase in temperature. Presence of coagulated carbide and micro-pores were detected. In addition, hardness value of tube sample had increased linearly with the exposed temperature. This indicates that the tube suffers from the early stage of tertiary creep damage.

In the future, it is very fascinating if the catalyst tube sample used from PFK which is assumed to be in secondary and early stage of tertiary creep damage could be put under accelerated creep condition to further induce it to reach later stage of tertiary creep damage until it ruptures. In doing so, extensive relation between the microstructures and wave attenuations of all three stages of creep damage can be further discussed.

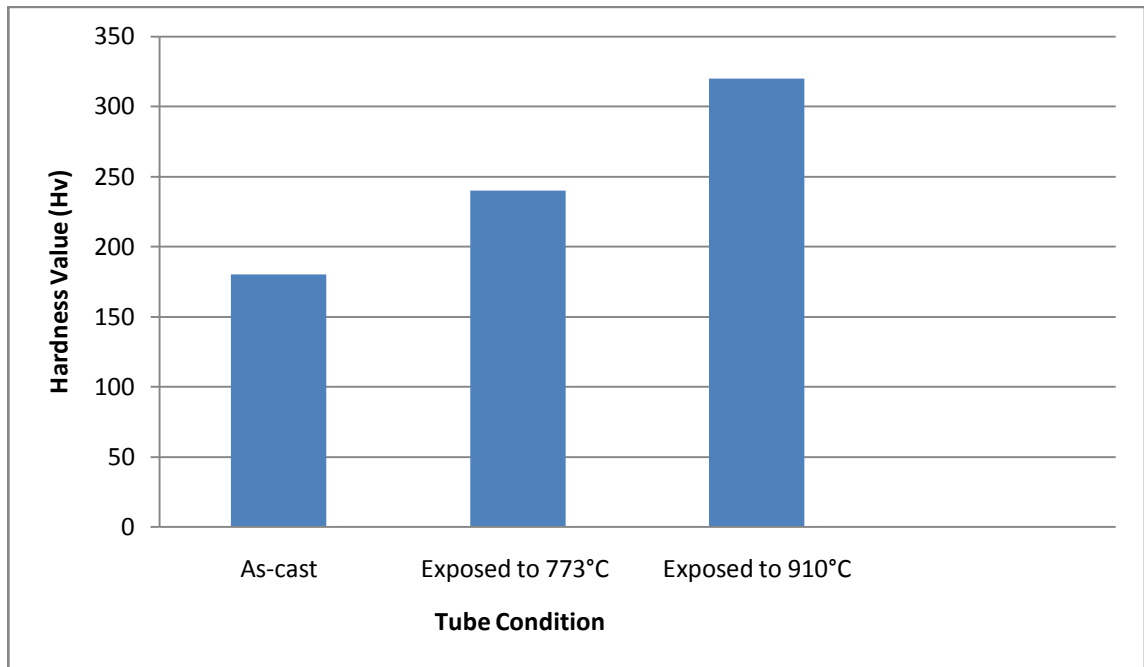
Figure 4.6: Hardness values of different tube conditions

The hardness value of the tube material in as-cast condition is 180 ± 6 [19]. It can be seen that after 40,000 hours of service in high pressure and high temperature environment, the hardness values of tube on both internal and external surface of the tubes had increased considerably to 240 Hv and 320 Hv, as shown in Figure 4.6. This is due to the increase of carbide precipitation along the grain boundaries which are extremely hard in nature [15]. As the temperature increases, the formation of carbides proved to be increasing and had undergone significant agglomeration as shown in the microstructure study, which explains the higher hardness value of tube sample operating at a maximum of 910°C (external surface) than that of the sample operating at around 773°C (internal surface).

The hardness value increased in relation to the tube condition as shown in Figure 4.6.
