Failure Analysis on the Wire Rope for Lifting Equipment

Dissertation submitted in partial fulfilment of
the requirements for the
Bachelor of Engineering (Hons)
(Mechanical Engineering)

Universiti Teknologi PETRONAS

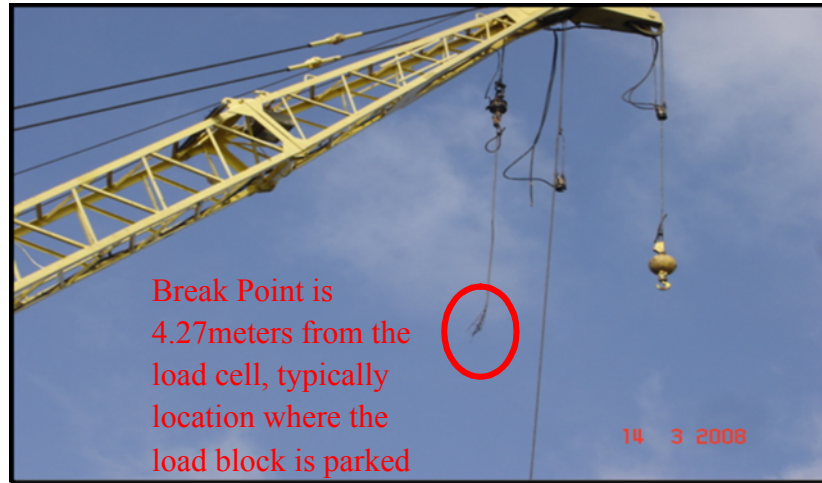
Figure 4.2: The crane boom position just after the incident

Based on Figure 4.2, the breaking point of the wire rope is in the red circle. The break point is 4.27meters from the load cell typically location where the load block is parked.

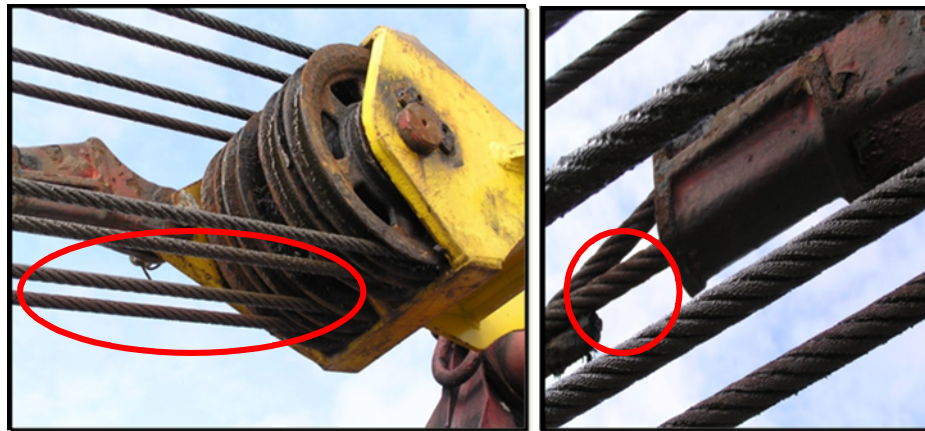
Figure 4.3: The crane anchor

The anchor is the tip point of the boom indicated in Figure 4.3. The red marked shows the portion of the wire rope without grease (improper maintenance on the wire rope).

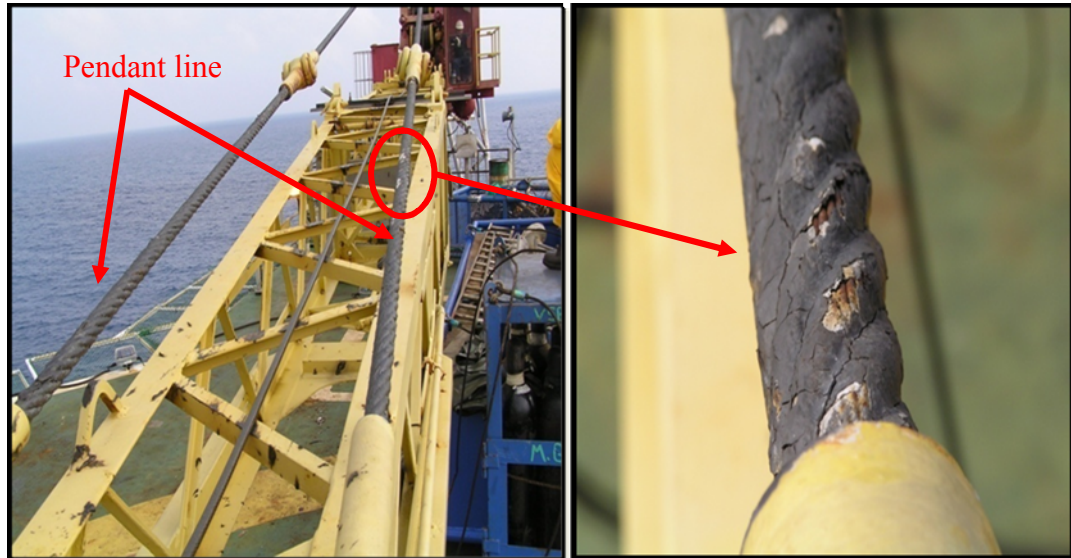
Figure 4.4: Pendant line on the crane (red arrows)

Based on Figure 4.4, the grease on the pendant line has become brittle and peel off from the wire rope. The grease become brittle due to the reaction with the environment since the pedestal crane did not park under any roof. This also shows that improper maintenance activity conducted to cover the peel off grease with new grease.

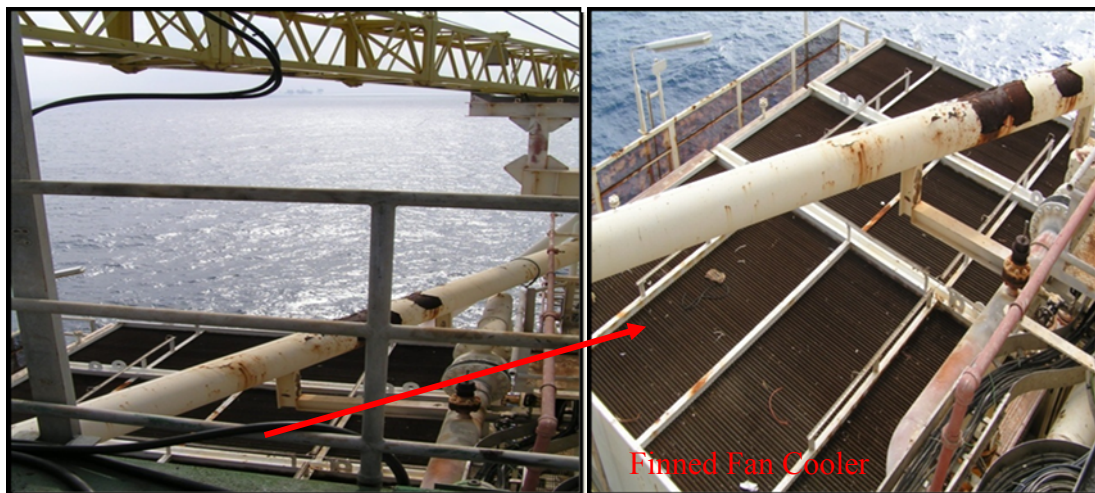
Figure 4.5: Boom on park position

The boom actually park on top of the finned fan cooler as per in Figure 4.5, the ambient temperature of approximately 40 °C is not significant to affect the strength of wire rope.

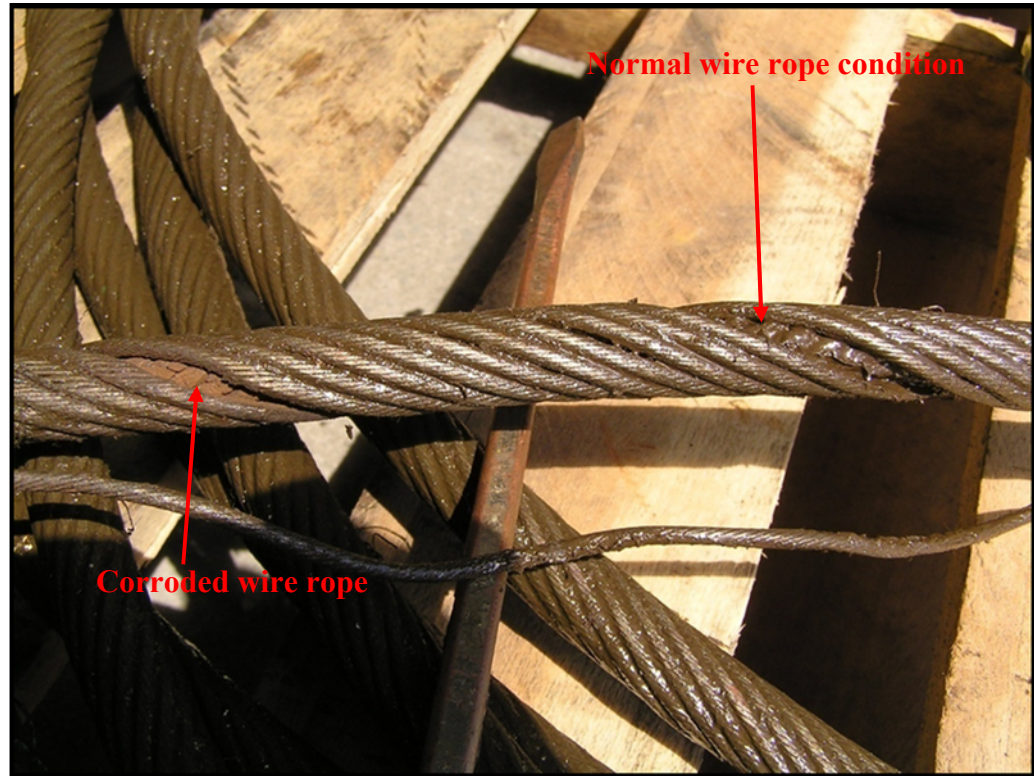
Figure 4.6: Corrosion internal part of the wire rope

At the static portion, observed the grease to be relatively dry. At running portion, the grease can penetrate to the core when the strands are opened by bending when running through sheave. As a result the static portion wire rope core is not protected from the environment. Figure 4.6 clearly show the different between corroded and protected part.

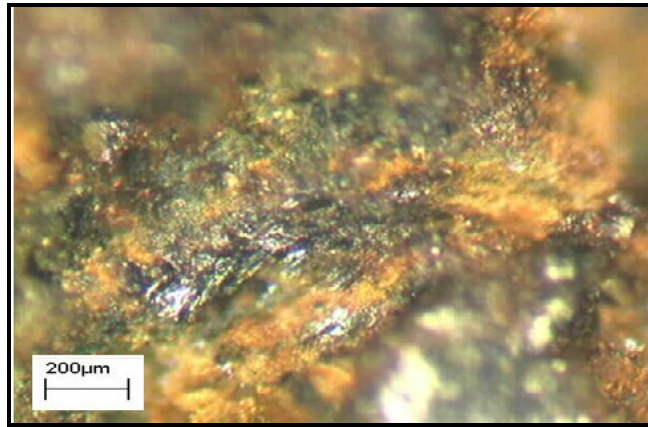
Figure 4.11: Corroded surface at 50X magnification with optical microscope

Based on the figure 4.11 the present of the yellow element indicated that the present of the rust which indicates that the wire rope already corroded. Figure 4.12 show how the undamaged surface of the wire rope, there no present of yellow element which shows that the coating of zinc was still protecting the carbon steel.

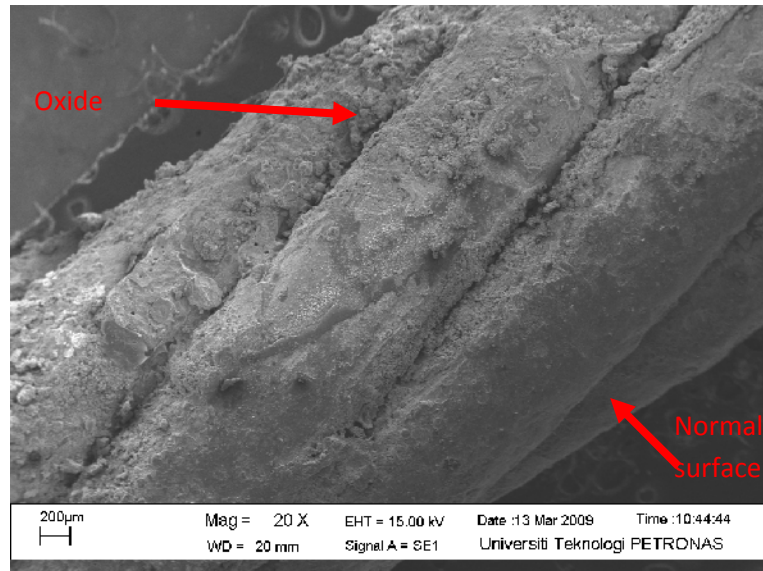
Figure 4.13: Surface Magnification under SEM at 20X magnification for single strand

Figure 4.13 shows the formation of oxide on the surface of the strand as per labeled. Zinc coating designed to sacrificed itself to protect the carbon steel for this wire rope design. As the time of operation increase the zinc may form zinc oxide and wear due to environment and movement of the wire rope. Greasing and lubrication on the wire rope will extend the life. The greasing will act as an inhibitor that will prevent the oxidation and reduction process thus stopping the corrosion. The pattern occurred on this wire is due to the improper greasing apply on the wire rope. The surface without greasing and zinc coating will corrode and the strength of the wire rope will reduce the probability of the wire rope to fail.

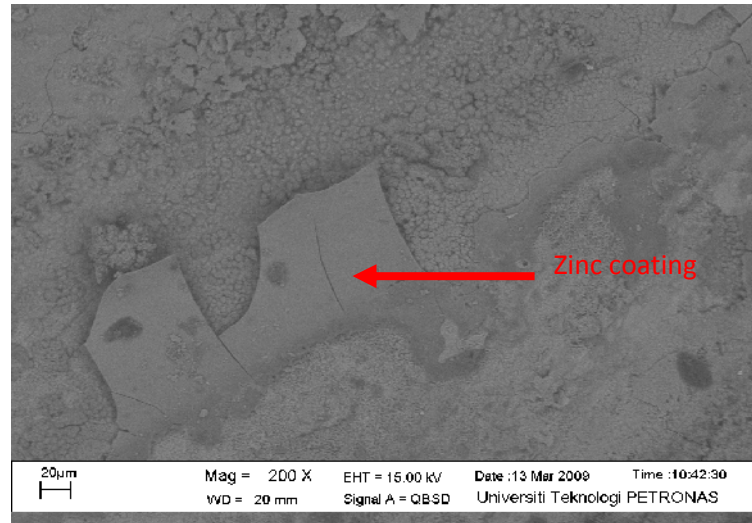
Figure 4.14: Surface Magnification 200X using SEM for single wire

Figure 4.14 show that the remaining of the zinc coating after it reacted with the environment to protect the carbon steel. The zinc peels off from the base metal.

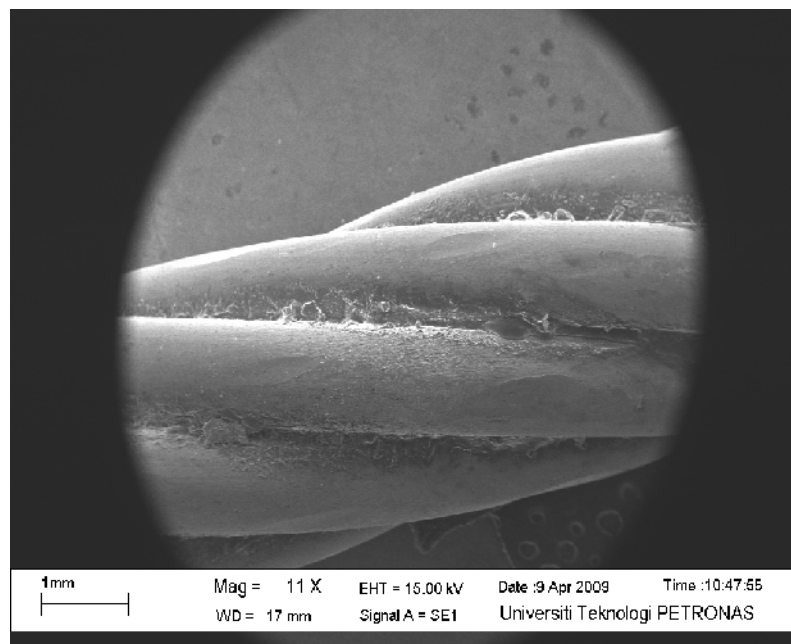
Figure 4.15: Surface magnification 11X for single strand using SEM

Figure 4.15 show the normal strand with zinc coating the surface protected with grease, the zinc coating also remain on the surface of the single wire. There is no sign of oxide formed on the wire surface.

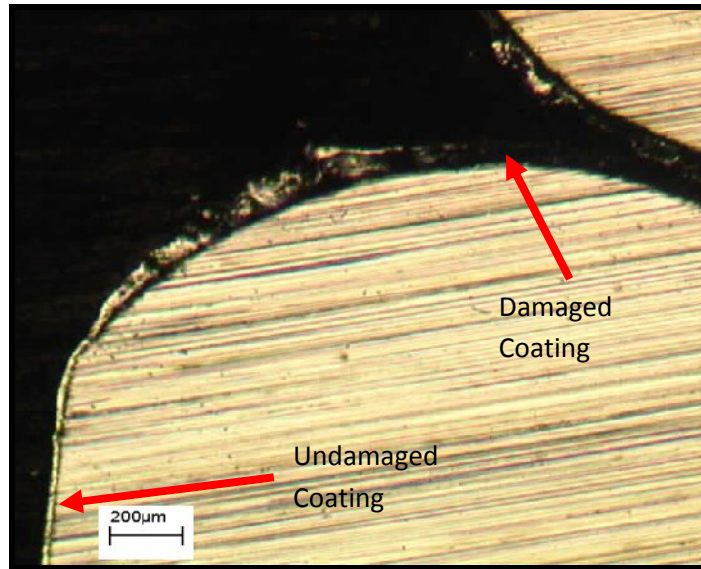
Figure 4.17: Cross sectional of wire at 50X magnification under optical microscope

Figure 4.17 show the zinc coating on the single wire from the corroded strand, here we can observe that some of the coating was already damaged, and the damage is due to degradation of zinc to the environment and wear. The wire without coating and without proper lubrication and greasing can lead to the failed wire rope due to the corrosion.

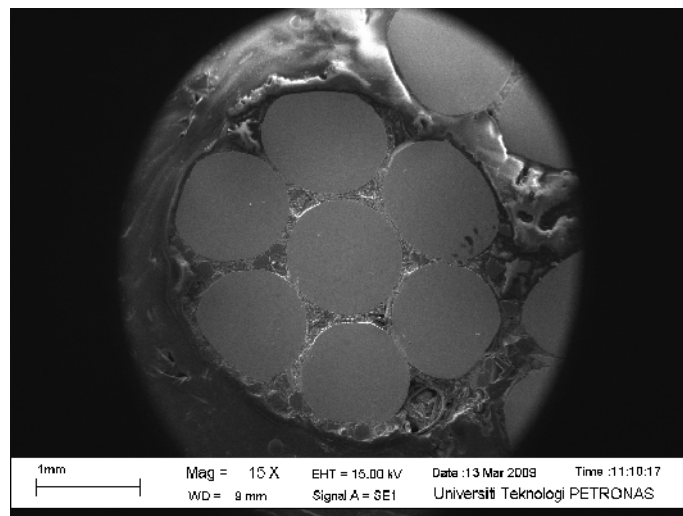
Figure 4.18: Cross sectional of Strand at 15X magnification under SEM

For the figure 4.18, the mounted specimen grinded and polished, there is no layer of zinc observed even though the specimen is the new wire rope. This is because there is imperfection of coating process conducted by the manufacturer, the thickness of the coating process for single wire did not measure closely during the manufacturing because API 9A did not state the thickness of the coating it only mention amount of the weight of coating per length of the wire produce, so there is slight possible that at certain part of the wire rope zinc coating is not enough.

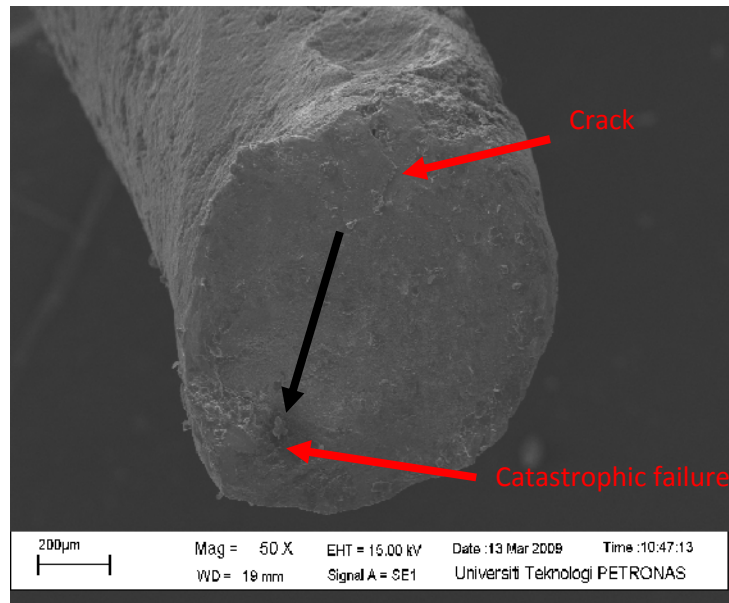
Figure 4.20: Fracture surface on the single wire (a)

Based on the figure 4.20, the fracture surface shows a trend of ductile failure that occurs normally due to tension. The black arrow shows the direction of the failure. There is no mark on the surface showing the propagation of the crack, indicating that this wire failed at single tension load.

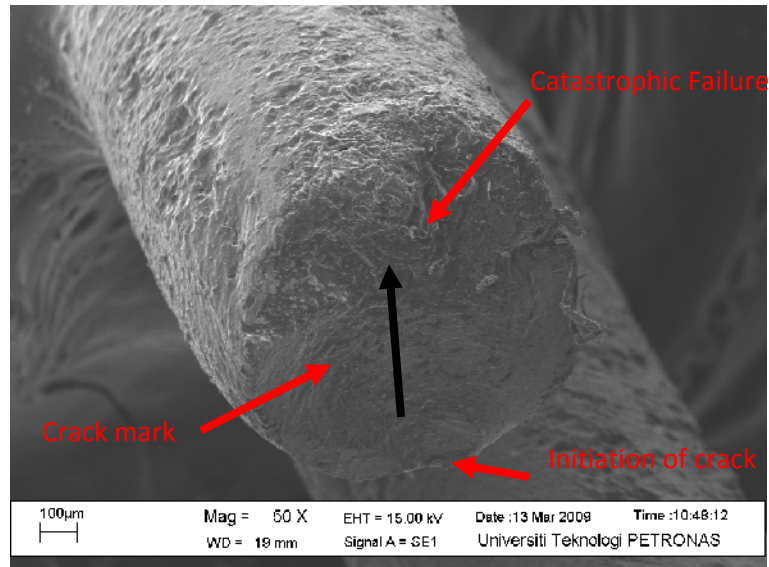
Figure 4.21: Fracture surface on the single wire (b)

Figure 4.21, shows clear mark that indicates the propagation of the crack before the failed of the single wire. The black arrow shows the direction of the crack before the catastrophic failure. The type of the failure is also similar in figure 4.20, which is ductile failure. However, this wire did not fail on single tension loading due to the existence of the marks on the fracture surface.

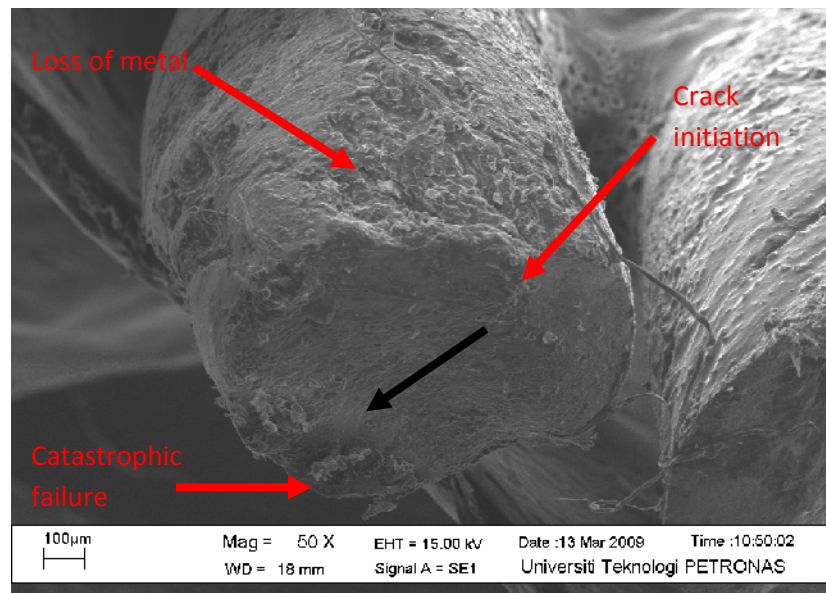
Figure 4.23: Fracture surface on the single wire (c)

Figure 4.23 shows the same type of the failure of the wire, there also loss of metal on the wire which starting the initial crack. The loss of the metal is due to the corrosion on the surface of the wire. The figure also shows no layer of the zinc that should be covered the surface of the wire as per stated in API 2C. The losses of the metal reduce the cross sectional area of the wire, at a tension loading the stress concentrates at the particular area and causing the crack to initiate. As the crack initiate, at the constant loading the crack will propagate (black arrow) until the wire fail. The surface in figure 4.23 also shows the grooving pattern, this pattern exist due to some twisting on the wire before failed.

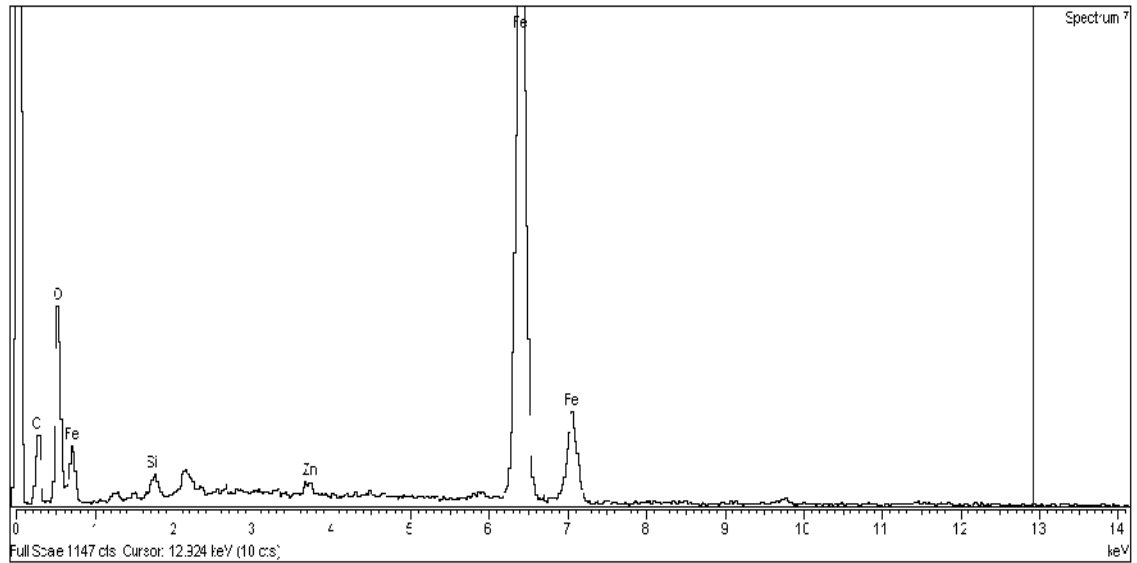
Figure 4.26: EDX on the failed surface

Based on the result obtain from Figure 4.26, there is present of the zinc oxide (listed in standard) on the failed sample due to the zinc reacted with the environment to protect the based metal of the wire rope. The present of iron oxide on the surface confirmed the result obtained from the optical microscope (Figure 4.11) that shows the present of the yellow color on the surface.
