# **Failure Analysis on Heat Exchanger Tube Bundle Leakage**

Nur 'Atikah bt Jamaludin Alias

SEPTEMBER 2011

Universiti Teknologi PETRONAS

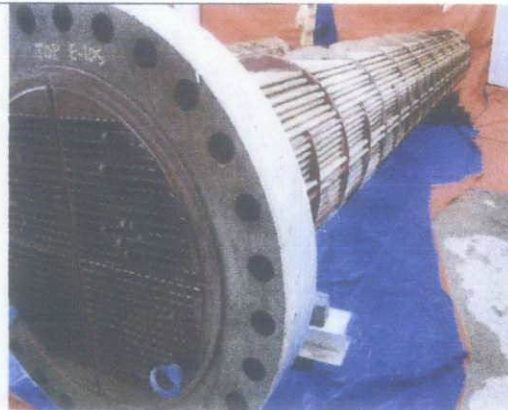
*Figure 3.1: E-105 after being removed from the shell [6]*

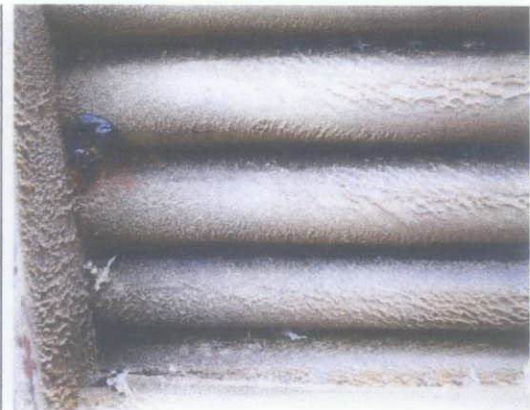
*Figure 3.2: Thick brownish/slimy deposit/fouling observed next to tubing and baffle plate intersection [6]*

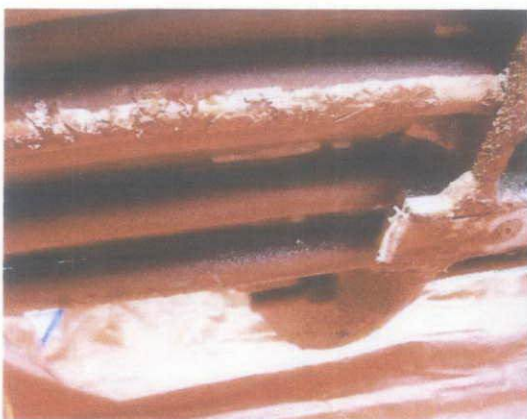
*Figure 3.3: Coating damage and blister observed on E-105 tubing [6]*

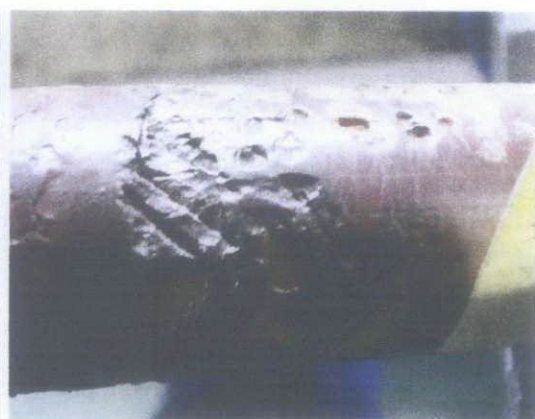
*Figure 3.4: Close-up of E-105 localized corrosion/pitting and groove/mechanical damage near baffle plate to tube intersection [6]*

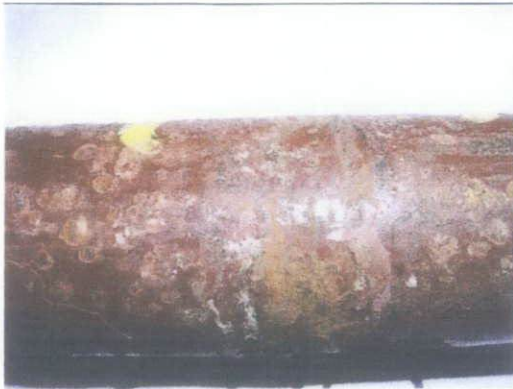
- i) E-105 shows the sign of coating damage along the tubing surface. Probable reason for coating blisters could be inadequate surface preparation, dirty/dusty and trapped solvent or air bubbles.
- ii) Compared to E-104 tubing, E-105 has more corrosion sites and the extent of corrosion pits is concentrative over a small area adjacent to the baffle plate to tubes intersection.
- iii) Mechanical damage i.e. long narrow groove is observed at one of the sites as shown in figure below.
- iv) Trough wall pitting is observed. Probable cause for high concentration of pitting at adjacent area of baffle plate to tubing intersection could be crevice corrosion and under deposit corrosion as this is the area where no flow to low flow condition prevails.

*Figure 4.1: As received E-105 with coating damage/blister on tubing external [6]*

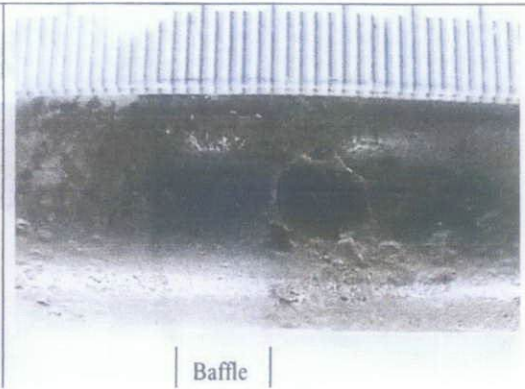
*Figure 4.2: E-105 with trough wall pitting 5mm x 6mm located next to baffle plate and tubing intersection. Smaller size pits observed in adjacent area. [6]*

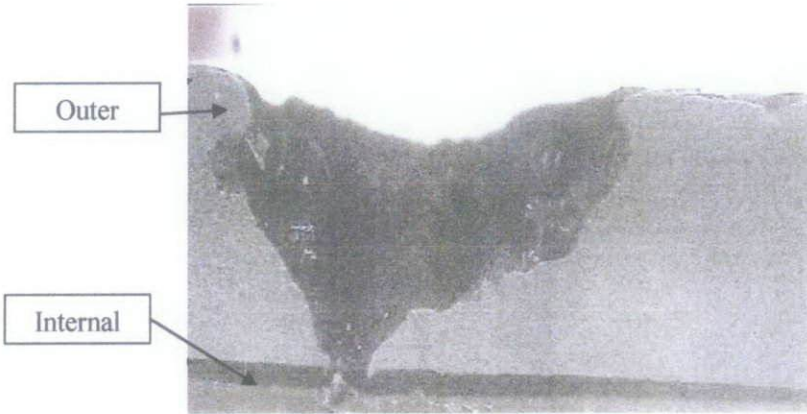
Figures 4.3 below show that the pit size was larger at external surface compared with internal surface of the tubes. This means that the corrosion originated from the external surface and penetrated into the tube wall. Both pits surfaces were covered with oxides/layer of corrosion deposit. [6]

*Figure 4.3: Cross-section view of E-105 through wall pit [6]*

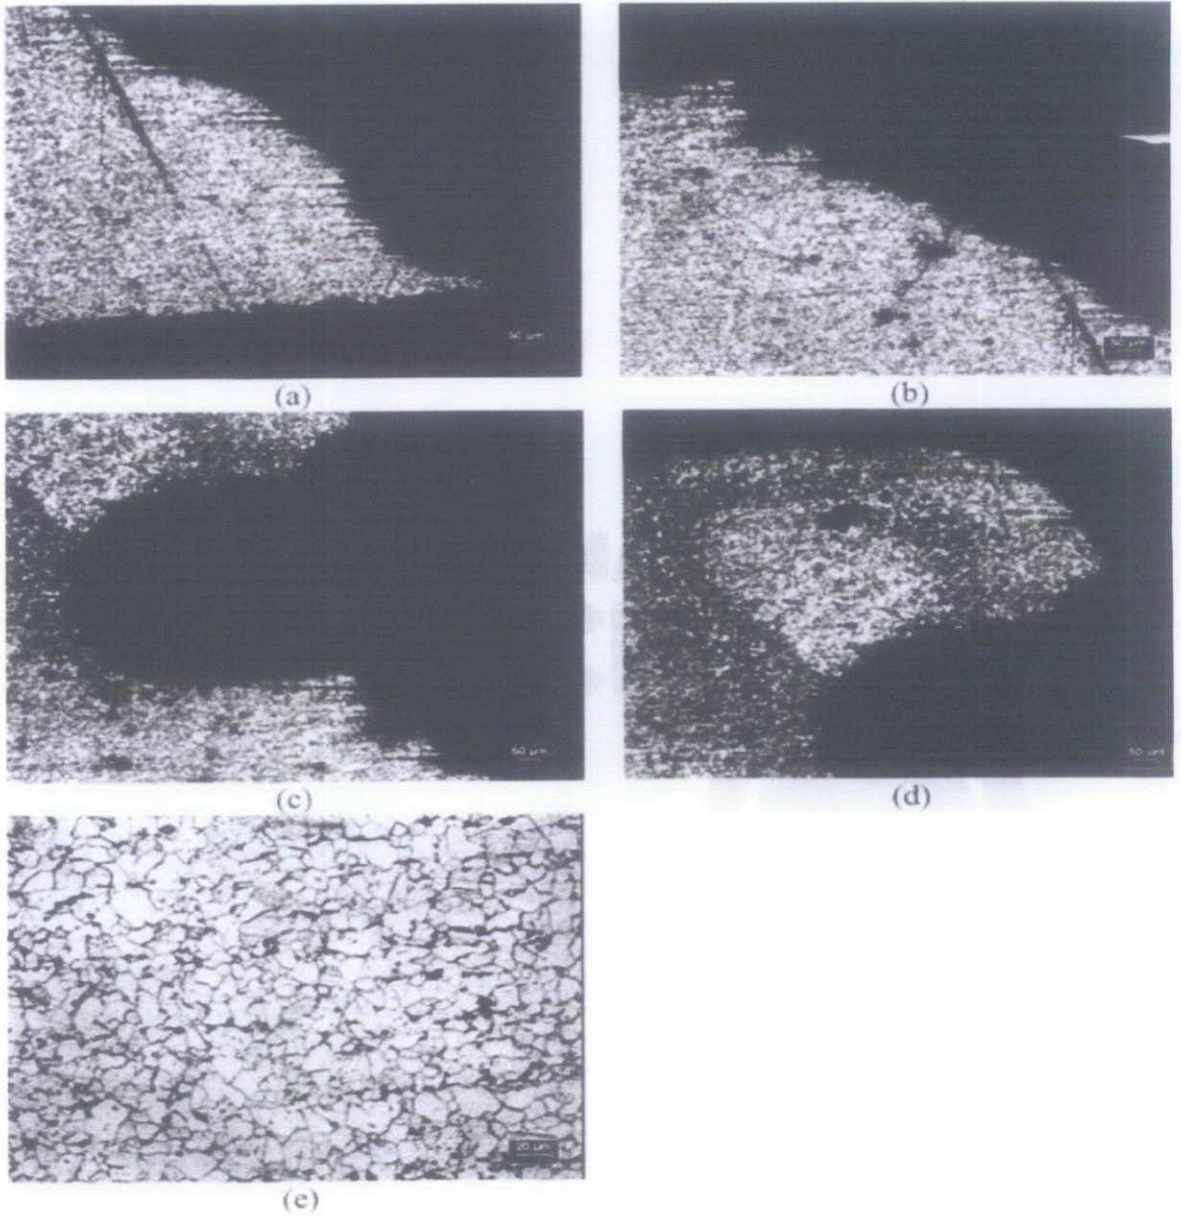
Typical microstructure is observed in E-105 tube sample consisted of large equi-axed grains; indicating that tubes were in the annealed condition and not over stressed. No grain growth, grain deformation or microcracks is observed on both tubes, and corrosion attack is along the grain boundaries. [6]

*Figure 4.4: Microstructure photo of tube E-105 taken from pit internal to external surface (d) and close-up view (e). [6]*

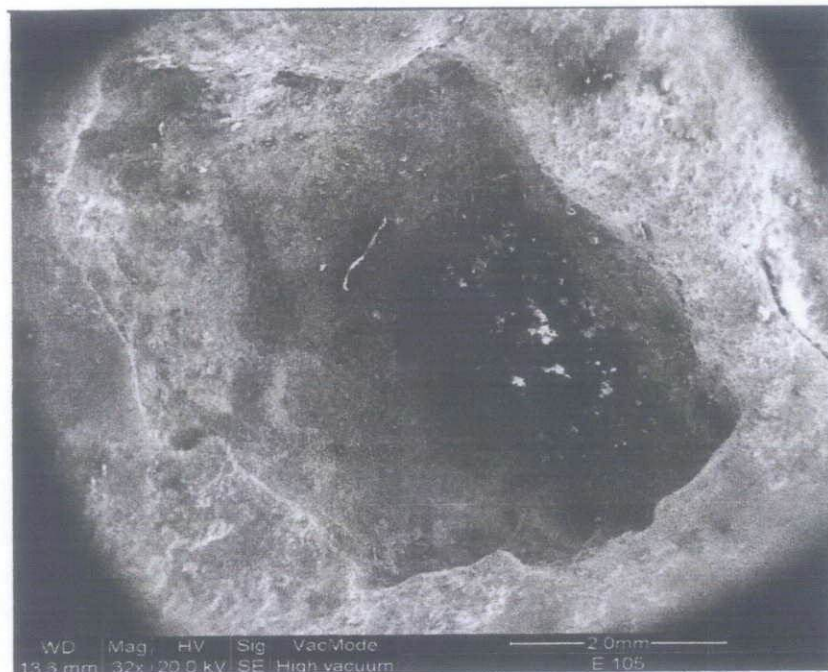
It is observed that a large proportion of the corrosion product consists mainly of iron oxides. Trace element of chloride was again detected which means that an acidic corrosion cell was present/active. [6]

*Figure 4.5: SEM photo from top surface E-105 pit hole [6]*

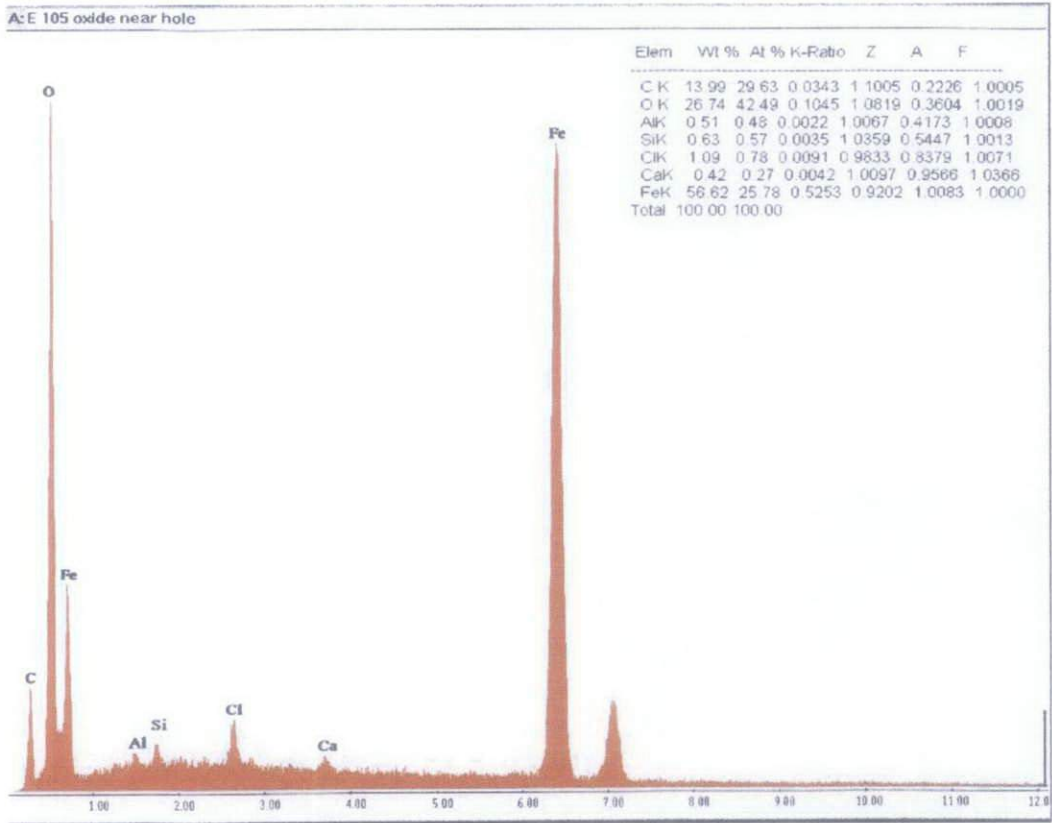
Figure 4.6: EDX analysis on corrosion product of E-105 tube [6]

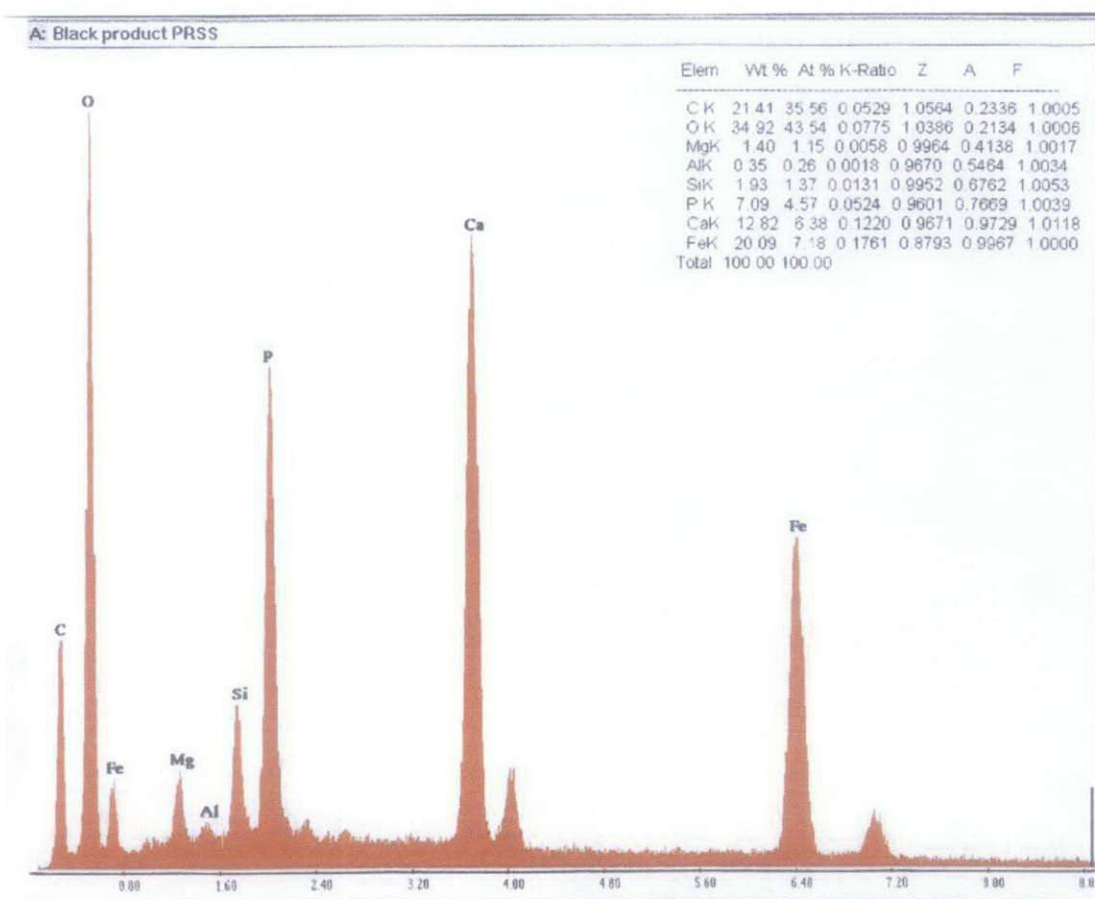
It is observed that a large proportion of the black deposits consist of calcium carbonate, phosphate, iron oxides and trace elements of silica, magnesium and aluminum. This is reflective of corrosion product from the metal itself and deposition product from the cooling water treatment.

Figure 4.7: EDX analysis on black deposit [6]

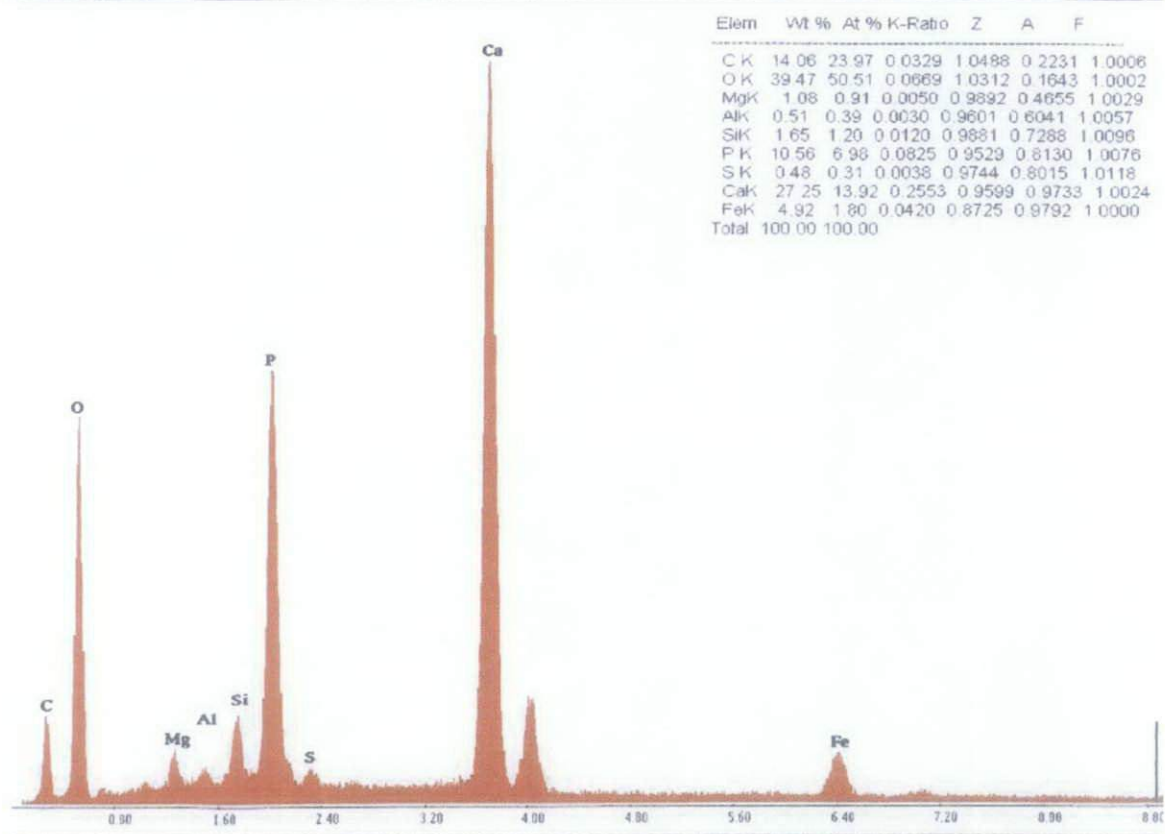
As for the white deposit, it is observed that a large proportion of the deposit consist of calcium carbonate, phosphate and trace elements of iron oxides, silica, magnesium and aluminum. This is reflective of corrosion product from the metal itself and deposition product from the cooling water treatment. A trace amount of sulfur is also founded suggesting that MIC could be present/active. Figure 4.7 and Figure 4.8 show the EDX Analysis on black deposit and white deposit respectively. [6]

Figure 4.8: EDX Analysis on white deposit [6]

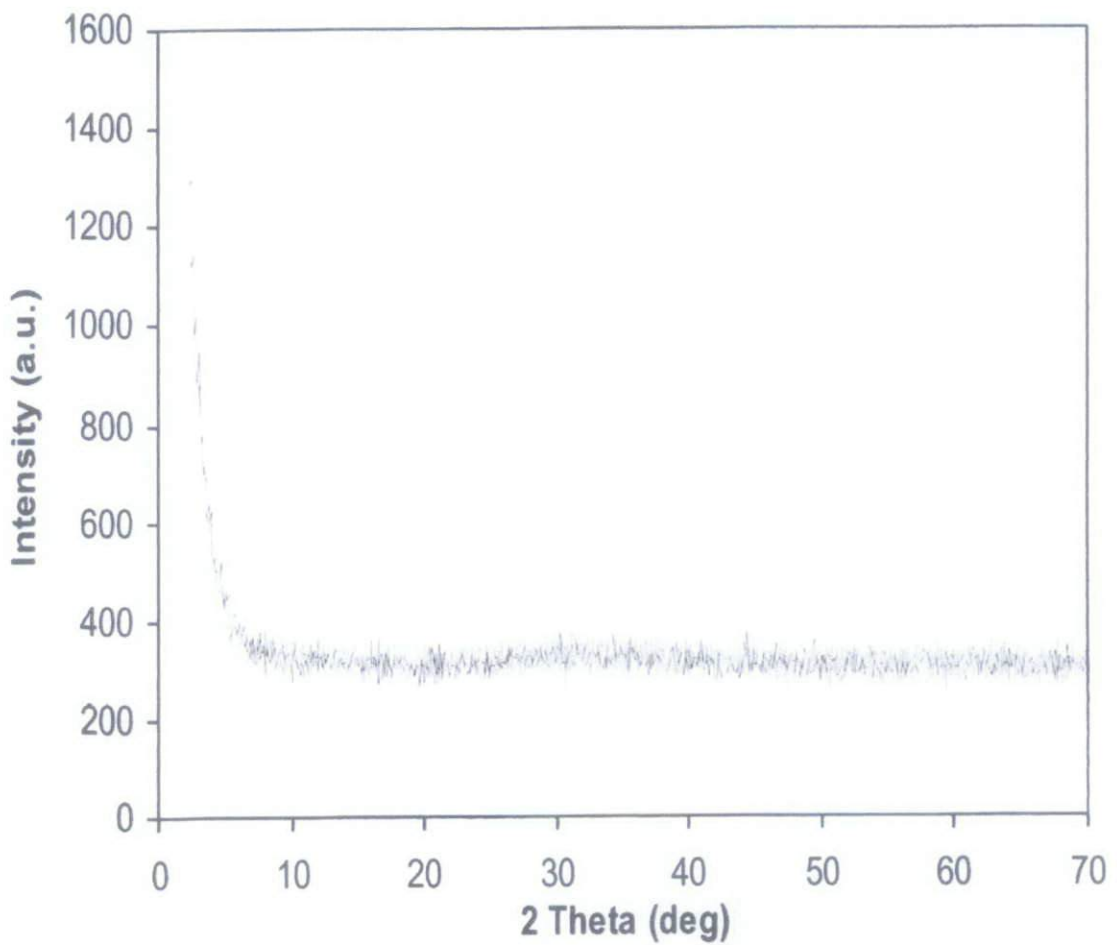
The XRD analysis result does not show any peak for both deposits as indicated in Figure 4.9 and 4.10 respectively. This means that both deposits are of amorphous material/powder that does not contain any crystalline. [6]

Figure 4.9: XRD on black deposit [6]

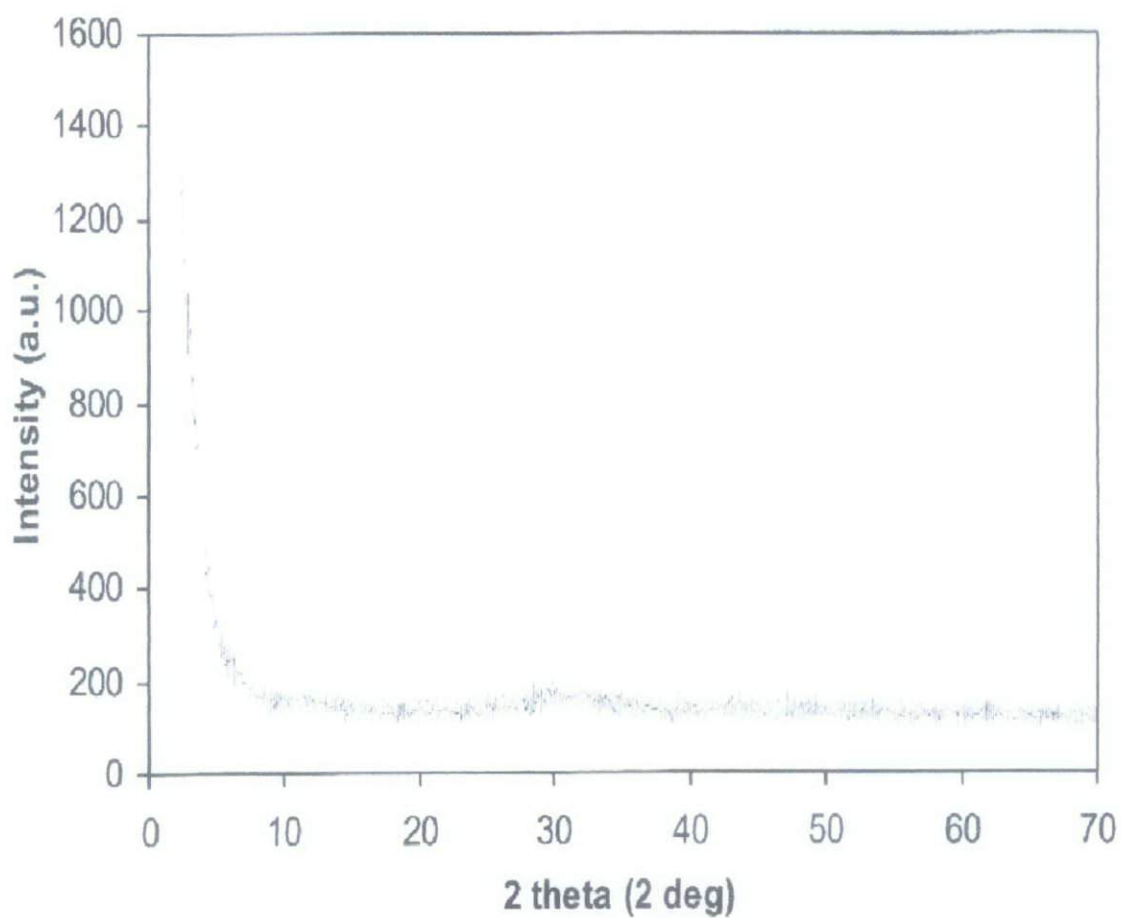
*Figure 4.10: XRD on white deposit [6]*

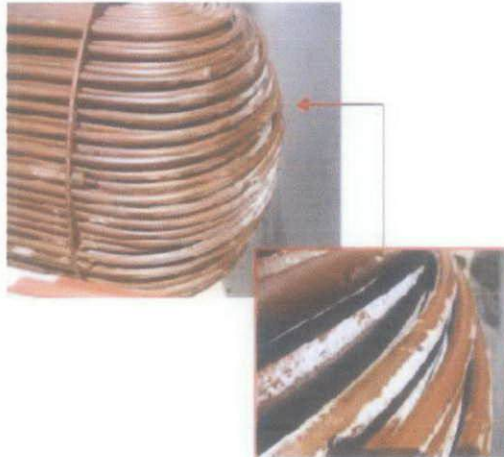
*Figure 4.11: Layer of deposits scale found at tubes and mostly accumulate at U-bend area [12]*

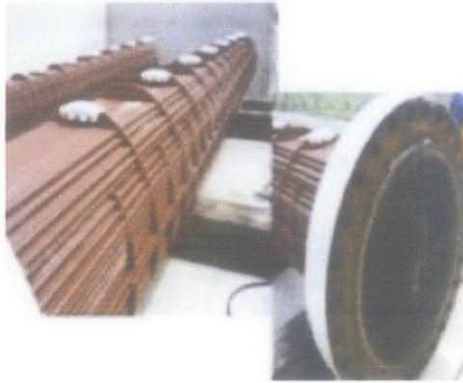
*Figure 4.12: View of tube bundle noted in satisfactory condition. No sign of any abnormalities observed [12]*

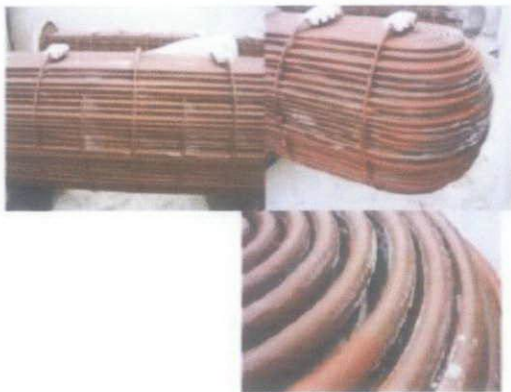
Water jetting done at external of the tube peeled off the coating in some areas. The removal of portion of the coating exposed the base metal which is prone for solid deposits that could lead to localized deposition/pitting corrosion. Therefore, action has taken to touched-up on the accessible areas but not on the inner layers. [12]

*Figure 4.13: Peeled off coating in some areas due to water jetting [12]*

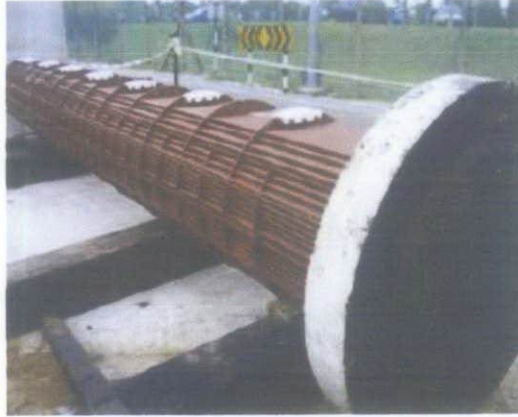
*Figure 4.14: Touched-up peeled off coating after the contractor did hydro-jetting due to some damaged peeled off the existing coating [12]*

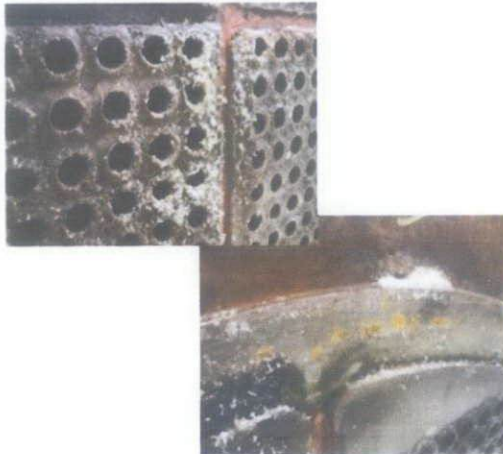
At the tube side, found a thick layer of sticky residue. [12]

*Figure 4.15: View of tubes sheet found with thick layer of product residue and white residue stick at tubes sheet [12]*

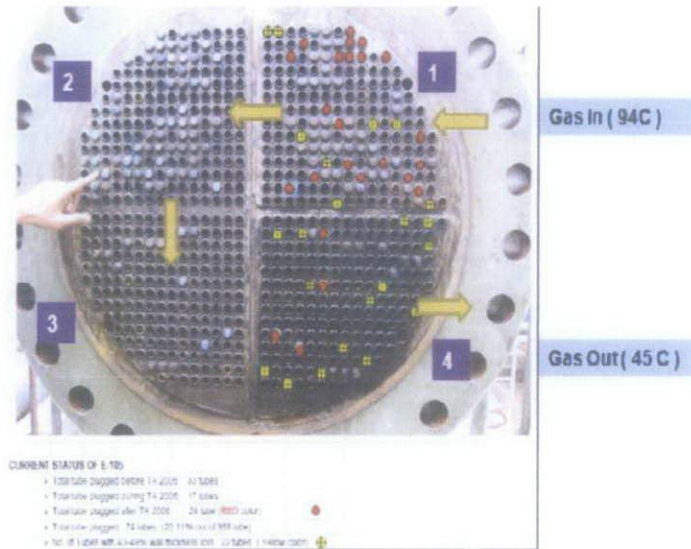
Figure 4.17: Old E105 Leaking Mapping [12]

The leak pattern is more concentrated at the upper portion (1/2 pass). Higher temperature at upper portion was found where deposition/pitting corrosion is accelerated. Refer to Figure 4.17. [12]

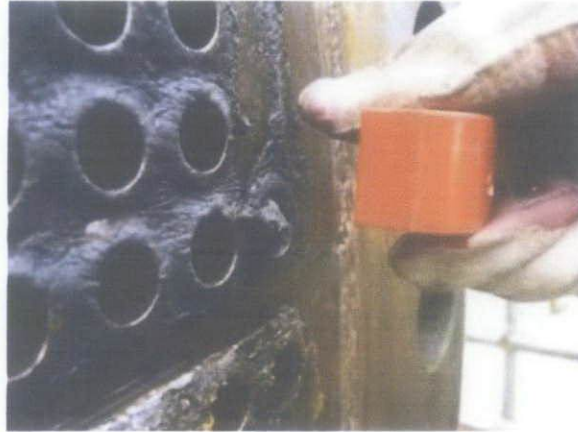
- Sticky foam was noted at the bottom section of tube sheet.
- Visual inspection was done at tube sheet face. No abnormalities noted. Sticky blackish deposited was noted entire tube sheet surface.
- Magnetic test were carried out at deposited surface and the deposit attract to magnet. [12]

*Figure 4.19: Magnetic test carried out at deposited surface [12]*

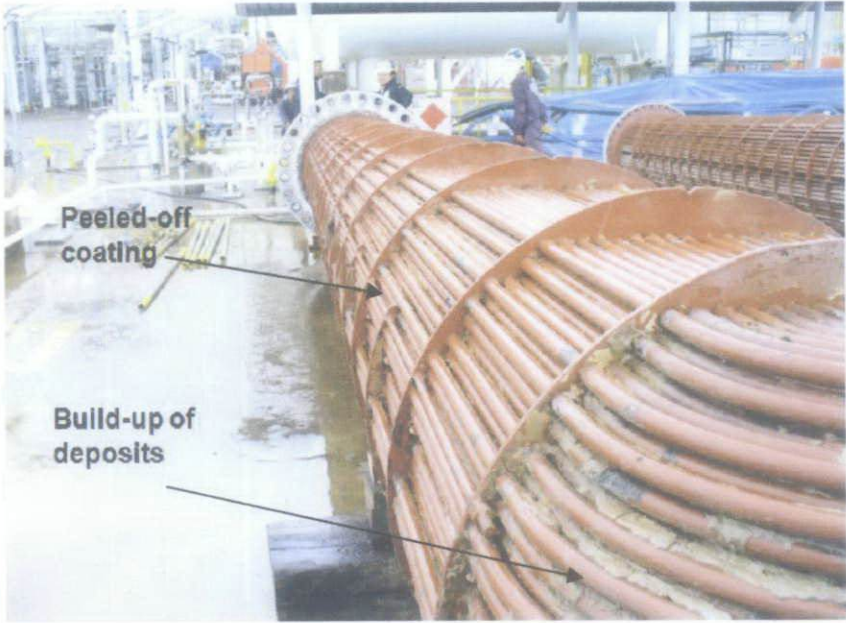
*Condition of E105 after cleaning [12]*

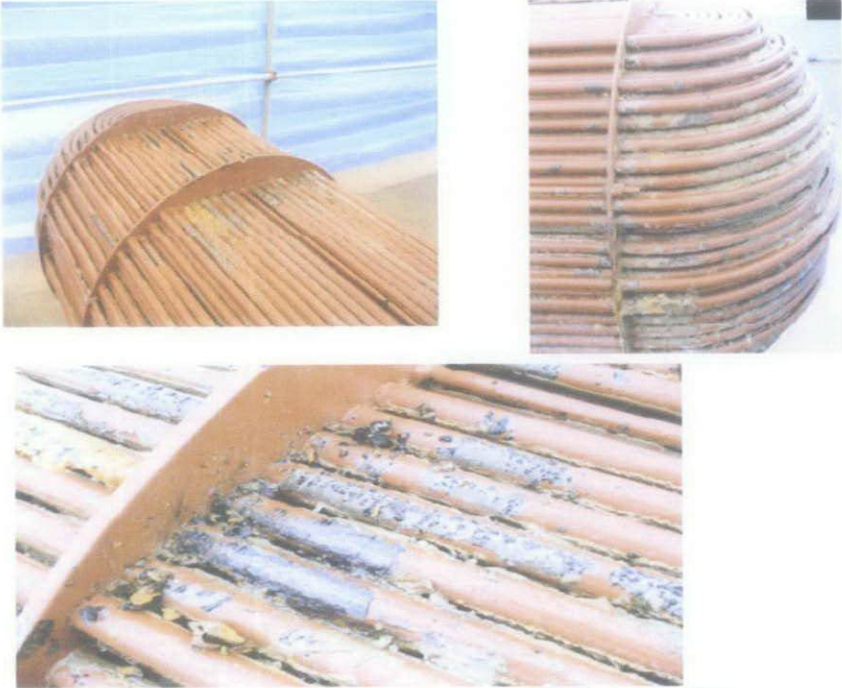
*Build up deposits concentrated on U-Tube surface [12]*
