**FAILURE ANALYSIS STUDY ON THE CUTTER BLADE OF  
POLYPROPYLENE PELLETER DRIVE**

FINAL REPORT PROJECT

Universiti Teknologi PETRONAS

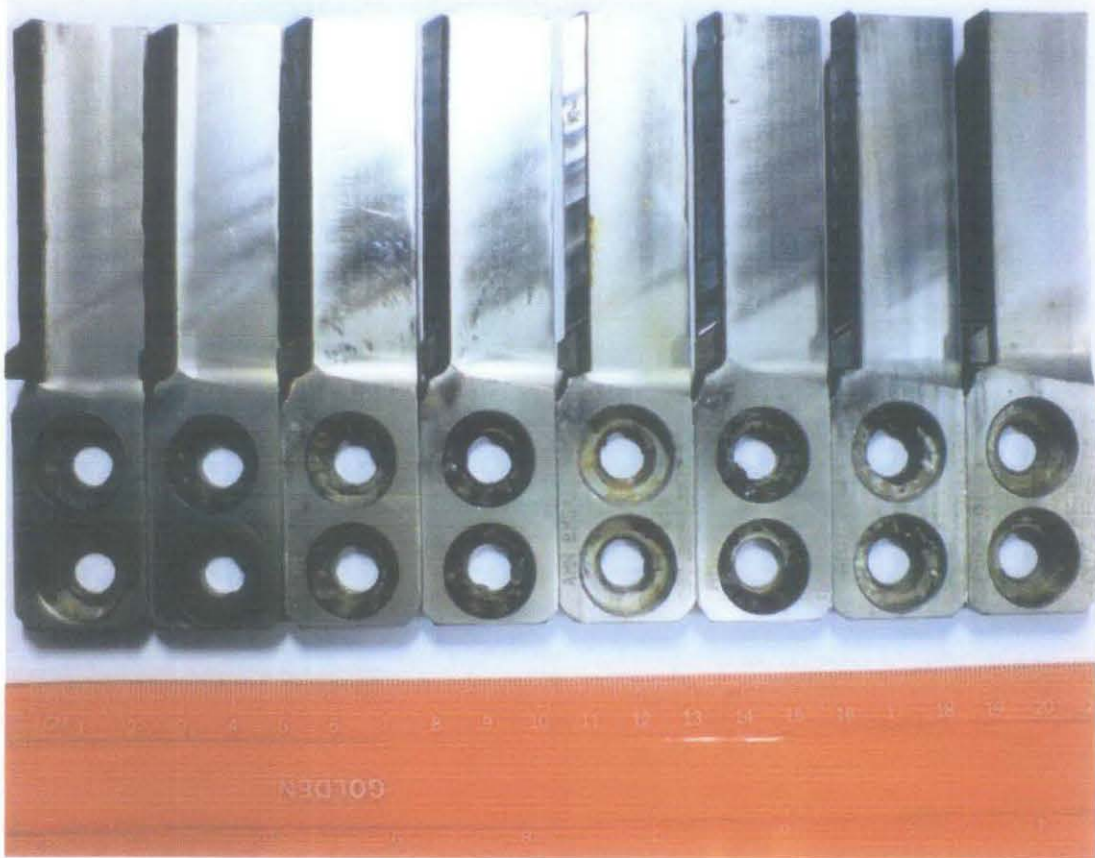
Figure 15: Samples of the failed cutter blades; mixed of excessive wear and uneven wear land of cutter blades.

Results based on the background and sample collection stage provide useful information about the failure of the cutter blades. It is manufactured by Kobe Steel Company or Kobelco in Japan. From the preliminary examinations, the cutter blades show severe wear, few blades are collected show some part had chipping marks.

The excessive wear on the cutter blades is suspected from poor operating procedure. During high melt index, polymer tends to produce tailings. To counter this problem the operator need to advance the pelleter rotor forward to the die plate. This resulting higher grinding force and higher wear rate.

To reduce wear, the author suggests reducing grinding force of the blade against the die plate but allowing the blade to rotate at high rotational speed to avoid polymer tailing.

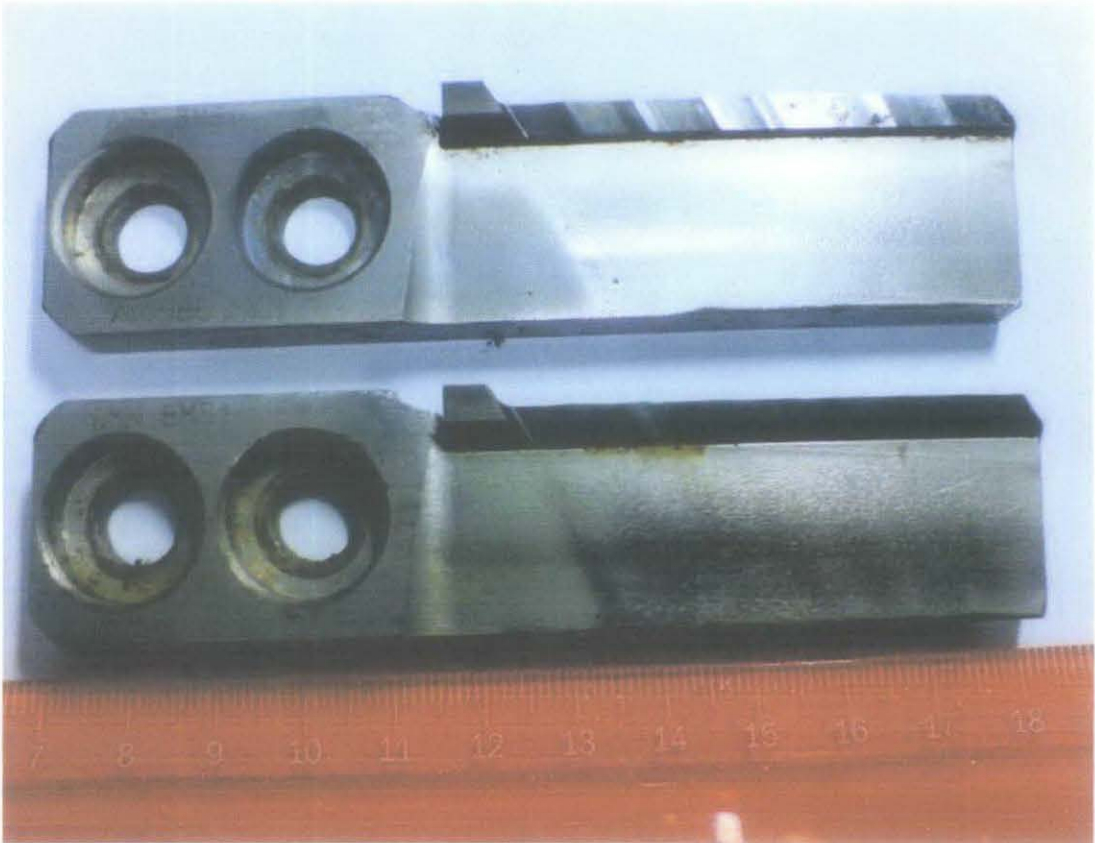
Figure 16: Uneven wear of the cutter blade.

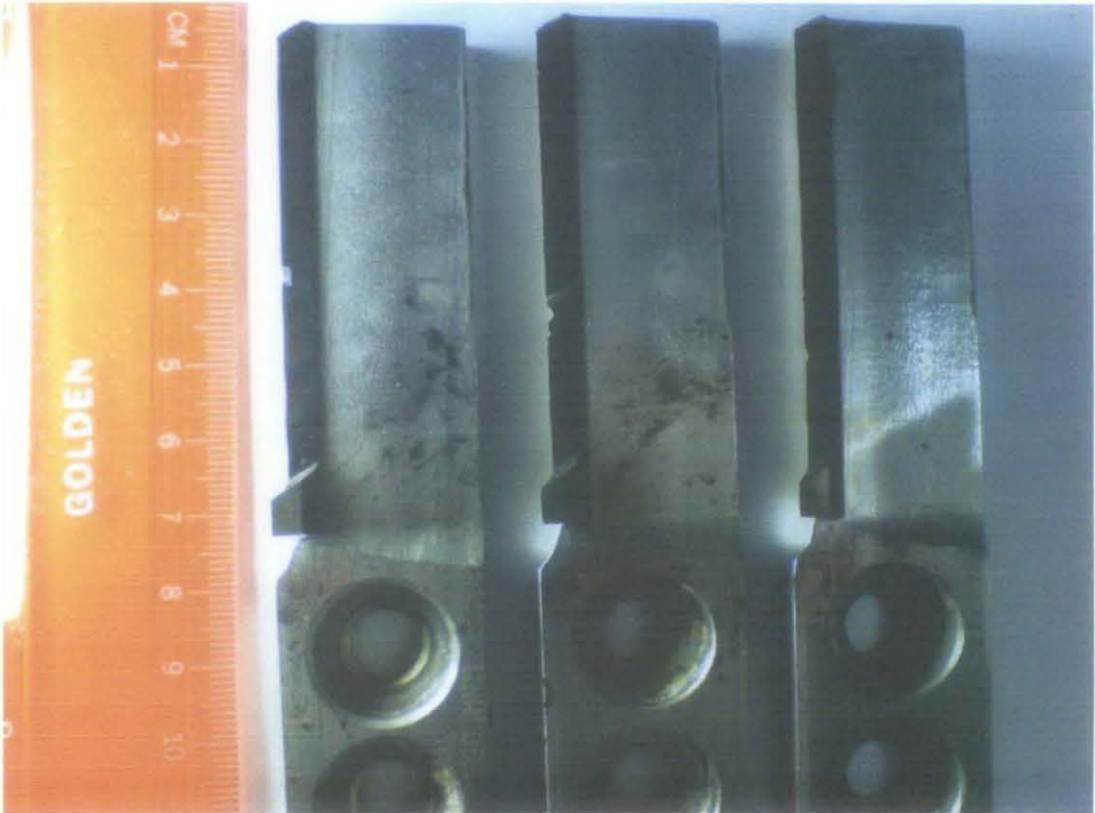
Figure 17: Chipped titanium carbide tip.

The blades chipped part indicates that possibilities that foreign particles carried along with cooling water may have come in between the rotating pelletizer. First impression the tip fractured when it collide heads on with the debris.

Lack of proper monitoring of cooling water entering the chamber may have lead to the chipping of TiC tip, debris may have come in between the blades during operation and collide with the tip. During cleaning of the chamber, the author had found sand inside the chamber.

From this study, the author would recommend to continue using this type of blade but modify the incoming flow of cooling water by installing a strainer which can prevent debris from entering the chamber.

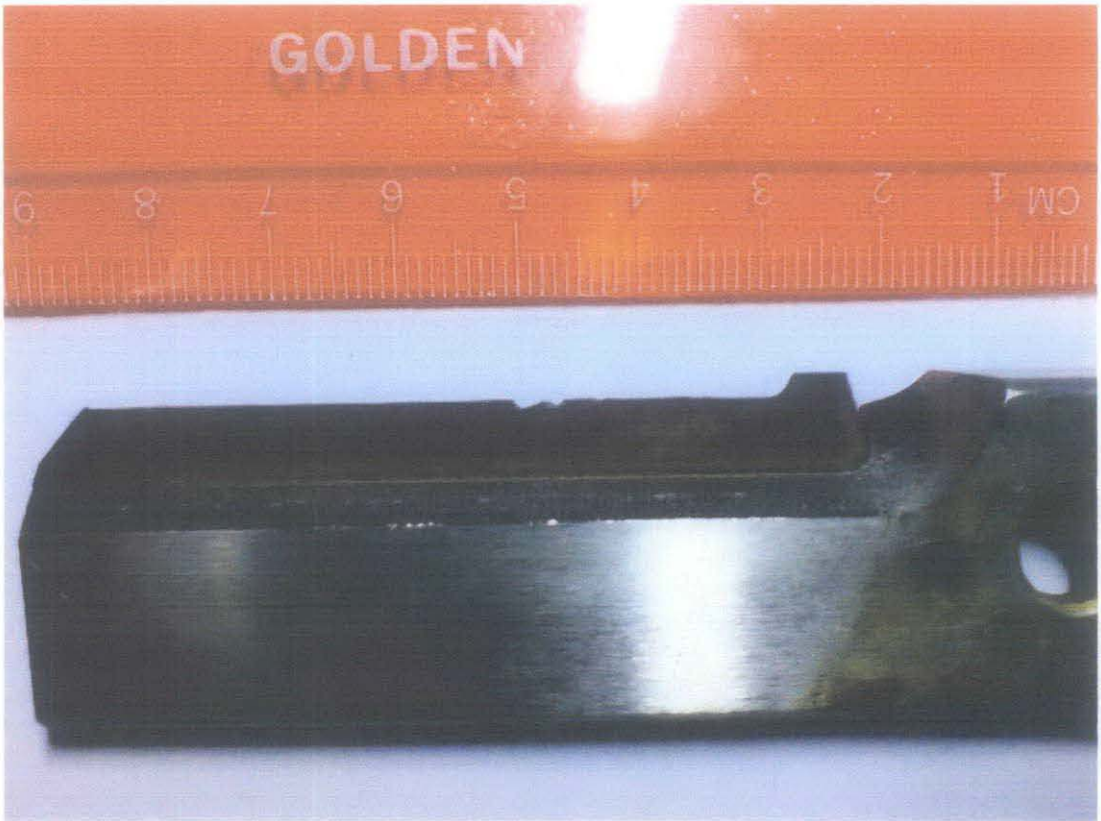
Figure 18: Close-up view of the chipped part.

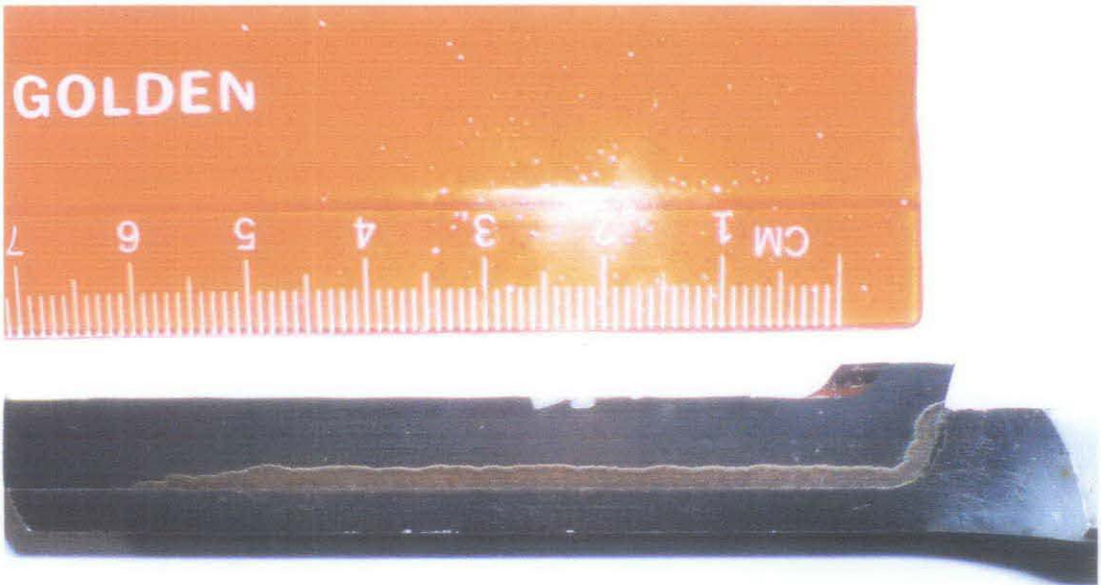
Figure 19: Top view of the chipped tip blade.

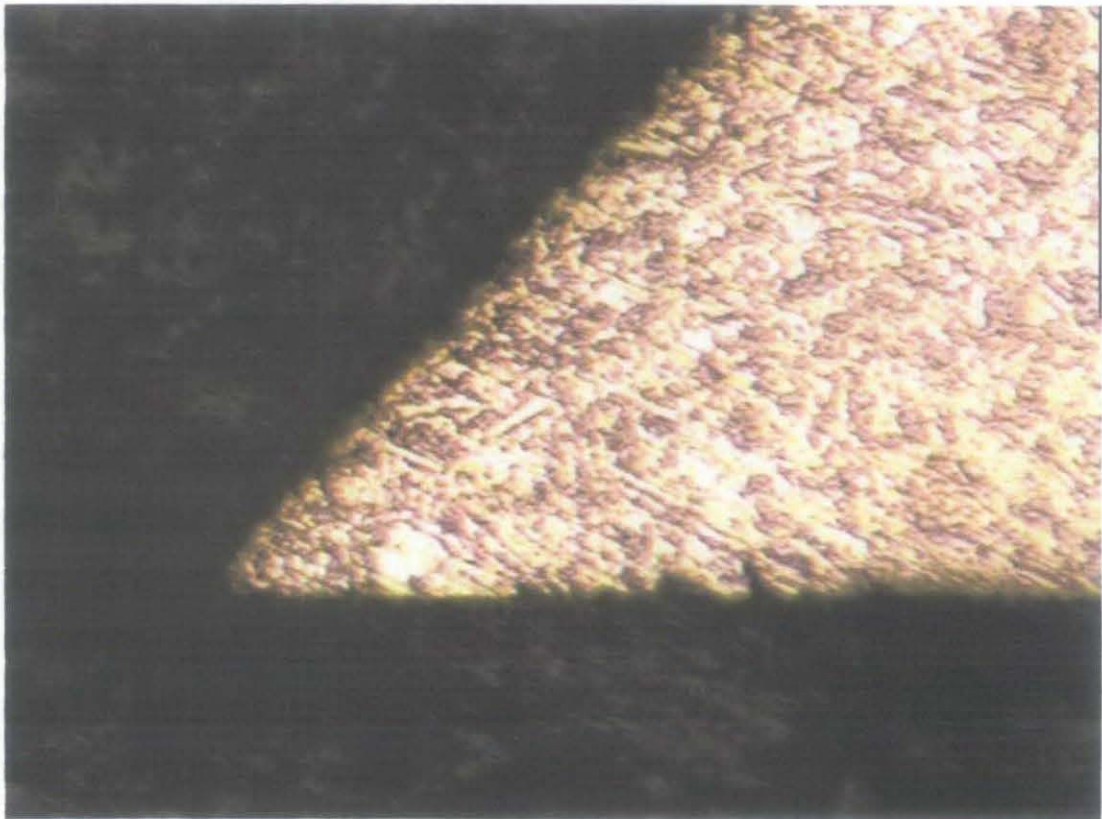
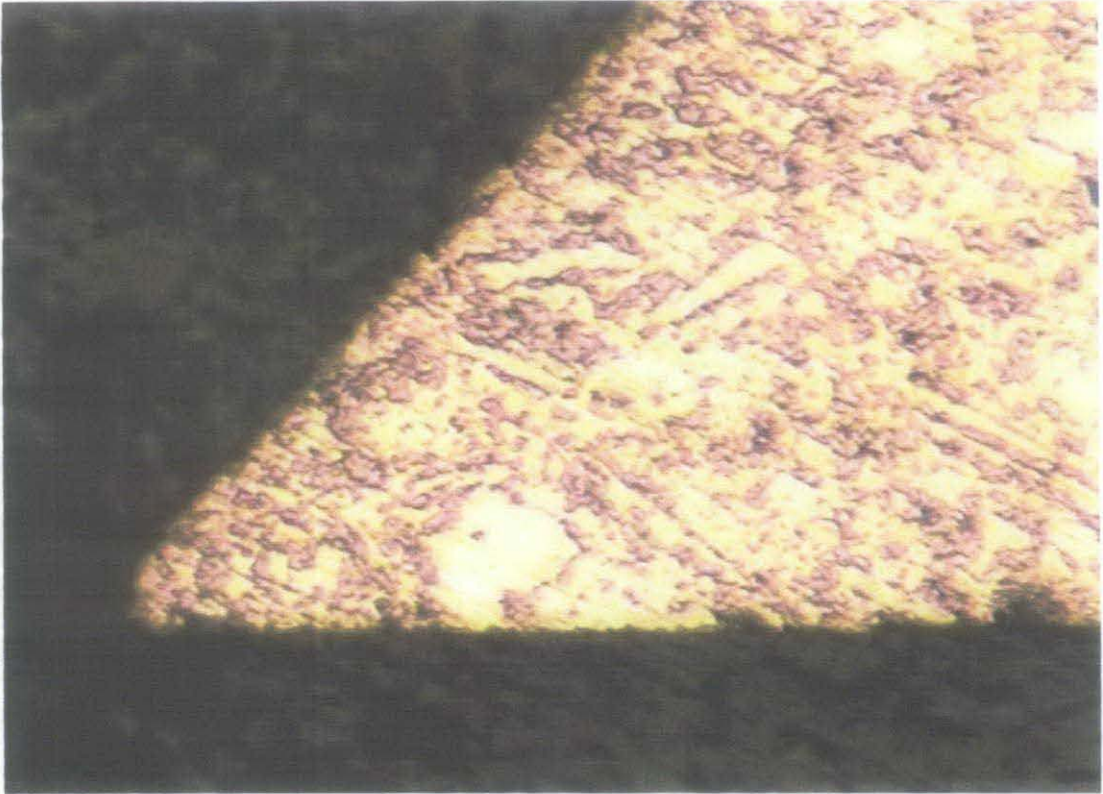
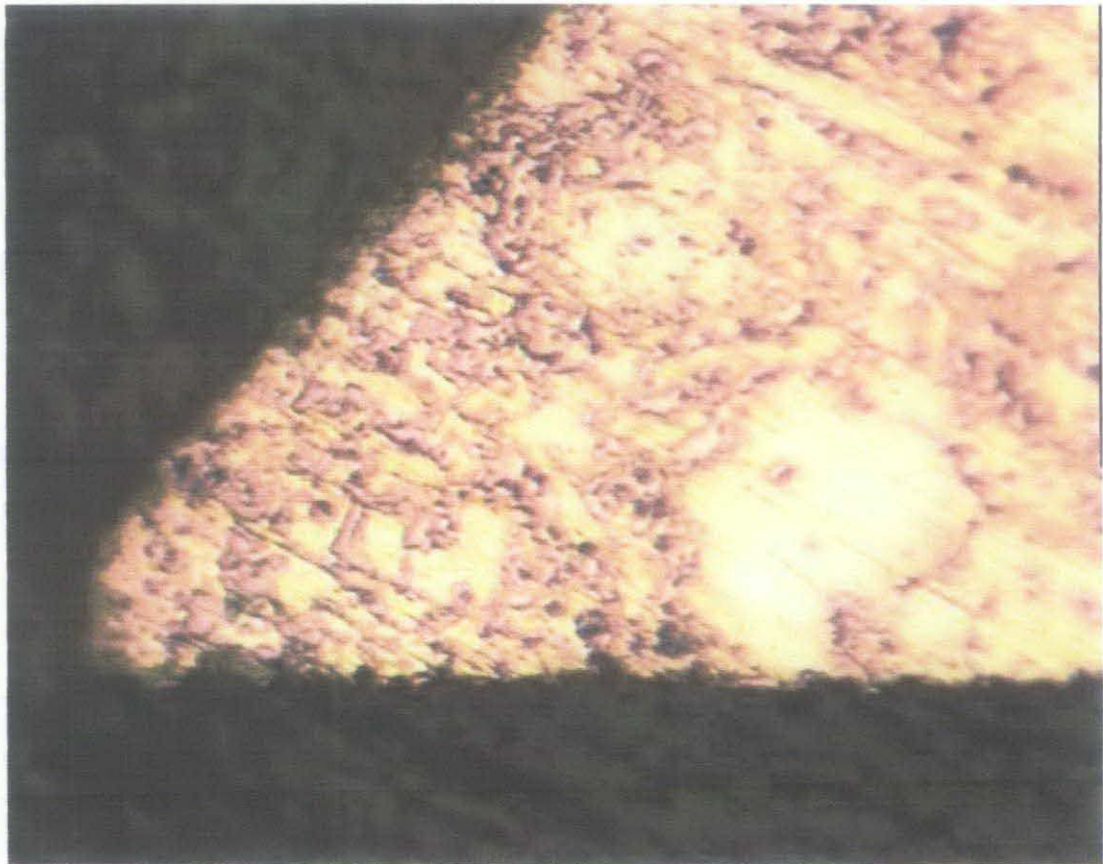
Result from the optical microscopic inspection at the cross-section of the tip shows it undergoes grain pull-out wear near the cutting surface (Figure 20 to 22).

Figure 20: Cross section of the titanium carbide tip at magnification of 50X.

Figure 21: Titanium carbide tip at magnification of 100X.

Figure 22: Magnification of tip at 200X.

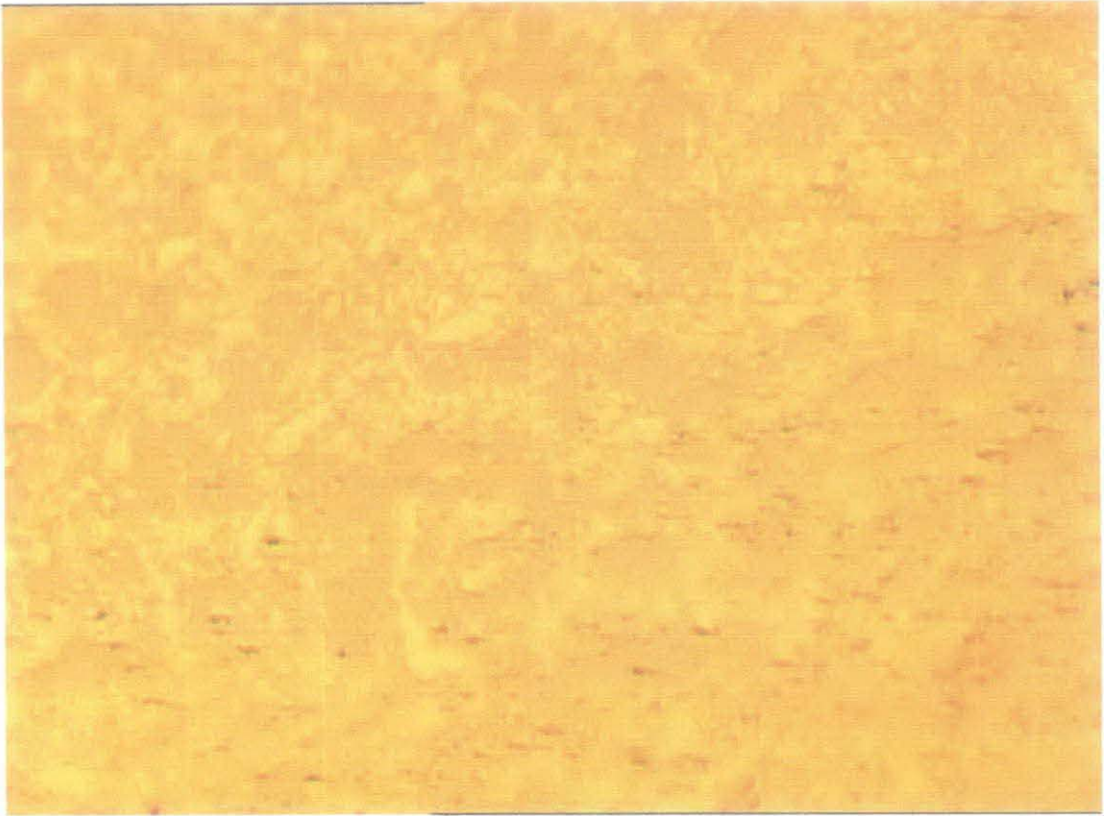
Metallography inspection of TiC reveals the microstructure at different magnification, the TiC have many voids in its microstructure, small dark spots. These voids have an effect of reducing the strength of TiC tip (Figure 23 to 25).

Figure 23: Microstructure of titanium carbide at 100X magnification.

Figure 24: Microstructure of titanium carbide at 200X magnification.

Figure 25: Microstructure of titanium carbide at 500X magnification.

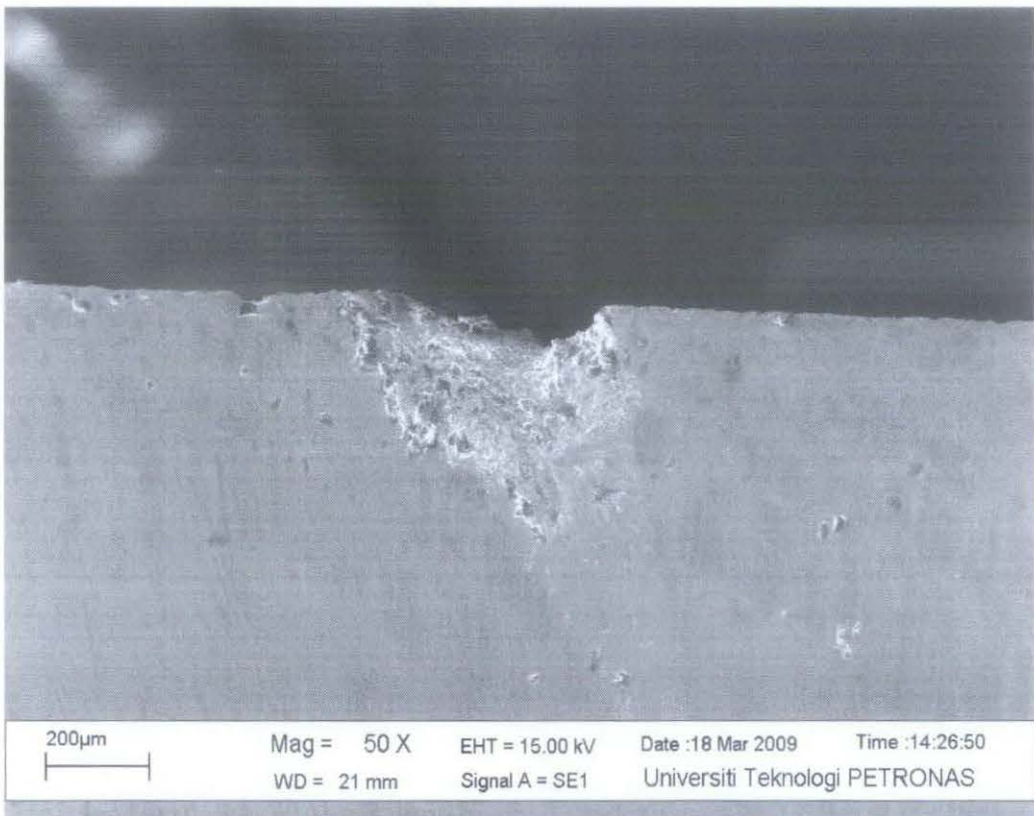
Observation under the scanning electron microscope reveals its microstructure in finer details (Figure 26 to 28). Fractography of the failed tip shows it had been hit by debris along its cutting path and undergoes brittle fractures (Figure 29 to 31).

.Figure 29: Fractured part of the blade observed under SEM.

TiC has very high wear resistance but low on impact resistance or toughness. Sudden impact on the tip can fracture it. Fractography of the blade tip observed from SEM, the tip break off consistent with brittle fracture, where the structure looks uneven, rough and follows the path of the objects which strike onto it.

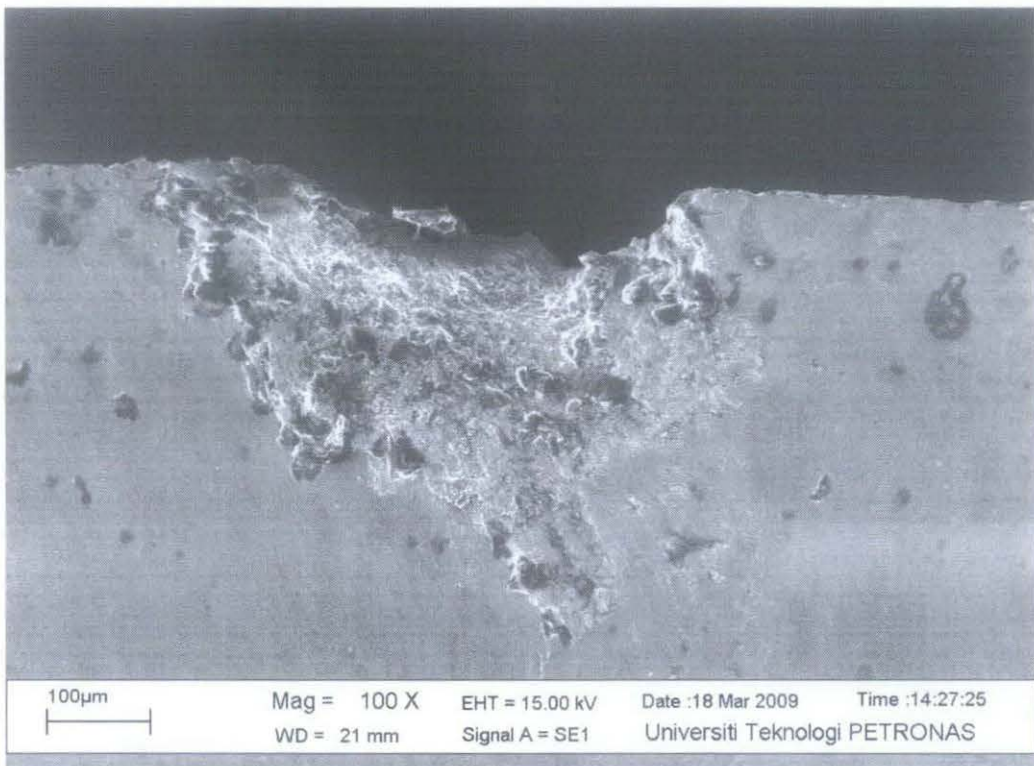
Figure 30: Tip fracture propagation is in line with cutting direction.

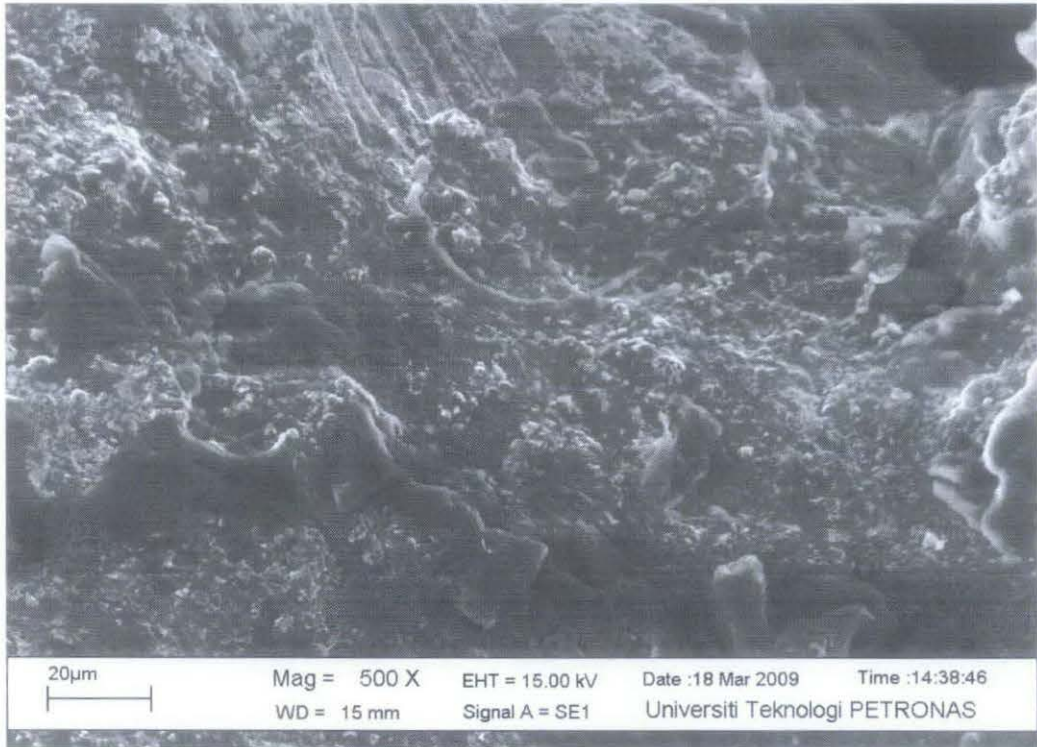
Figure 31: Magnification of the fractured area shows TiC undergoes brittle type fractures.
