After several years of service, the radiator system of a Kancil car is experienced leaking on its steel pipe. On the early stage of its failure the owner of the car found that the level of radiator coolant has decreased prematurely and the engine temperature increase higher than normal. Regardless of the problem, the owner just filled up the radiator tank with water.

In view of the premature steel pipe failure, it is imperative to investigate the cause of the failure for future action and recommendation.

1. To investigate the cause and the mode of pipe failure.
2. To recommend ways to improve the service life of radiator pipe as well as the radiator system.

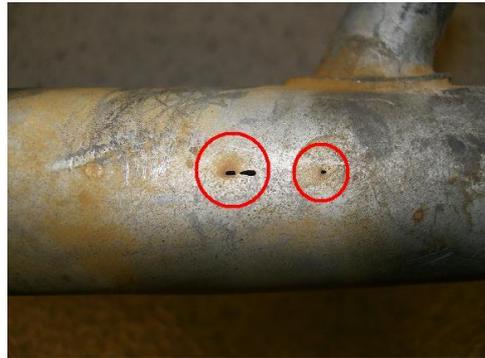
Before any failure analysis and nondestructive examination were preceded, the condition of the sample must be recorded and the pictures of the failure sample are taken as a record. The picture of the external part and internal part were taken. The condition of the steel pipe was capture as shown in Figure 4.1 and 4.2. The location of the leaking area is marked with red circle.

Figure 4.2: The picture showing the closed up view of leakage area of the pipe

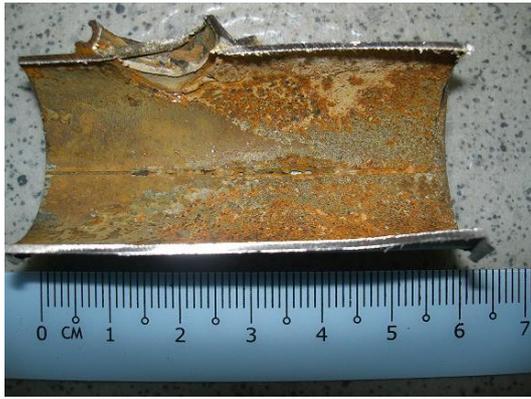
Figure 4.3: The internal view of the leakage pipe

After the preliminary examination, the steel pipe was cut into smaller pieces. The focused area is around the leakage. The internal wall of the pipe is shown in Figure 4.3. It shows that the internal pipe experiences corrosion and the most critical part that experiences corrosion is on the welding line.

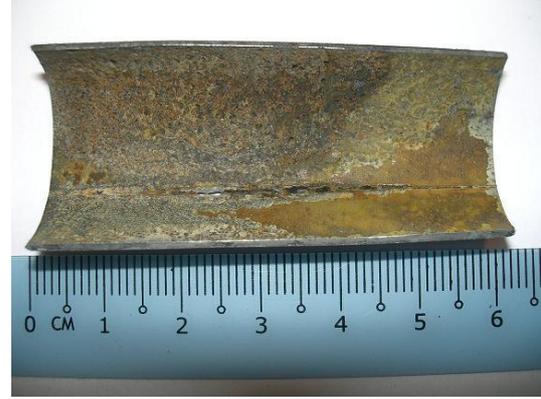
Figure 4.4: The internal view of the pipe after cleaned with rust removal solution

Then the steel pipe sample was cleaned with rust removal solution in order to remove the rust. The rust removal solution will only attack the corrosion element and not react with normal pipe material. Figure 4.4 shows the steel pipe after washed with rust removal solution.

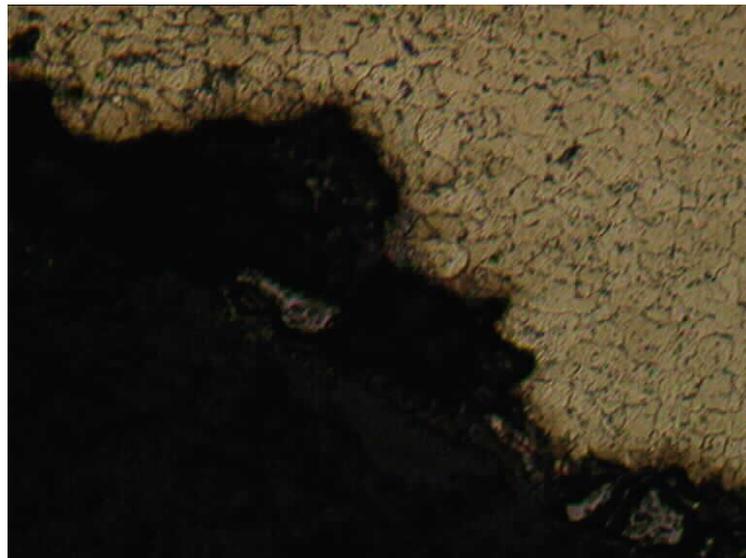
Figure 4.6: The grain boundary of the sample.

The grain boundaries of the steel pipe were observed using optical microscope as shown in Figure 4.6. The figure was captured along the internal wall of the steel pipe. It shows that the corrosion attack along the grain boundary. The jagged surface indicated the lost of grain boundaries.

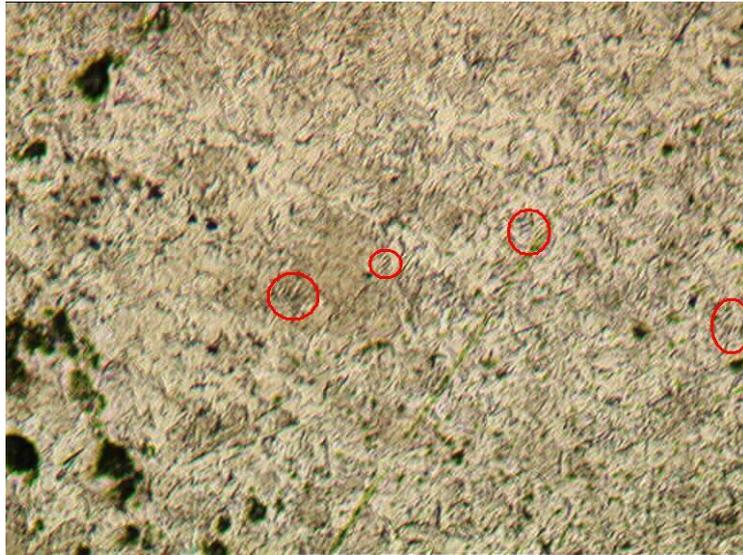
Figure 4.7: The location of slip plane in the red circles.

The pipe experienced residue stresses, can be observed by formation of slip planes as shown in Figure 4.7 (marked with red circle). The slip plane occurred during manufacturing process, pressing of metal sheet and rolling process to form pipe. In order to form stress corrosion cracking (SCC), the metal should be under corrosion.

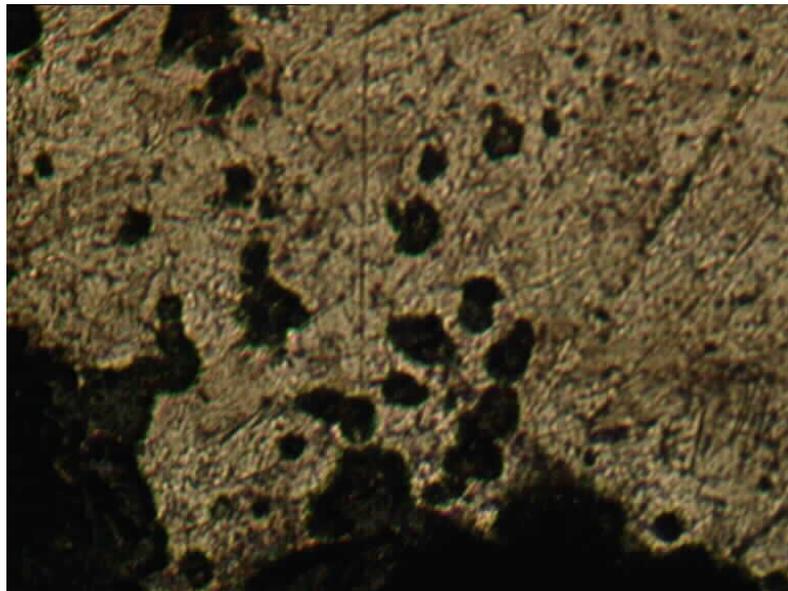
Figure 4.8: The corrosion along the grain boundaries.

attack results since grain boundaries are usually only slightly more reactive than the matrix. However, under certain conditions, grain interfaces are very reactive and intergranular corrosion results. Localized attack at and adjacent to grain boundaries, with relatively little corrosion of the grains, is *intergranular corrosion*. The alloy or metal disintegrates (grains fall out) and or loses its strength.” This type of corrosion attack can be seen in Figure 4.8 and 4.9.

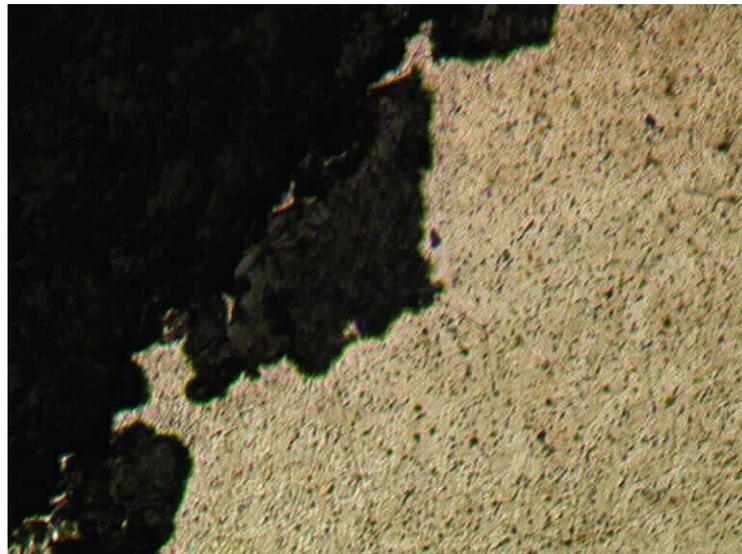
Figure 4.9: The intergranular corrosion will produce the jagged surfaces.

By looking at the microstructure surfaces in Figure 4.9, it was observed that the surfaces are rugged due to corrosion attack. The typical corrosion is intergranular corrosion as can be observed where the attack along grain boundaries. Similar work has been carried out by Stephen C. Dexter in ASM Metal handbook, page 114 [5]. Intergranular corrosion is the form of metallurgically influenced corrosion.

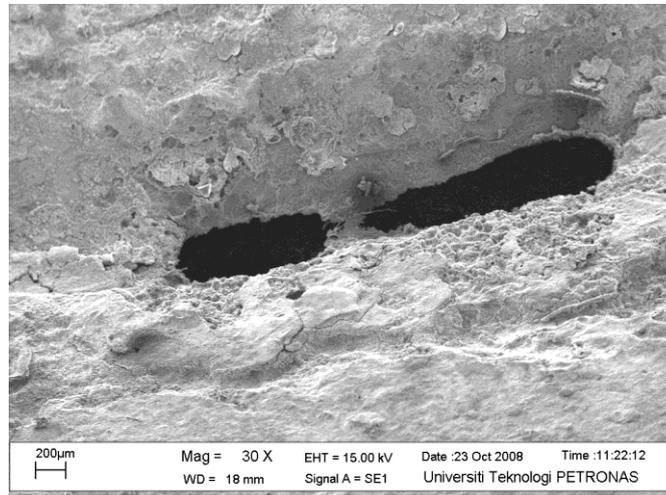
Figure 4.10: SEM fractograph shows the location of major leaking at the welding line.

The SEM examination was conducted on the welding line and internal wall of the steel pipe. From the SEM result, it shows that the welding line and internal wall were experienced corrosion. With magnification of 30x, the grain boundary is almost visible as shown in Figure 4.10. This image is taken at the major leakage area. It shows that the steel pipe has experienced corrosion attack. In Figure 4.11, the image is taken at the second leakage area on the welding line. It also indicate the corrosion attack is the cause leakage.

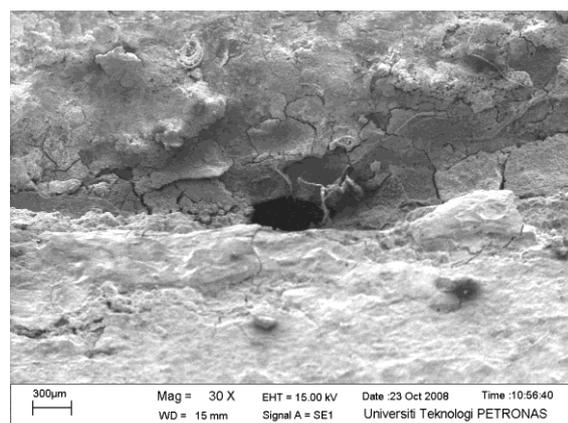
Figure 4.11: SEM fractograph shows the pin hole on welding line.

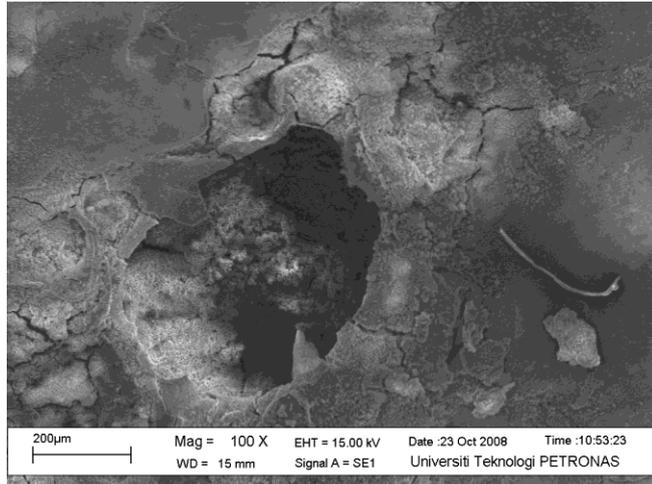
Figure 4.12: This fractography shows the micro cracks around the pin holes.

Then the SEM is focus on pin holes on the internal wall of steel pipe with 100x magnification. By referring to Figure 4.12, it shows that there are micro cracks around the pin hole area. The micro cracks indicated the steel pipe is experienced intergranular corrosion.

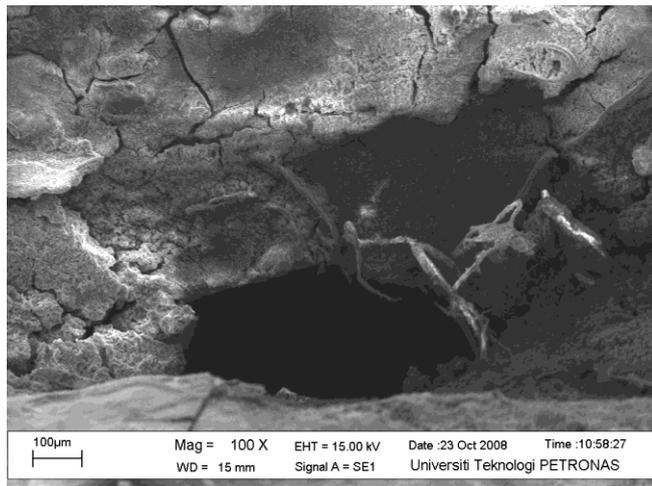
Figure 4.13: Closed up view of fractography of the pin hole area.

The image of different pin hole is taken using SEM with 100x magnification as shown in Figure 4.13. It also indicate the micro cracks and intergranular corrosion. The continuous lost of grain boundaries will produce the pin holes.

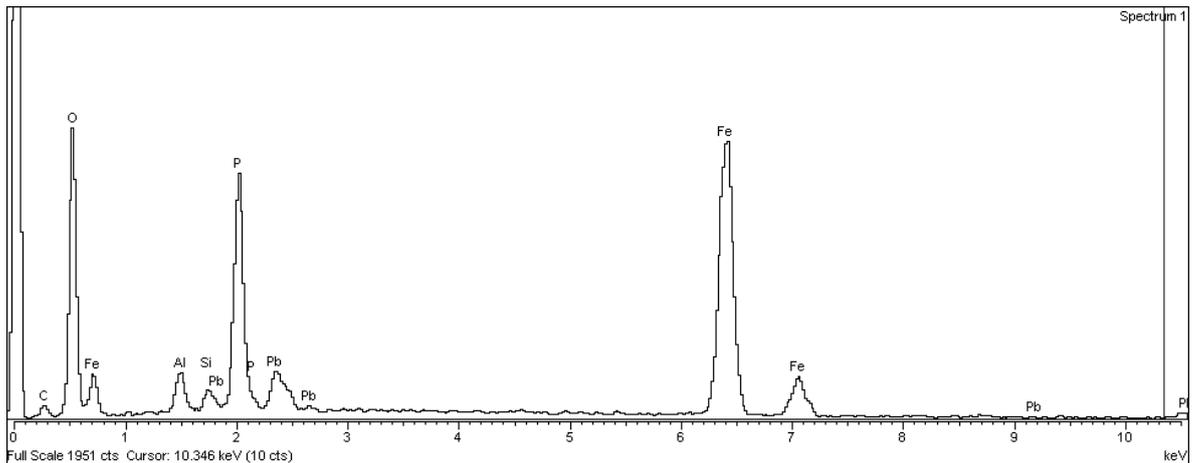
The results are provided in Tables 4.1 and 4.2 together with the Figure 4.14 and 4.15. The results show the loss of Fe element in leakage pipe area is very critical. The Fe has been replaced by other element so the corrosion occurred.

Figure 4.14: The element distribution along the failed pipe sample.

The Figure 4.14 and Table 4.1 show the pipe experienced corrosion attack. The percentage of oxygen element in the pipe indicates that the oxidation occurred. The percentage of Fe element is small because it has been replaced by oxygen element.

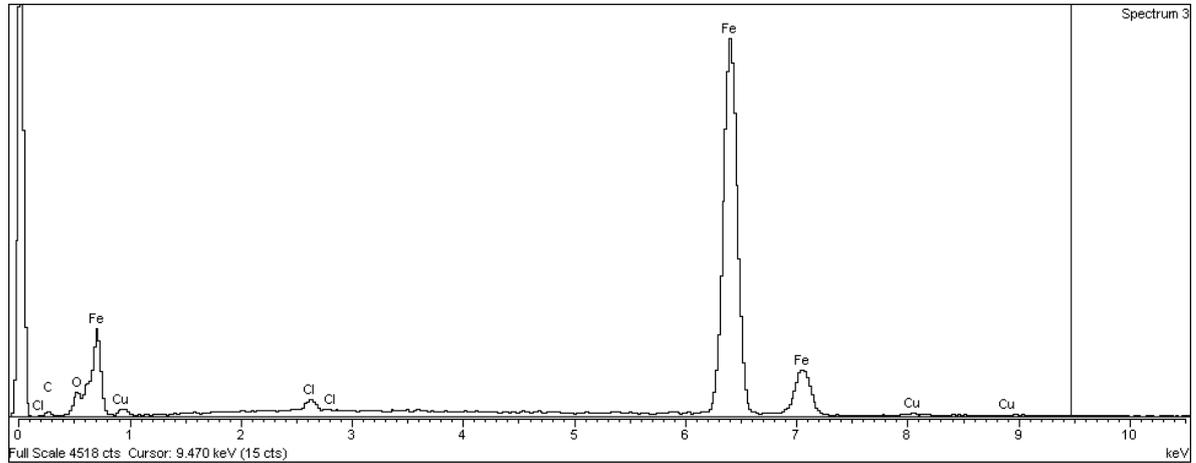
Figure 4.15: The element distribution along the normal pipe sample.

Different EDS examination is taken from pipe sample that far away from failure location and the result is as in Figure 4.15 and Table 4.2. The graph and table show that the percentage of Fe element is high compare to previous data. The oxygen element percentage is very low. These qualitative results indicate that the sample is still in good condition.
