Gas Turbine Blade Failure Due To Hot Corrosion

Dissertation submitted in partial fulfilment of
the requirements for the
Bachelor of Engineering (Hons)
(Mechanical Engineering)

JANUARY 2008

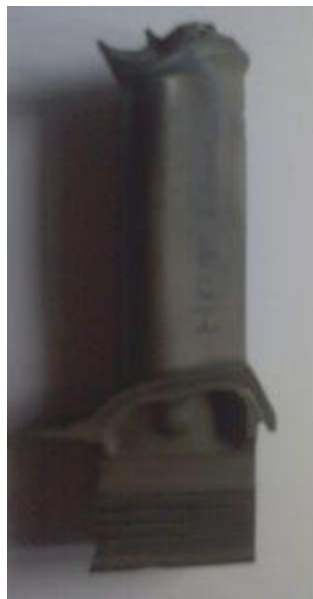
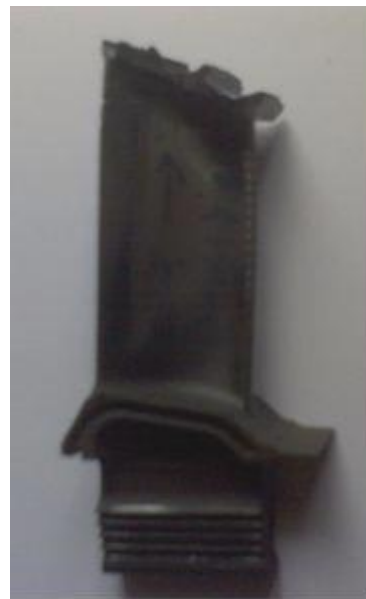
Figure 4: The gas turbine blade failure

This is the high pressure turbine blade failure from the Rolls-Royce Engine RB211 that studied in this experiment shown in **Figure 4** below.

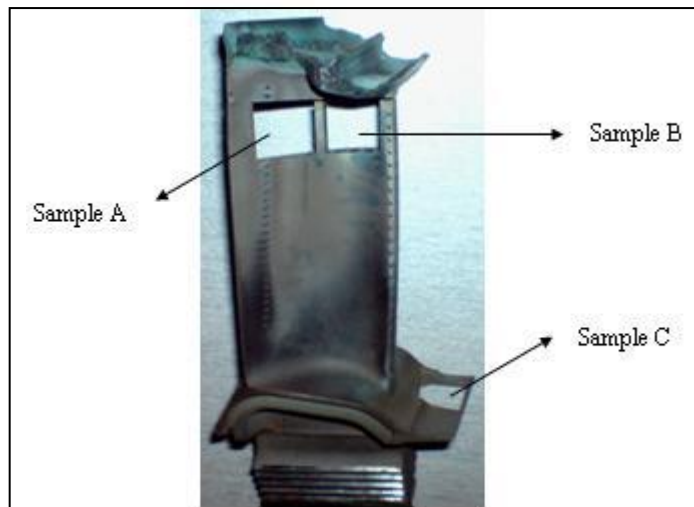
Figure 6: Sample location on the blade failure

From the sample of gas turbine blade failure, there are 3 areas that will be named as Sample A, B and C. The machine used to cut the sample from the blade is Electro Discharge Machine (EDM) Wire Cut (see **Figure 7**) in Building 16 room 16-00-05. The picture of the each sample and its location on the blade are as previewed below (**Figure 5 and 6**). Sample A had experienced type I hot corrosion because has greenish appearance. Whereas sample B had been exposed to type II hot corrosion because has whiteness appearance [5]. Sample C is taken from the area with no corrosion appearance. The size for each sample is about 1 cm x 1 cm with small thickness.

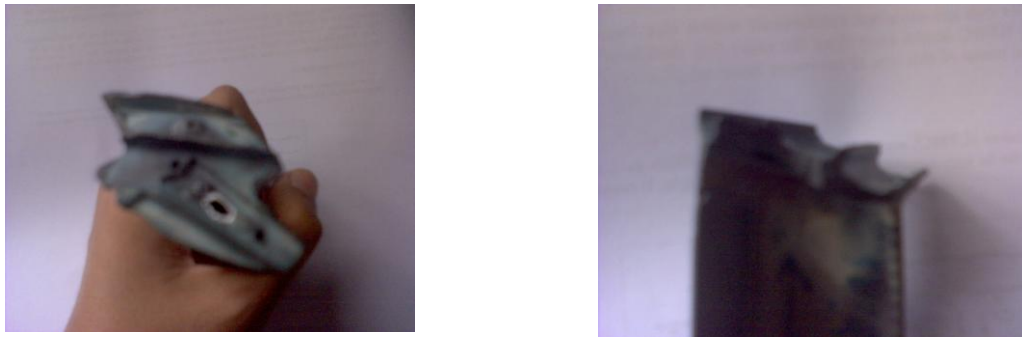
In the vicinity of the platform, the convex side had whiteness appearance and concave side had a greenish and whiteness appearance. Loss of materials and thickness (that may have been caused by interaction of different mechanisms such as hot corrosion and creep or fatigue) was observed at the top of the blade and green coloration on the concave side (**Figures 8**). The trailing edge was distorted in the shape of small cups and cones. The leading edge, towards the platform was broadened. From the evidence at the edges, it may be concluded that erosion has occurred. On both sides of the blade, there is also evidence of impact by small particles which indicated by red circle (**Figures 9**). Eliaz and et al. [2], have reported that a greenish color is a macroscopic feature of HTHC. This is in contradiction with the results of metallographic and X-ray mapping examination in the present work. Some color change was also seen near regions where LTHC had occurred.

Figure 8: Loss of thickness at the blade tip.

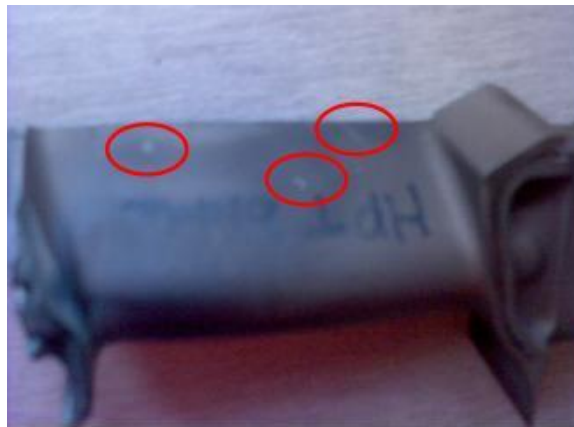
Figure 9: Impact by small particles

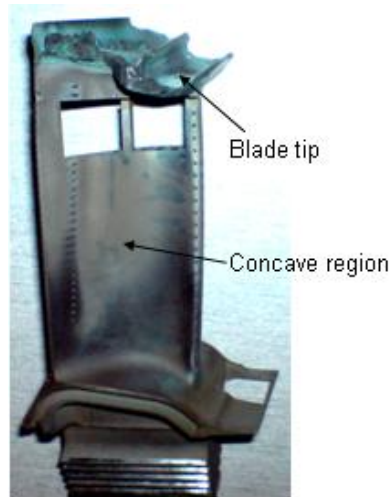
This experiment was done at Building 17, ground floor, room 13 (**Figure 10**). Metallographic examination showed three different types of features, depending on the location of the specimen. Generally in the regions near the blade tip, type I was evident. Type II was dominant at the concave region (**Figure 11**). The third type of features belongs to those areas that had a rough macroscopic surface.

Figure 11: Blade tip and concave region

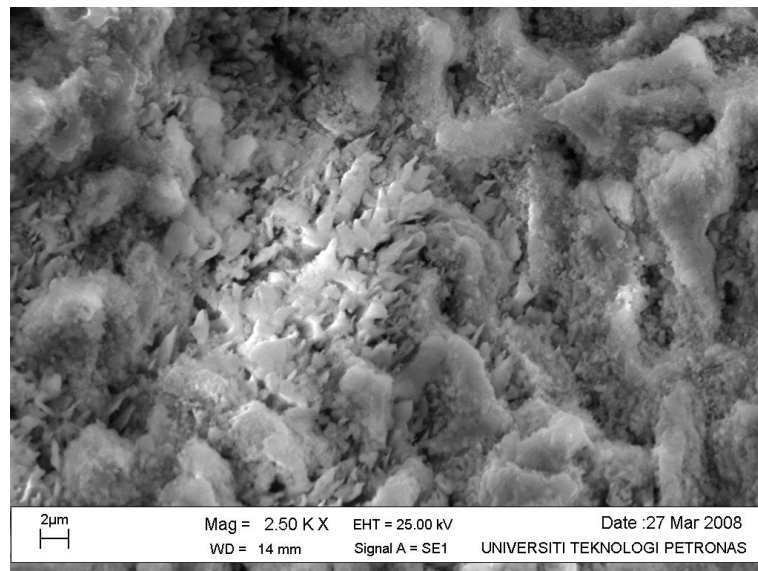
The result cannot be achieved due to the limitation work of SEM machine. The machine can only get the picture of the surface for each sample (**Figure 14 and 15**). From these two pictures, we can obviously see the difference from the pattern of its surface. Sample A showed that it has more concentrated corrosion than the Sample B. This must be due to high temperature that had been experienced.

Figure 14: Type I hot corrosion, Sample A.

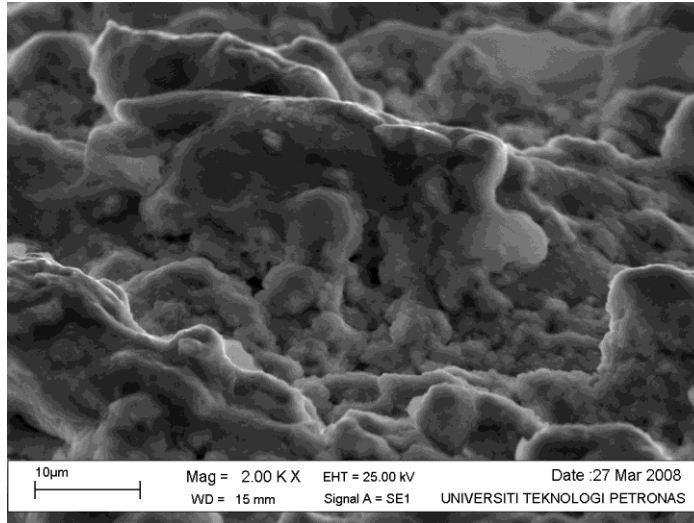
Figure 15: Type II hot corrosion, Sample B.

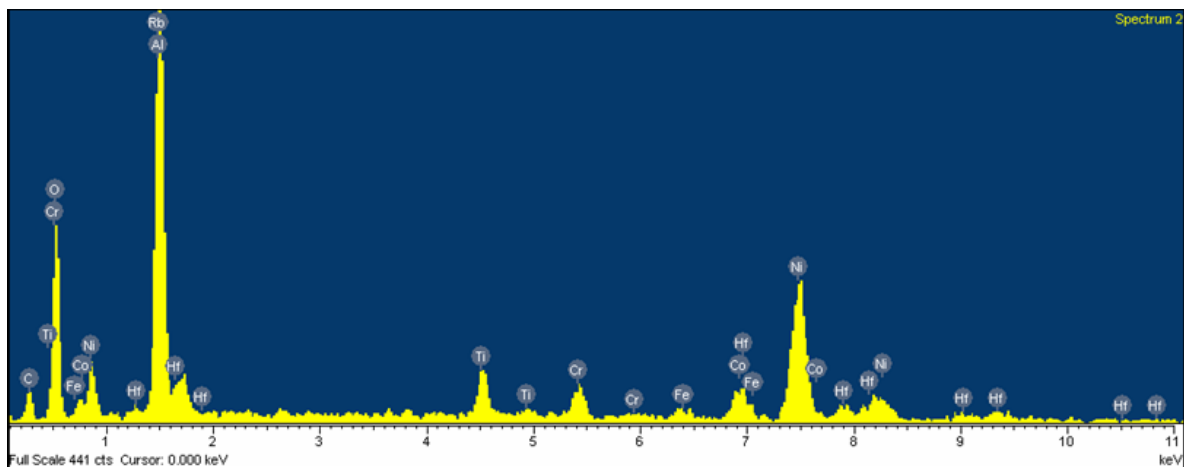
Using EDX analysis Sample A and B revealed the presence of C, O, Al, Cr, Co and Ni elements in the scale. From this result there was evident of coating. The EDX analysis showed the two different graphs for Sample A (**Figure 16**) and Sample B (**Figure 17**) material composition. **Table 3** below shows the table of material composition for both samples.

Figure 16: Graph of material composition for Sample A

From this two results show that there are presence of contaminants in compound composition which are Cr_2O_3 , NiO , TiO_2 and FeNi . Both Cr_2O_3 and NiO have a greenish color [5]. The red color from **Table 2** shows the corrosive element. This indicated that Sample A has more corrosive elements than Sample B.

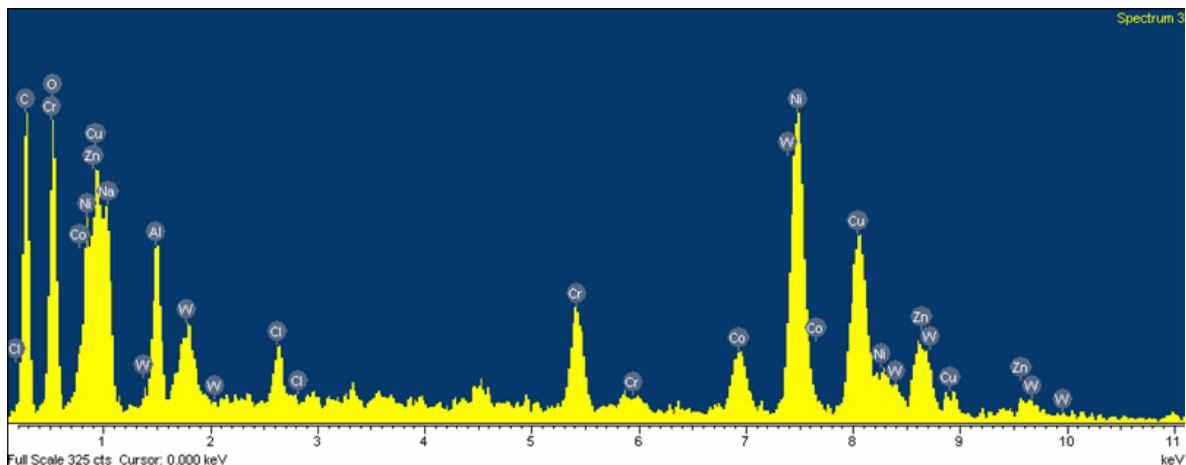
Figure 17: Graph of material composition for Sample B

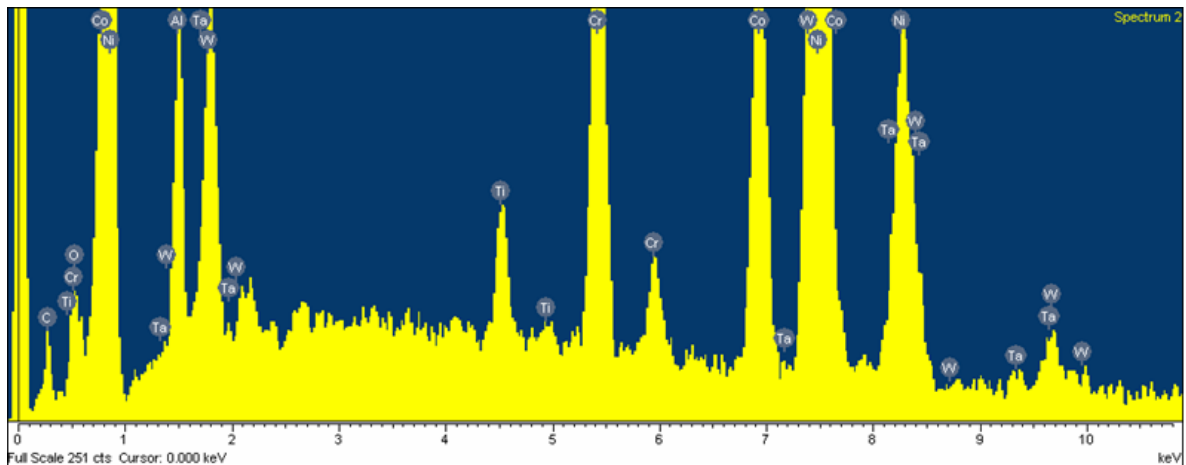
Figure21: Graph of material composition for Sample C

From this result shows that the surface for Sample C which has no corrosion appearance is very smooth and clean. The material composition is lesser than the Sample A and Sample B. This blade is mostly Ni based alloy because has the highest percentage in weight and atomic element. This is shown by red color in **Table 4**. However the value of carbon is too high for each sample. It should lower than 0.1% in weight. In EDX analysis, carbon concentration is not accurate. EDX cannot be used to quantify carbon.

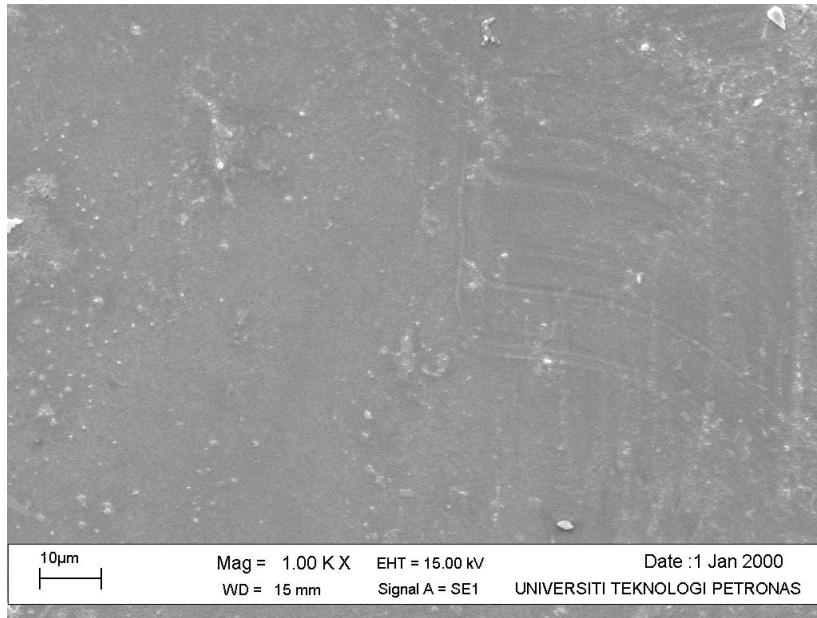
Figure 22: Surface of Sample C
