**Failure Analysis on Stainless Steel Tubing of a Lube Oil Console for Gas
Generator**

Dissertation submitted in partial fulfillment of
the requirements for the
Bachelor of Engineering (Hons)
(Mechanical Engineering)

JULY 2010

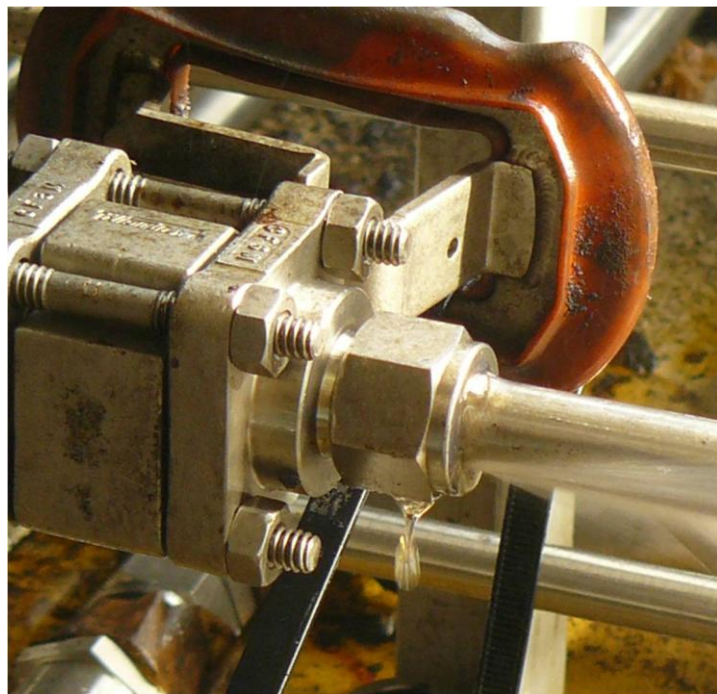
On 20th February 2009, the tubing for the lube oil console of the Gas Generator at Area 200, MTBE/Polypropylene (M) Sdn. Bhd. snapped and caused the lube oil to leak to the atmosphere (refer to Figure 2.2). When the lube oil was leaking, the lube oil level in the lube oil reservoir is lowering until the low level alarm was triggered. When the lube oil level is very low, the second alarm also triggered and the Gas Generator control shutdown was occurred on 21st February 2009 at 1810 hrs due to hydraulic oil leak. The cost for the plant shutdown is approximately RM 2 million per day excluding the cost for manpower and spare parts. Regarding to this failure, MTBE/Polypropylene (M) Sdn. Bhd was shut down for about 2 days and the cost for this failure is approximately RM 3 million. Figure 2.3 shows the sample material is the ¾ inch 316L stainless steel tubing.

Figure 2.1: Lube oil leaking caused by tubing snap.

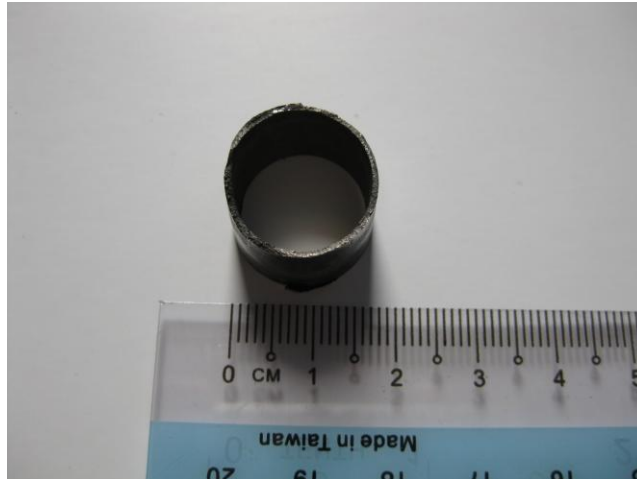
Figure 2.3: Sample material- $\frac{3}{4}$ inch 316L stainless steel tubing.

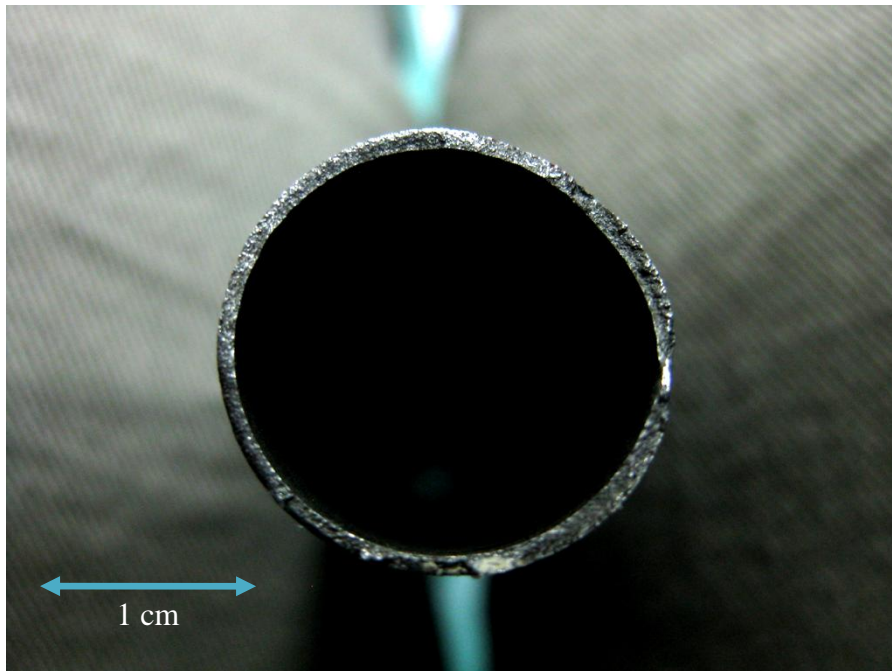
fracture and ductile fracture. Figure 4.1 shows the fracture surface of the stainless steel tubing. It appears to be brittle fracture where there are no sign of the ductile fracture such as reduction of cross sectional area, cup and cone shape and etc. Table 4.1 lists the comparison between brittle fracture and ductile fracture characteristics.

Figure 4.1: Close view on fracture surface of the stainless steel tubing.

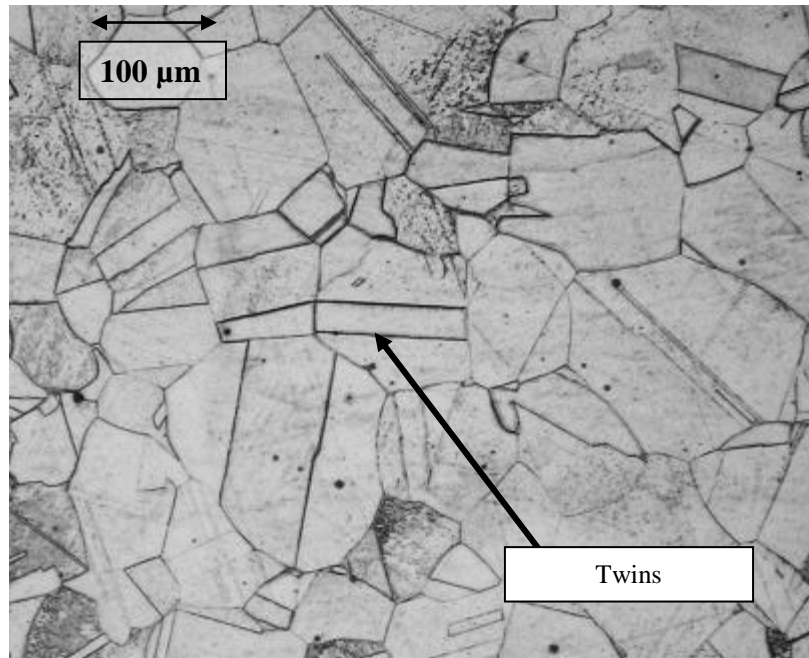
After the sample preparation completed, the specimen can be observed under OM. Figure 4.2 shows the microstructure of the specimen in 10X magnification which is the stainless steel tubing. There are twins in the microstructure which prove that the microstructure is the austenitic type which is 316L as claimed by manufacturer.

Figure 4.2: Microstructure observed under Optical Microscope (OM) for normal sample.

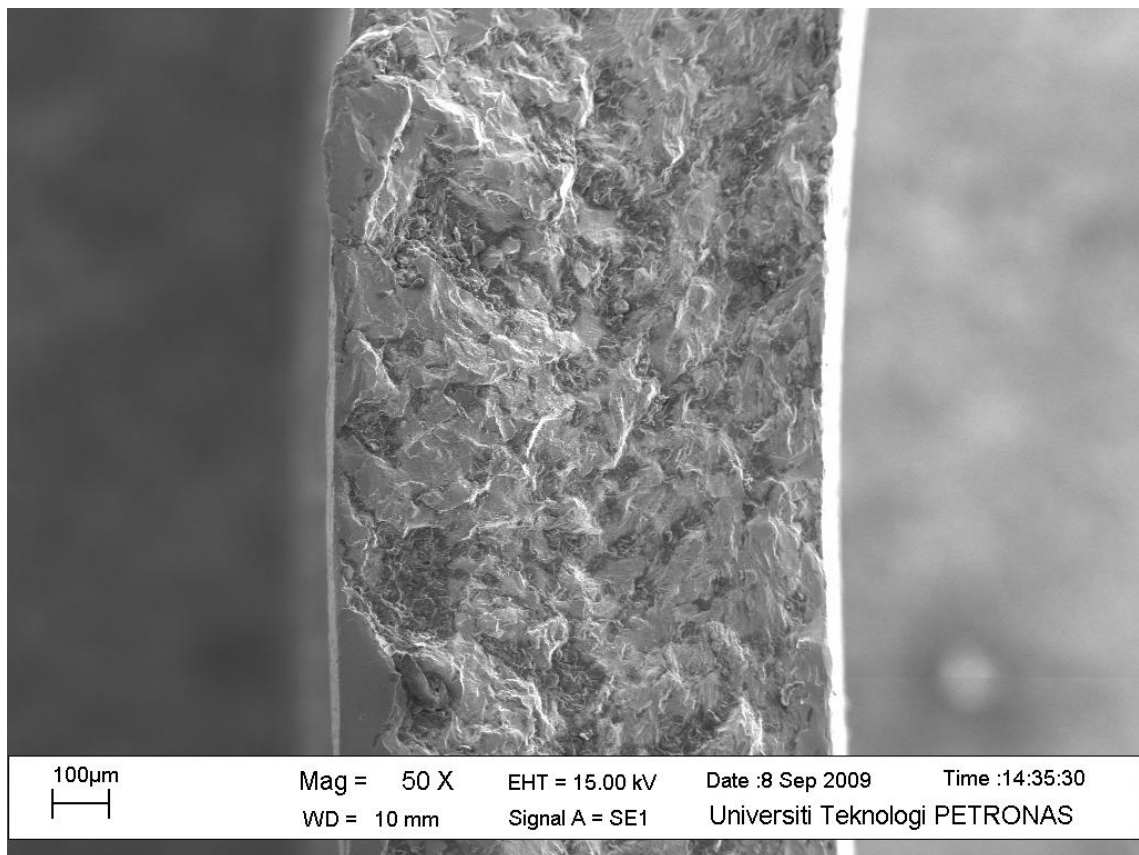
Figure 4.3 shows the fracture surface of the stainless steel tubing under SEM observation with 50X magnification. From the figure, the fracture is a brittle fracture because the fracture surface is flat and perpendicular to component surface. The fracture can be said brittle because of the coarse texture and crystalline of the material. The crack growth rapidly and there is no sign of dimple for ductile fracture.

Figure 4.3: Fracture surface observed under Scanning Electron Microscope (SEM).

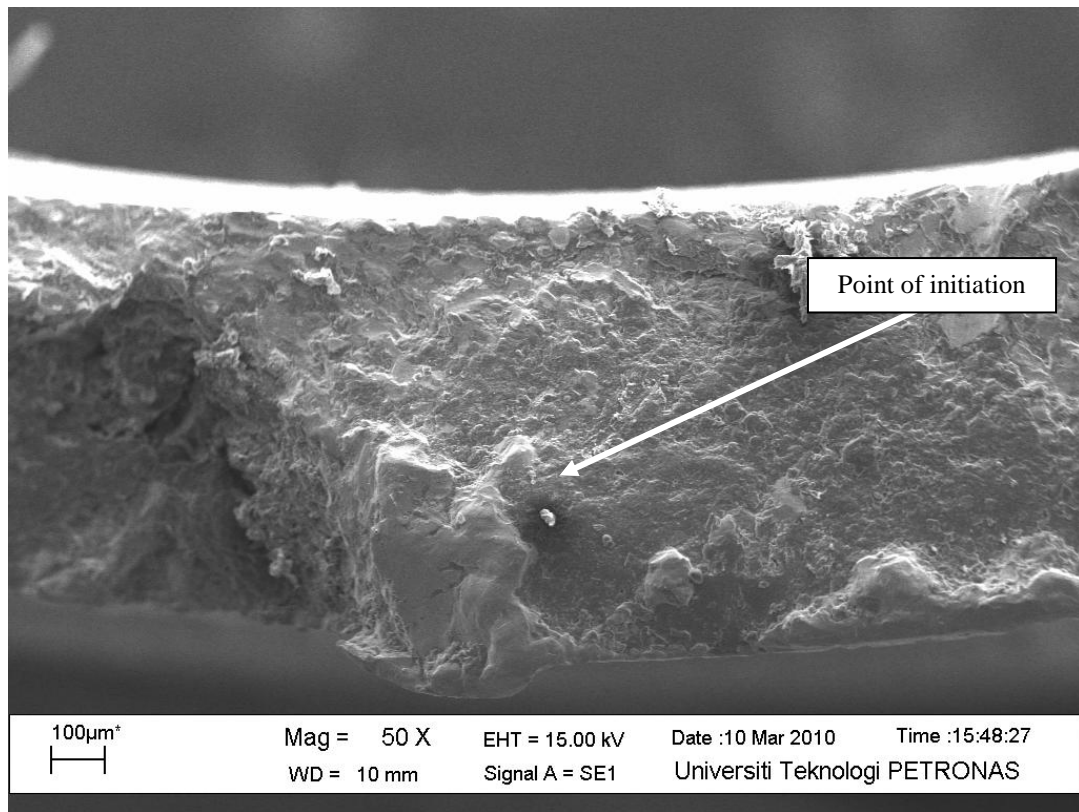
Compare to Figure 4.5 from the journal ^[3], the fracture surface from the stainless steel tubing is similar to that in the journal where the point of initiation takes place. The fracture surface around the point of initiation is brittle because of work hardening due to cyclic strain reduced the ductility of materials. Work hardening, also known as strain hardening, is the strengthening of a metal by plastic deformation. This strengthening occurs because of dislocation movements within the crystal structure of the material. ^[14]

Figure 4.5: Point of initiation on the fracture surface of sample material.

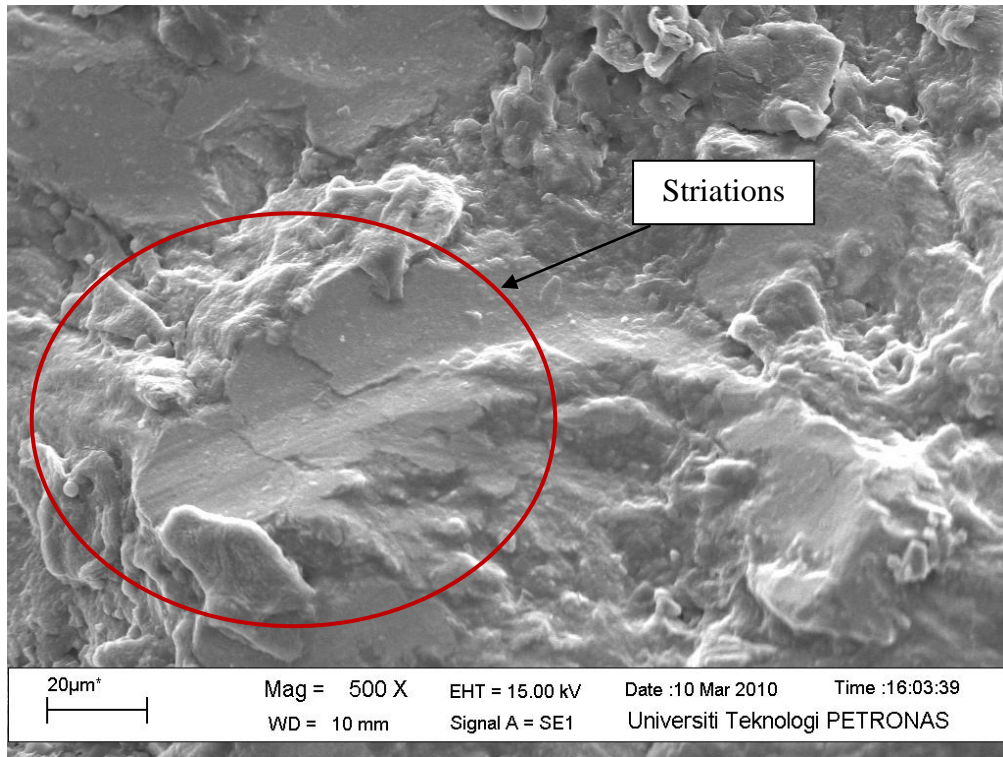
The striations on the fracture surface can be visualized as in Figure 4.6 while Figure 4.7 shows close up view on the striations area. The striations were found on the fracture surface proved that the failure was caused by high cycle fatigue failure. Fatigue failure is the phenomenon leading to fracture under repeated or fluctuating stresses that are less than the tensile strength of the material. Fatigue fractures are progressive, beginning as minute cracks that grow under the action of fluctuating stress. There are three stages of fatigue failure: initiation, propagation, and final fracture.

Figure 4.6: Striations on fracture surface.

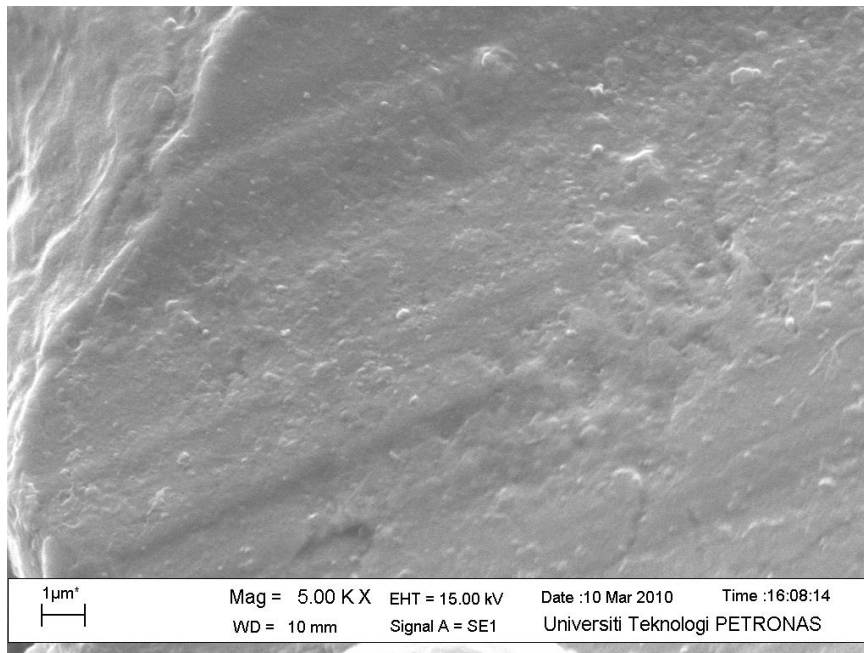
Figure 4.7: Close up view on the striations area.

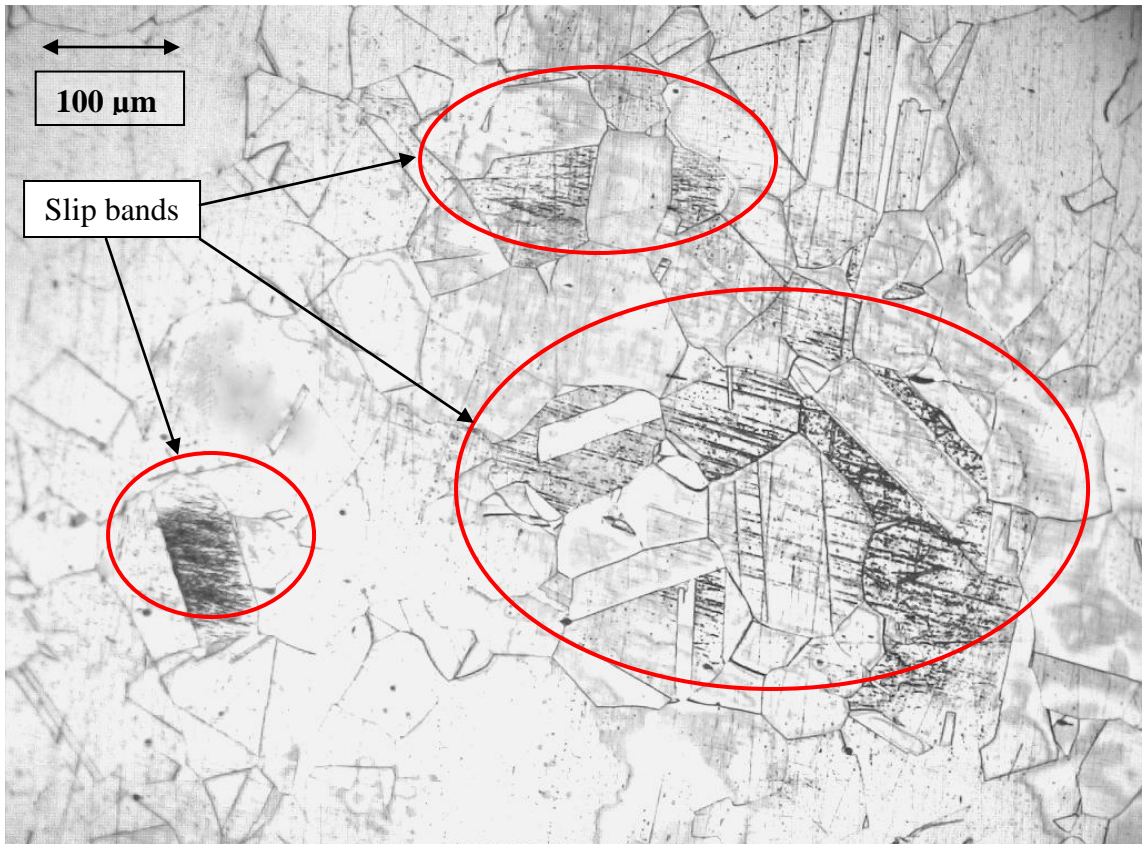
Figure 4.8 shows the slip bands in the microstructure for the 316L stainless steel tubing with 10X magnification near the fracture surface. This explains why the brittle fracture occurs on the 316L stainless steel which is ductile material. During the fracture, the material deformed due to cyclic loading from the vibration called work hardening.

Figure 4.8: Microstructure observed under Optical Microscope (OM) near the fracture.

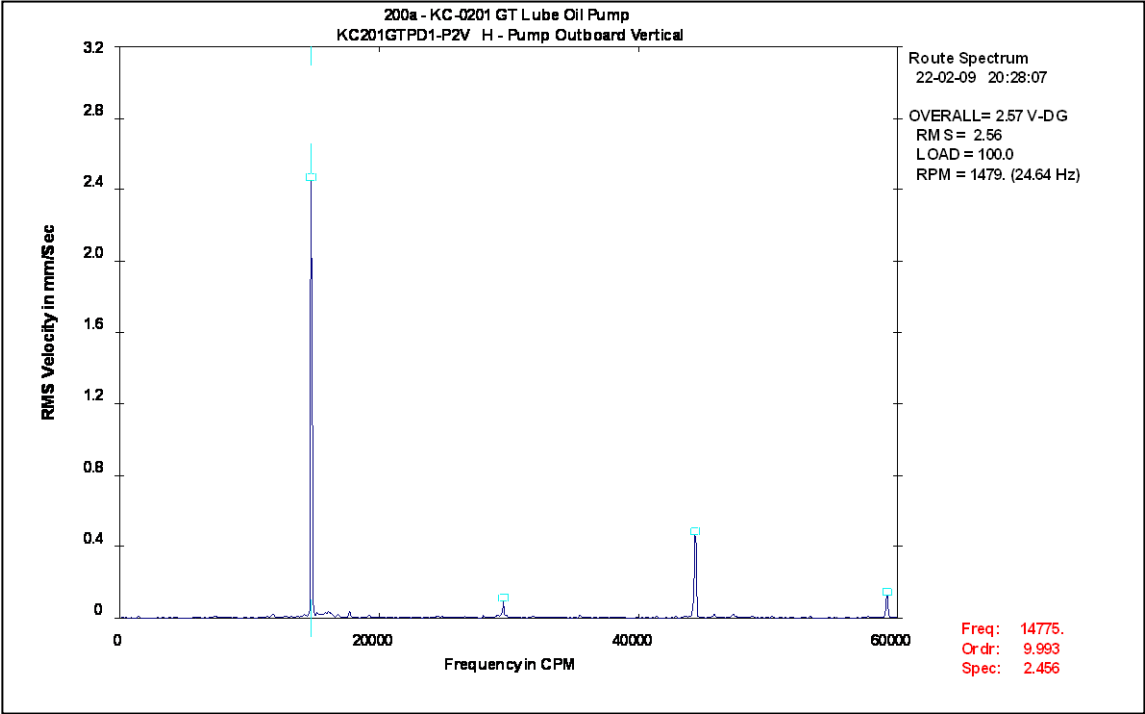
Referring to Figure 4.9 and Figure 4.10, the lube oil pump for Gas Generator is operating in high vibrations which are 2.56 mm/sec for pump outboard vertical and

2.01mm/sec for pump inboard vertical. Both values are taken from Root Mean Square value. For pump outboard vertical, the early warning limit is 1.513mm/sec while for pump inboard vertical the value is 1.530mm/sec (refer to Appendix 7 & 8). These mean that the pump operates at the vibration value above the early warning limit according to the pump specification. The pump is connected to the tubing and transferred the vibration through the tubing which caused failure.

Figure 4.9: Vibration spectrums for KC 201 GT lube oil pump outboard vertical.

Instead of monthly monitoring and vibration data collection, it is recommended that vibration transmitter should be installed at the lube oil pump and any other equipment that can cause vibration so that the monitoring can be done 24 hours and there is warning if the vibration exceeds the early warning limit value. Apart from that, the condition of the pressure safety valves also important that should be monitored more frequently. The lube oil console is a critical system because the failure of this system can cause major problem in the plant operation.

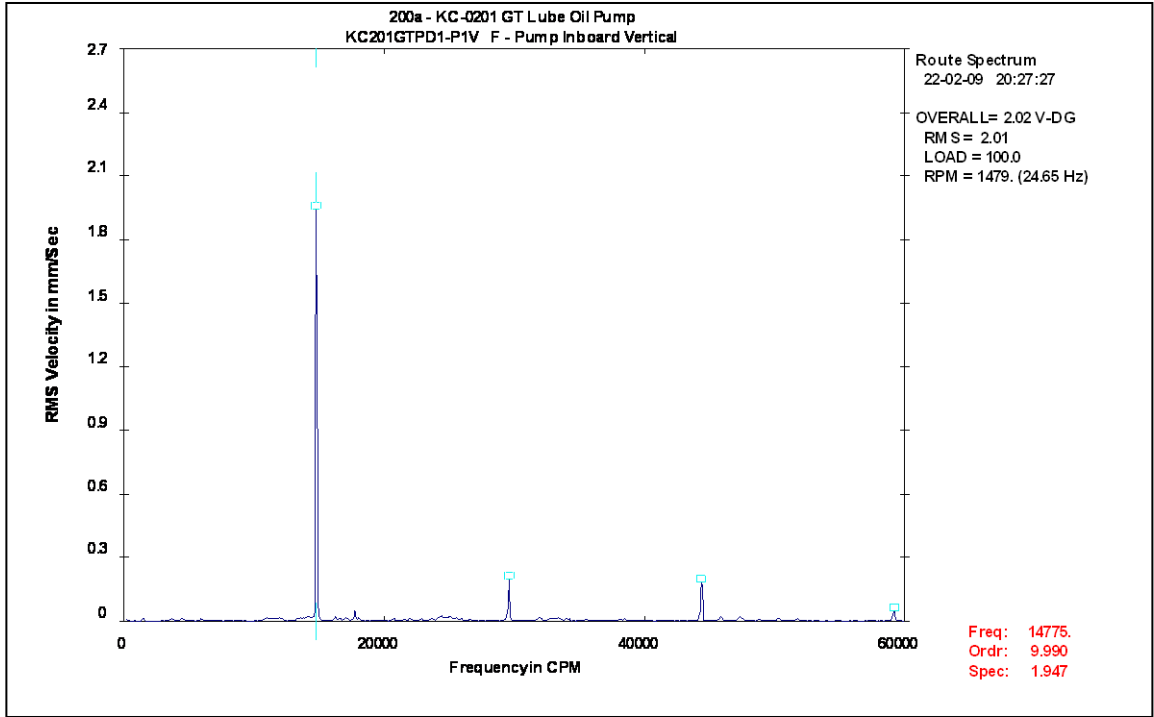
Figure 4.10: Vibration spectrums for KC 201 GT lube oil pump inboard vertical.

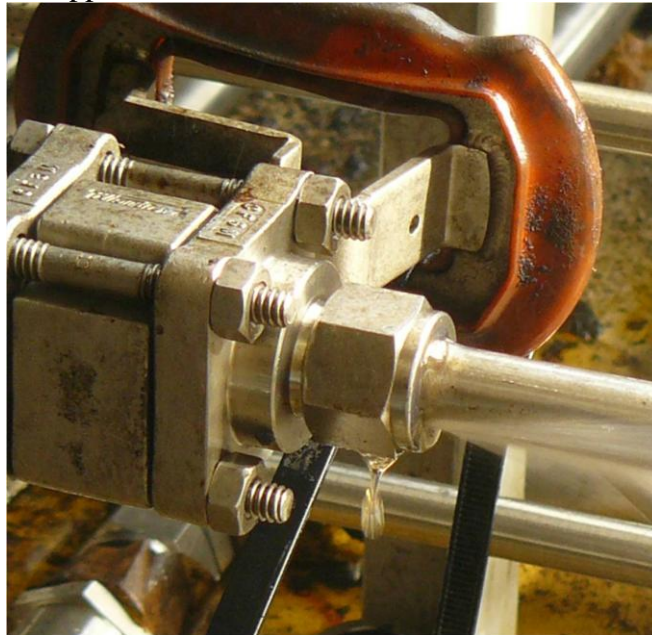
observed that the lube oil tubing broken at the fitting side (**refer to Appendix 4 & 5**) and caused the lube oil leak (**refer to Appendix 3**).

Appendix 3: Close view on the leaking tubing.

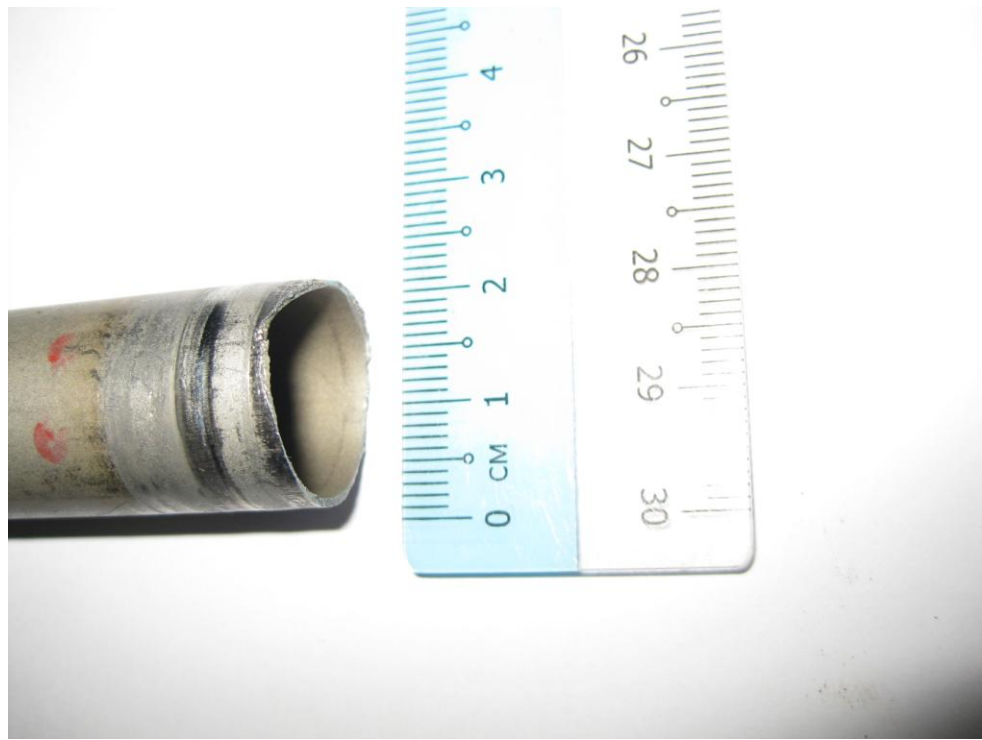
When the broken part of the tubing was observed, it was found that the ferrule is loose. When installing ferrules, it must be fixed and tight to the tubing which the ferrule cannot be rotated by hand. This is maybe the sign that wrong installation of ferrules has caused the failure.

Appendix 4: Broken side of the stainless steel tubing.

Based on the root cause, the failure occurred because of the high vibration from the lube oil pump and pressure safety valves. So, the author had suggested that the tubing can be replaced with flexible hose with the same size and specification. With the use of flexible hose, even if the system operates in high vibrations, the flexible hose will absorb some of the vibrations that can avoid failure that can lead to plant shutdown and production loss.

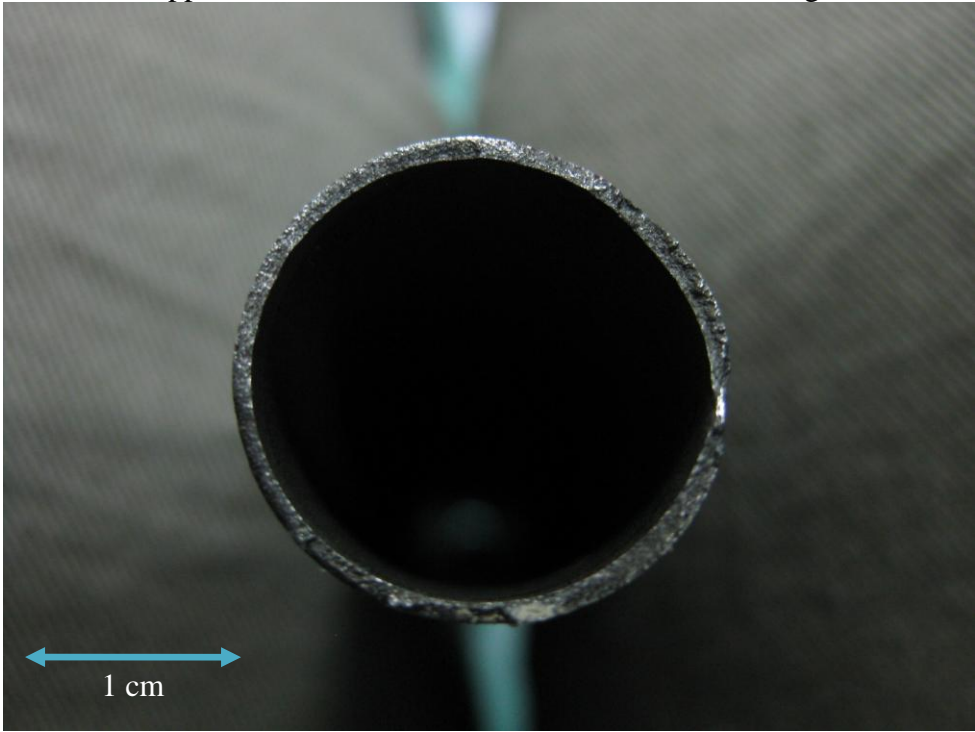
Appendix 5: Fracture surface.
