# CHAPTER 1

The failures of tubes in heat exchanger T-831 in Kerteh resulted carry unnecessary downtime to GPP Kerteh. The heat exchanger is shown in Figure 1. The tubes failure occurs approximately once every two years. Various opinions and suggestions have been given as the possible cause of failure. However a proper failure analysis study has not been performed. There were no study done to analyze the relations between the possible causes of problem, the exercised maintenance, and the implemented operation.

The objective of this project is to determine the causes of premature failures of heat exchanger tubes for Propane Refrigerant Condenser (T-831) in GPP Kerteh. This task consists of employing failure analysis methods in order to examine and investigate the possible causes of failure. Scope of work will include investigation of the material properties, review of regular operation parameter used, and inspection of maintenance activities conducted on the heat exchanger. It is anticipated that at the end of project, author will be provide suggestions in order to reduce the failures of the heat exchanger tubes.

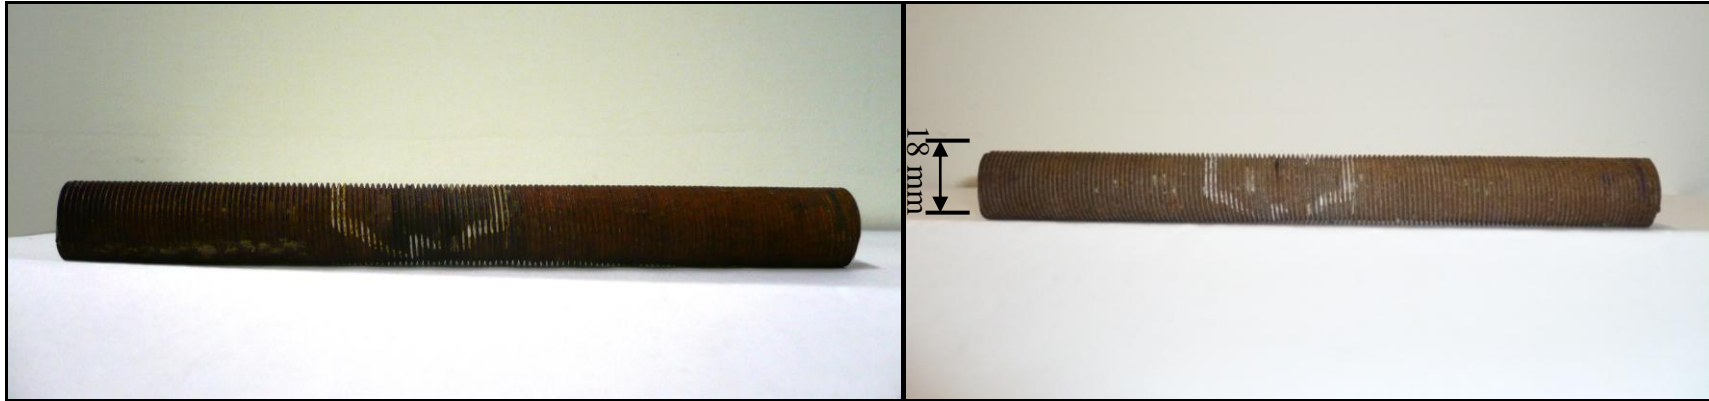
Figure 16 : A2 part before and after rust removal

Before performing NDT, the samples were cut into shorter pieces and the rust on the surface were removed. Tube A was cut into five parts as shown previously in the Figure 12. Parts A-2 and A-4 were selected for NDE. Sample A-2 was selected because videoscope examination reveals excessive corrosion of the location. Sample A-4 show acceptable condition of the heat exchanger tubes.

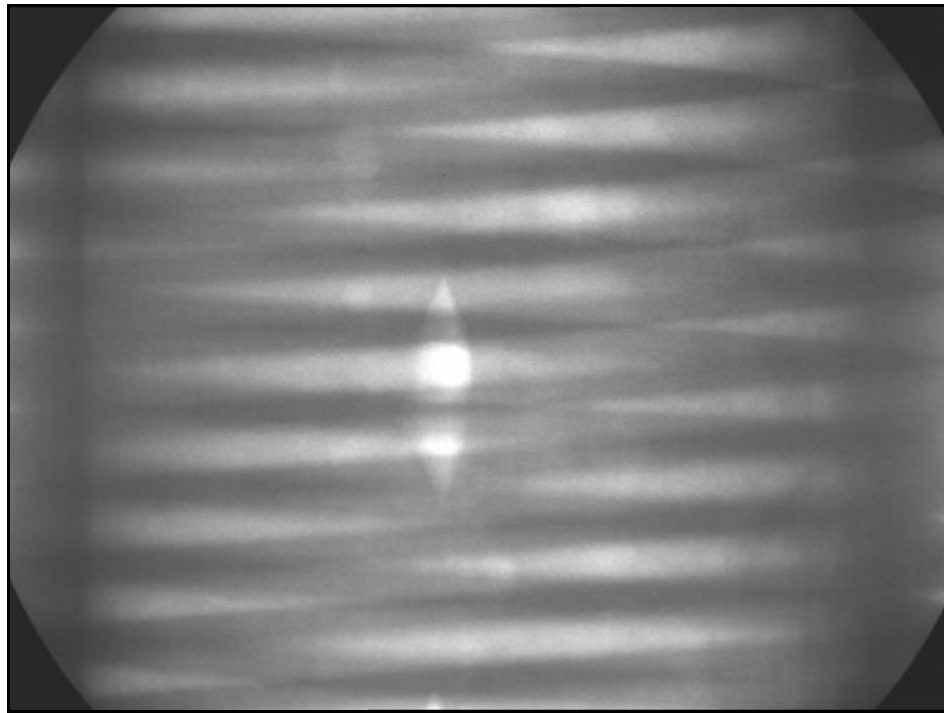
Figure 18 : A bright spot revealed. (Part A-2)

The X-ray examination revealed an elliptical pit in the tube. The elliptical pit is normally seen in failure of pressurize component which the shape propagation start at the middle shape and further increased at the edges of the shape.

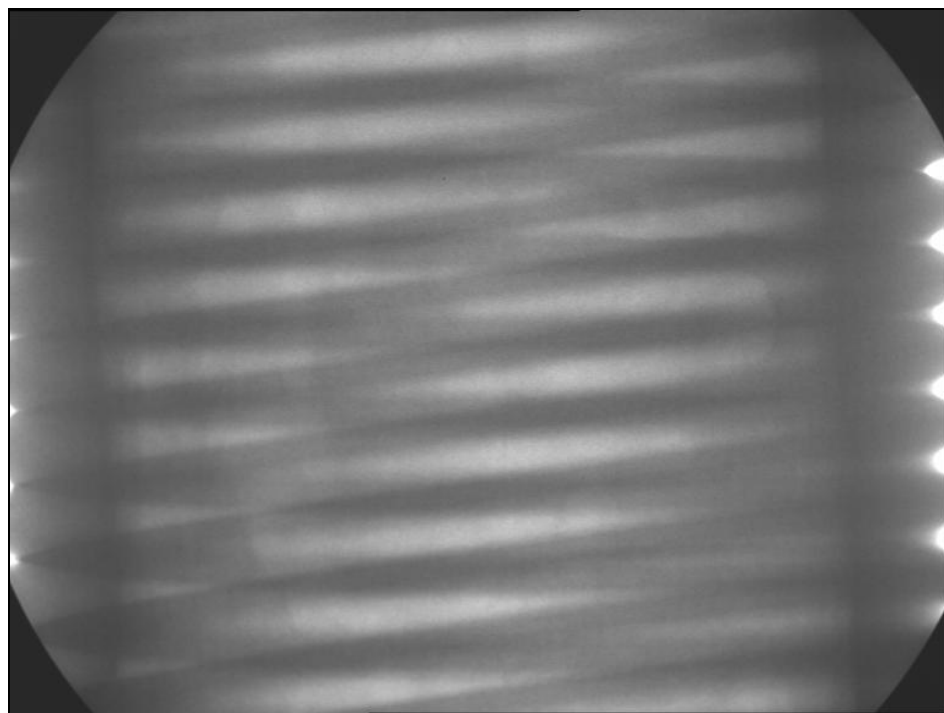
Figure 19 : Part A-4 found having good condition with less wall loss incident.

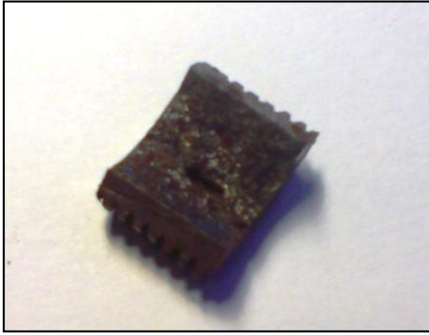
Figure 22 : Sample of failed part

- A corrode section from A-2 part revealed by X-ray testing.
- Coated and tested by EDX and SEM machine.

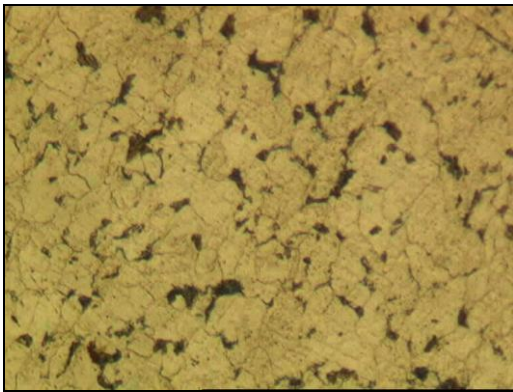
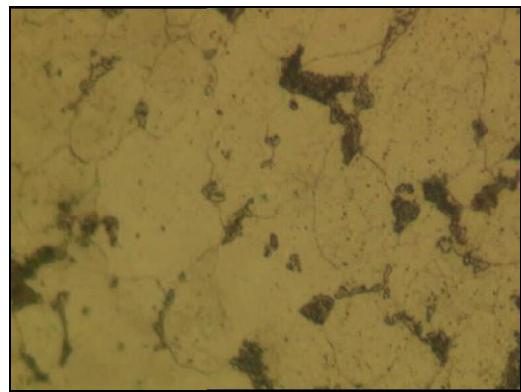
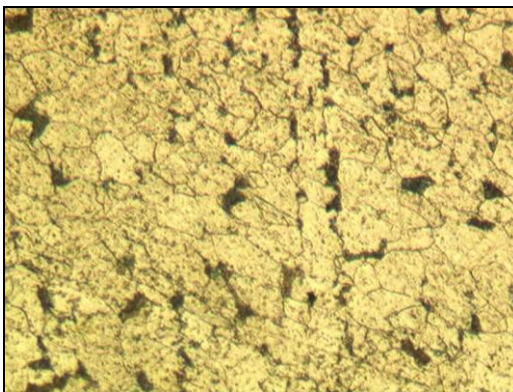
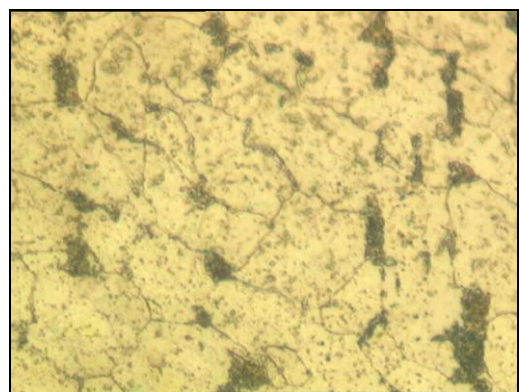
Presences of pearlites (dark region) in the presence of ferrite matrix show that the material is carbon steel-based material. Noted that grain boundary sample A is also look same in size and their arrangement as sample B which shown that heat treatment onto these two specimens are quite similar.

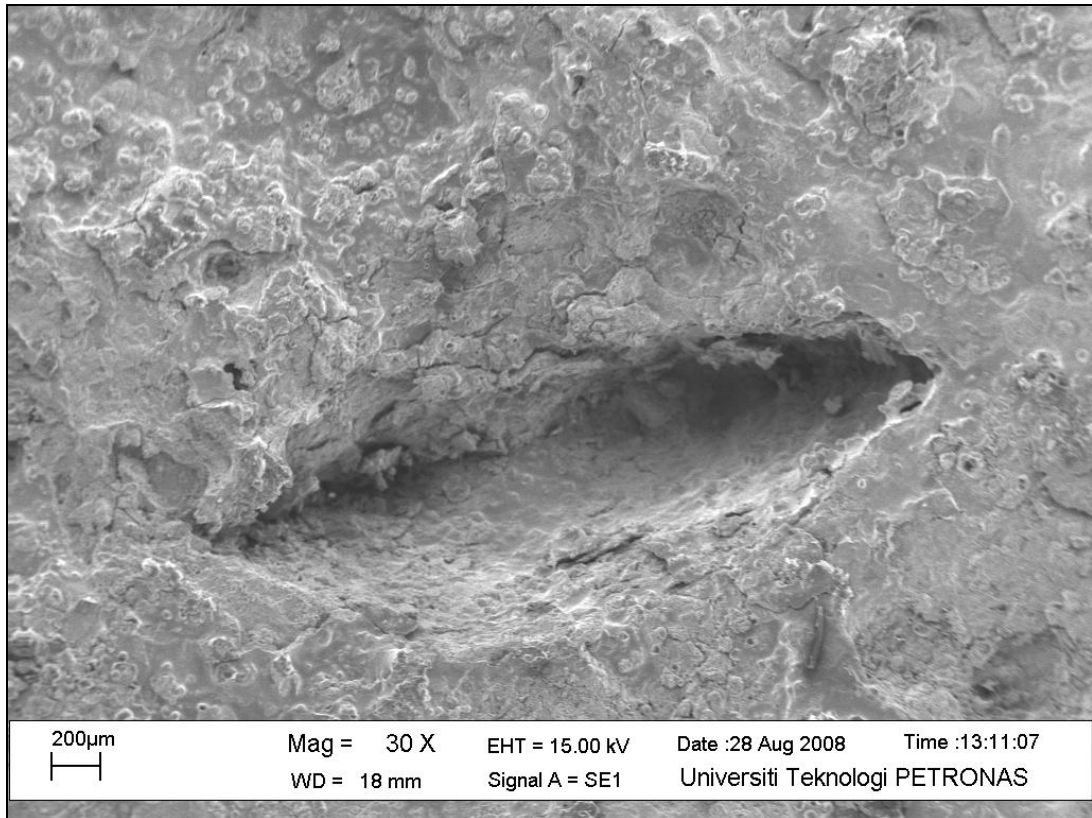
Scanning Electron Microscopic examination and Energy Disperse Spectroscopy examination have been done at the same time. The elliptical shape shown previously in the X-ray image in Figure 18 is again examined in the SEM. Figure 27 distinctly shows the elliptical shape almost 2mm in length. This pit is the reason for the tube to be out of specification because the wall thickness did not fulfill requirement.

Figure 27 : Corroded part taken from part A-2

The ellipsoid shape examined showed that the pit could continue to propagate from the current condition. Darker region inside the ellipse show that these areas are deeper. There is the possibility that these areas will become a through wall rupture if operation of the tube continued.

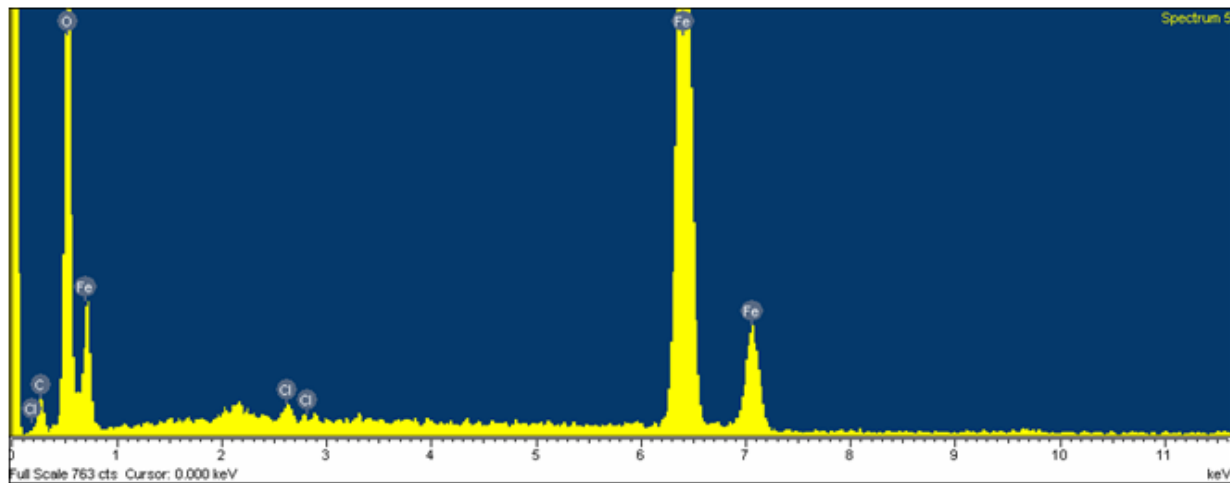
- Attendance of Cl element found on the sample surface
- Assume as one of the cause of corrosion

Figure 29 : EDX result of corroded sample

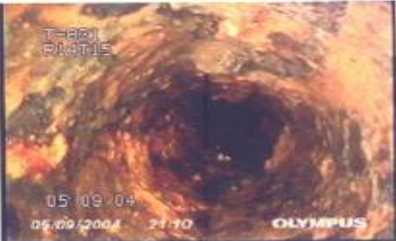
Photo Description	Photo 1 (Tube no 15 on row 14)
Finding	Deposit accumulate inside the tube
Recommendation	To be monitored

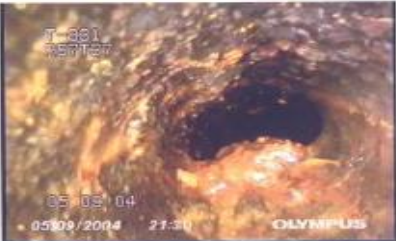
Photo Description	Photo 2 (Tube no 17 on row 57)
Finding	Deposit accumulate inside the tube
Recommendation	To be monitored / cleaned

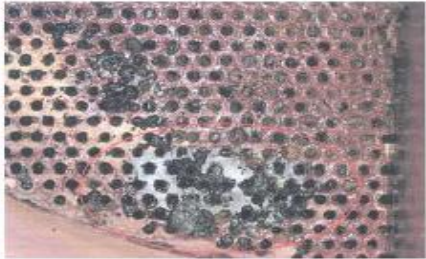
FINDINGS: HARD DEPOSITE FOUND AT THE TUBES SHEET AND MOST TUBES WAS FOUND CLOGGING WITH DEPOSITE.	
PHOTO NO	04	PHOTO DESCRIPTION

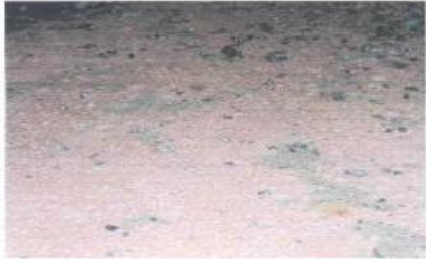
FINDINGS: TOP SIDE OF THE SOUTH SIDE PARTION PLATE WAS FOUND WITH PAINT BLISTERING AND LAYER OF DEPOSITE SCALE.	
INSPECTOR: AZMIR B. MOHAMD AMIN		REVIEWED BY:
