Most of Carbon Steel tubing for Water Injection wells at Dulang Fields was badly corroded even though wells were completed with the new downhole tubing. In order to avoid or minimize the tubing internal corrosion problems, the study on microstructure of the tubing parts should be done especially on how to improve the material of the tubing.

The objective of the study is to determine the primary cause of a failure by investigating the corroded parts and to provide with the suggested improvement of suitable material for the downhole tubing. Also, to study on the microstructure of the Carbon Steel tubing i.e. whether the part has experience extreme heat, cold work, reveal crack and fatigue. The scope of the study covered on the analysis of material for Carbon Steel tubing by using optical microscope (OM) and scanning electron microscope (SEM) attached with

the energy dispersive x-ray spectroscopy (EDX/EDS). The determination of the failure was performed on well Dulang A-29L.

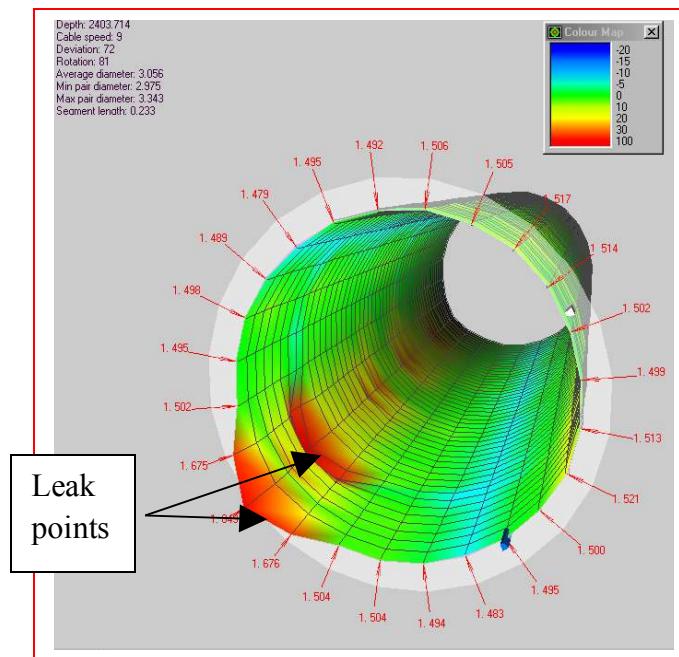
2002 [6]. In 2004, Production Logging Tool (PLT) and Multi-finger Imaging Tool (MIT) surveys confirmed severe leaking in the long string of DLA-29 (refer to Appendix I) which was impacted in declining of the recovery due to loss of good pressure maintenance for E-7, E-12/13 and E-14 [7]. Thus, the long string was shut-in in 2004 after MIT confirmed over 30 leak points along the internal tubing wall (refer to Figure 2.1).

Figure 2.1: Multiple holes detected at 2403.71m MDBDF.

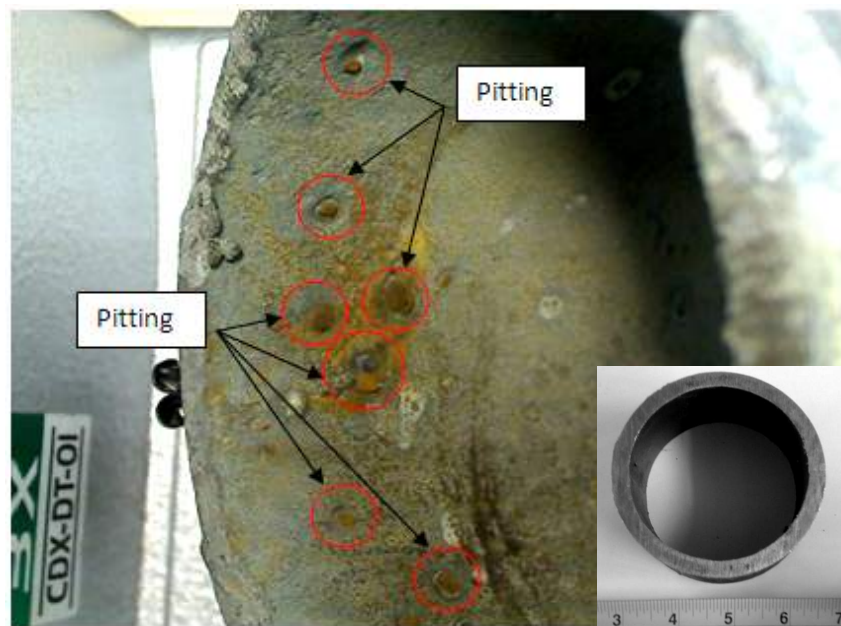
Figure 4.4: The internal surface of tubing cut sample.

The investigations began when steel tubing cut sample was received for analysis. This was immersed into a chemical solution for a day in order to remove a very thick brown scale throughout the metal surfaces (refer to Figure 4.4). Beneath this

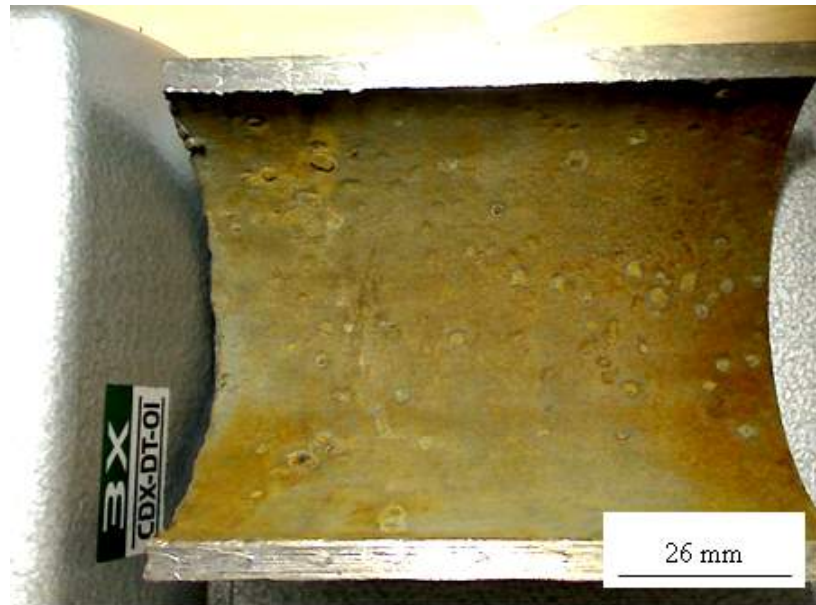
Figure 4.5: The internal surface of tubing cut sample showing extensive pitting.

brown layer, pit penetrating into the tubing wall was resulted in hole (see red marked in Figure 4.6). Furthermore, localized deposits of corrosion product in the form of pitting were also evident (see arrow in Figure 4.4). Some tubular was sectioned to reveal the internal surfaces which were found to be covered with a several small pits at the tubing wall (refer to Figure 4.5). A deposit build-up of corrosion product on the both surfaces in same location was also observed. There was some evidence of attack on others areas of the tube.

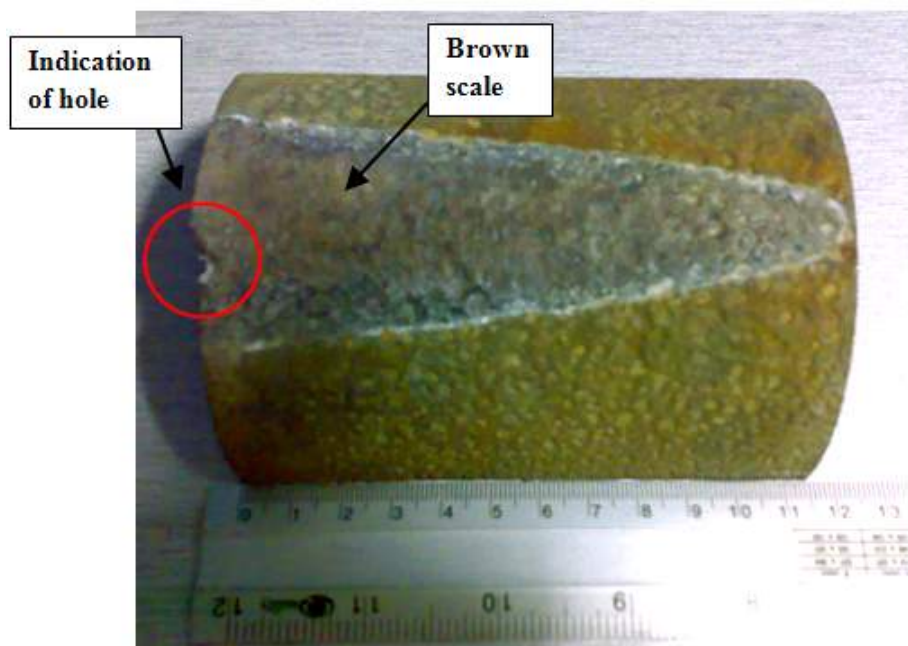
Figure 4.6: The external surface of tubing cut sample showing extensive pitting.

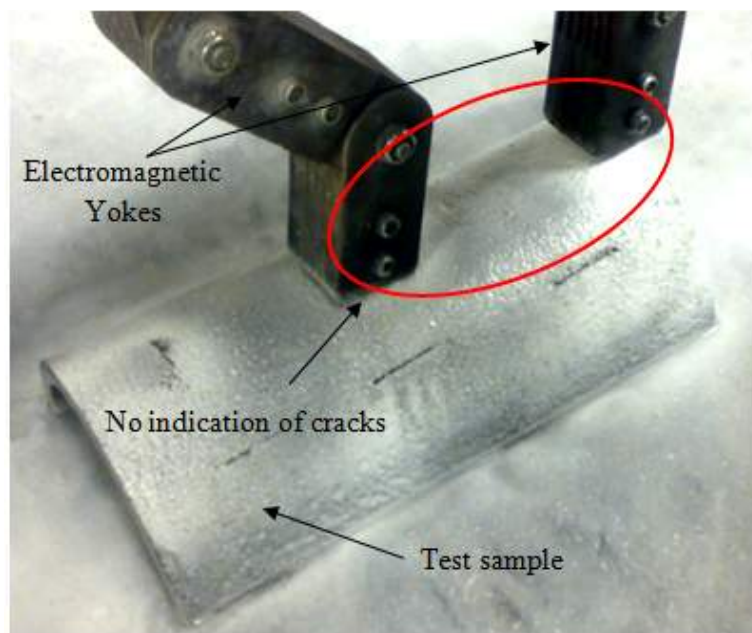
Figure 4.7: The magnetic particle inspection on tubing cut sample.

defects (i.e. cracks) on the tubular sample as shown in Figure 4.7. As a result, there was no evidence of any defects presence on internal and external surfaces of the failed steel tubular (refer Figure 4.7). If discontinuity is founded at any surface of tubular sample, the leakage of magnetic field will indicate the defect.

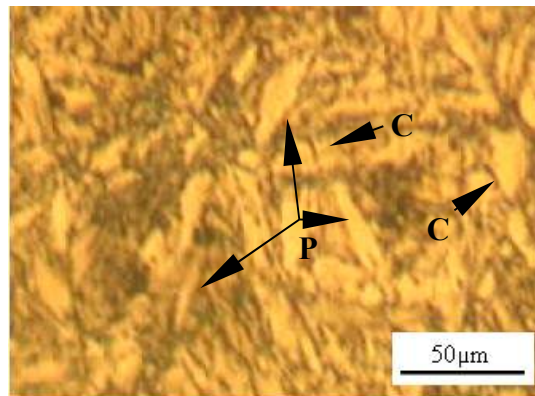
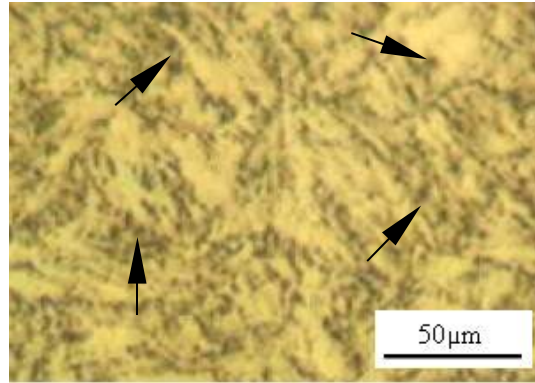
Two metallographic cross sections were prepared from two different locations on the steel tube. Both of them were subjected to the extreme operating conditions during the service life. The two areas of the tube were examined and compared. The characteristic structures developed were tempered martensites (see Figure 4.10 (a) and 4.10 (b)) [9, 15]. The formation of two forms of martensite in the medium-carbon (0.4%) steel was clearly shown as indicated in Figure 4.10 (a). The presence of plate martensite among lath martensite were formed as individual in regions marked P as shown in Figure 4.10 (a). Also, the formation of fine carbides known as cementite ( $\text{Fe}_3\text{C}$ ) were detected in the regions marked C as in Figure 4.10 (a) with nital etched. Meanwhile, the cementite particles became increasingly spheroidal in shape towards near the through wall hole as indicated by arrows in Figure 4.10 (b). Hence, there was an evidence of excessive thermal exposure near the through wall holes area during the operation. Moreover, most cementite particles were founded to be located at the ferrite grains boundaries (see Figure 4.10 (b)). The light phases appear as illustrated in Figure 4.10 (b) were ferrite probably due to the recovery and recrystallization of martensite (compare Figure 4.10 (a) and 4.10 (b)) due to continuous exposure on heating during the operation. At this stage, the ferrite grains continue to grow and gradually assume an equiaxed in shape. Although, the discrete grains of ferrite cannot be recognized clearly because of the confusion caused by the presence of many partly resolved of particles cementite and probably can be recognized after etching by appropriate techniques.

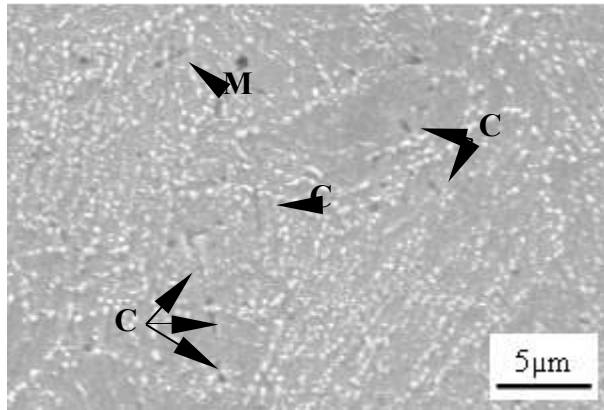
Figure 4.11: The scanning electron micrograph of Fe-0.4C. The arrows C show the fine cementite particles appeared as far away from the hole area. Mag. 2000x.

Detailed examination of the microstructure by scanning electron microscopy (SEM) shows the same features of tempered martensites found in the steel tube (see Figure 4.9 and 4.10). The region marked C as in Figure 4.11 and 4.12 indicated that the presence of carbides precipitate probably cementite at two different locations. In both areas, the microstructures features were dissimilar and not uniform throughout. The SEM shows that the fine cementite particles appear as far away from the hole area (see Figure 4.11). Besides, the abnormality confirmed by SEM as indicated by the region marked C as in Figure 4.12 which show that the spheroidized cementites appear towards the through wall hole. This was probably due to the excessive thermal exposure near the through wall holes area during the operation. Also, an arrow M indicates as a probable microcrack, an intragranular microcrack which runs transversely in regions of plate martensite. That arrow identified as a probable microcrack because the feature was aligned perpendicular to the direction of major arrays of cementite particles (regions marked C in Figure 4.11). This indication was probably due to cracking produced during quenching.

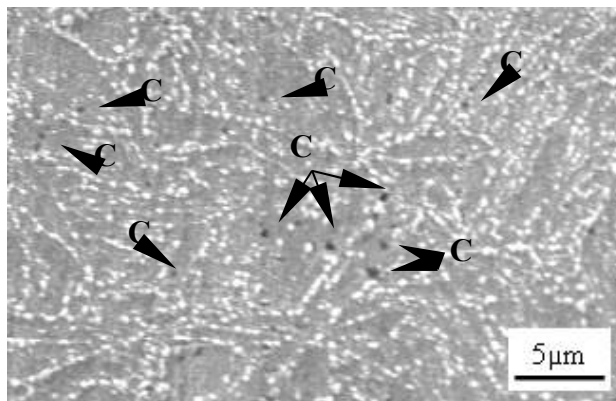
Figure 4.12: The scanning electron micrograph of Fe-0.4C. The arrows show the spheroidized cementite have been introduced towards near the hole area. Mag. 2000x.

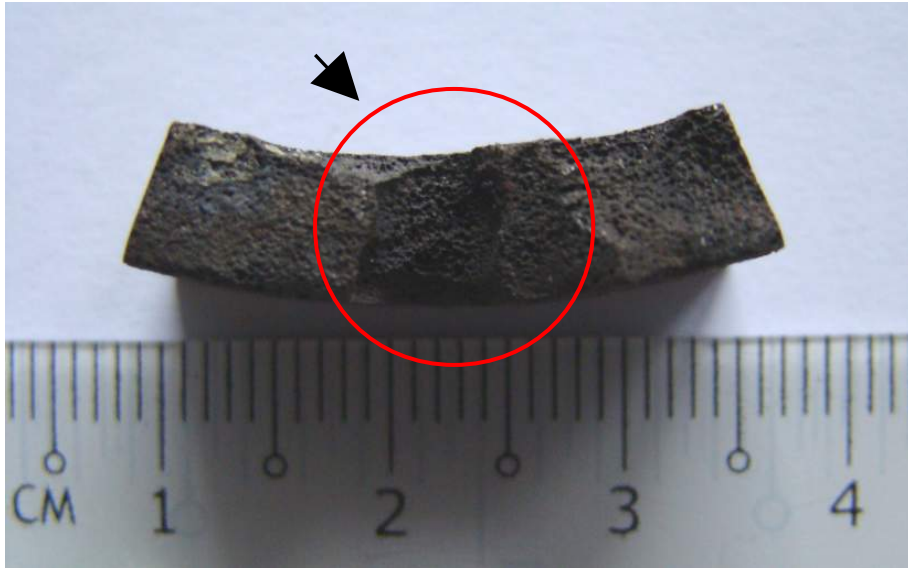
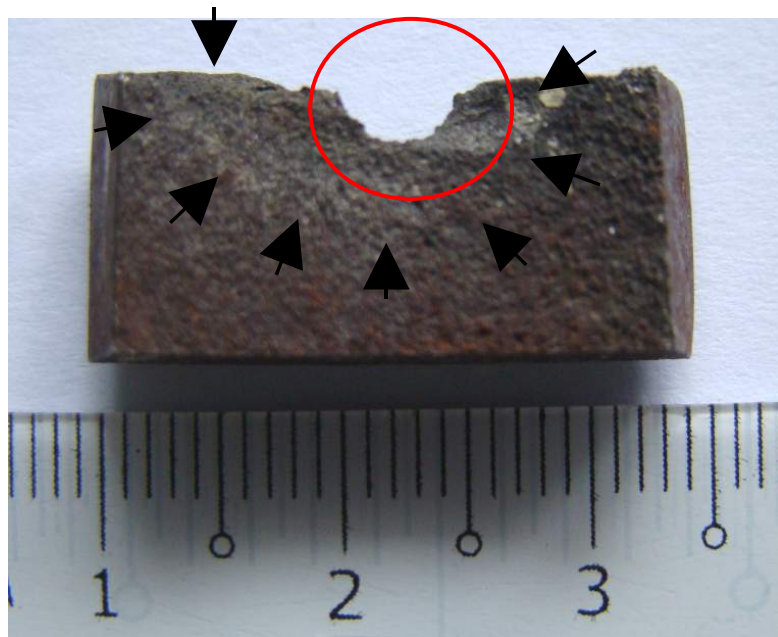
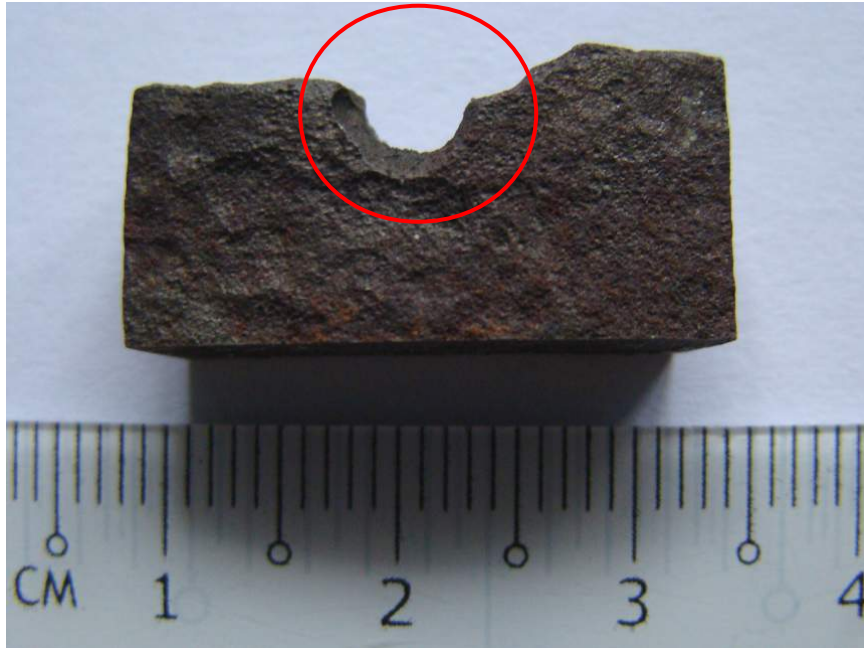
Figure 4.13 (a): Photograph showing a cross-section of internal region of the tube through wall hole area (pointed by arrow).

Figure 4.13 (b): Photograph showing a cross-section of internal surface of the tube at the hole area (region marked red).

Figure 4.13 (c): Photograph showing a cross-section of external surface of the tube at the hole area (pointed by arrow).

Figure 4.13 (a, b and c) show severely pitted region in cross-section. The visual examinations results indicate that the tube was attacked in localized area on both internal and external surface of the tube in the form of pitting. Also, the internal surface of the failed tube contained a region of severe metal loss (pointed by arrows) as indicated in Figure 4.13 (b). In addition, it was clearly shown that (refer Figure 4.13 (c)) the large and deep pit has been form on the external surface of tube. Thus, the attacked penetrated the tube wall and resulted in through wall hole.

It is therefore recommended that the steel tubular should be replaced by using AISI type 316 Stainless Steel that susceptible to pitting and crevice corrosion attack. From the literature, it was noted that the AISI type 316 Stainless Steel exhibit excellent corrosion resistant to pitting and crevice corrosion [16]. In addition, this 300 series type of steel exhibit some degree of susceptibility to Stress Corrosion Cracking (SCC). The present of chromium is the element essential in forming the passive film in 316 Stainless Steel. Meanwhile, molybdenum in combination with chromium is very effective in terms of

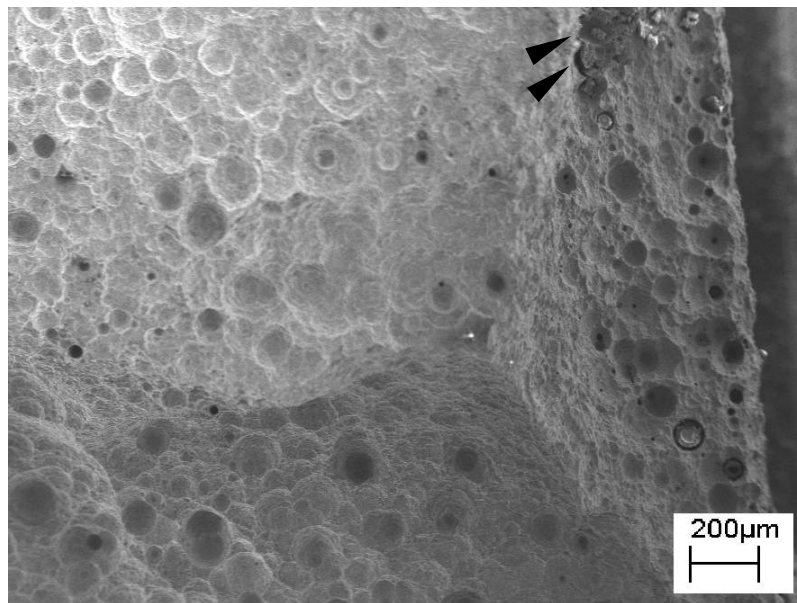
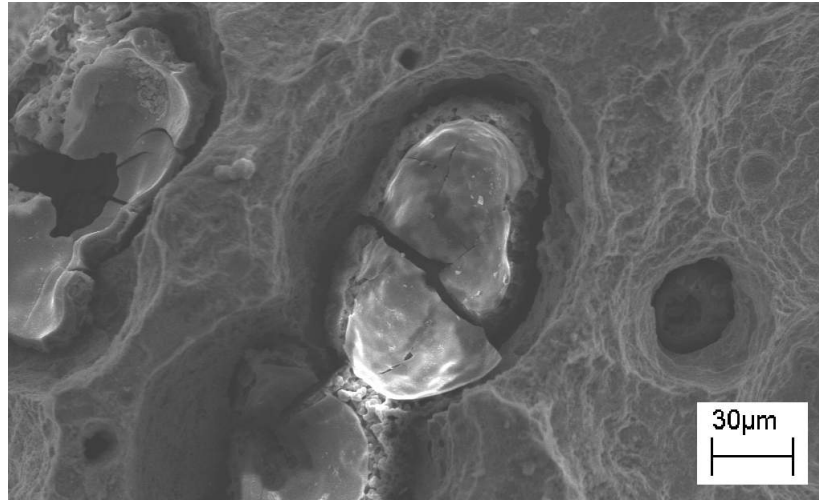
A section containing the hole area was removed for examination in a SEM equipped with an Energy Dispersive X-Ray Spectroscopy (EDX). SEM examination revealed the internal side of the tube was attacked by the numerous of pitting (see Figure 4.14 (a)). Figure 4.14 shows close-up photographs of the attack at the hole area where the corrosion pits were present and the EDX plot is shown in Figure 4.15. However, the

Figure 4.14: The scanning electron fractograph of Fe-0.4C. The arrows in photograph (a) show the approximate close-up location of photograph (b). (a) Mag. 50x. (b) Mag. 200x.

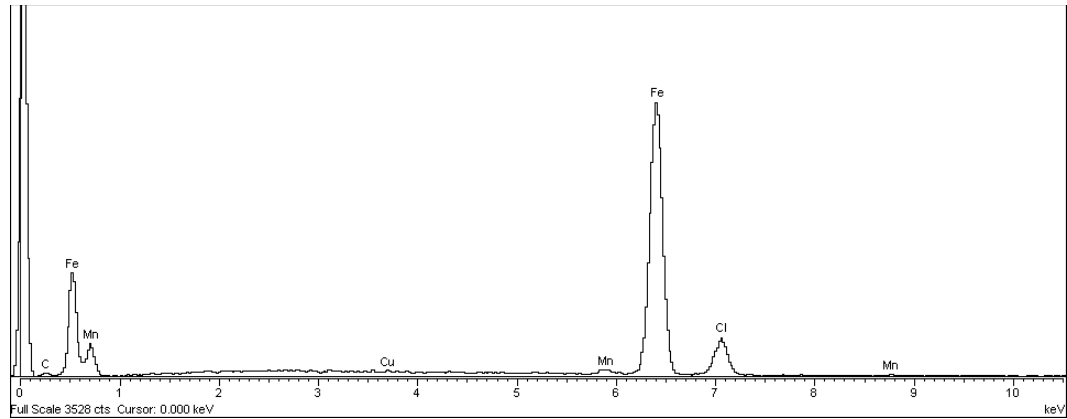
Energy Dispersive X-Ray Spectroscopy (EDX) indicated that the internal region of the tube through wall hole area consisted primarily of iron (56.5%) and manganese (19.4%) with minor trace amounts of carbon (6.3%) and copper (5.1%) as shown in the Table 4.2. This was noted that the elements appear above in the EDX analysis was those originated from the base metal.

Figure 4.15: The EDX elemental analysis results of the internal side of the tube through wall hole area.

In addition, the results of the analysis revealed that the corrosion pits was high in chlorine (12.7%). The presence of the chlorine probable due to continuous exposure of the tube on the seawater during the extent of the service. Here it was hypothesised that metal surface of the tube was attacked by the chloride containing acidic environment from the seawater and lead to start of pitting. This corrosion rates increased with temperature as the tubing goes deeper into the target reservoir formation. Thus, the heated seawater may deposit protective scale or lost of its oxygen on the pits area and accelerate the corrosion attack. The results of deposits on the pits area tends to restrict the oxygen access and lead to crevice corrosion attack. Therefore, this localized attack will developed the severe form of pitting that results in through wall hole on the steel surface.

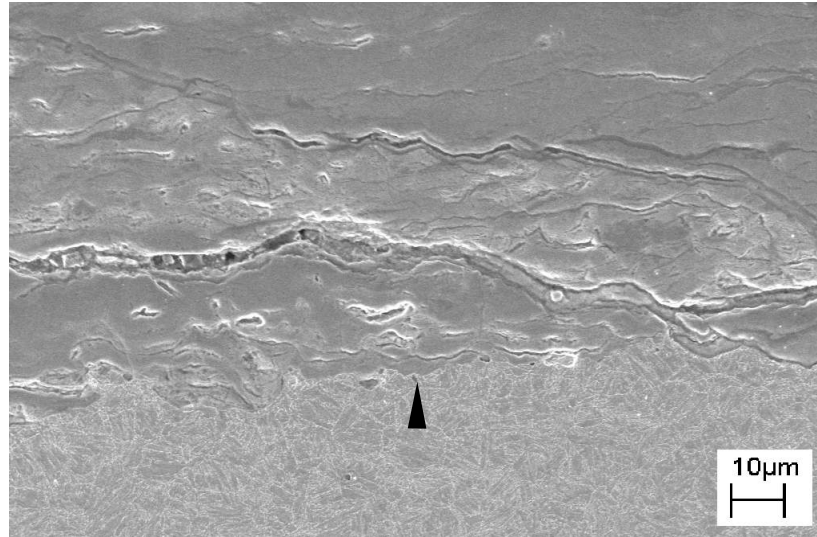
Figure 4.16: The corrosion product analysed using EDX. Mag. 500x.

Figure 4.16 shows the scanning electron micrograph of the tube internal surface and scale deposit in the region of metal loss. The arrow in this figure indicated that the interface between the deposited scale and steel surface on the pitted area.

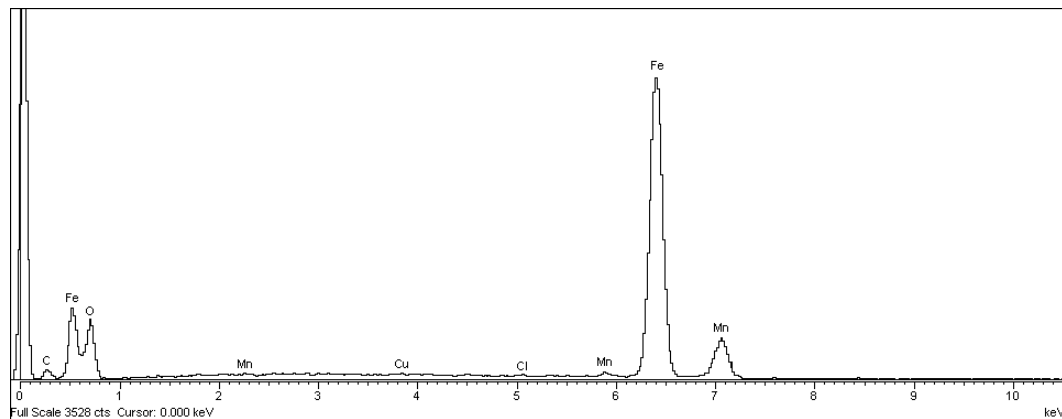
Figure 4.17: The EDX analysis of the corrosion product showed a marked presence of iron oxide and chlorine.

Figure 4.17 shows the EDX results of the corrosion residue present at the pitted region. The iron, manganese, carbon and copper peaks in Figure 4.17 arise from the carbon steel itself. The results of the analyses revealed that the steel tubular was being chemically corroded by chlorine compounds from the seawater. At the

interface between the pit and adjacent surface, iron hydroxide will be formed due to the interaction between hydroxide ions from seawater and metal surface. This will further oxidised by the dissolved oxygen in seawater to form iron oxides and therefore detected in scale deposits. There was not enough of the corrosion residue present to conduct X-Ray Diffraction (XRD) analyses to determine the specific corrosive compounds and iron oxides compounds.
