Preventive Program for Small Bore Piping Failure At Gas Processing Plant

Dissertation submitted in partial fulfilment of
the requirements for the
Bachelor of Engineering (Hons)
(Mechanical Engineering)

JANUARY 2009

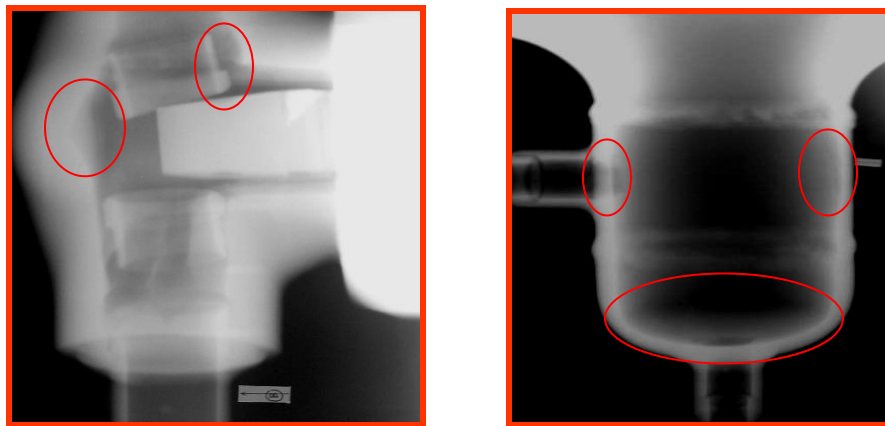
Figure 2.2 : Radiography examination for small bore

Sample of internal erosion (Figure 2.2) at small bore by using radiography testing:

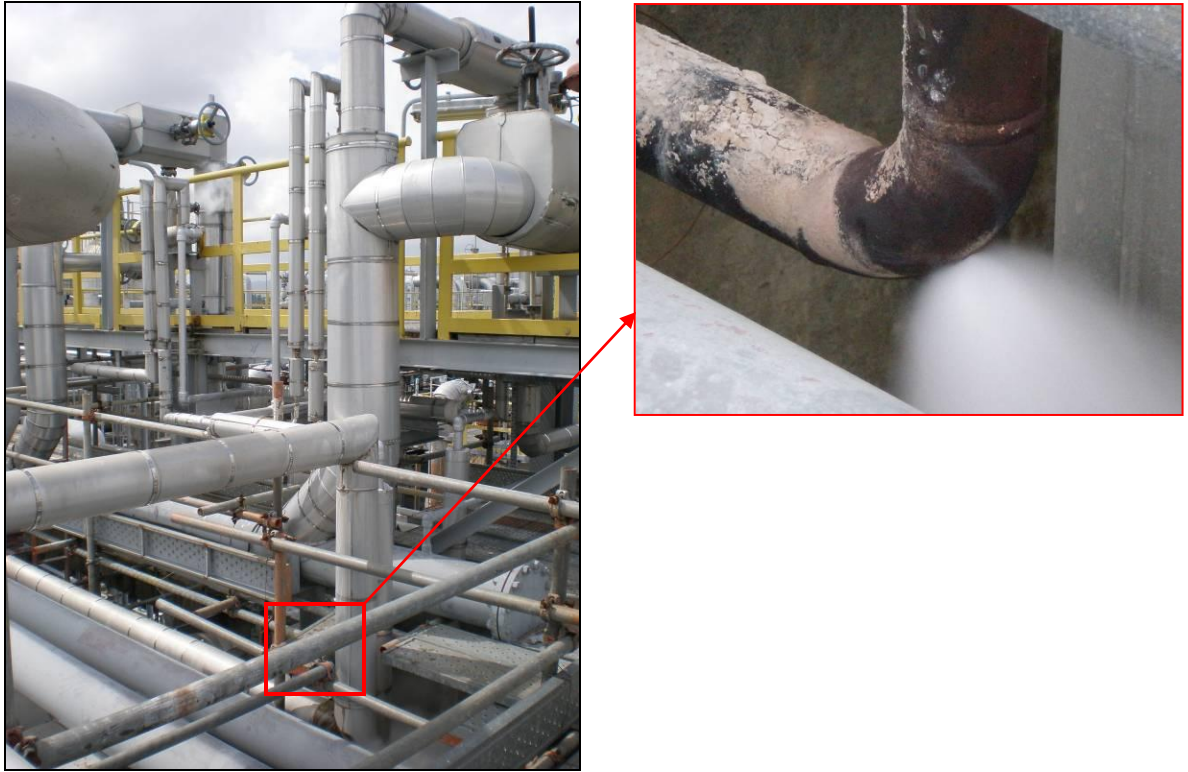
Figure 3.2: The Actual Case of Small Bore Piping Failures for elbow pipe

The figures below (Figure 3.2 and Figure 3.3) show the actual case pictures of small bore piping failure occurred at Gas Processing Plant. These failures occurred several times because internal erosion effect at the same piping design; elbow pipe and tee pipe. Therefore, the pressure develop will be measured to investigate internal erosion effect.

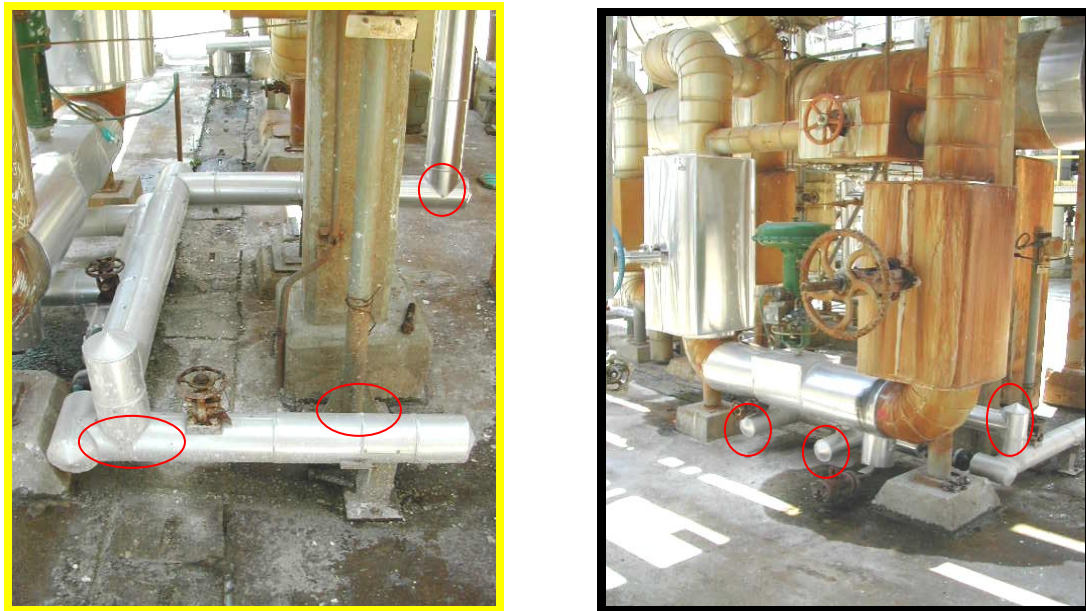
Figure 4.2: Suspected internal erosion area

- Downstream of control valves, especially when flashing is occurring.
- Downstream of pump discharges
- At any point of flow direction change, such as the inside and outside radii of elbows.
- Downstream of piping configurations (such as welds, thermowells and flanges) that produce turbulence, particularly in velocity sensitive systems such as ammonium hydrosulfide and sulfuric acid systems

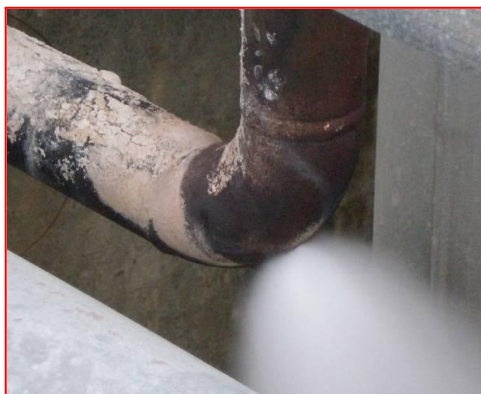
(a) elbow pipe

This pipe also category in SD 1 (failure leads to total plant shut down) if the pipe leak and fail. Based on RBI analysis, this elbow pipe is in HIGH RISK category. It need immediate action to repair, replacement or rectification.

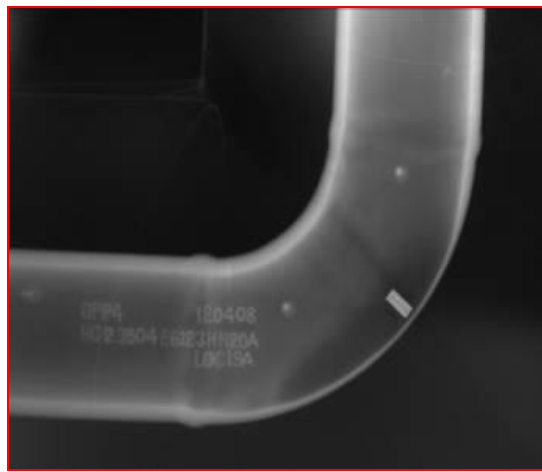
Figure 4.4: Radiography Film show wall lose

First, the author got the Radiography testing result from Inspection department, PGB. From Radiography film (Figure 4.4), it shows that severe internal erosion observed at elbow's socket and severe internal erosion observed at elbow's body. This erosion effect will cause wall lose or decreasing of wall thickness.

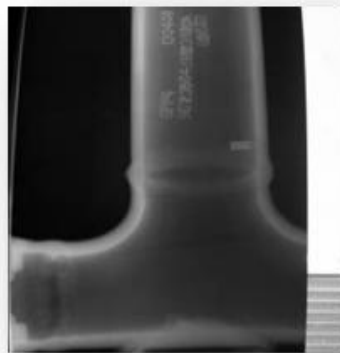
Figure 4.8: Radiography Film show wall lose

The author also got the Radiography testing result from Inspection department, PGB for tee pipe sample. From Radiography film (Figure 4.8), it shows that severe internal erosion observed at tee joint and severe internal erosion observed at tee joint body. This erosion effect will cause wall lose or decreasing of wall thickness.

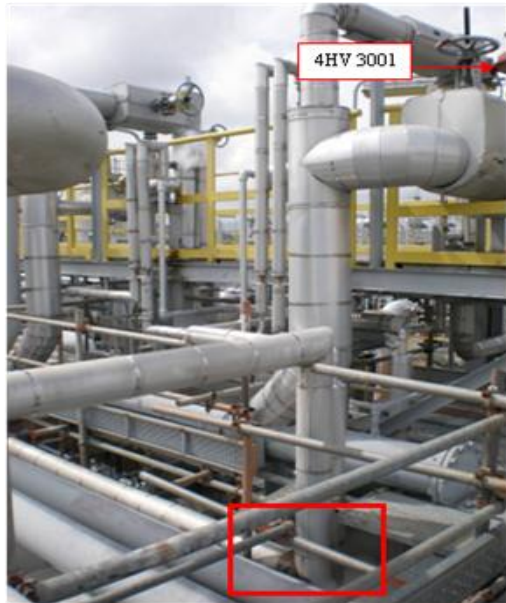
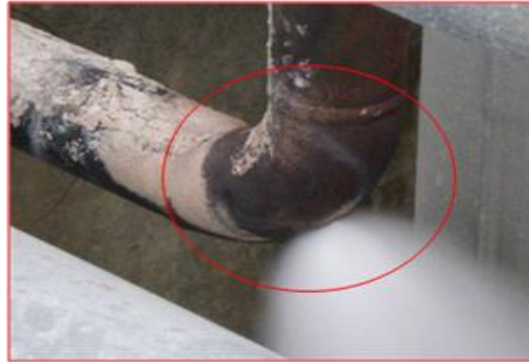
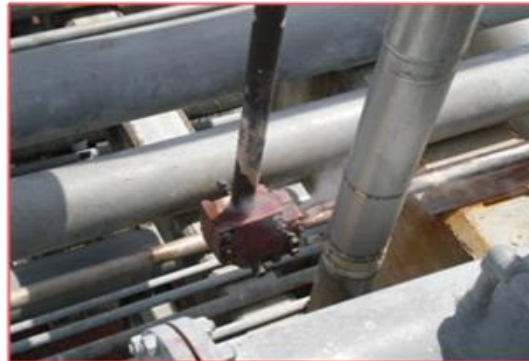
**LINE NO: HC-2"-3504-E6123-H(N20A)
TAG NO: 4A-IS4-1517
PHOTO NO: 4-399**

Elbow type clamped observed at 2" elbow

Heavysteam splash leak observed at clamped area.

PreparedBy : RamlanIbrahim Date: 18.12.07 Status: **LEAK** Re-inspect Date: **21.2.08** Status: **HEAVY SPLASH STEAM LEAK** Re-inspect by: RamlanIbrahim

1. To rectify leak, i.e.: by inject sealant into elbow type clamped.
2. To be monitor the clamps quarterly and to identify the extend of internal erosion to the whole line and repair accordingly during next opportunity shutdown window.

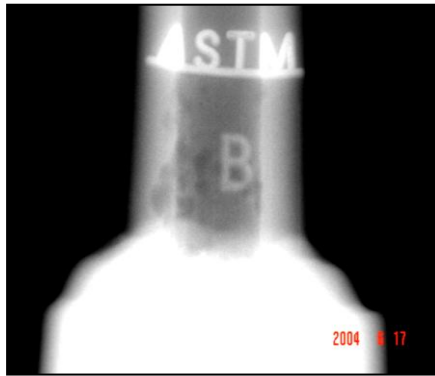
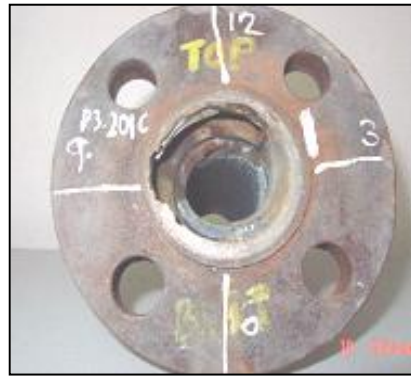
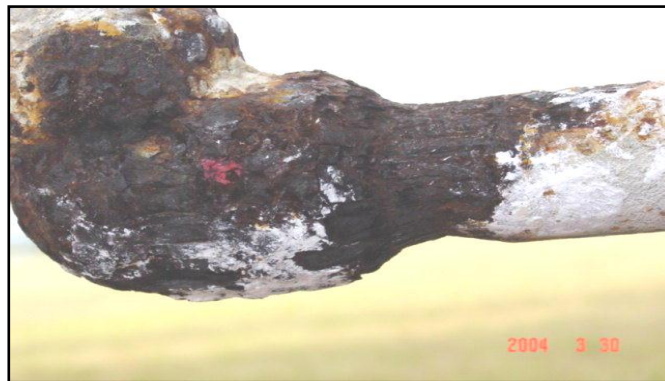
Internal erosion and external corrosion

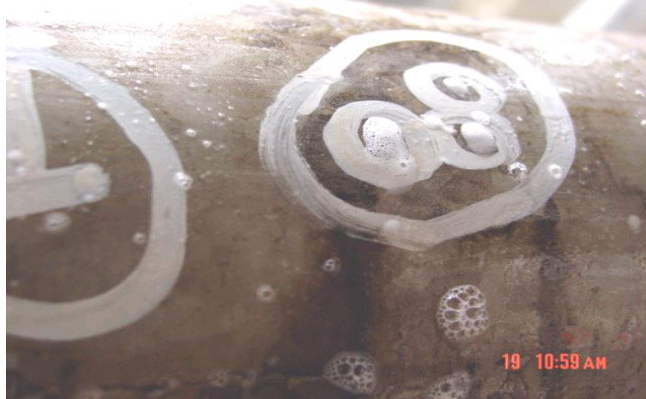
Chloride Stress Corrosion Cracking - leak spots at stainless steel pipe

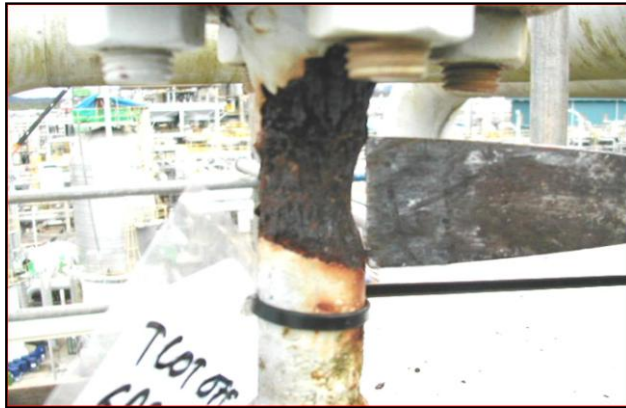
Small Bore Piping Failure at Air Fin Cooler (AFC)
