Failure Investigation of a Steel Pipe

**A project dissertation submitted to the
Mechanical Engineering Programme
Universiti Teknologi PETRONAS
in partial fulfilment of the requirement for the
BACHELOR OF ENGINEERING (Hons)
(MECHANICAL ENGINEERING)**

July 2008

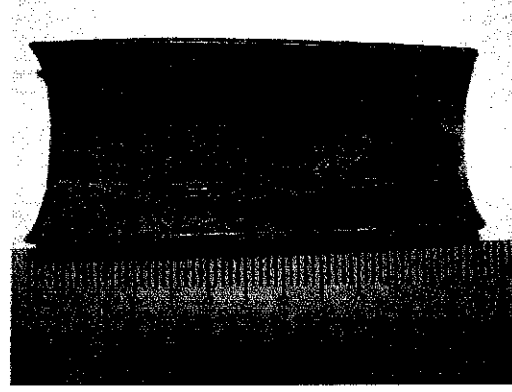
Figure 4.4: The internal view of the pipe after cleaned with rust removal solution

After the preliminary examination, the steel pipe was cut into smaller pieces. The focused area is around the leakage. The internal wall of the pipe is shown in Figure 4.3. It shows that the internal pipe experiences corrosion and the most critical part that experiences corrosion is on the welding line.

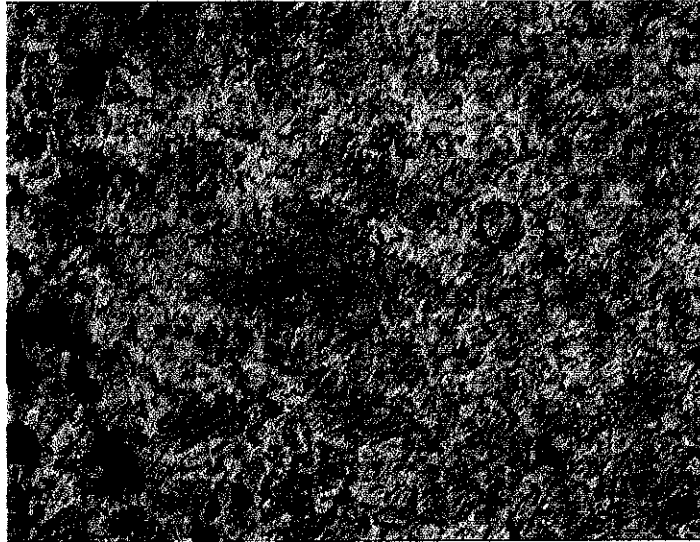
Figure 4.7: The location of slip plane in the red circles.

The pipe experienced residue stresses, can be observed by formation of slip planes as shown in Figure 4.7 (marked with red circle). The slip plane occurred during manufacturing process, pressing of metal sheet and rolling process to form pipe. In order to form stress corrosion cracking (SCC), the metal should be under corrosion.

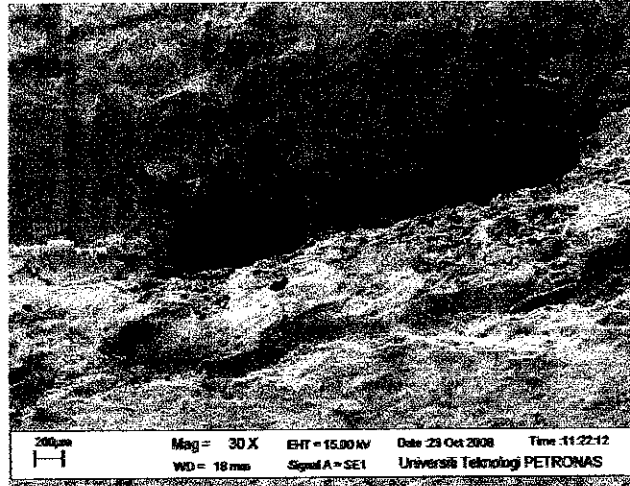
Figure 4.10: SEM fractograph shows the location of major leaking at the welding line.

The SEM examination was conducted on the welding line and internal wall of the steel pipe. From the SEM result, it shows that the welding line and internal wall were experienced corrosion. With magnification of 30x, the grain boundary is almost visible as shown in Figure 4.10. This image is taken at the major leakage area. It shows that the steel pipe has experienced corrosion attack. In Figure 4.11, the image is taken at the second leakage area on the welding line. It also indicate the corrosion attack is the cause leakage.

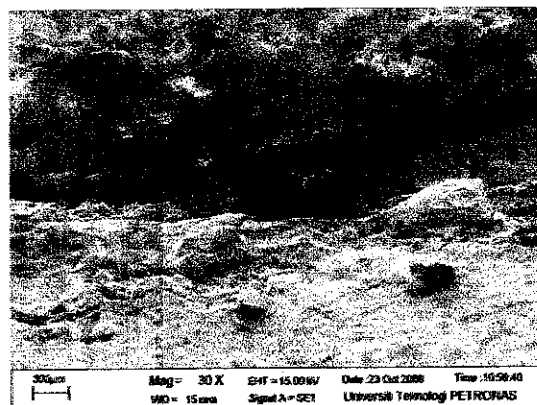
Figure 4.11: SEM fractograph shows the pin hole on welding line.

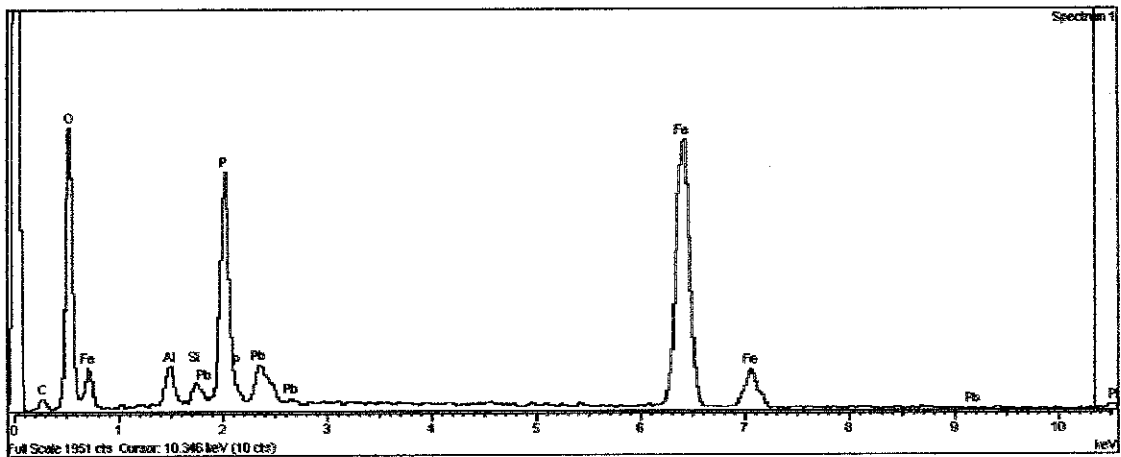
The results are provided in Tables 4.1 and 4.2 together with the Figure 4.14 and 4.15. The results show the loss of Fe element in leakage pipe area is very critical. The Fe has been replaced by other element so the corrosion occurred.

Figure 4.14: The element distribution along the failed pipe sample.
