Failure Analysis of Heat Exchanger's Tubes at GPP Kerteh

Dissertation report submitted in partial fulfilment of
the requirements for the
Bachelor of Engineering (Hons)
(Mechanical Engineering)

JULY 2008

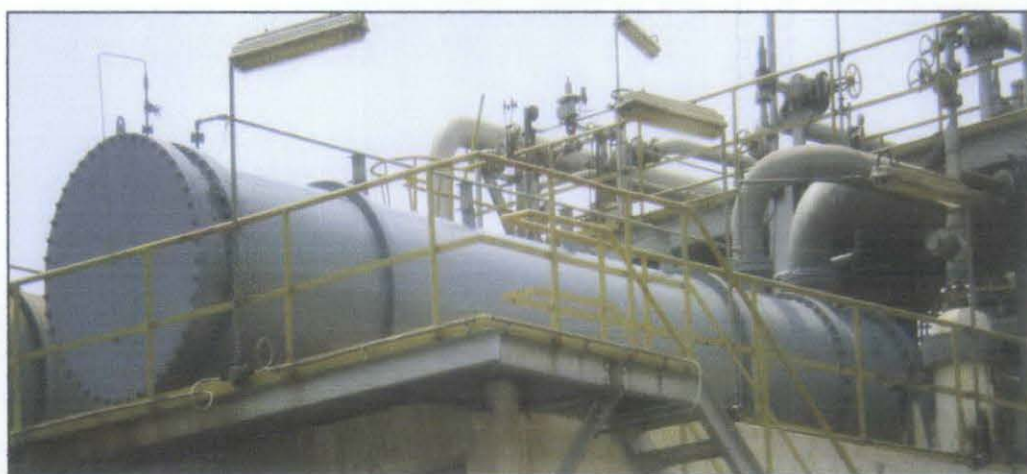
Figure 1 : Heat exchanger T-831

The failures of tubes in heat exchanger T-831 in Kerteh resulted carry unnecessary downtime to GPP Kerteh. The heat exchanger is shown in Figure 1. The tubes failure occurs approximately once every two years. Various opinions and suggestions have been given as the possible cause of failure. However a proper failure analysis study has not been performed. There were no study done to analyze the relations between the possible causes of problem, the exercised maintenance, and the implemented operation.

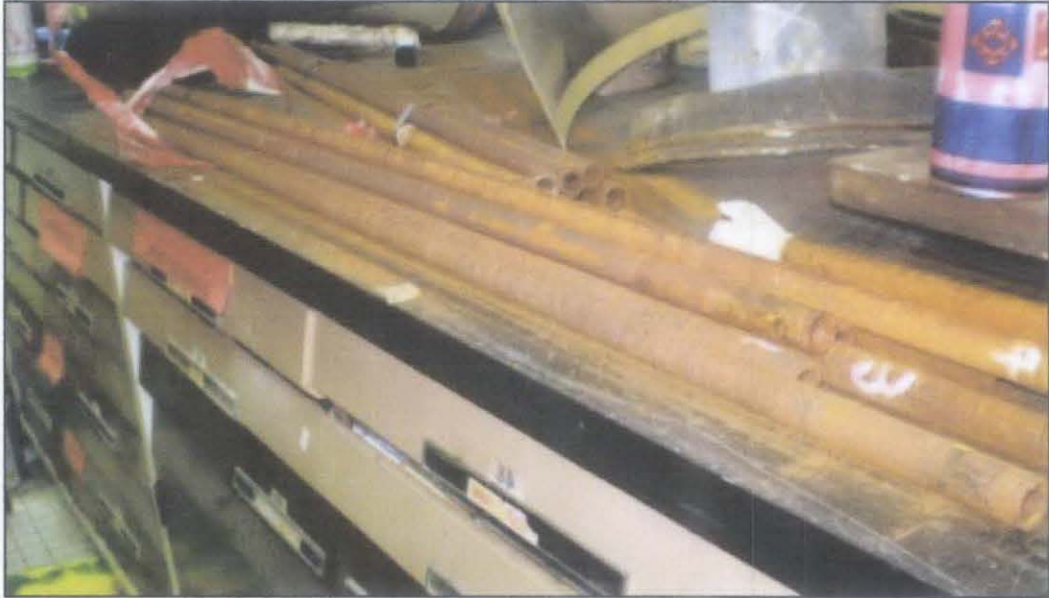
Figure 13 : Tubes sample stored at Inspection Section, GPP Kerteh

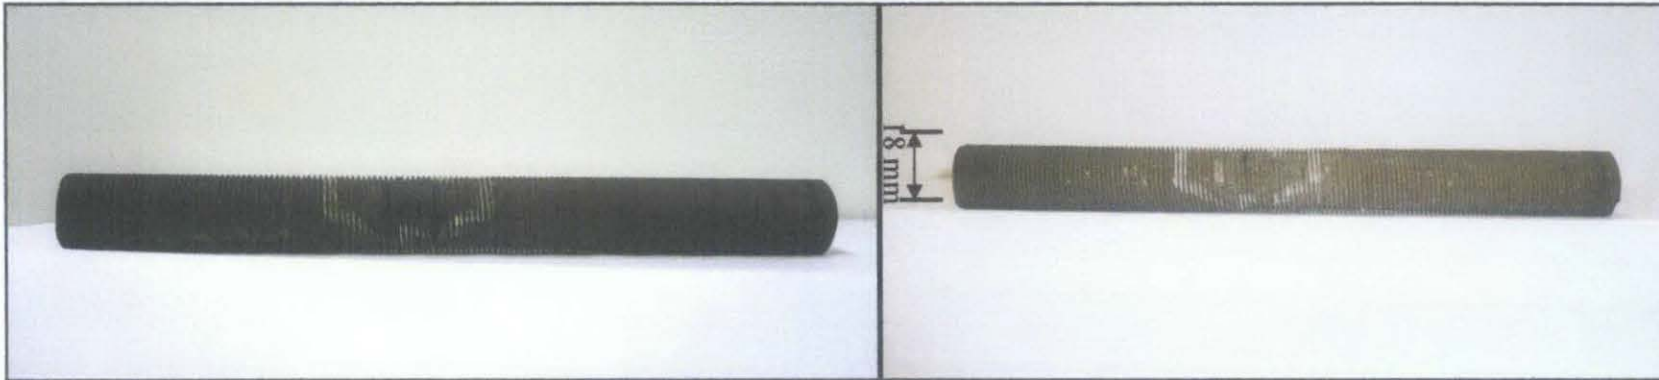
Figure 16 : A2 part before and after rust removal

Before performing NDT, the samples were cut into shorter pieces and the rust on the surface were removed. Tube A was cut into five parts as shown previously in the Figure 12. Parts A-2 and A-4 were selected for NDE. Sample A-2 was selected because videoscope examination reveals excessive corrosion of the location. Sample A-4 show acceptable condition of the heat exchanger tubes.

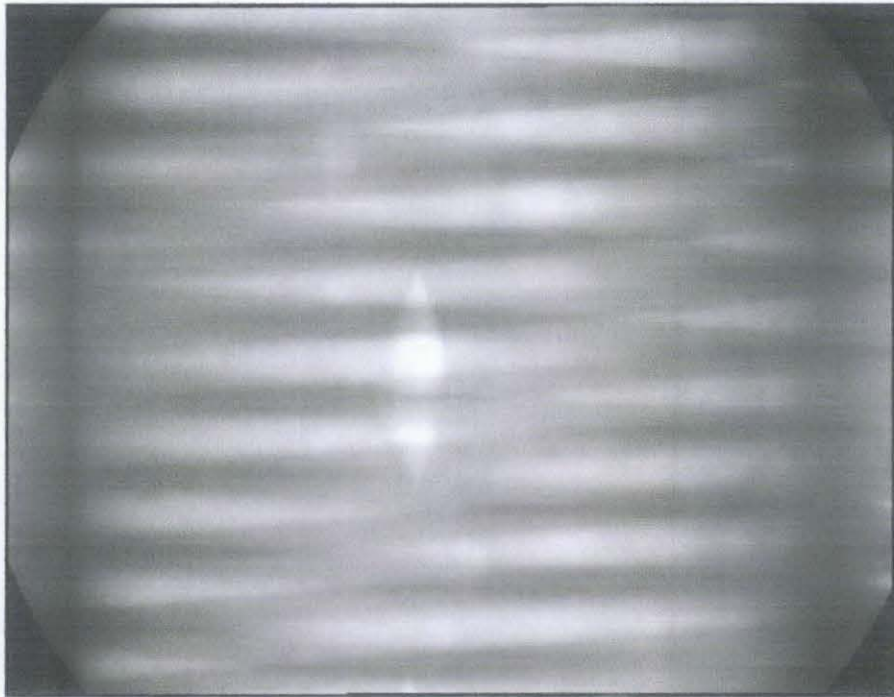
Figure 18 : A bright spot revealed. (Part A-2)

The X-ray examination revealed an elliptical pit in the tube. The elliptical pit is normally seen in failure of pressurize component which the shape propagation start at the middle shape and further increased at the edges of the shape.

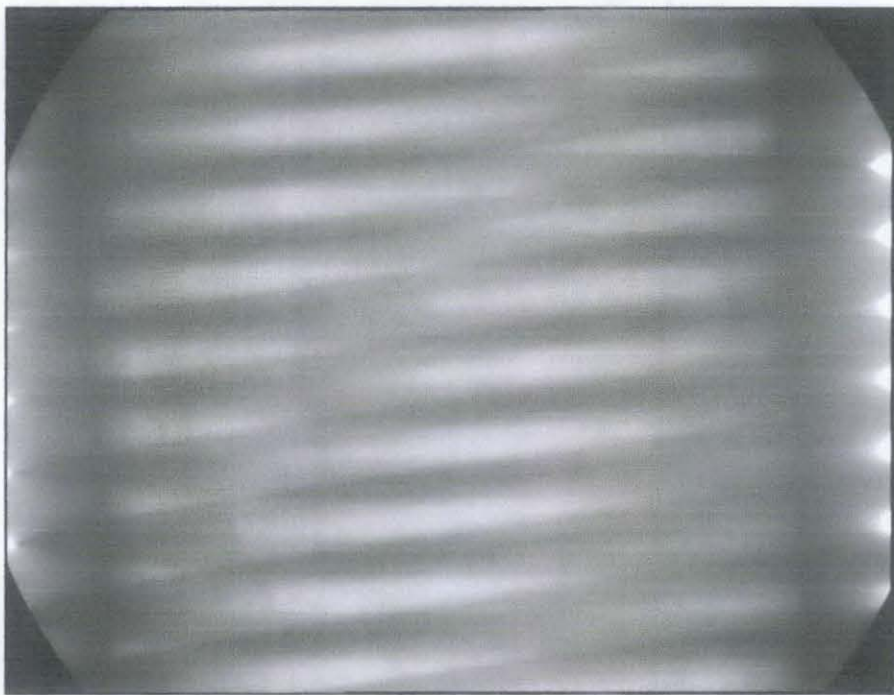
Figure 19 : Part A-4 found having good condition with less wall loss incident.

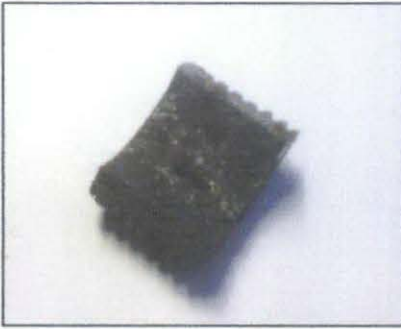
Figure 22 : Sample of failed part

- A corrode section from A-2 part revealed by X-ray testing.
- Coated and tested by EDX and SEM machine.

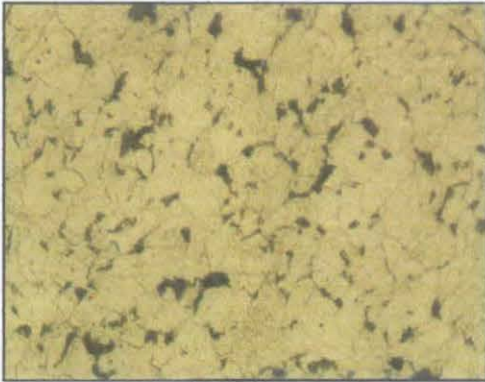
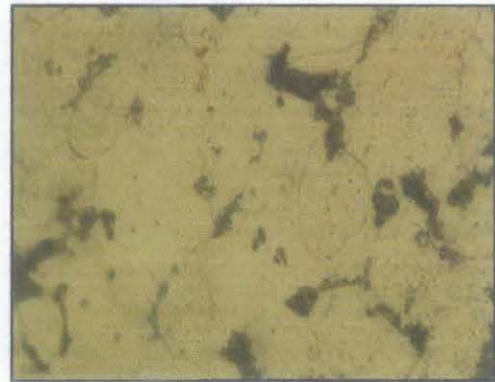
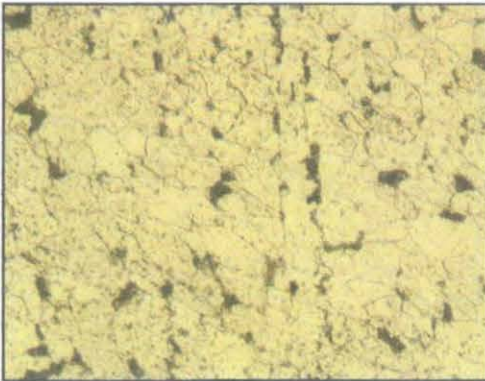
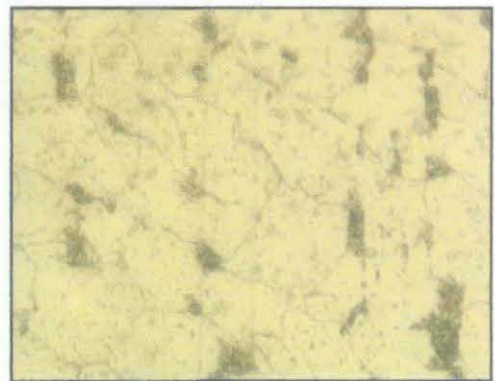
Presences of pearlites (dark region) in the presence of ferrite matrix show that the material is carbon steel-based material. Noted that grain boundary sample A is also look same in size and their arrangement as sample B which shown that heat treatment onto these two specimens are quite similar.

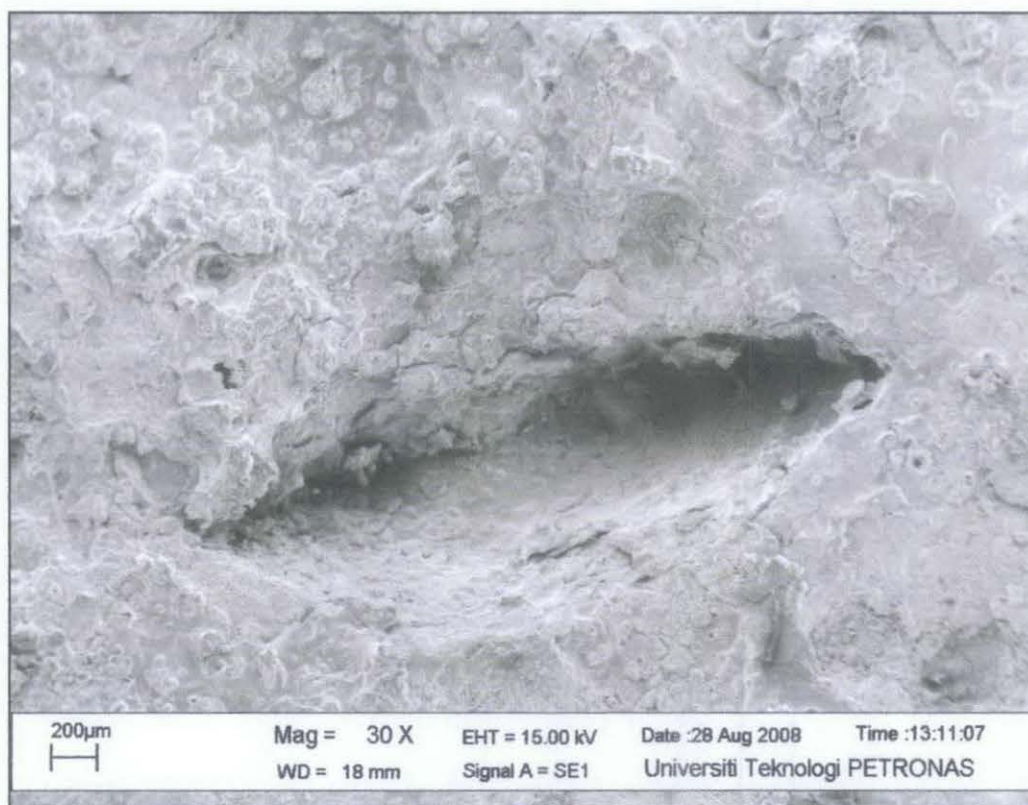
Figure 27 : Corroded part taken from part A-2

Scanning Electron Microscopic examination and Energy Disperse Spectroscopy examination have been done at the same time. The elliptical shape shown previously in the X-ray image in Figure 18 is again examined in the SEM. Figure 27 distinctly shows the elliptical shape almost 2mm in length. This pit is the reason for the tube to be out of specification because the wall thickness did not fulfill requirement.

The ellipsoid shape examined showed that the pit could continue to propagate from the current condition. Darker region inside the ellipse show that these areas are deeper. There is the possibility that these areas will become a through wall rupture if operation of the tube continued.

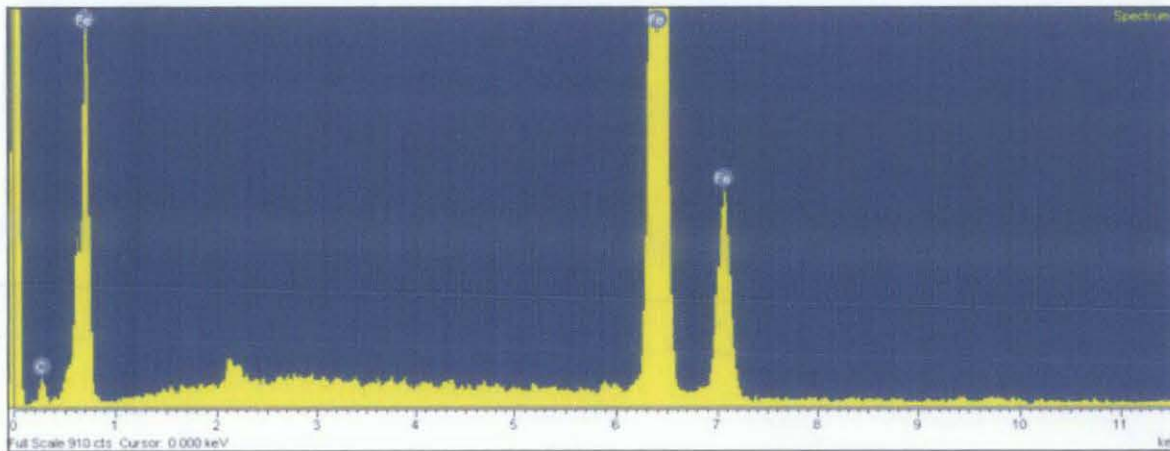
Figure 28 : result of Sample B (approximately same as Sample A)

- Shown that high attendance of Fe element.
- Carbon steel was used as the tubes material

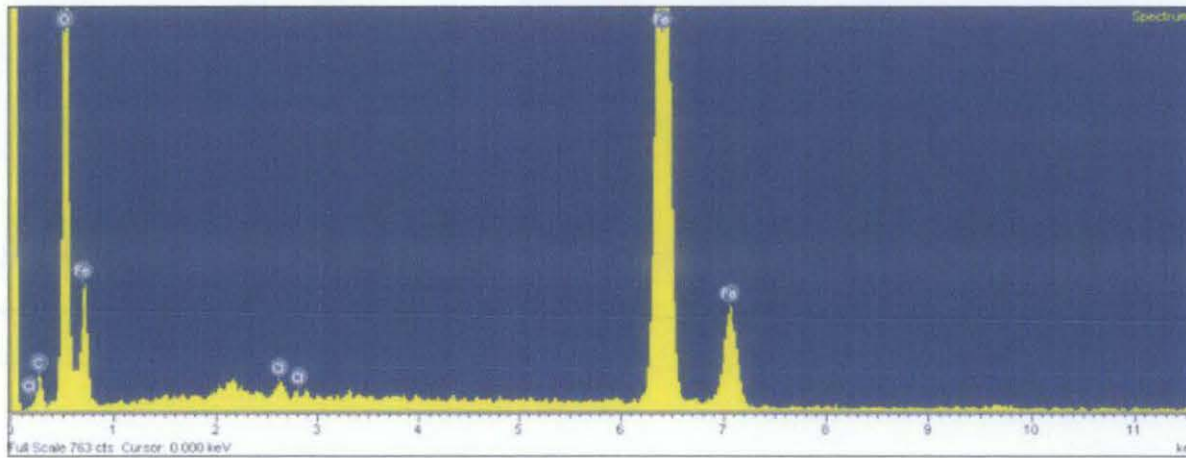
Figure 29 : EDX result of corroded sample

- Attendance of Cl element found on the sample surface
- Assume as one of the cause of corrosion
