# LANDSLIDE ASSESSMENT ON UTP CUT SLOPE

NUR AMIRA BINTI ABDUL RASHID

Bachelor Of Engineering (Hons)

Universiti Teknologi PETRONAS

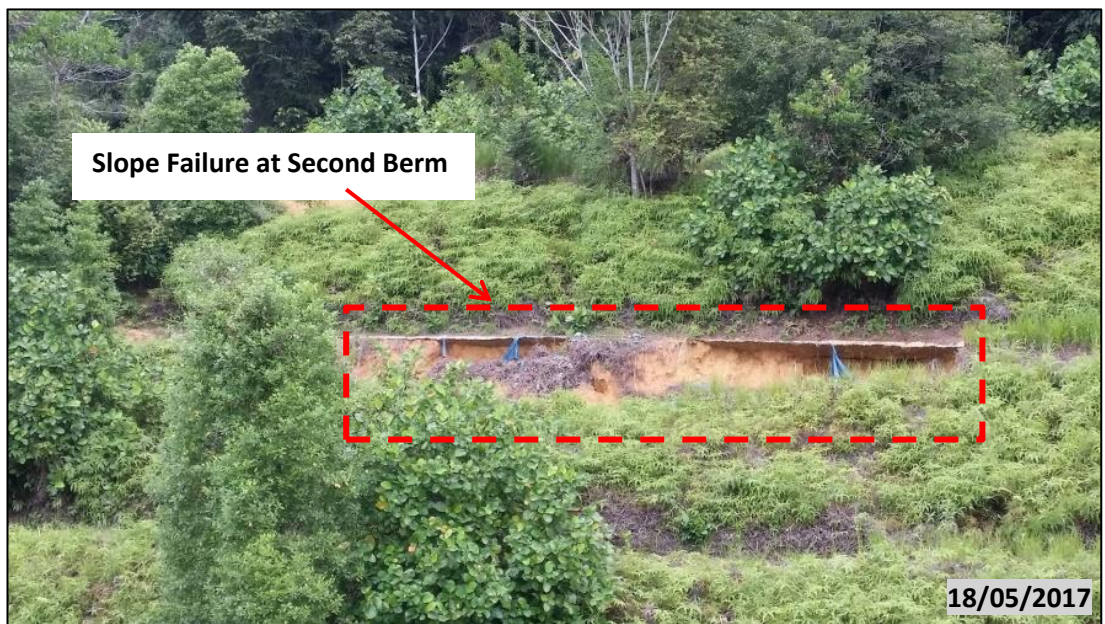
Figure 1-2: Slope Failure View from Block 14 (Source: Author)

Localised slope failure incident at Block 14, UTP was identified at the second berm of the cut slope which consists of three-level berms and it has been happening on February 2017. The soil condition, drainage system, high ground water level and the type of vegetation in the cut slope area might be the causes of the slope failure. Due to that, further investigation on the slope failure is required to do and the next step should be taken in order to ensure the condition of slope failure does not cause destruction to public.

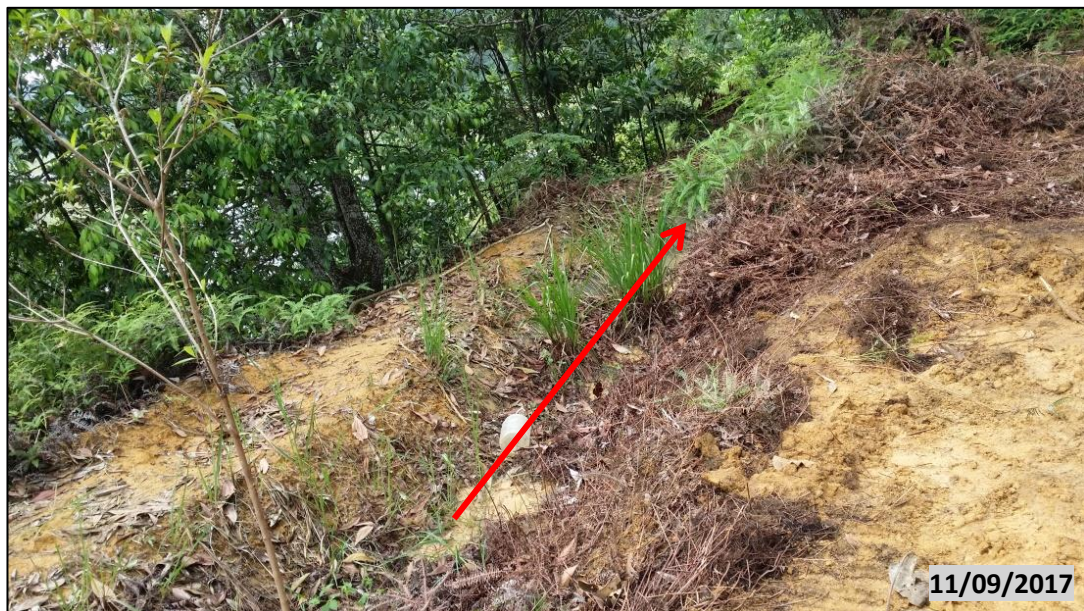
Based on the site survey to the slope failure area, the author found that the drainage system at a certain placement is damaged either not functioning. *Figure 4-1* shows the drainage at the third berm of slope and the red line shows the drain that has been covered by soil and dried leaves. This problem has caused the drain clogged and water does not have a correct flow line. Besides, the clogged drains also cause stagnant water as in *Figure 4-2* and indirectly become mosquito breeding place.

Figure 4-1: Clogged Drain (*Source: Author*)

As a conclusion, poor maintenance at the drainage channels of the cut slope has caused the slope failed. It is because water does not have proper line flow to discharge thus, it makes the soil have high water content. The amount of high water content in soil has resulted damaging of the drain. The groundwater level not a caused of the slope failure as the level is in the range of 4 to 5m from the ground surface.

For the future work, the slope maintenance needs to be performed frequently to prevent any blockage in the drainage channels. If it is not made, the slope failure will occur again and might be harmed to the environment and surrounding

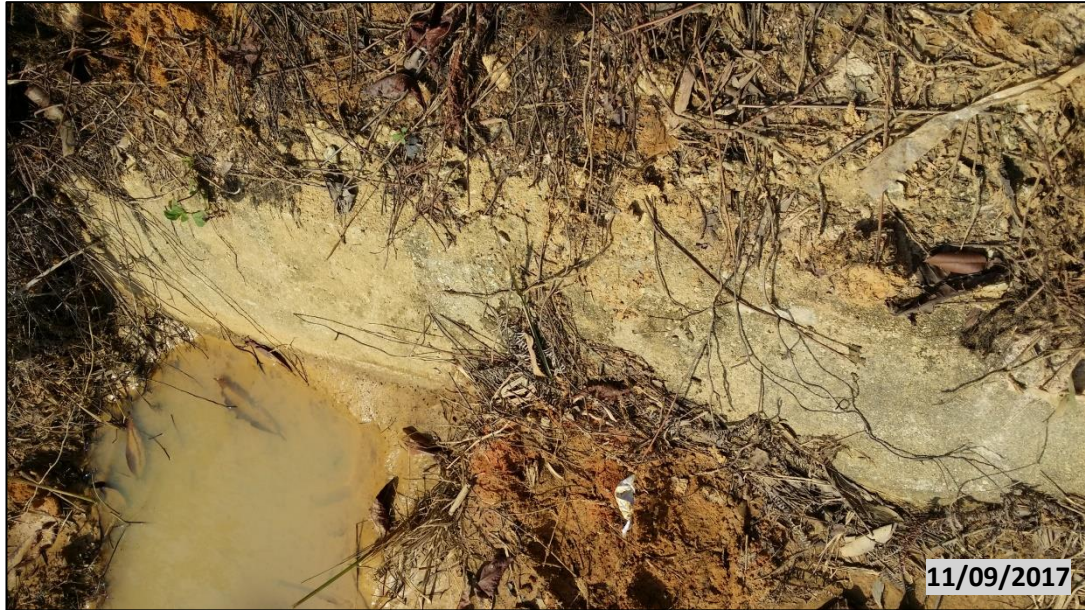
**Figure 4-2: Stagnant Water in the Drain (Source: Author)**

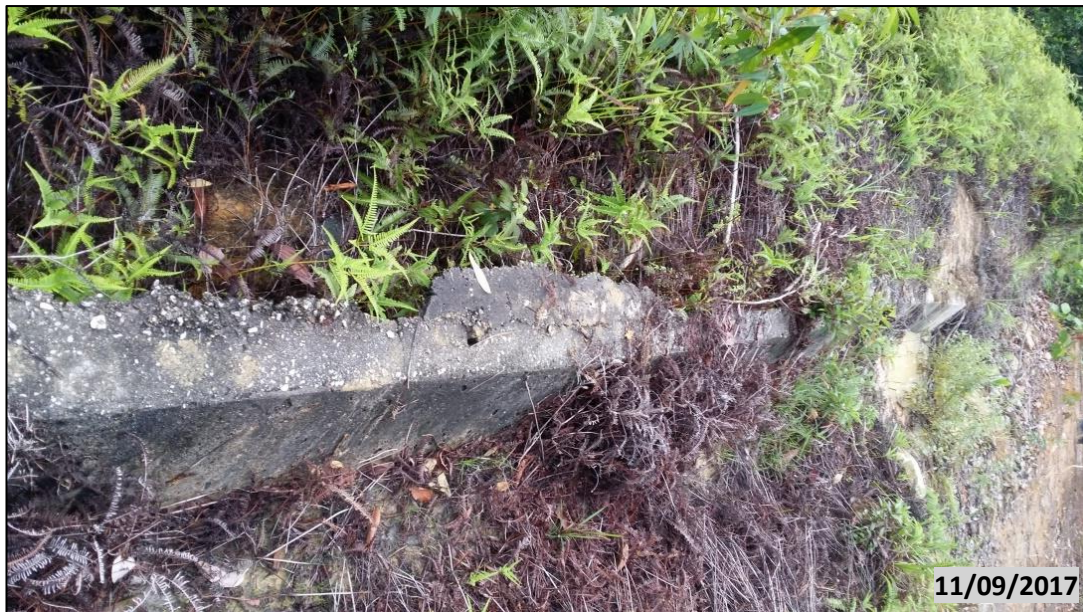
*Figure 4-3* shows the drain's position has moved from the original position. The movement of the drain might be caused by the movement of the soil towards water flow. Sew, G.S. and Yun, W.S. (2010) mentioned that infiltration and erosion that causes by heavy rain can be reduced by maintaining the quality of the drainage system. High infiltration from heavy rain and catchment areas has also caused the slope failed. The soil strength reduced because having high water content and *Figure 4-4* shows the cracked drain due to the damaged discharge line.

**Figure 4-3: Misaligned Drainage (Source: Author)**

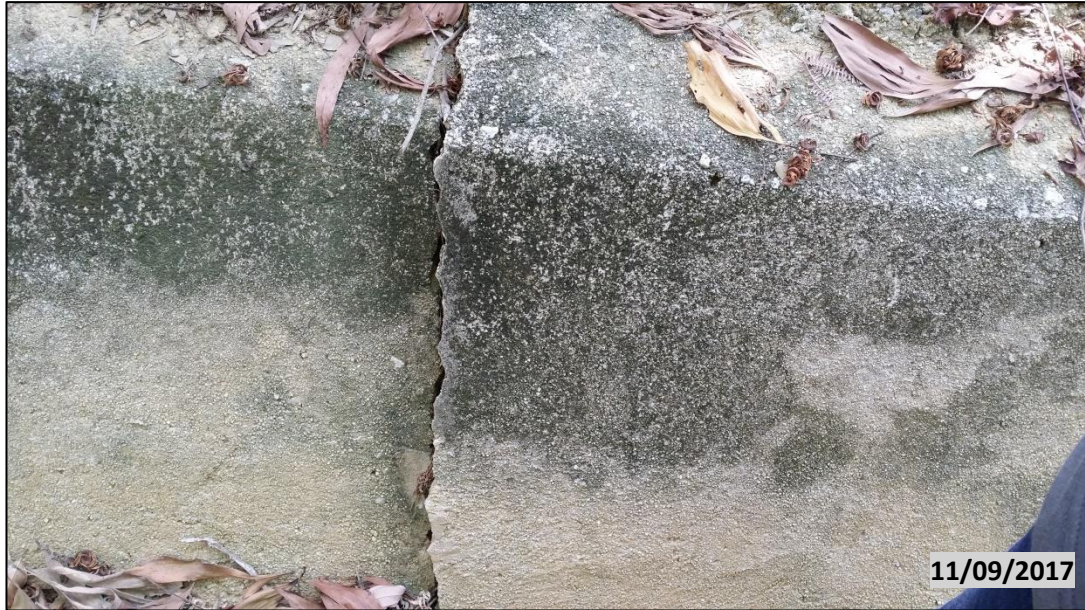
**Figure 4-4: Cracked Drain** (*Source: Author*)

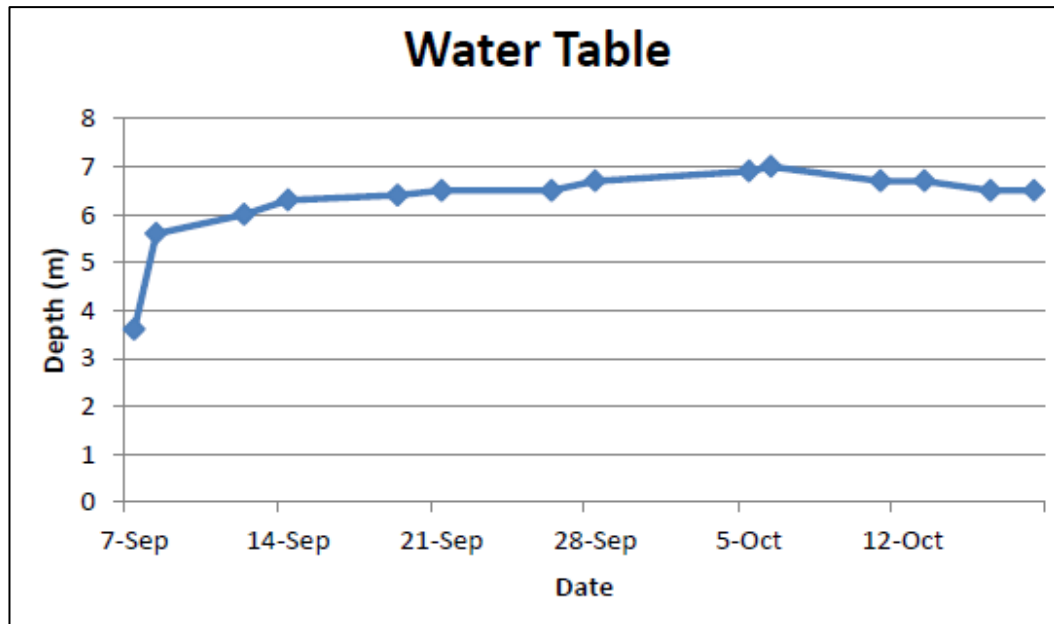
The measurement of the water table in the water standpipe was executed using measuring tape. The recordings were taken at the end depth of borehole and repeated twice a week. The casing top was capped overnight to prevent entry of rainwater. The groundwater table was detected at depth of 3.6 m below surface level during the soil exploring. After that, the monitoring work proceeded twice a week and Figure 4-9 shows the result of groundwater table. From the result, the depth of water table increase to 4 m from the ground surface level. The range of the result is from 5.9 to 6.5 m and it can be said that the ground water table is not the cause of the slope failure.

Figure 4-9: Graph of Water Table against Date

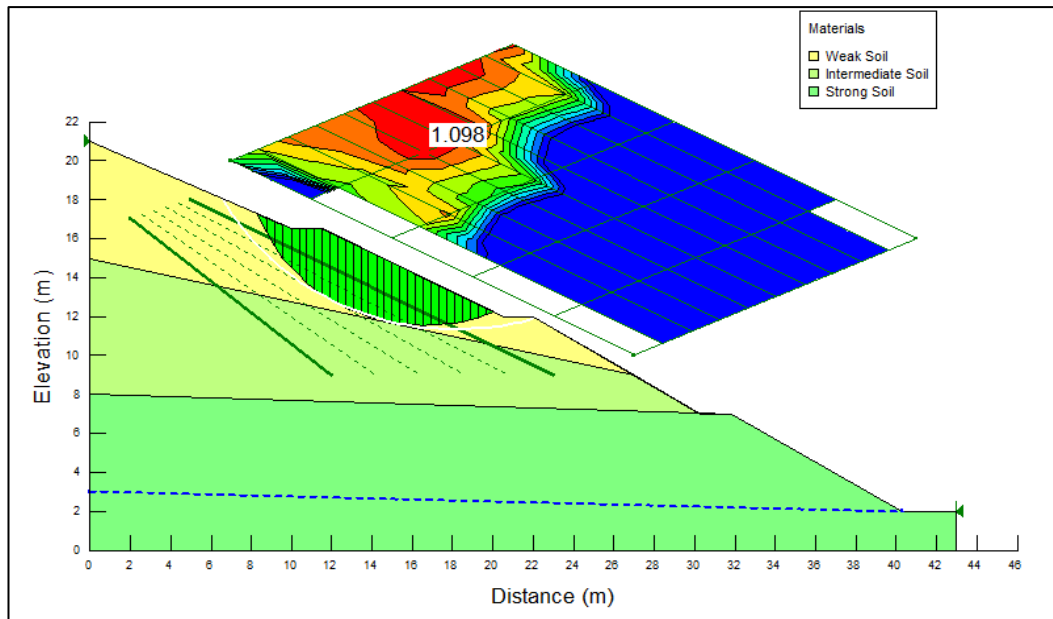
Based on *Figure 4-17*, the FOS value using Morgenstern analysed method is 1.098 which is low value of FOS and its means the slope condition is already failed as in reality. The calculated lowest FOS from the other two methods of Limit Equilibrium is as below;

By using the soil parameter in *Table 4-9*, the FOS values of the three methods show the low result of FOS which means the second level berm of the cut slope

is already failed. The value of soil parameter is using residual soil which at the critical point 24% of axial strain. According to Chin, T.Y. and Sew, G.S. (2001), they mentioned the critical state of the residual soil is in the range of 10% to 30% of axial strain as the shearing state continues at constant volume and constant effective stress.

**Figure 4-17: FOS of the Existing Cut Slope in Failure Mode which in Morgenstern Analyse Method**

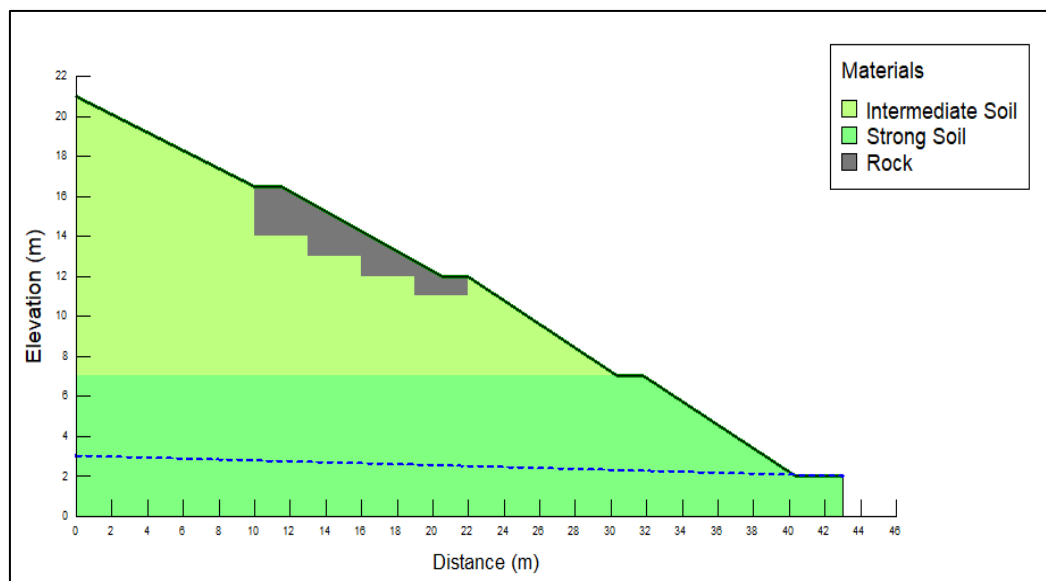
**Figure 4-18: Slope Modelling with Rock Filling**

In order to recover the cut slope failure at the second level berm, new modified design of cut slope has been done by filling the rock at the failure area. Rock filling or gabion is used in designing the modified cut slope because it has good interlocking between rock and its flexible as it able accommodate significant differential settlement. It also cost effective because it only require minimal labour during the installation work. Other than that, it has low maintenance which the structure of gabion itself is strong.

*Figure 4-18* shows the new modified cut slope design at the second level of berm. The grey colour is representing rock which act as a gabion to re-stabilize the slope. It consists of benching which it can increase the strength of the slope. The volume of each gabion is 1 m<sup>3</sup>.

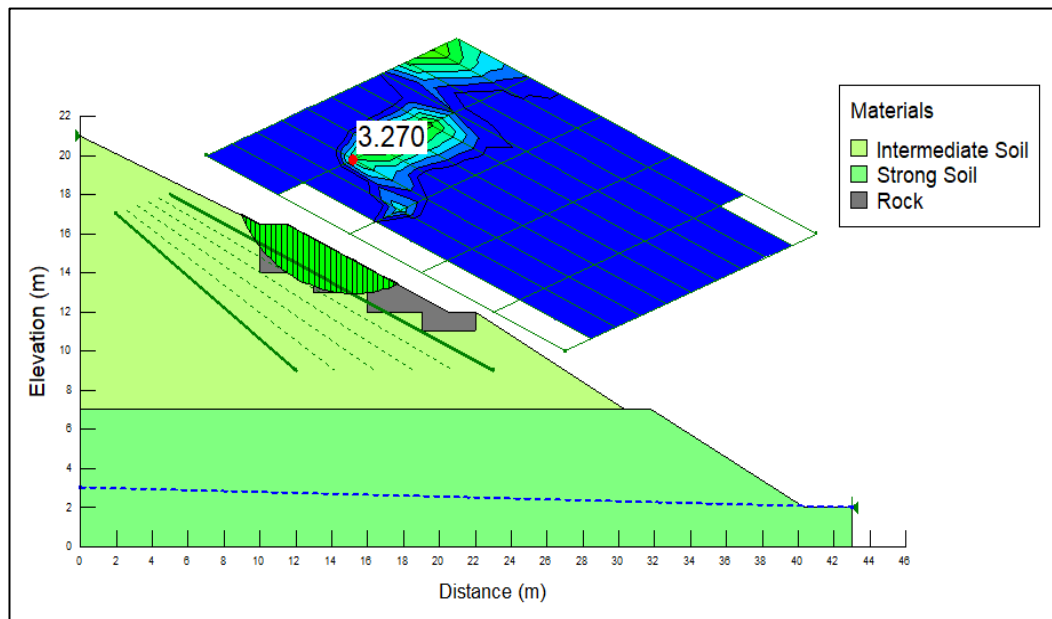
Based on *Figure 4-19*, the value of FOS shows is 3.270 which greater than 1 after the failure area is covered with gabion and using soil parameter in *Table 4-10*. It can be said that the usage of gabion in remedial works is very useful which it can be stabilized the cut slope. The following are the FOS value of the other two methods;

**Figure 4-19: FOS of the Modified Cut Slope in Failure Mode which in Morgenstern Analyze Method**
