Using Spatial Images to Detect Changes in Shorelines

Progress Report submitted in partial fulfilment of

(Civil Engineering)

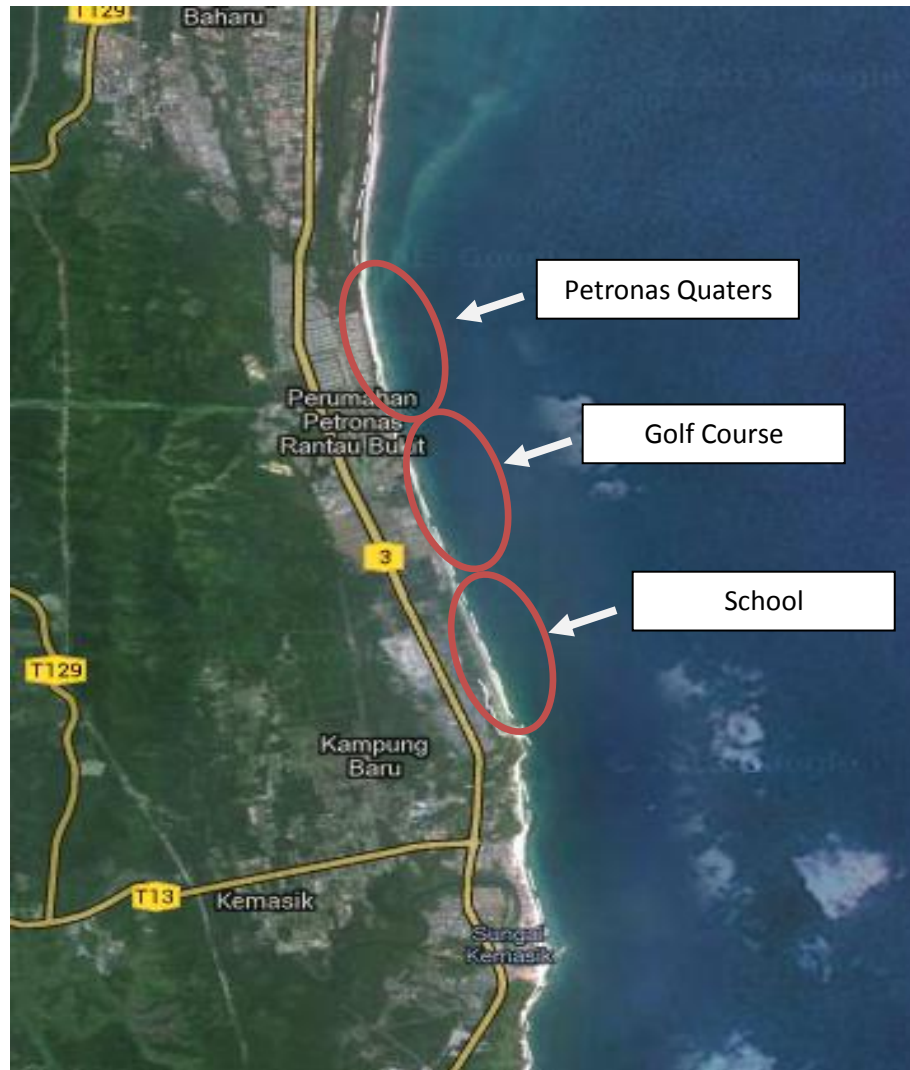
Figure 8: Divided Area for Data Analysis (Kerteh)

Based on the result, at this point of time the movement of the shoreline shows different pattern of movement at the three part of the area. As for PETRONAS Quarters, the shoreline indicate of erosion from 1995 – 2000, then starting from years

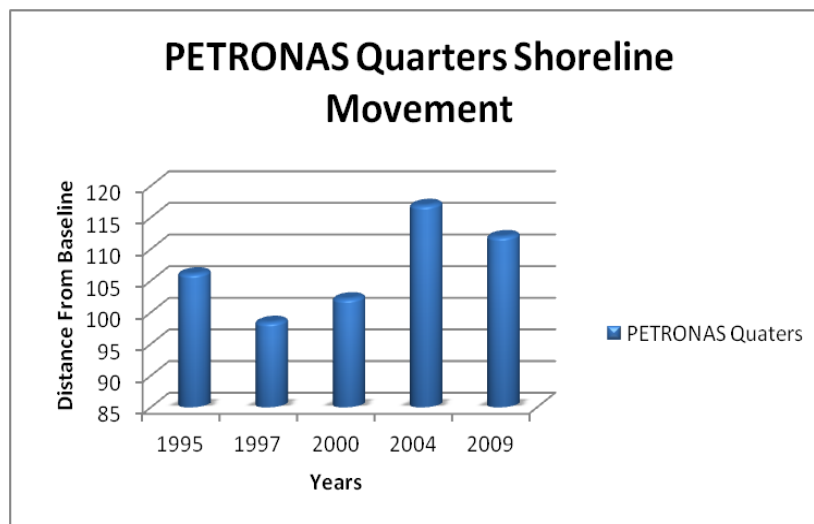
Figure 9: PETRONAS Quarters Distance from Baseline

of 2000, the result show a huge amount of accretion process at the site with the movement about 6.5 meter per year from year of 2000. The Golf course part also shows the same pattern of accretion and erosion from year 1995. While, profile that show the positive result is at the school where the pattern of accretion occur starts from year of 2000 until 2009 which show signs of sediment accretion. At this point of time however, it is impossible to conclude if beach slope continues to change for the upcoming years. For more clear view, the movement of the shoreline vs distance from baseline is presented in the Figure 8, 9, and 10 below.

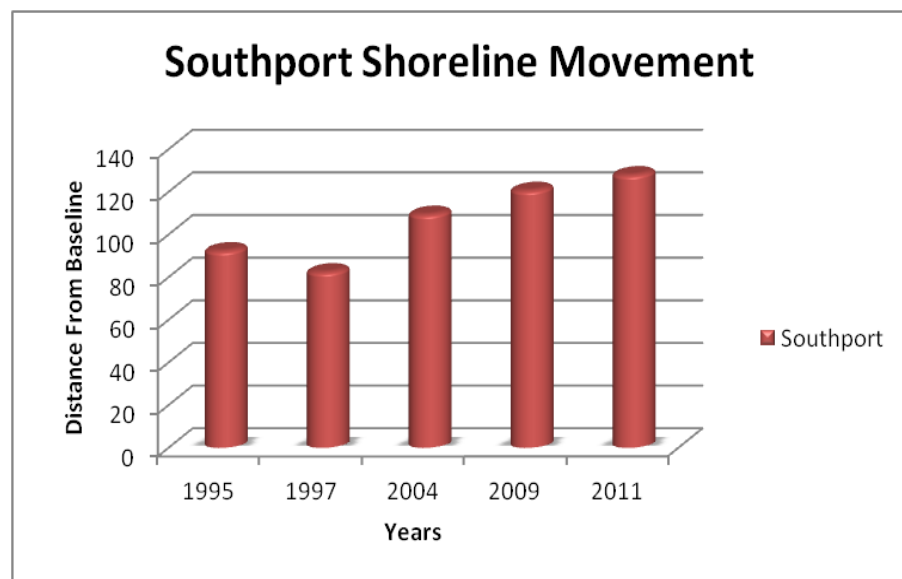
Figure 15: Southport Distance from Baseline

By refer to the result, the movement of shoreline for are showing the positive result after the installation of the submerged breakwater. At first, the Gold Coast facing the serious erosion problem where according to past researcher, the Gold Coast almost lost its coast due to the erosion. During the 1995-1997, the erosion still occurred at all part of the beach. The eroded rate per year is almost 5 meter at the Southport, about 10 meters at Broadbeach, and 13 meter at the National Park. The most accretion recorded by using Arc GIS software is during year of 1997-2004. All part of the coast stretch. Below 15, 16, and 17 below is the figure of the distance from the baseline with the movement of the coastline.

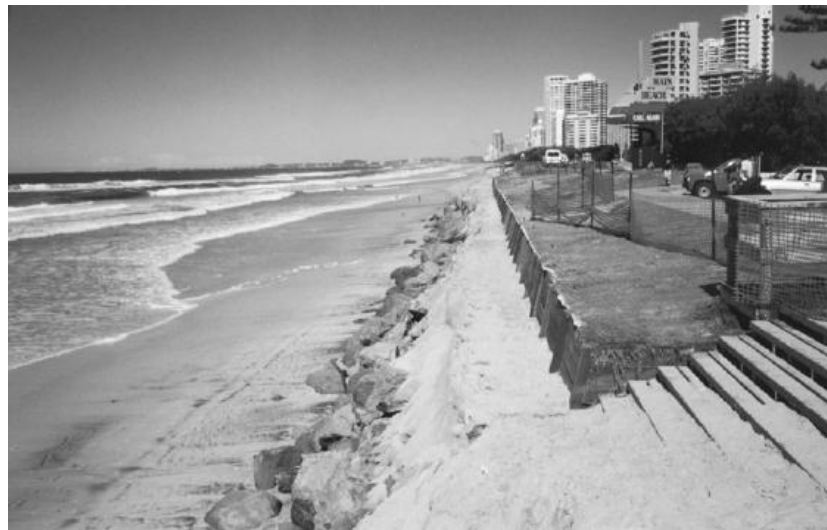
Figure 19: Gold Coast Beach Condition on 1995

By refer to the result, the accretion trend still increasing but much slower that the earlier of the installation of the breakwater. The most effective part of the submerged breakwater is at the Southport area. This indicates that by using the variable parameter, the submerged breakwater purpose of design can be achieve to the fullest to manage the erosion problem. However, the continuous visit and reading must be observed to understand more of the pattern coast changes with the parameters used. Figure 19 and 20 below is the actual site images taken before and after the installation of breakwater.
