WATER LEAKAGE IN UNIVERSITI TEKNOLOGI PETRONAS (UTP) FROM TAPS TO CARBON DIOXIDE (CO₂) EMISSION

Water Leakage In Universiti Teknologi PETRONAS From Taps To Carbon Dioxide (CO₂) Emission.

Dissertation submitted in partial fulfilment of

Bachelor of Engineering (Hons)

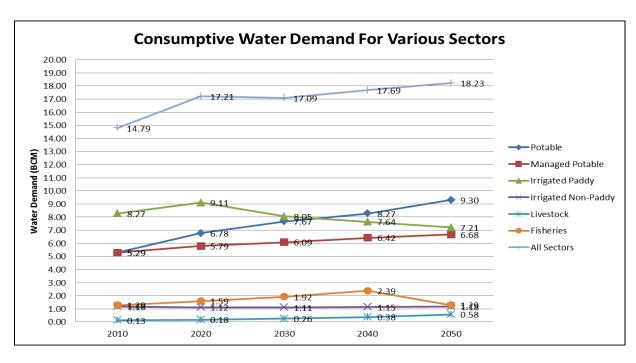
Figure 1: Projection of Water Demand Trend of Various Sectors in Malaysia

Graph shows the projection of Water Demand Trend of Various Sector in Malaysia

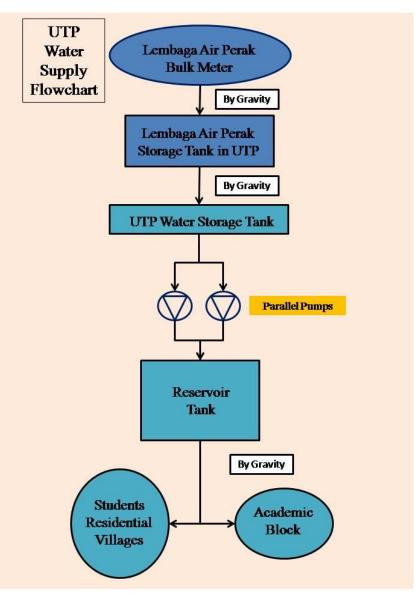
Figure 5: UTP Water Supply Flowchart

UTP water Supply flowchart

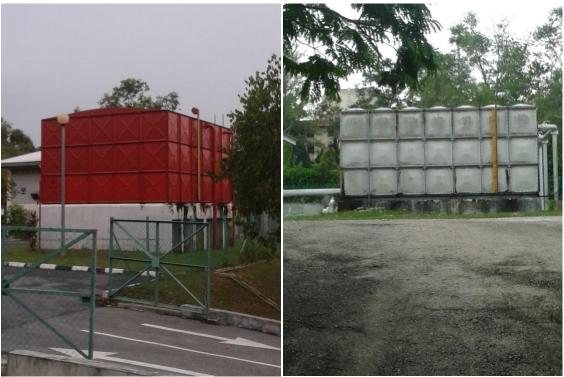
Figure 8: Block O Water Storage Facility

Figure shows the water storage facility which is located near Block O of

Old campus block

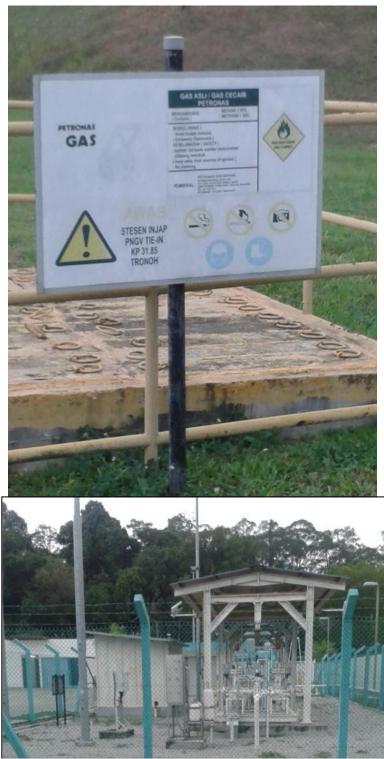
Figure 10: GDC Gas Supply

Figure shows the Natural Gas supply method to the GDC plant in UTP which includes a receiving station, valve station, and intake manifold from Gas Malaysia distribution.

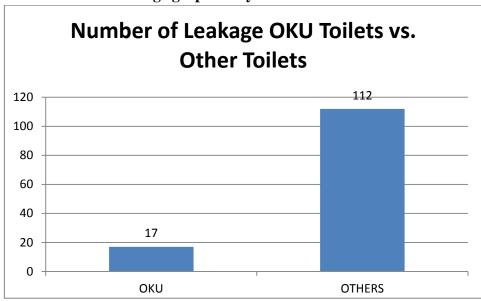
Figure 11: Number of Leakage OKU Toilets vs. Other Toilets

Graph above shows the number of OKU toilets and other toilets in UTP that experience water leakage. This graph clearly indicates that the number of other toilets that has leakage is higher compared to OKU toilets where OKU toilets are only 17 whereas other toilets are 112. This trend is probably due to the general number of OKU toilets is practically less than other toilets.

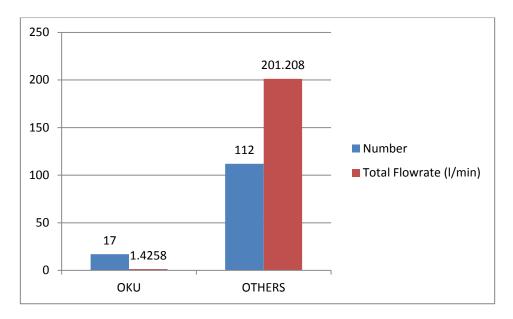
Figure 12: Number of Leakage Toilets with Flow Rate

On the other hand, graph above shows the refined number of OKU toilets and other toilets in UTP that experience water leakage together with the total flow rate of these toilets. From the graph, the total flow rate for OKU is 1.428 l/min while other toilet is 201.208 l/min.

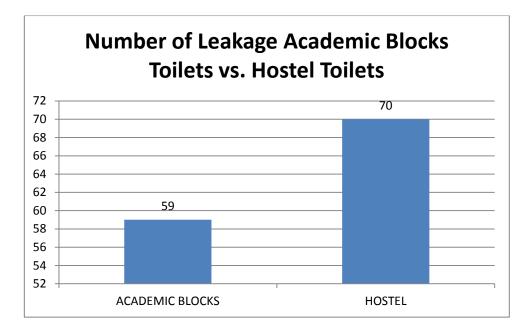
Figure 13: Number of Leakage Academic Block Toilets vs. Hostel Toilets

Graph above shows the number of toilets in academic blocks and hostel that has water leakage. This graph depicts that the number of hostel toilets that has leakage is higher compared to the number toilets in academic blocks with 70 and 59 respectively.

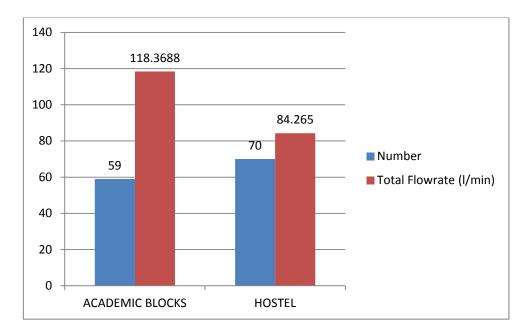
Figure 14: Number of Leakage Toilets with Flow Rate

On the other hand, graph above shows the number of academic toilets and hostel toilets in UTP that experience water leakage together with the total flow rate from these toilets. From the graph, the total flow rate for toilets in academic blocks is 118.3688 l/min while other toilets in hostel are 84.265 l/min. Despite the fact that the number hostel toilets is more by 11 compared to number of toilets in academic blocks, the flow rate of water wastage in hostel toilets is relatively lower than that of academic blocks. This might be contributed to the frequency and awareness of people using the toilet where the hostels toilets are much more visited by people thus, the leakage of any taps will be reported and will be fixed accordingly. The other factors that play a part in giving this particular trend is some of the toilets in hostel are newly renovated like the toilets in Village 1 and Village 2.
