# CHAPTER 1

## INTRODUCTION

### 1.1 Background of Study

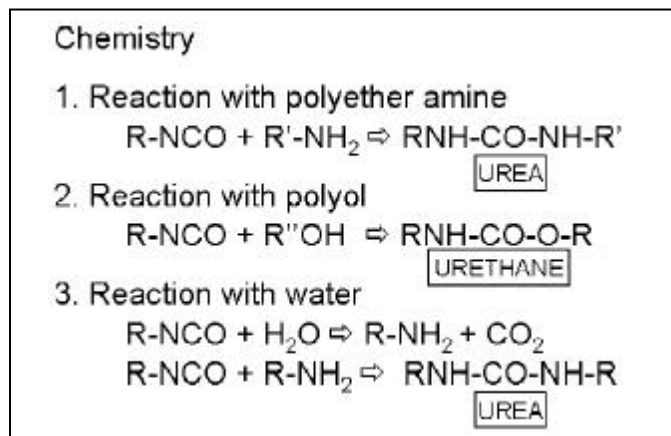
Figure 1: Isocyanate reactions [6]

- c) Hybrid polyurethane/polyurea coatings, all linked to different isocyanate reactions (refer Figure 1).

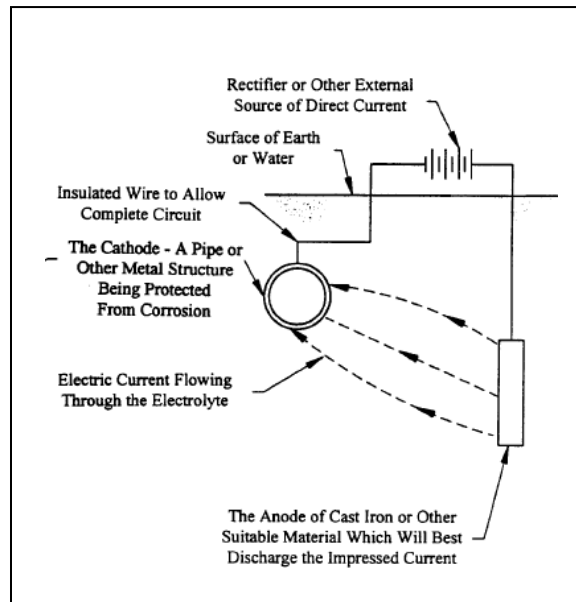
Figure 2: Impressed Current System [7]

There are two main types of CP systems which are sacrificial anodes and impressed current. Impressed-current CP systems represent the vast majority of CP systems for transmission pipelines. Impressed-current systems (Figure 1) can be readily adjusted to compensate for changes in the amount of current required to adequately protect the structure; however, they may also contribute to the interference of other structures in the vicinity. Depending upon soil, pipe coating properties, and pipe size, impressed-current CP systems can be used to protect long lengths of pipe. However, impressed-current CP systems require more expensive installation and equipment, increased monthly monitoring, and greater power consumption charges than that of sacrificial anode systems [7].

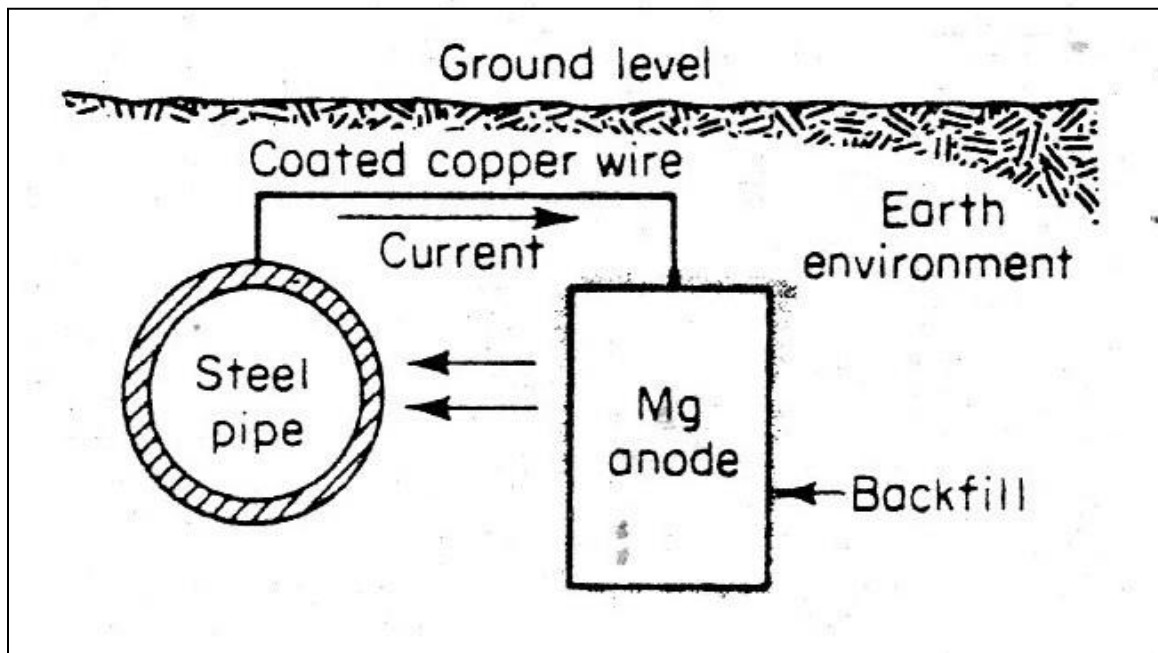
Figure 3: Underground protection of magnesium sacrificial anode, (Fontana, 1986) [7]

Sacrificial anode CP systems are used extensively to protect gas distribution pipelines, but are applied more as a remedial measure for problem areas on transmission pipelines. Sacrificial anodes (Figure 2) are relatively inexpensive, do not require an external power supply, and require no regular monitoring of the anode (rectifiers for impressed-current systems require bimonthly monitoring to ensure proper operation). Due to their low driving voltages, however, sacrificial anodes are not applicable in all environments and do not have the power to protect long lengths of pipeline [7].

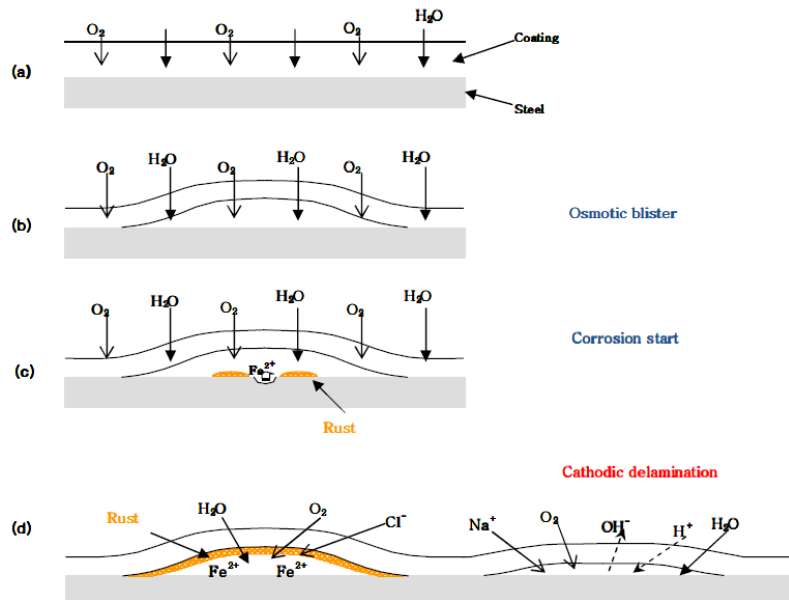
Figure 4: Mechanism of Blistering and Delamination [15]

Cathodic blistering is caused by this electrochemical reduction of oxygen beneath intact and sometimes defective coatings [15]. Water, oxygen, and alkali metal cations (e.g., sodium cations) diffuse through the coating to cathodic sites to produce strongly alkaline solutions. Anodic sites may be located at nearby corroding sites as shown in figure 4. As the reaction is localized beneath the coating film, the hydroxyl ions are trapped by the semi-permeable film at the site of adhesion loss (the incipient blister). There, ionic accumulation equates with increasing pH. The mechanism of cathodic blistering and delamination is presented in Figure 4. Figure 5 and 6 show images of blister defect seen under SEM.

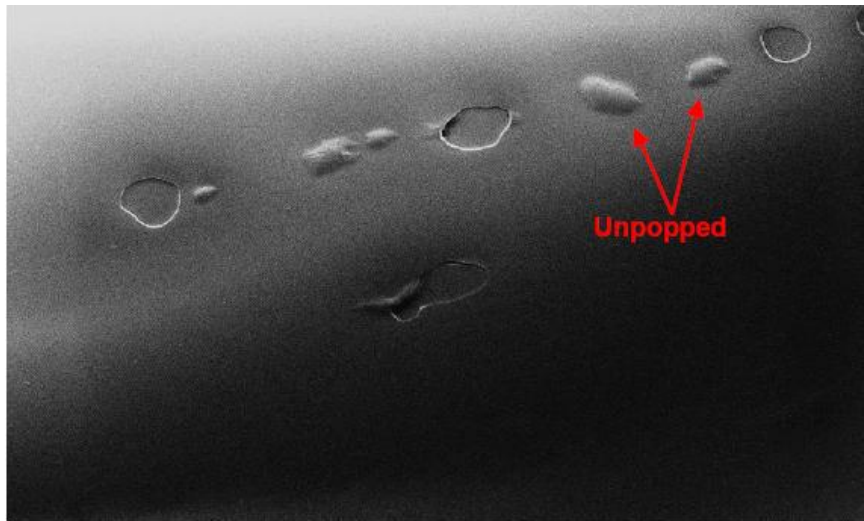
Figure 5: Blisters Defect Captured by SEM at 30X Magnification [16]

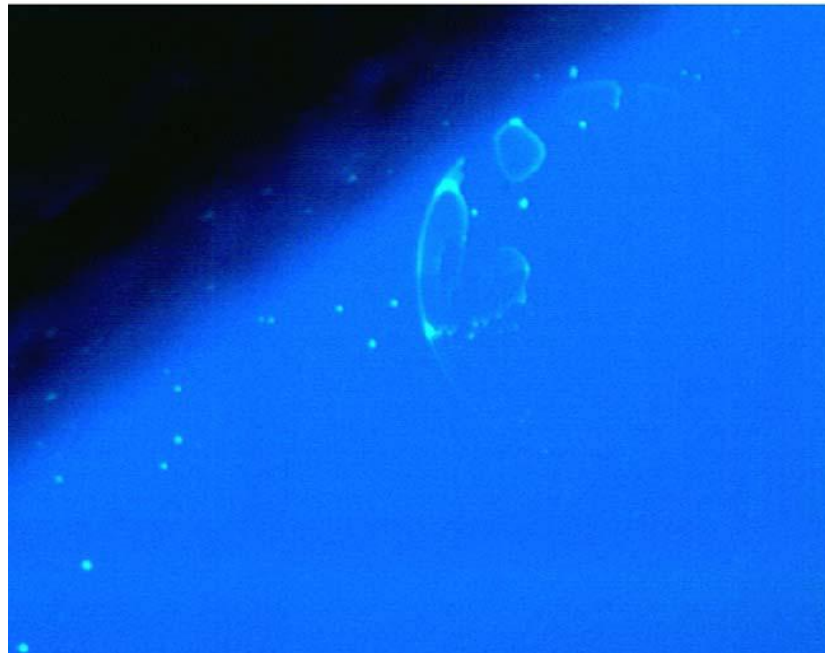
Figure 6: Blister Defect at 20X Magnification [16]

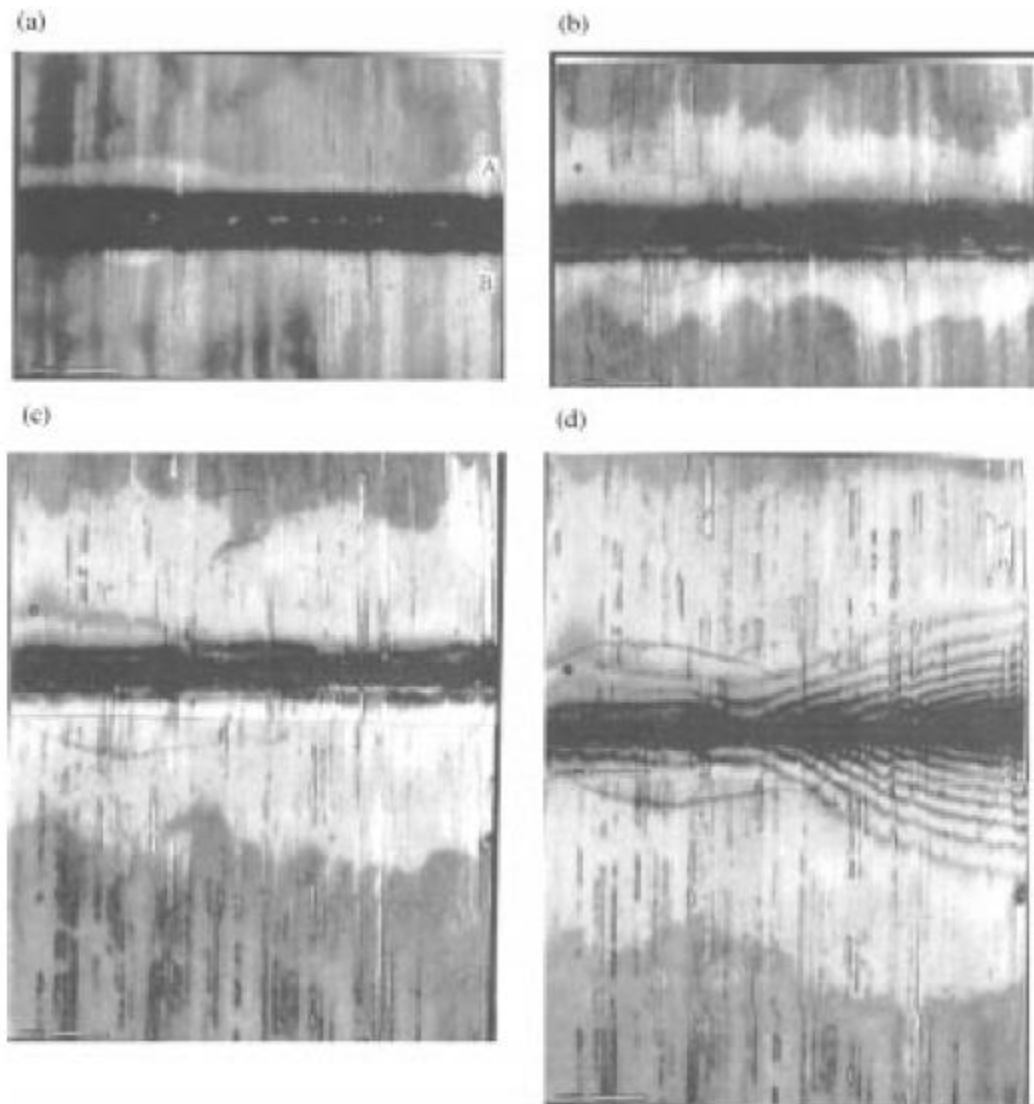
Figure 7: SAM images showing early disbondment of an epoxy-polyamide coating from mild steel at a scribed defect after (a) 10, (b) 32, (c) 42, (d) 54 min of immersion in 0.05 M NaCl solution. Scale bars are 100  $\mu\text{m}$ . [14]

In an experiment conducted by J.D. Crossen, he used Epoxy-polyamide as the coating to observe cathodic disbonding effect [14]. Figure 7 below shown result of his experiment. In the pictures, we can see how disbondment spreads away from the defect.

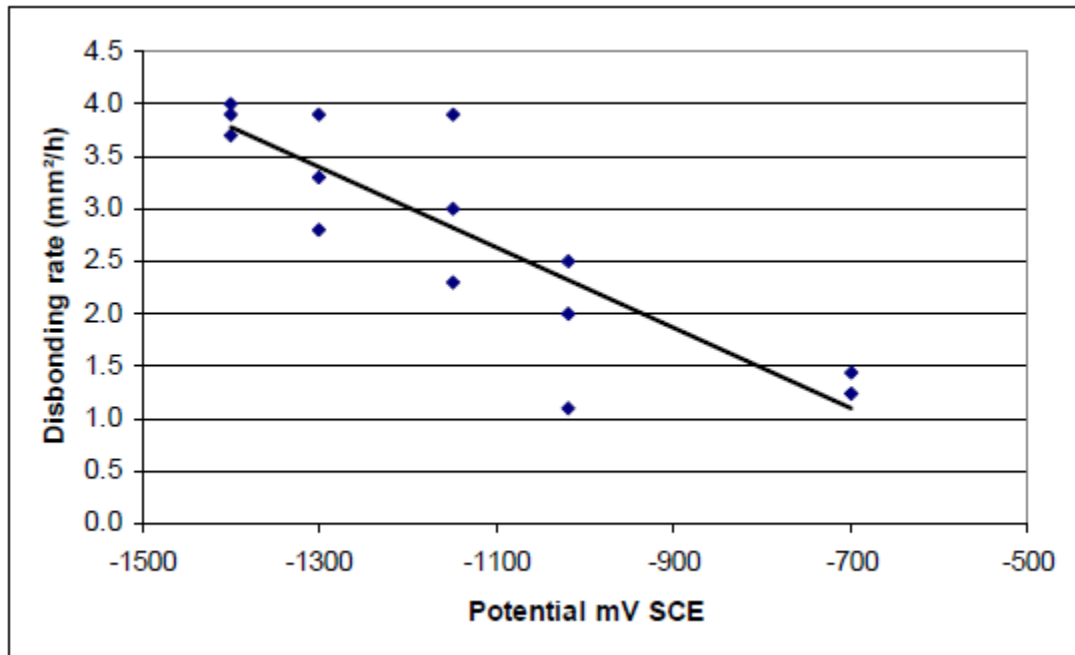
Figure 8: Disbonding rate for Epoxy 0 as function of applied potential. Test conditions: 0.5%. [2]

Using Epoxy 0 in his experiment, he found out a linear relationship between applied potential and disbonding rate. As we can see in figure 8, decreasing in potential will cause decreasing in disbonding rate. However, another relationship cannot be ruled out, since the variation between parallels was rather high [2]. The correlation coefficient for the straight line is 0.72. A linear relationship between applied potential and disbonding rate indicates that the process is controlled by an Ohmic resistance.

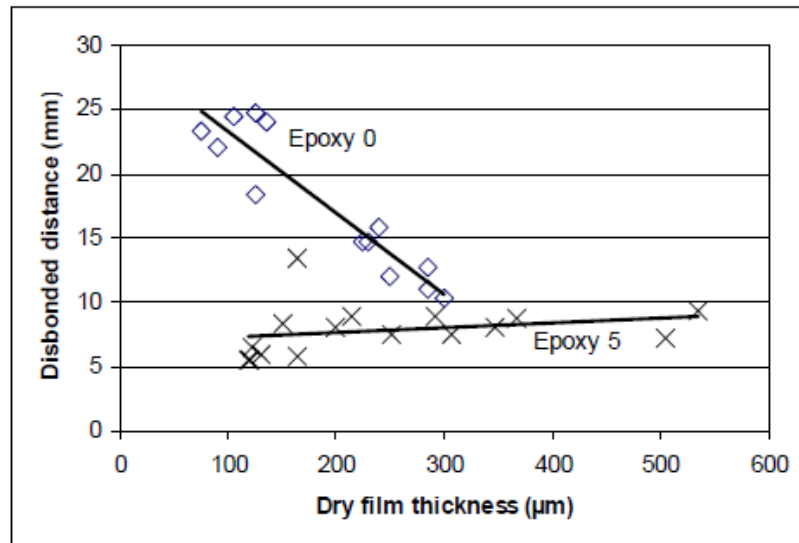
Figure 9: Effect of dry film thickness on cathodic disbonding. Experimental conditions for Epoxy 5: substitute seawater, 25°C, -1050 mV SCE, blast cleaned steel substrate. Experimental conditions for Epoxy 0: 1.5% NaCl, 20°C, -700 mV SCE, blast cleaned steel substrate.

As we can see in Figure 9, Epoxy 0 showed a linear decrease in cathodic disbonding with increasing film thickness. Increasing the film thickness usually improves the barrier properties of the film, which may explain the effect. The film thickness did not seem to have any effect on the disbonding rate for Epoxy 5. Epoxy 5 was pigmented with aluminum flakes, which has been shown to have a significant effect on cathodic disbonding. The ruling factor is probably a reaction of aluminum with hydroxyl ions [2]. Hence, the effect of film thickness on disbonding rate will vary between coating products.

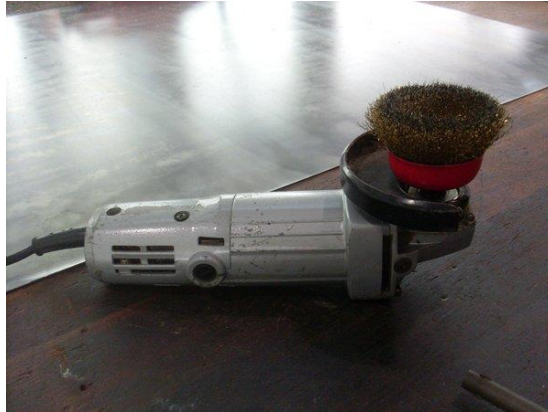
Figure 11: Wire brush machine

- a) **Scraping & Wire brushing (Figure 11 and 12):** loose rust, mill scale & old paint can be removed by hand or power tools such as power wire brush

& grinders are more effective than hand tools. It can give surface preparation up to St 3 which is equivalent to Sa 2.5. This method was used during first trial of sample preparation.

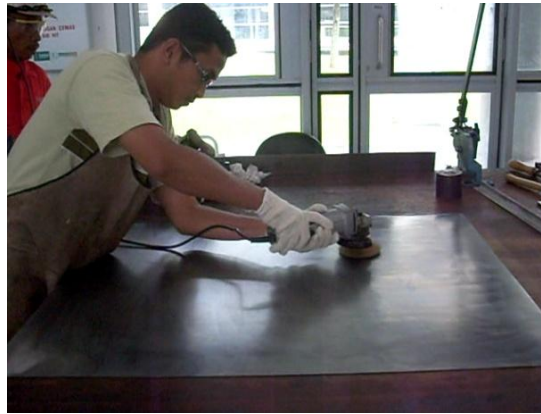
Figure 12: During wire brush process

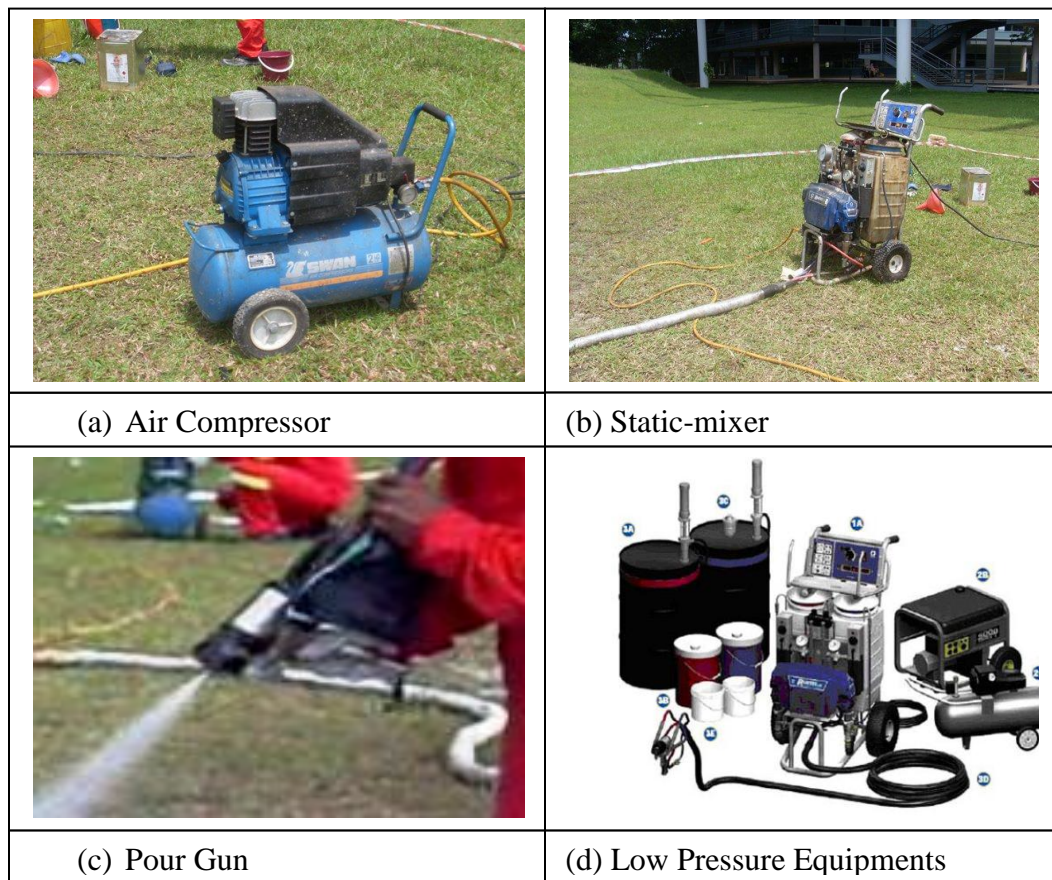
Figure 13: Low Pressure Equipments to Coat Polyurea

Polyurea coating was sprayed on the samples using low pressure equipments. It requires minimal application pressure and do not require added heat which allow for the use of less complex and less expensive equipment. A few equipments are shown in Figure 13.

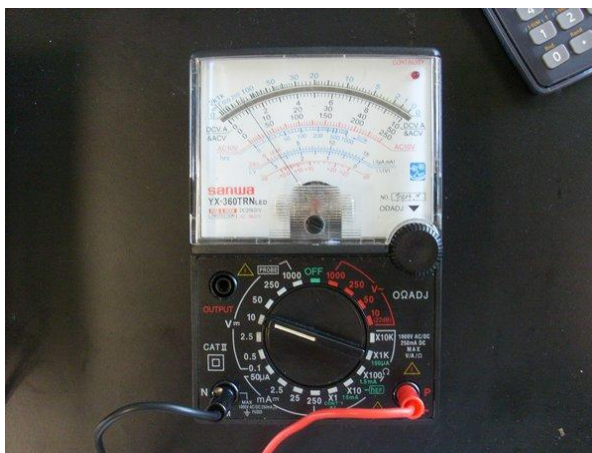
Figure 14: Power supply

- f) *Power Supply, DC Converter* – act as rectifier (Figure 15).
- g) *Electrolyte*- consist of potable tap water with the addition of 1 mass % of sodium chloride. Freshly prepared solution was used for each test.

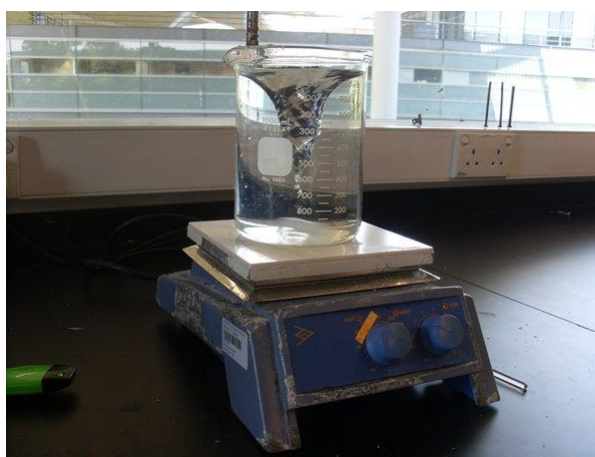
Figure 16: Stirrer

- h) *Stirrer* – used to stir solution of electrolyte (Figure 16).
- i) *Mounting Board* introduced through holes in the top ends of test specimens have been found suitable for suspending test specimens from the vessel cover.

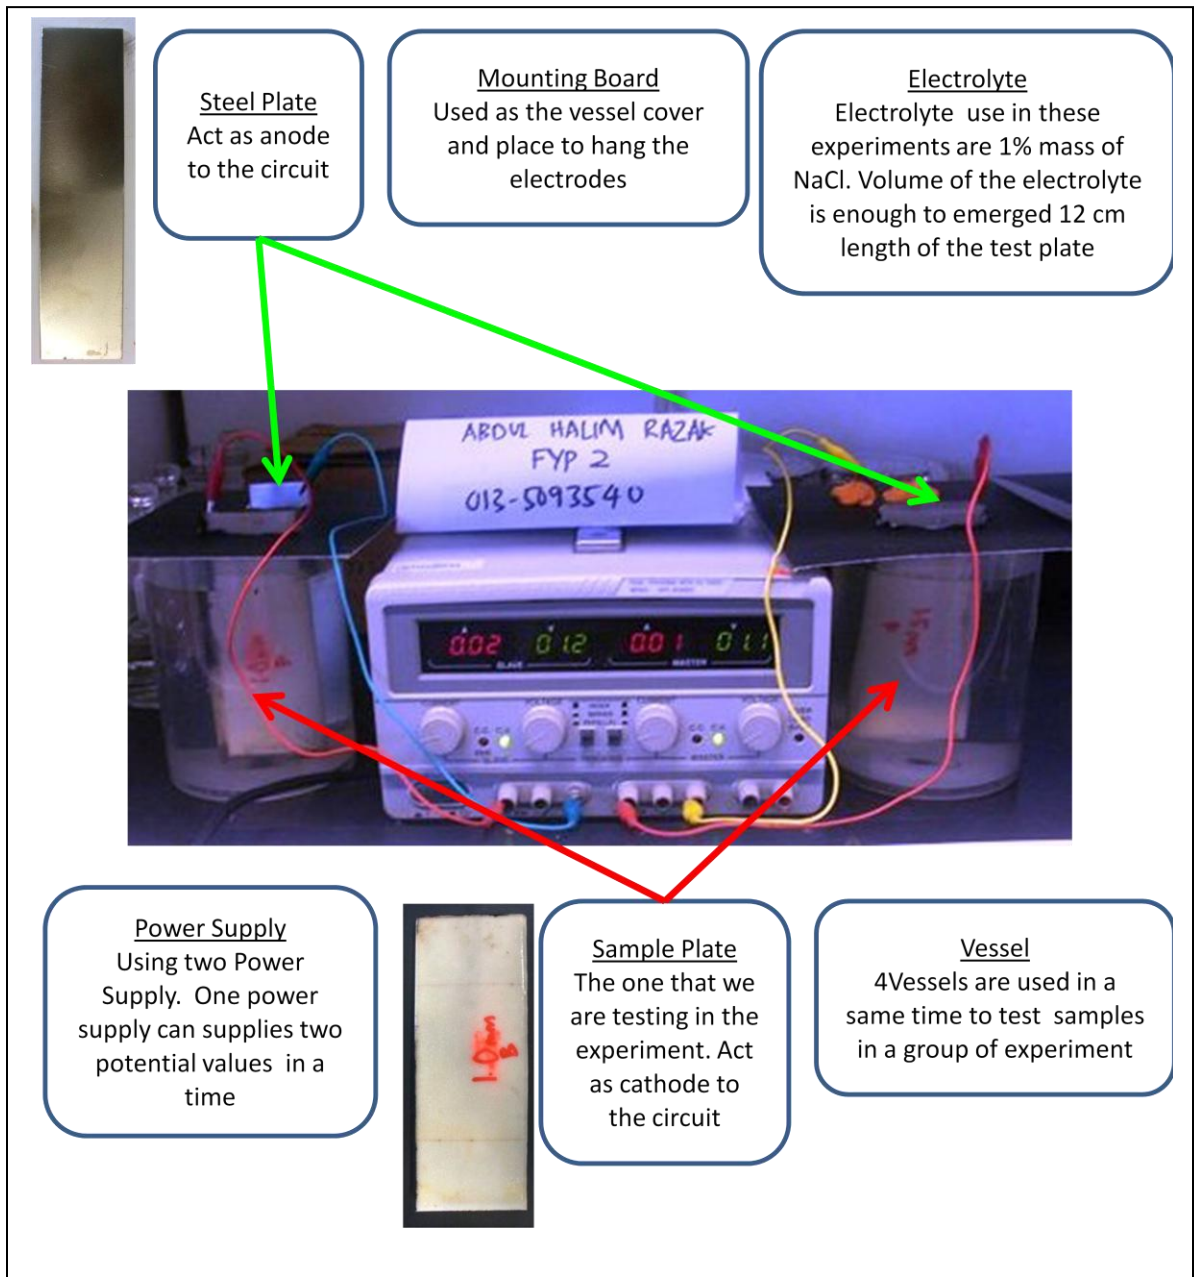
Figure 18: Experimental Test Setup

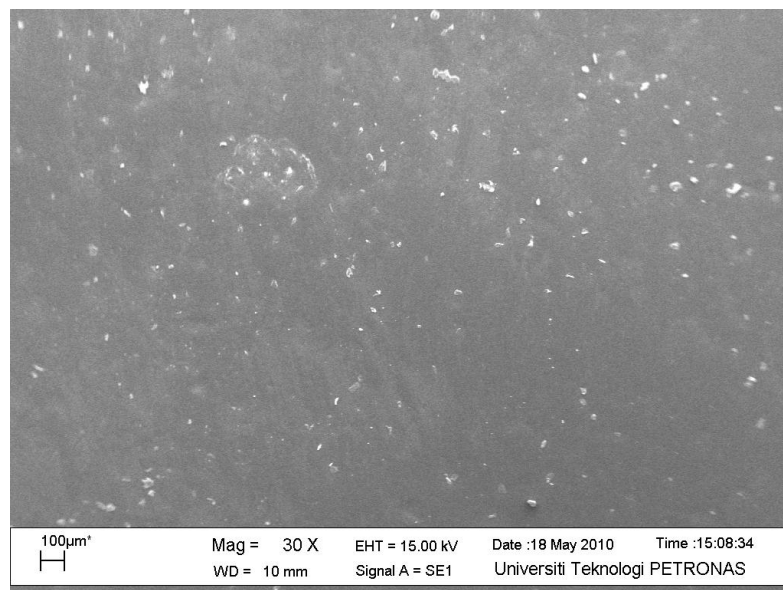
Figure 19: Coating Surface for -600 mV potential Applied (Mag = 30X)

Figure 19 shows SEM image of samples exposed to -600 mV. The surface of the samples is still smooth and there are no signs of blistering. This shows that lower potentials which are -600 mV and -850 mV are able to reduce the effect of CD. Figure 20 shows the same surface but with bigger magnification to verify the conditions of the coating surface.

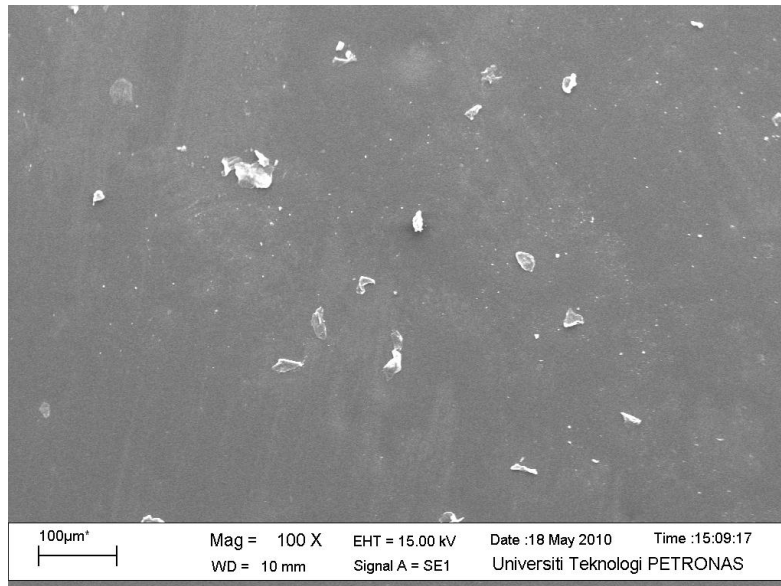
Figure 20: Coating Surface of -600 mV potential testing (Mag = 100 X)

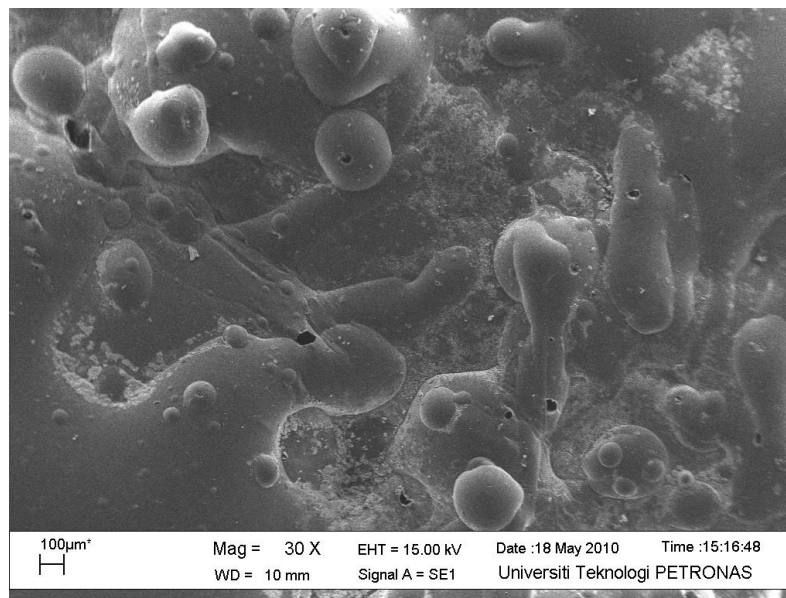
Figure 21: Coating Surface for -1500 mV potential testing (Mag = 30X)

Figure 21 shows SEM image of samples exposed to -1500 mV. The image shows that blistering has occurred rapidly when exposed to the potential. The blistering has grown big and even holes are already developed at this stage. This image shows that blistering and dissolution of coating will start occurred at potential lower than -1500 mV. Figure 22 shows the same surface but with bigger magnification.

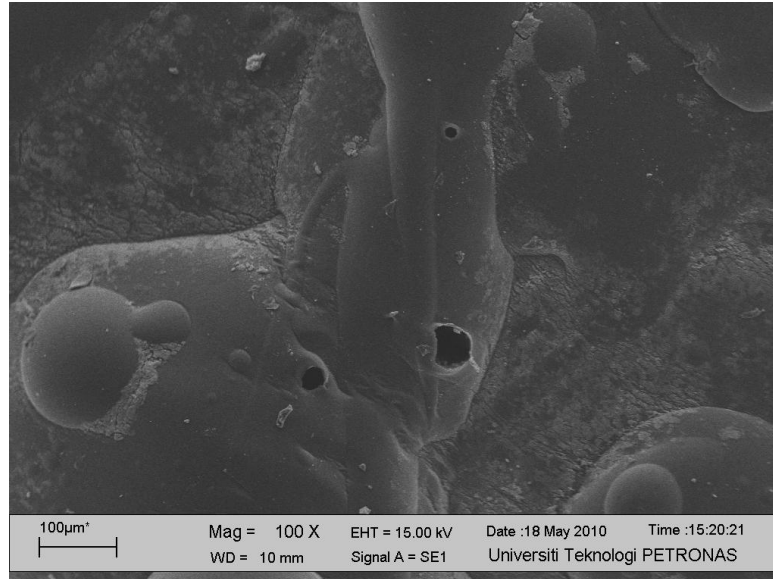
Figure 22: Coating Surface for -1500 mV potential testing (Mag = 100X)

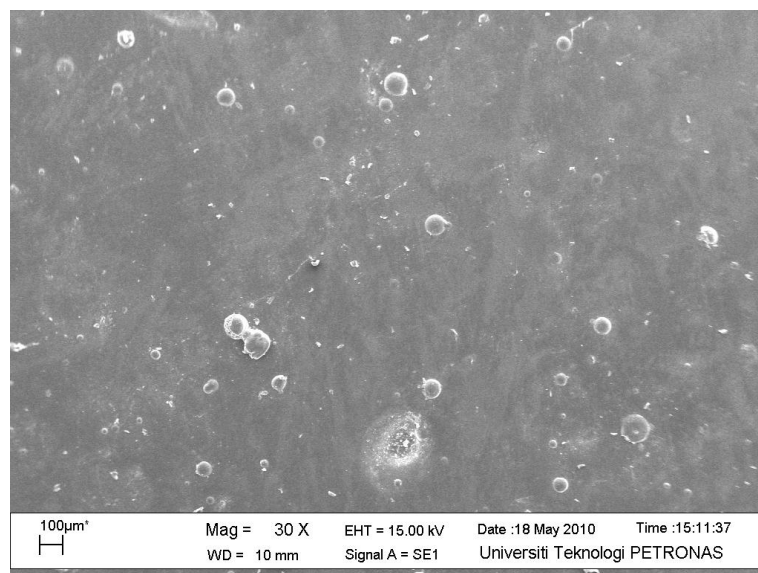
Figure 23: Coating Surface for 1.5 mm coating thickness testing (Mag = 30X)

From Figure 23, it could be seen that a few image of blistering start to appeared on coating surface of 1.5 mm thickness. The blisters are still small and not concentrated on close area. Only one or two of the blister are already popped. In Figure 24, it shows the same image of blister but in a bigger magnification.

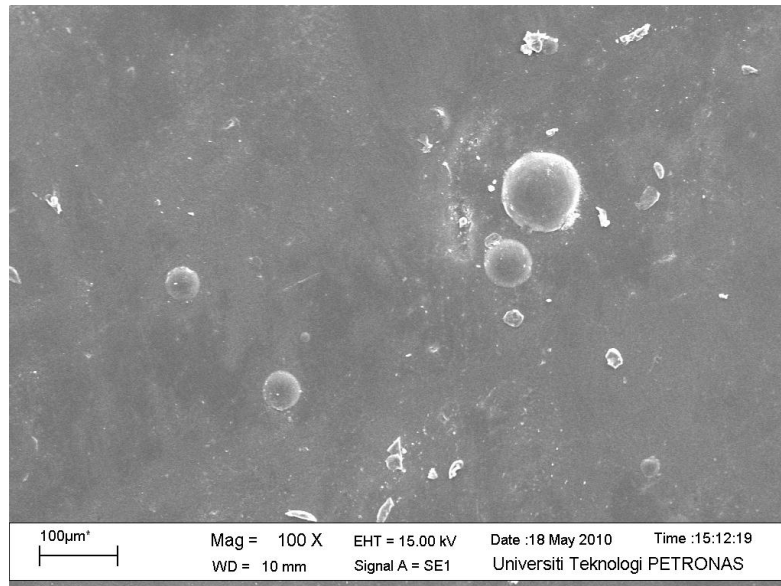
Figure 24: Coating Surface for 1.5 mm coating thickness testing (Mag = 100X)

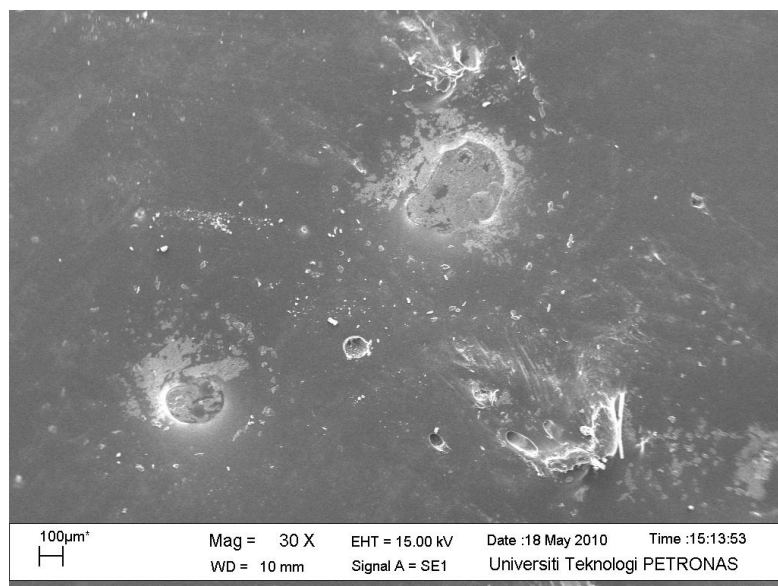
Figure 25: Coating Surface of 2.5 mm coating thickness testing (Mag = 30X)

From Figure 25, it could be seen that blisters on coating surface of 1.5 mm thickness have grown bigger. The blisters are located close to each other which mean blistering are occurring rapidly on this coating compare to 1.5 mm coating thickness. They are also already popped blisters. In Figure 26, it shows the same coating surface image but in a bigger magnification.

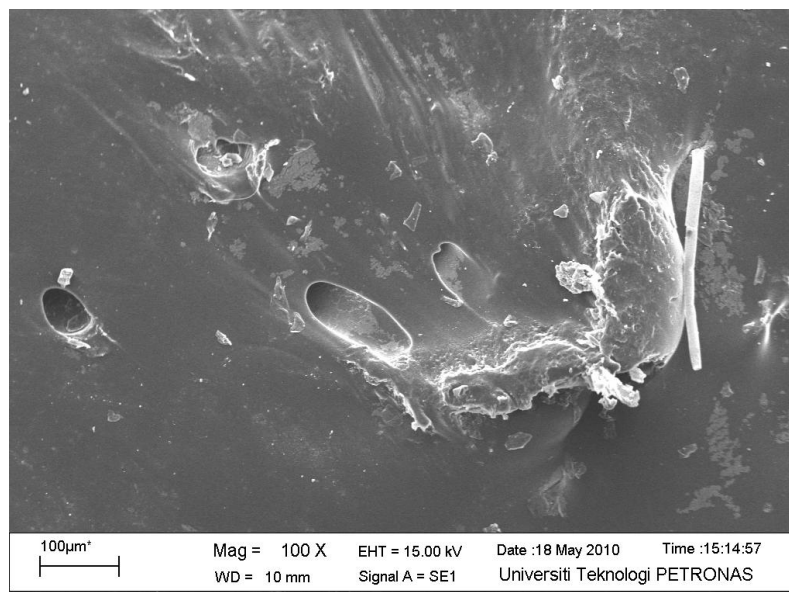
Figure 26: Coating Surface for 2.5 mm coating thickness testing (Mag = 100X)

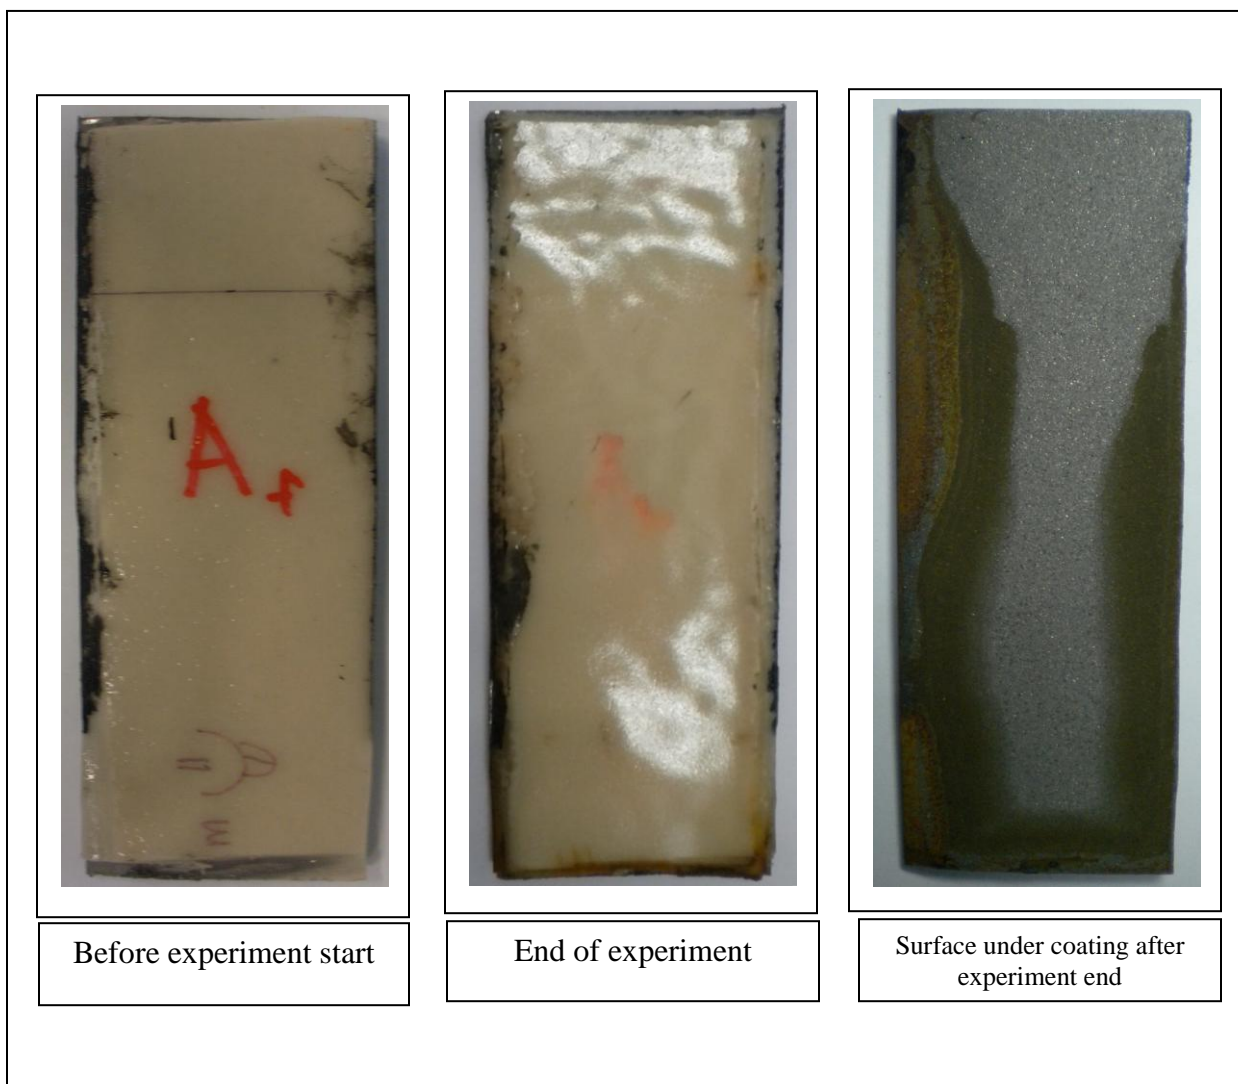
**APPENDIX 1(a):** APPEARANCE OF THE SAMPLES FOR APPLIED POTENTIAL TESTING DURING INITIAL OF EXPERIMENT, END OF EXPERIMENT WITH COATING AND END OF EXPERIMENT WITHOUT COATING - Samples for Applied Potential Testing – 600 mV

However, observation of surface under coating showed that water was coming under the coating from the defected area (edge of sample). It happened on every sample. However, water cannot penetrate directly to the surface through the coating. Even though, polyurea coating are absorbing electrolyte, the electrolyte were still contain inside the polymer and did not reach until steel surface. Appendix 1 shows pictures of the samples at the initial of the experiment, after experiment and pictures of samples without coating.

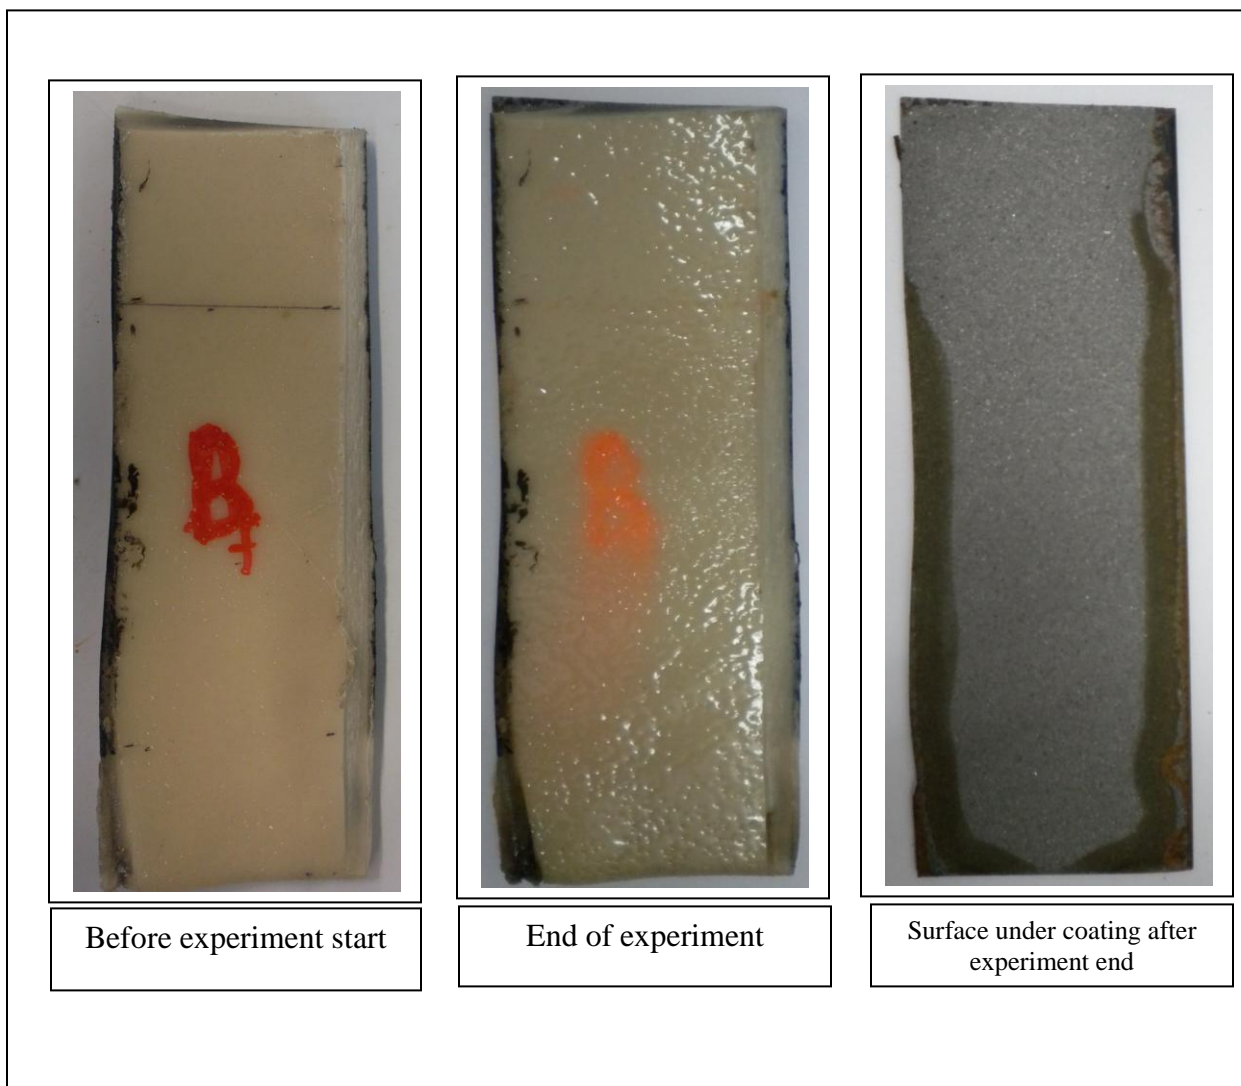
**APPENDIX 1(b):** APPEARANCE OF THE SAMPLES FOR APPLIED POTENTIAL TESTING DURING INITIAL OF EXPERIMENT, END OF EXPERIMENT WITH COATING AND END OF EXPERIMENT WITHOUT COATING - Samples for Applied Potential Testing – 850 mV

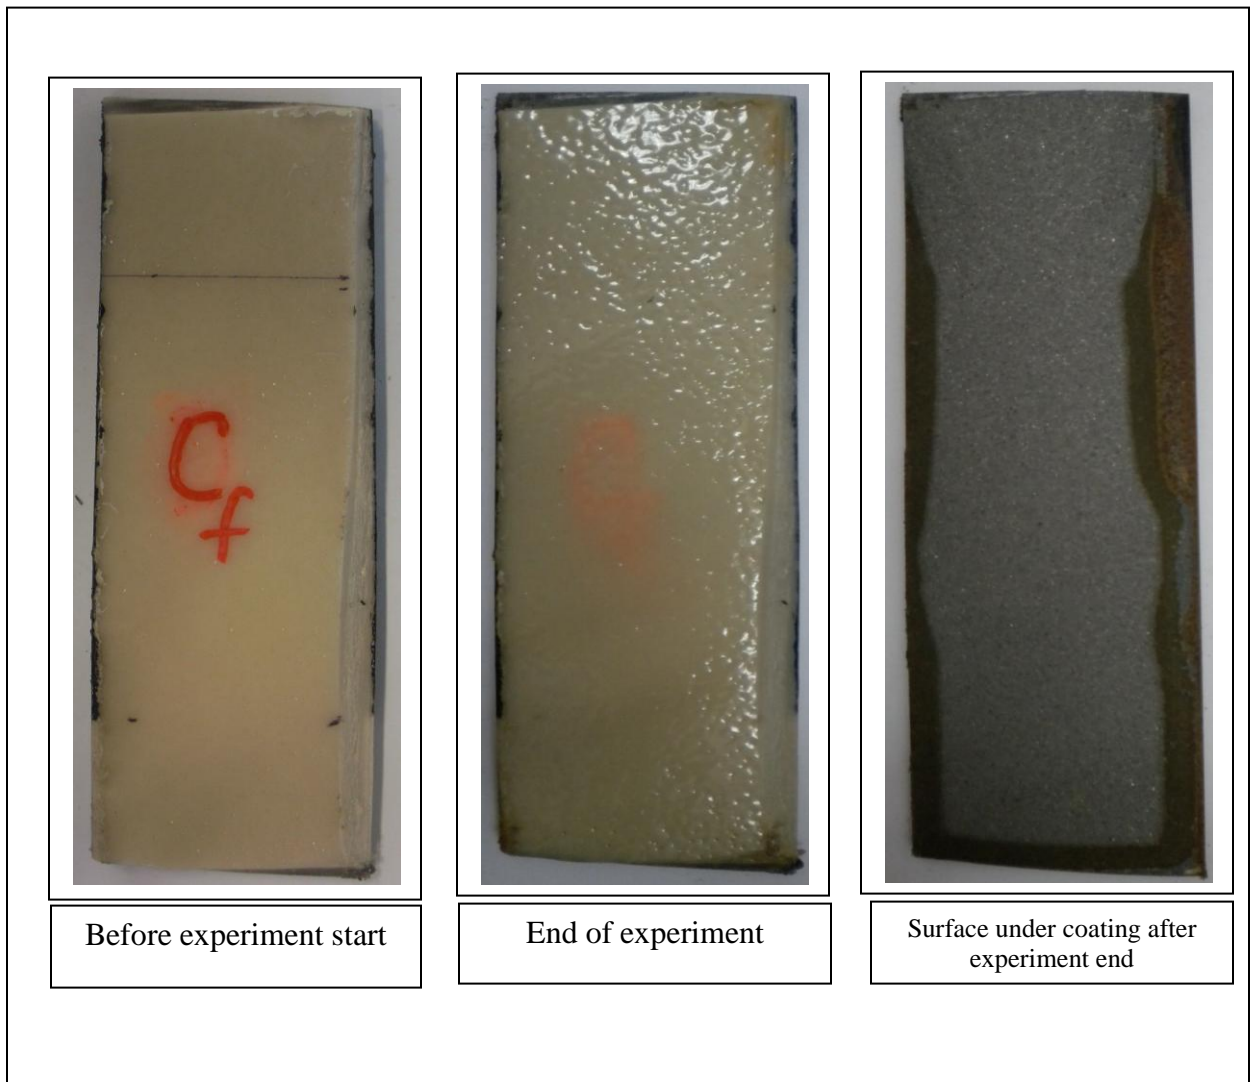
**APPENDIX 1(c):** APPEARANCE OF THE SAMPLES FOR APPLIED POTENTIAL TESTING DURING INITIAL OF EXPERIMENT, END OF EXPERIMENT WITH COATING AND END OF EXPERIMENT WITHOUT COATING - Samples for Applied Potential Testing – 1000 mV

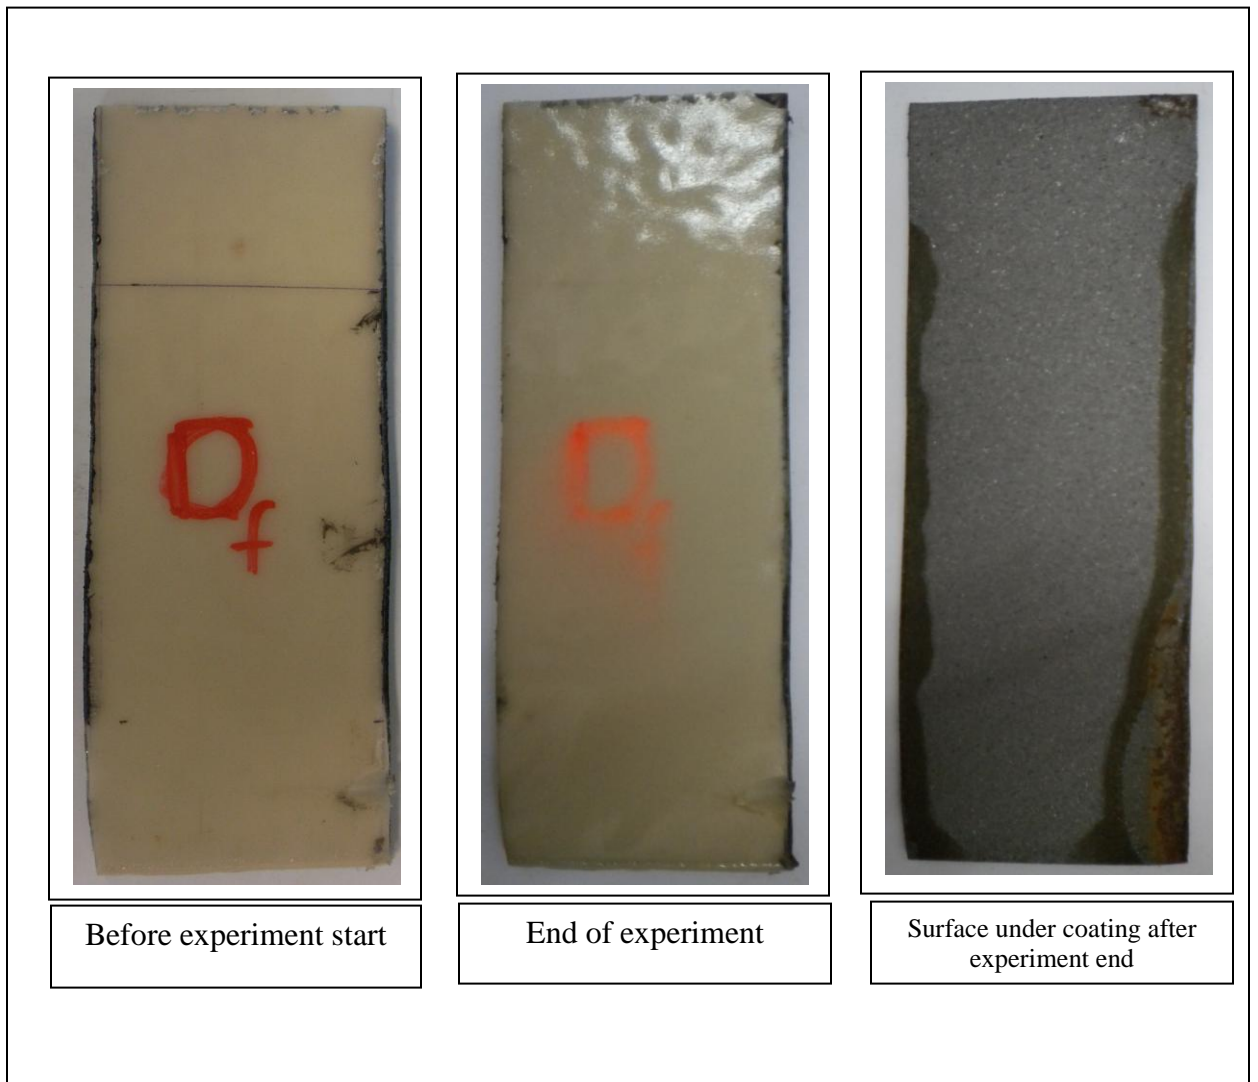
**APPENDIX 1(d):** APPEARANCE OF THE SAMPLES FOR APPLIED POTENTIAL TESTING DURING INITIAL OF EXPERIMENT, END OF EXPERIMENT WITH COATING AND END OF EXPERIMENT WITHOUT COATING - Samples for Applied Potential Testing – 1500 mV

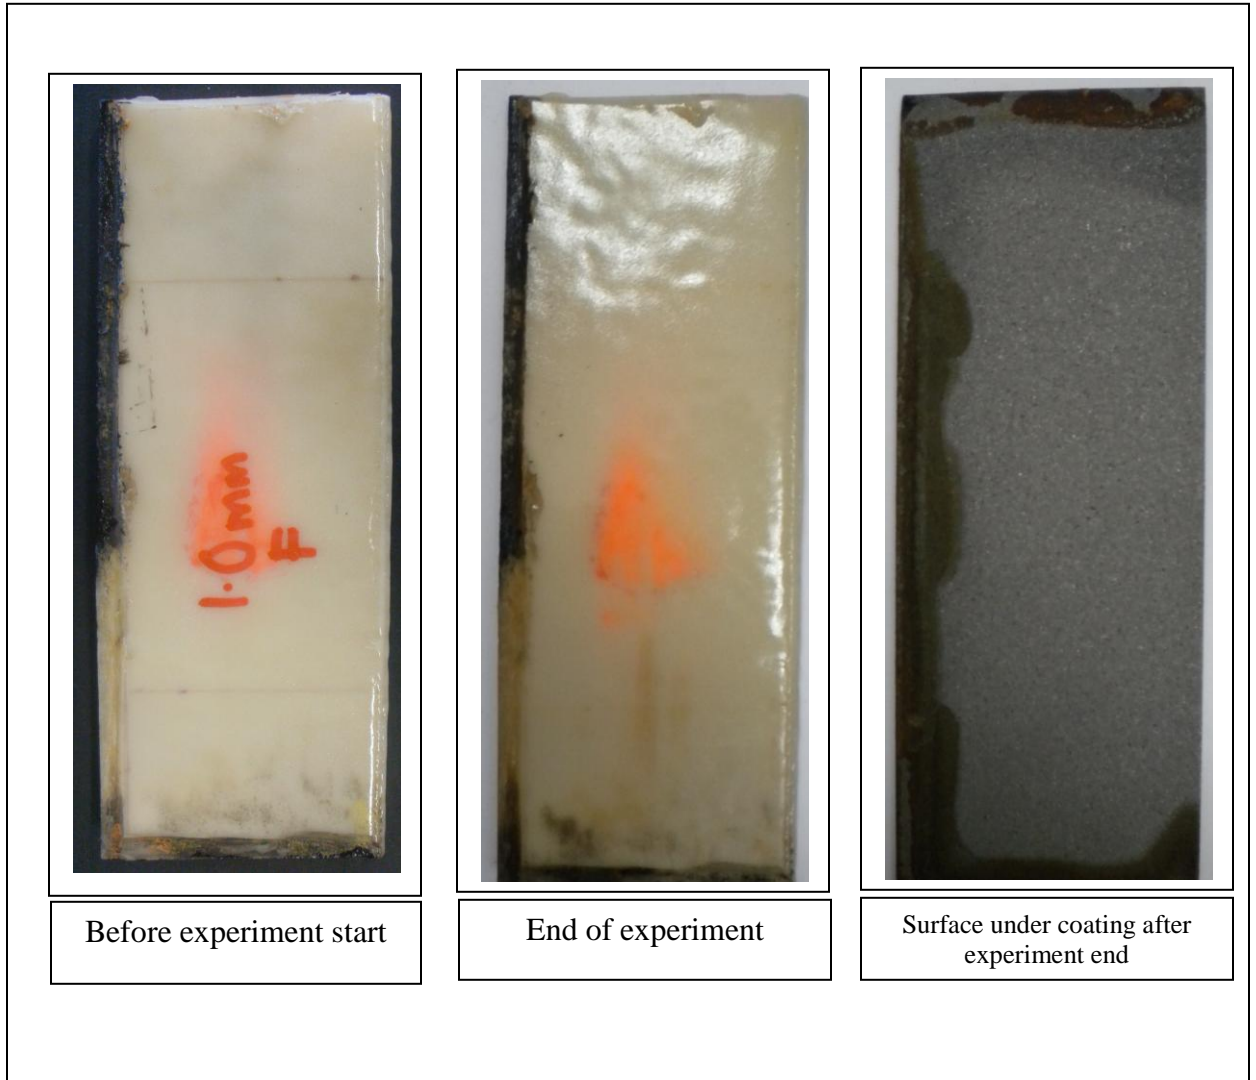
**APPENDIX 2(a):** APPEARANCE OF THE SAMPLES FOR COATING THICKNESS TESTING DURING INITIAL OF EXPERIMENT, END OF EXPERIMENT WITH COATING AND END OF EXPERIMENT WITHOUT COATING - Sample for Coating Thickness Testing – 1.0 mm

under the coating from the defected area (edge of sample). It happened on every sample. Water cannot penetrate directly to the surface through the coating. Even though, polyurea coating are absorbing electrolyte, the electrolyte were still contain inside the polymer and did not reach the steel surface. Appendix 2 shows pictures of the samples at the initial of the experiment, after experiment and pictures of samples without coating.
