# CHAPTER 1

## INTRODUCTION

### 1.1 Background of Study

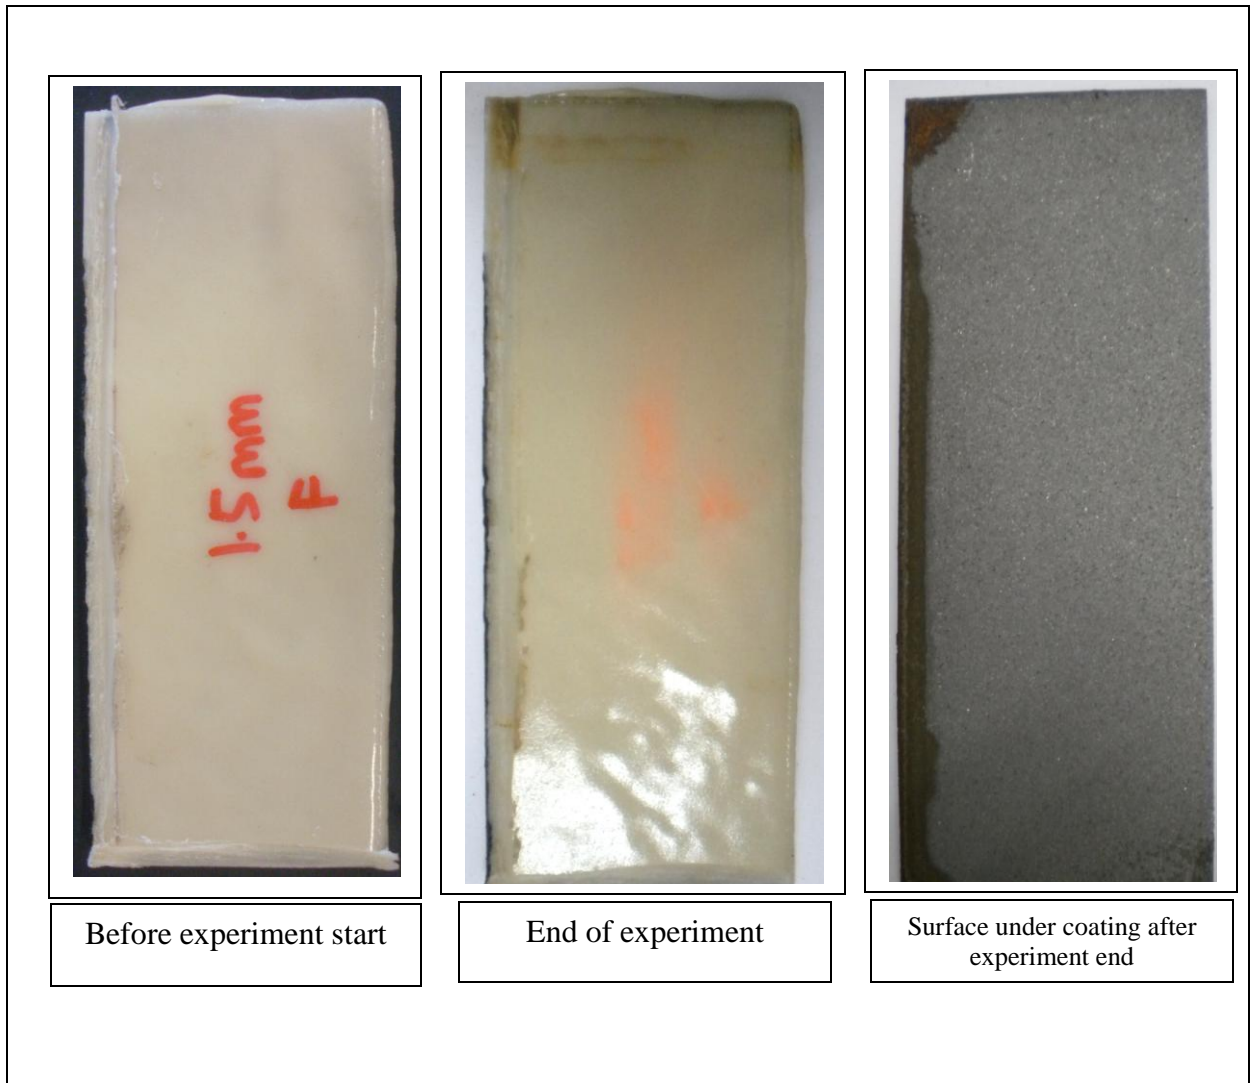
**APPENDIX 2(b):** APPEARANCE OF THE SAMPLES FOR COATING THICKNESS TESTING DURING INITIAL OF EXPERIMENT, END OF EXPERIMENT WITH COATING AND END OF EXPERIMENT WITHOUT COATING - Sample for Coating Thickness Testing – 1.5 mm

under the coating from the defected area (edge of sample). It happened on every sample. Water cannot penetrate directly to the surface through the coating. Even though, polyurea coating are absorbing electrolyte, the electrolyte were still contain inside the polymer and did not reach the steel surface. Appendix 2 shows pictures of the samples at the initial of the experiment, after experiment and pictures of samples without coating.

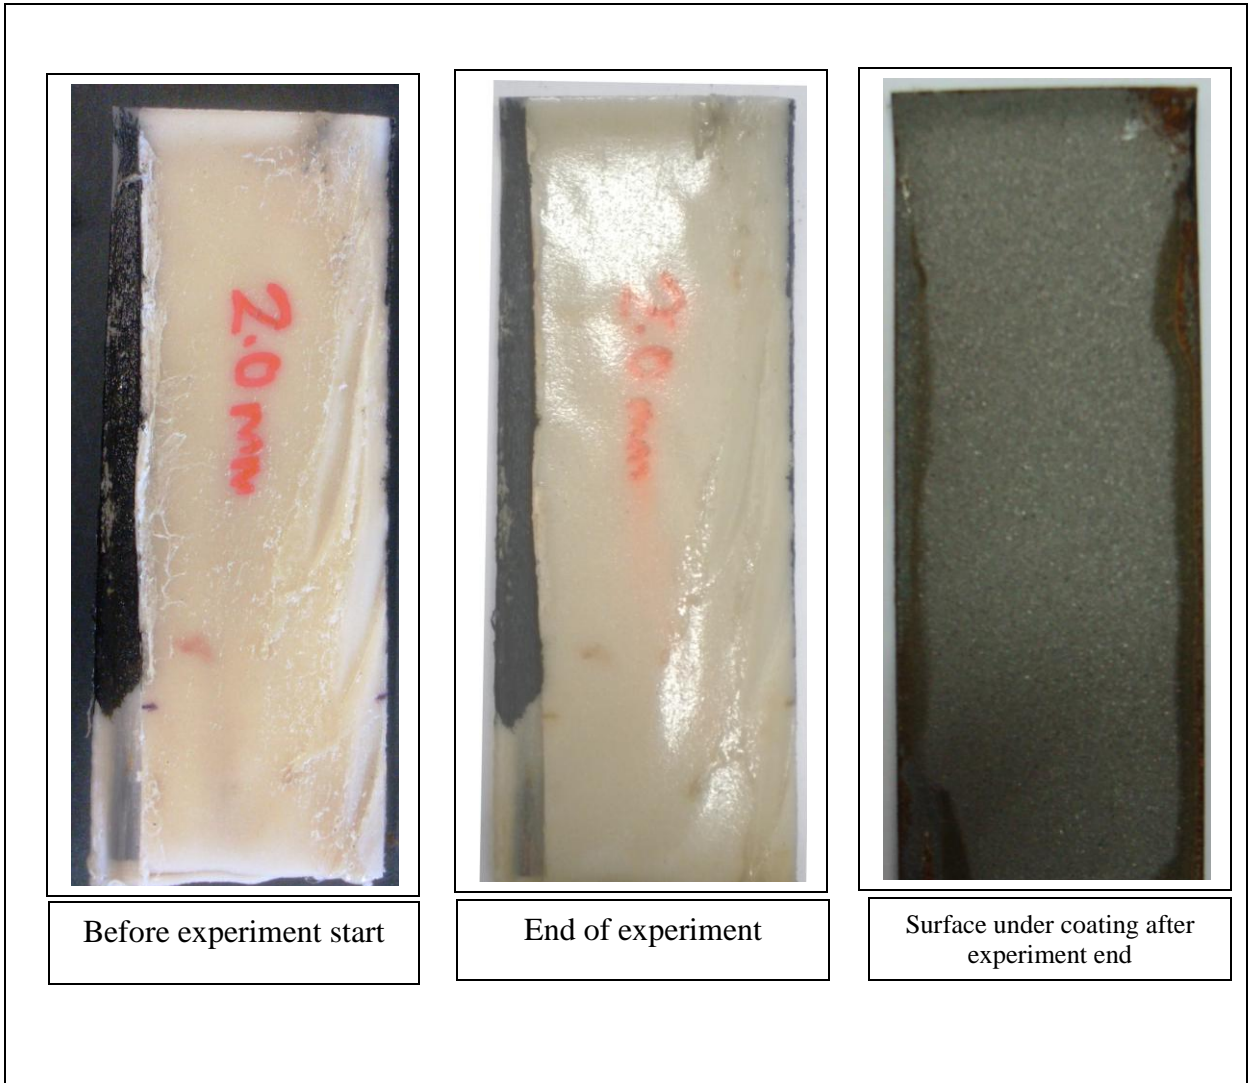
**APPENDIX 2(c):** APPEARANCE OF THE SAMPLES FOR COATING THICKNESS TESTING DURING INITIAL OF EXPERIMENT, END OF EXPERIMENT WITH COATING AND END OF EXPERIMENT WITHOUT COATING - Sample for Coating Thickness Testing – 2.0 mm

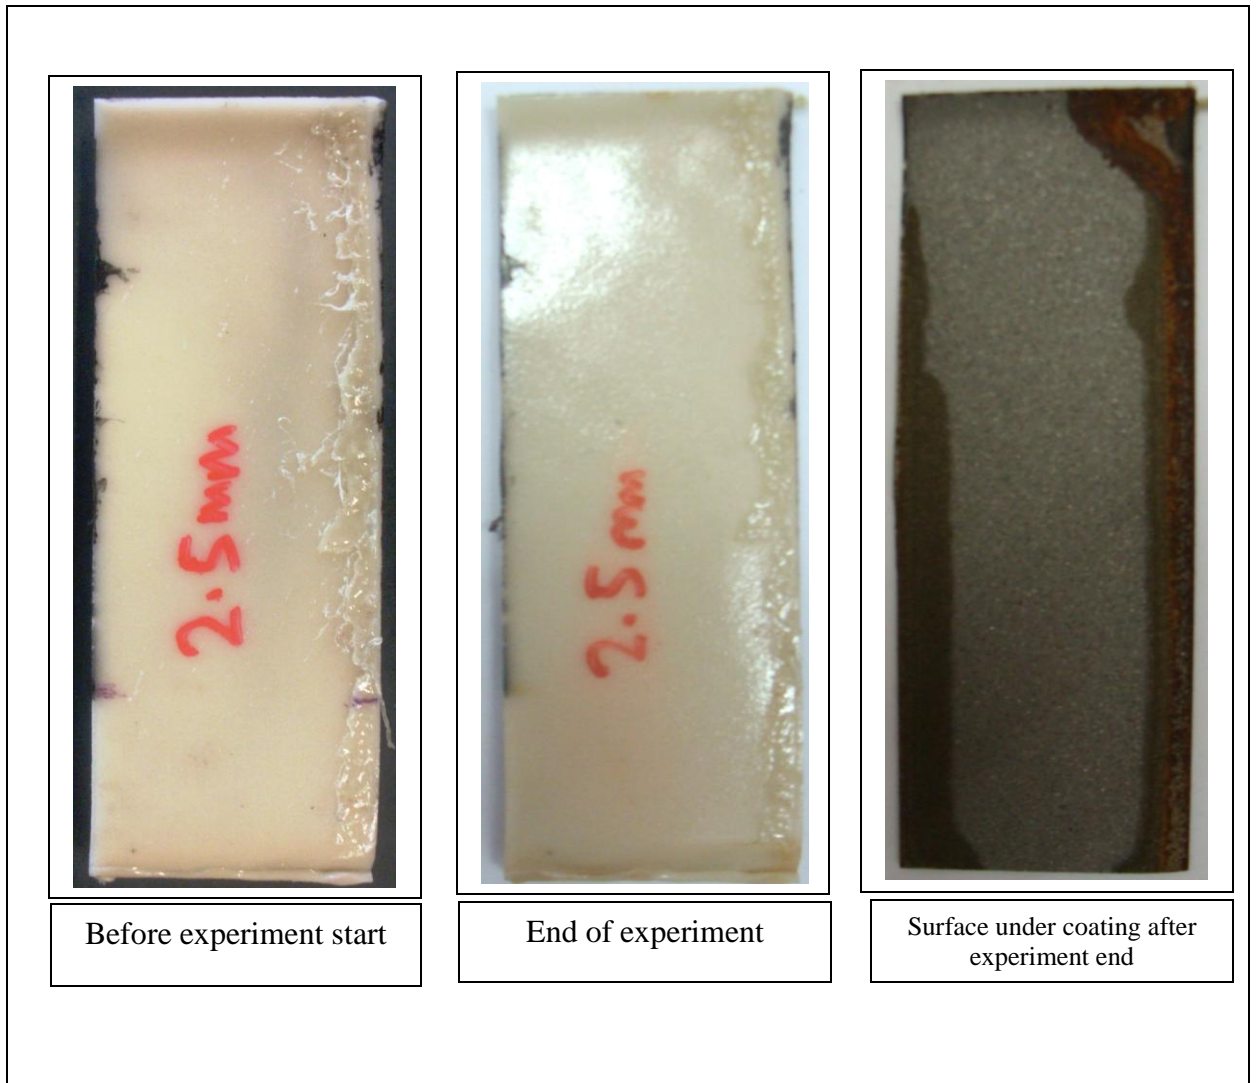
**APPENDIX 2(d):** APPEARANCE OF THE SAMPLES FOR COATING THICKNESS TESTING DURING INITIAL OF EXPERIMENT, END OF EXPERIMENT WITH COATING AND END OF EXPERIMENT WITHOUT COATING - Sample for Coating Thickness Testing – 2.5 mm
