Study of Plain Dent on Seamless Mild Steel Pipe

Dissertation submitted in partial fulfilment of
the requirements for the
Bachelor of Engineering (Hons)
(Mechanical Engineering)

JULY 2010

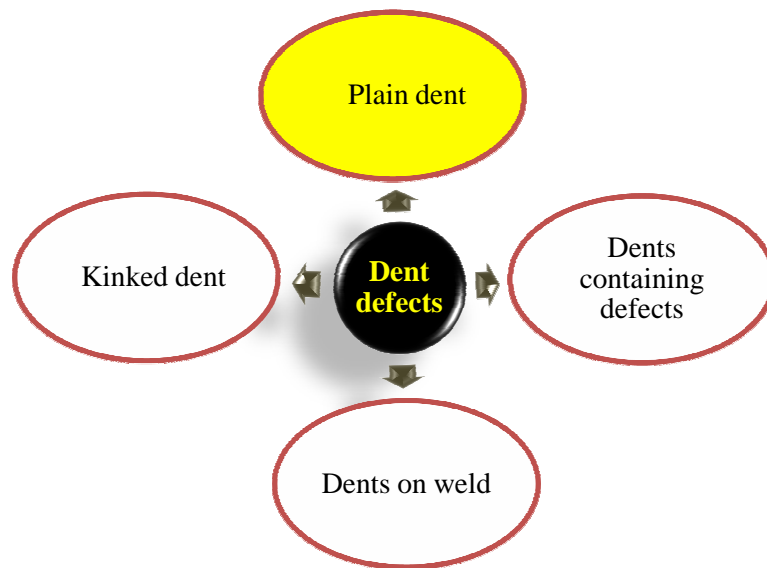
Figure 2-1 : Types of Dent

The dent defects can be differentiating due to the differences of physical damage and behavior. Below are the types of dent defects occur in the pipeline [3].

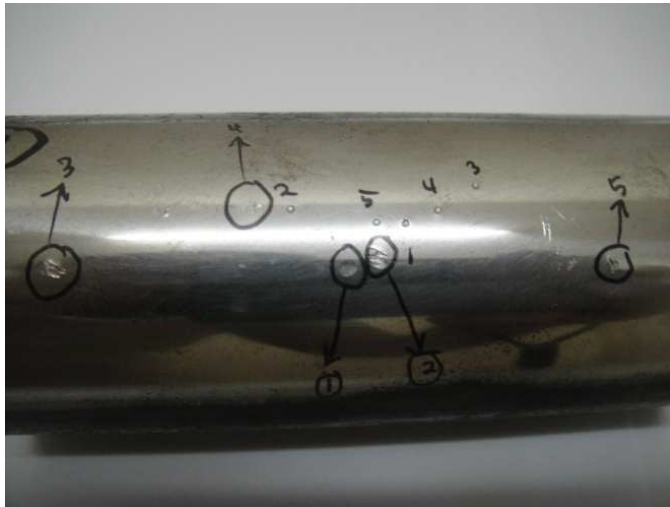
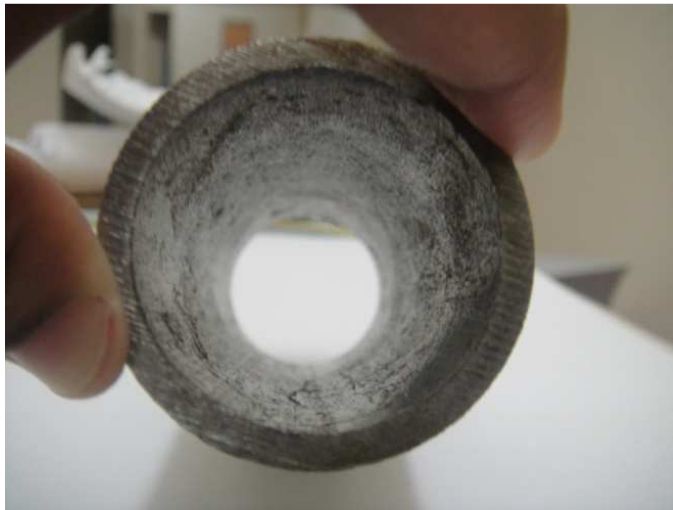
Figure 4-1 : The sample after drop test (height = 20cm)

Outside view

- The dent produce is very shallow.
- The diameter of the dent is very small.

Inside view

- Cannot visually observe the deformation of structure at the inner wall.

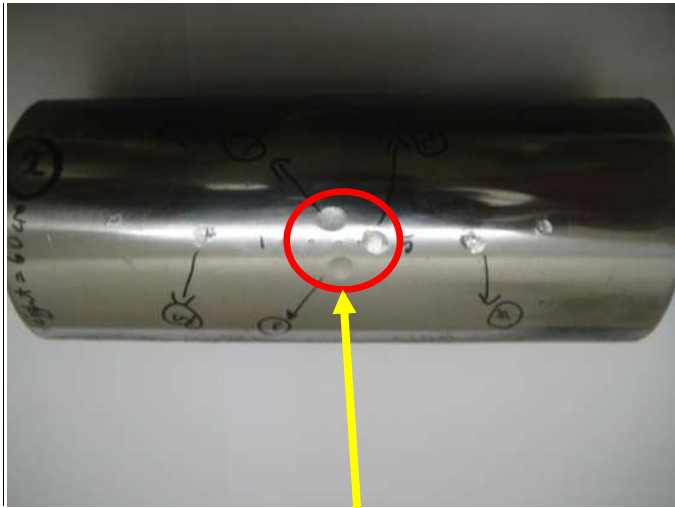
Figure 4-2 : The sample after drop test (height = 60cm)

Outside view

- The dent produce is shallow.
- The diameter of the dent is bigger than the diameter at 20cm height.

Inside view

- Able to visually observe the deformation of structure at the inner wall quite clear.

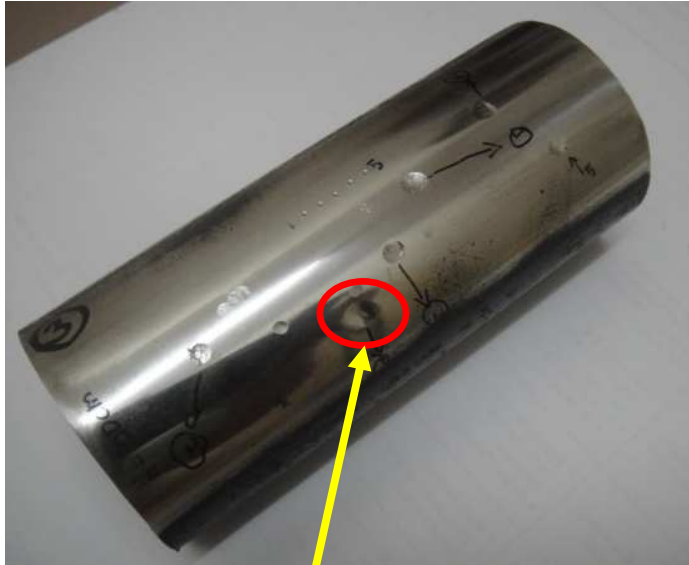
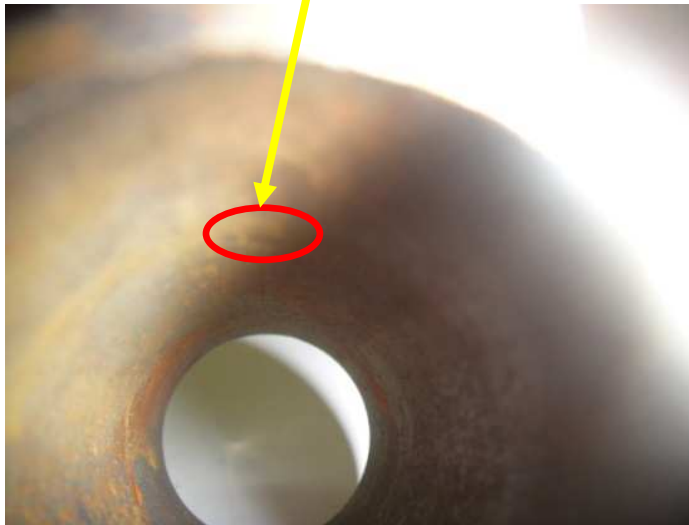
Figure 4-3 : The sample after drop test (height = 100cm)

Outside view

- *The dent produce is quite shallow.*
- *The diameter of the dent is bigger than the diameter at 60cm height.*

Inside view

- *Able to visually observe the deformation of structure at the inner wall quite clear.*

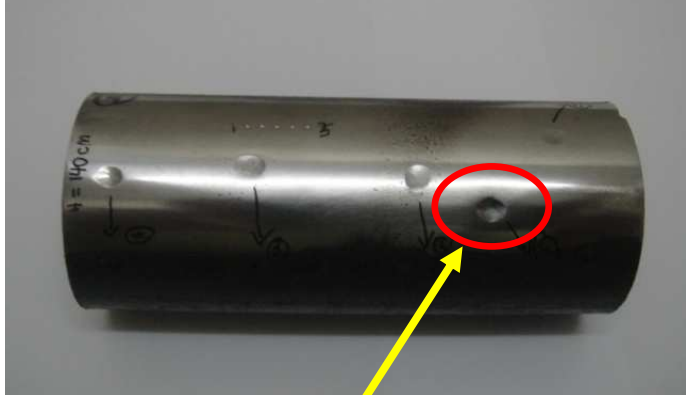
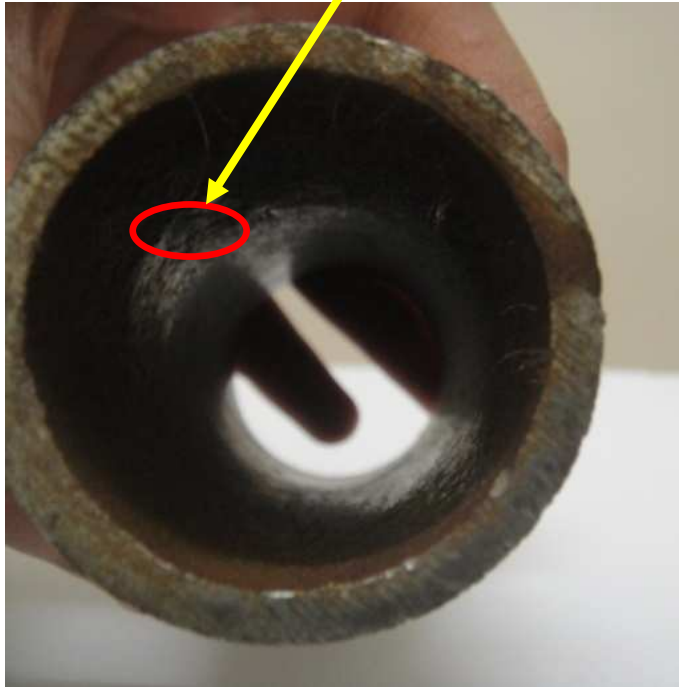
Figure 4-4 : The sample after drop test (height = 140cm)

Outside view

- *Deeper dent.*
- *Larger diameter of the dent.*

Inside view

- *Able to visually observe the deformation of structure at the inner wall quite clear.*
- *Not all dent able to defect visually.*

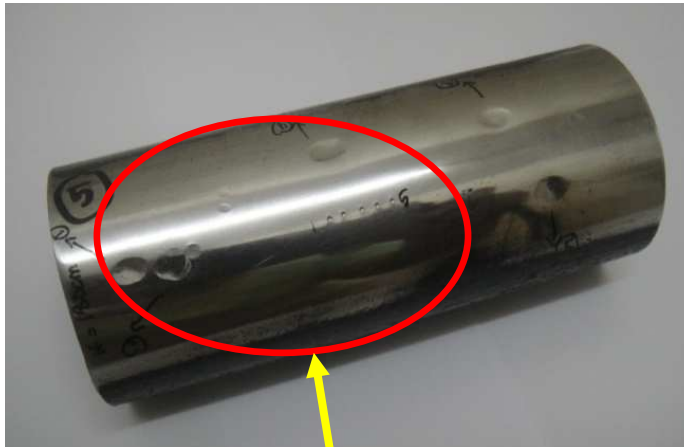
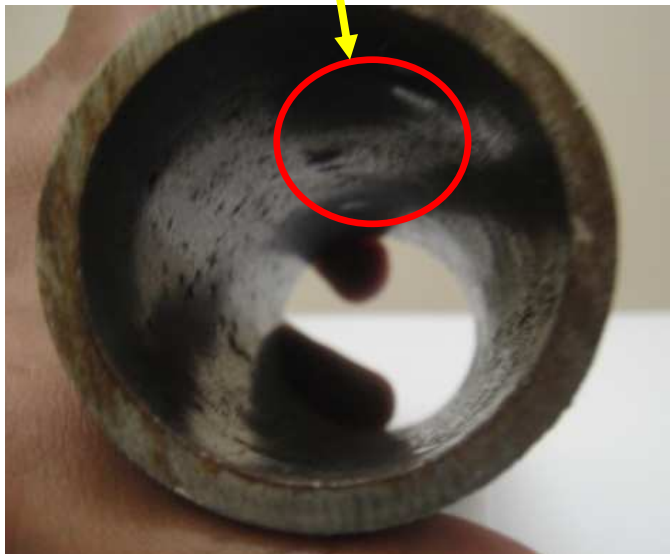
Outside view

- *Deeper dent.*
- *Larger diameter of the dent.*

Inside view

- *Deeper dent.*
- *Larger diameter of the dent.*
- *Able to inspect visually and clearly for all dents.*

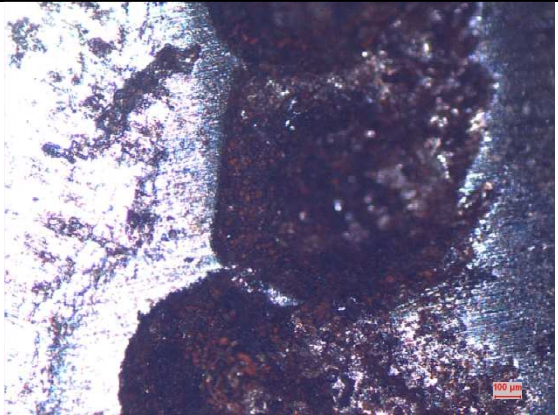
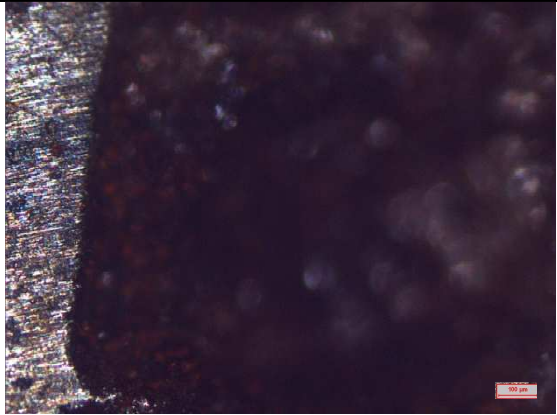
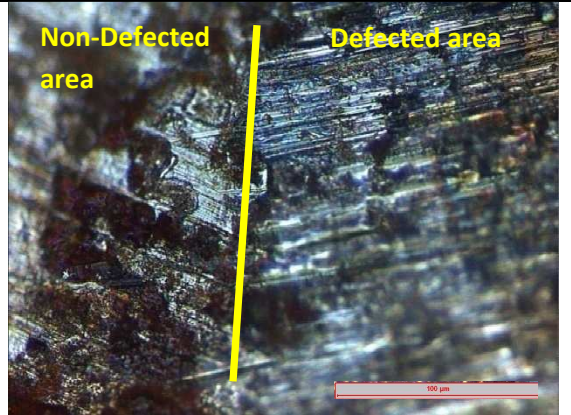
Figure 4-10 : Optical Observation at height of 20cm

<ul style="list-style-type: none">• The picture at 50x magnification.• No appearance of fracture around the defect area.	<ul style="list-style-type: none">• The picture at 100x magnification.• Clear line of defected are without any fracture or defect.	<ul style="list-style-type: none">• The picture at 500x magnification• There are changes in the orientation of the structure between the defected area and non-defected area.

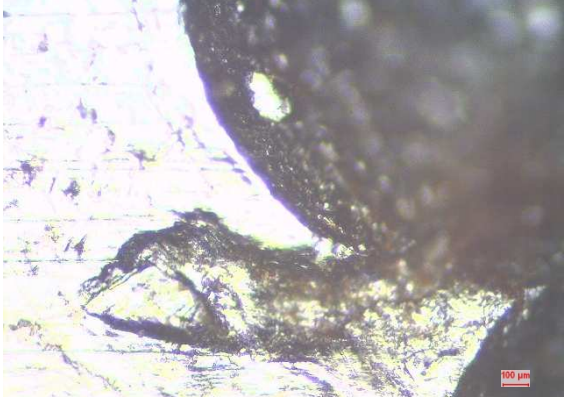
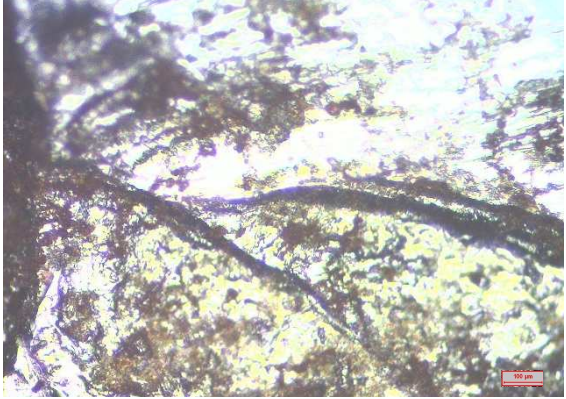
Figure 4-11 : Optical Observation at height of 60cm

<ul style="list-style-type: none">• The picture at 50x magnification.• The crack starting at the indentation of the hardness test.• The crack is not straight, so it cracks along the grain boundary.	<ul style="list-style-type: none">• The picture at 100x magnification.• Appearance of two cracks from different initial sources of crack.• The plastic deformation of the material producing the crack which reducing the strength of the structure

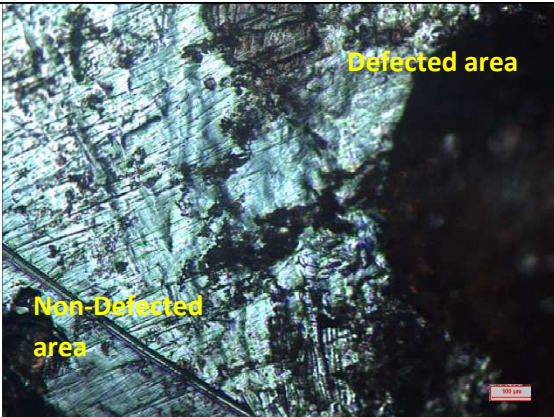
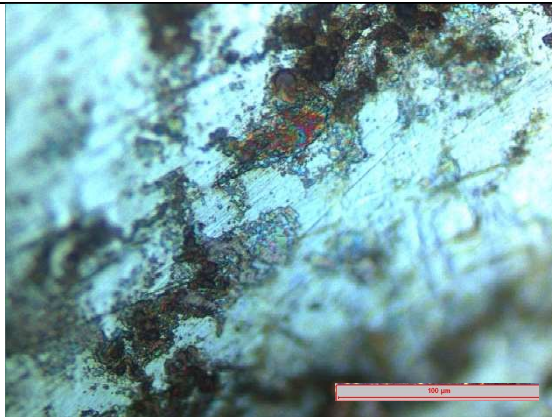
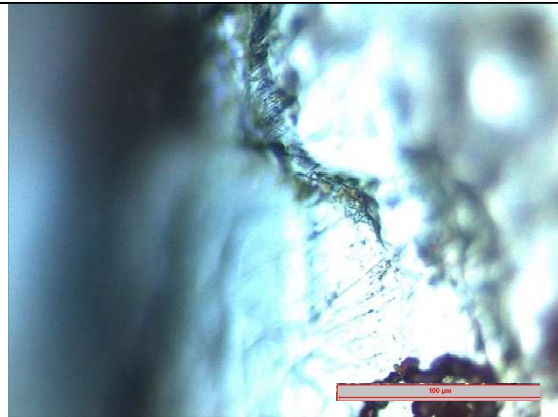
Figure 4-12 : Optical Observation at the height of 100cm.

<ul style="list-style-type: none"> • The picture at 100x magnification. • Able to differentiate between dented area and non-dented area. • The dented area seems that the grain boundaries had been pressed. 	<ul style="list-style-type: none"> • The picture at 500x magnification. • There black spot like pitting. 	<ul style="list-style-type: none"> • The picture at 500x magnification. • Able to identify crack at the dent area • There also black spot around the crack's area. • The shape of the black spot is like producing along the grain the boundary.

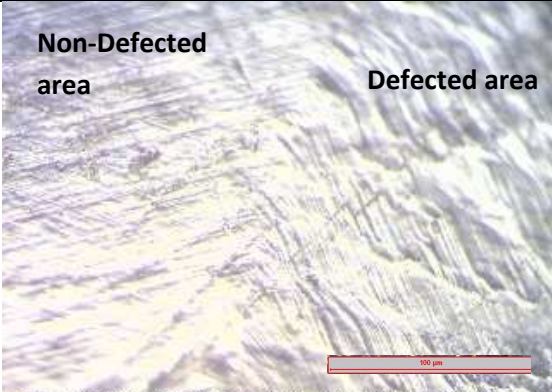
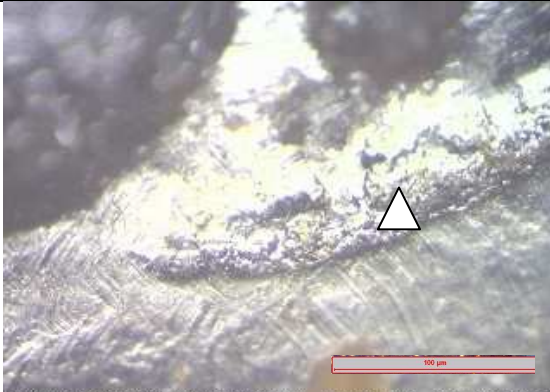
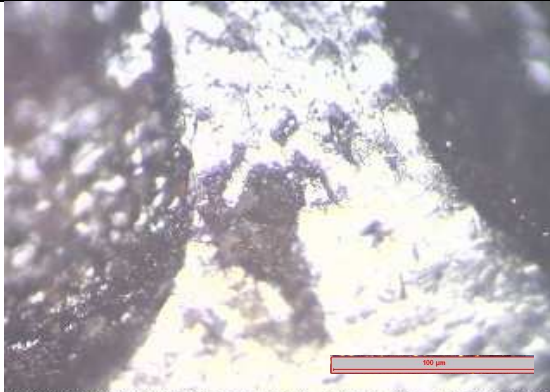
Figure 4-13 : Optical Observation at the height of 140cm

<ul style="list-style-type: none"> • The picture at 500x magnification. • Able to differentiate between dented area and non-dented area. • The orientation of the structure at the defected area, it likes the material had been pressed by a load. 	<ul style="list-style-type: none"> • The picture at 500x magnification. • There are existed of small crack at the defected area. 	<ul style="list-style-type: none"> • The picture at 500x magnification. • There is loss of metal at dented area.

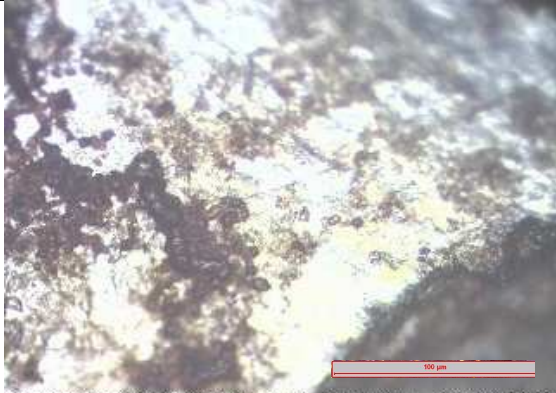
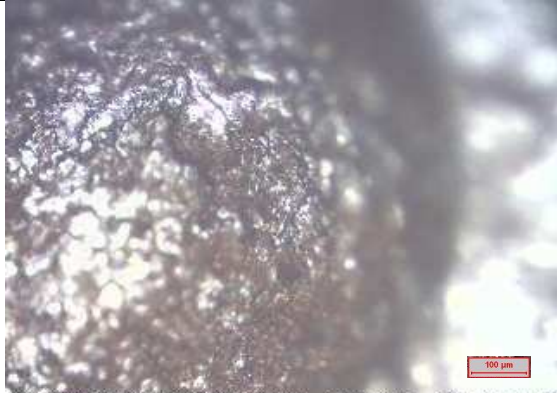
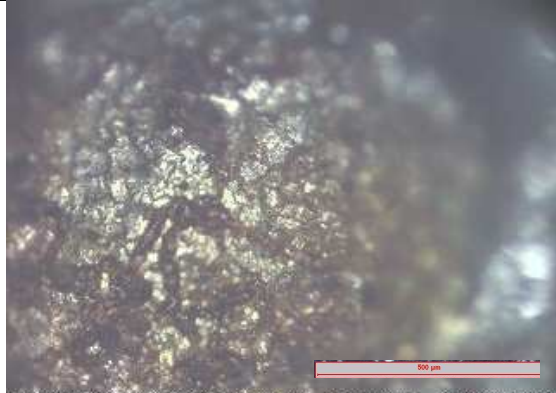
Figure 4-14 : Optical Observation at the height of 180cm.

<ul style="list-style-type: none">• The picture at 500x magnification	<ul style="list-style-type: none">• The picture at 1000x magnification	<ul style="list-style-type: none">• The picture at 1500x magnification
<ul style="list-style-type: none">• At all picture, there are production of stress concentration.• At all picture, there are black spot created along the grain boundaries.

From the optical observations is the orientation of the material changed after introducing artificial defect on the sample. The macro crack on the dent was also observed.
