**FAILURE ANALYSIS OF POLYVINYLIDENE
FLUORIDE BY DEGRADATION FOR A PIPELINE**

Dissertation submitted in partial fulfilment of the requirements
for the Bachelor of Engineering (Hons) Mechanical Engineering

January 2020

Universiti Teknologi Petronas

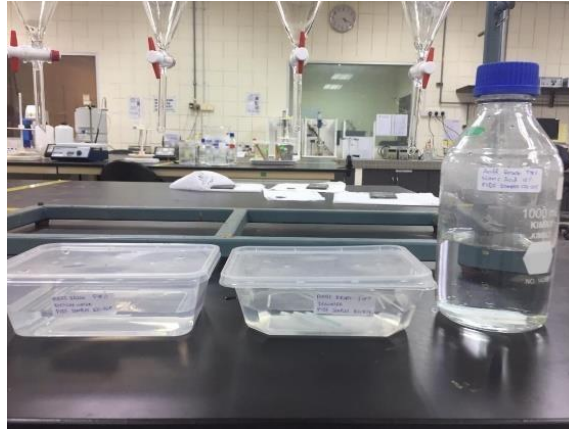
FIGURE 3.4. Samples Immersed in Distilled Water, Seawater and Nitric Acid

According to Chemical Resistance Chart from Plastic International, this source had identified that nitric acid of 10% concentration would cause slight attack by absorption. Thus, it would result some swelling and a small reduction in mechanical likely. The samples had been kept in glass container to ensure it did not affect by the corrosiveness of the acid as shown in Figure 3.4.

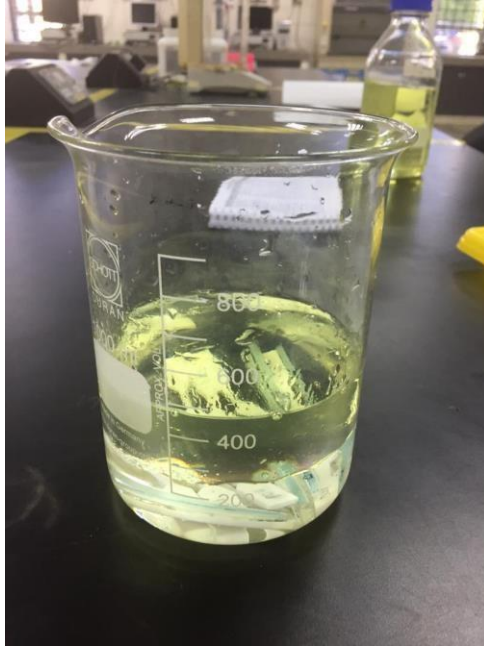
FIGURE 3.5. PVDF Samples in Hydrocarbon and Distilled Water Mixture

250 ml hydrocarbon had been mixed with 250 ml distilled water as shown in Figure 3.5. This solution had been exposed in CO₂ in three different parameters. 15 samples of PVDF in total had been separated in three different containers for the parameters set. For the first parameter, the samples had been exposed at 1 bar pressure of CO₂ at 25°C. Next, the samples exposed at 20 bar pressure of CO₂ at 25°C. These parameters had been kept in a pressure vessel to seal the gas pressure as shown in Figure 3.6. For the third parameter, the samples had been exposed to 20 bar pressure of CO₂ at 60°C. This test executed in autoclave machine due to parameters set. All of these parameters were tested for five days.

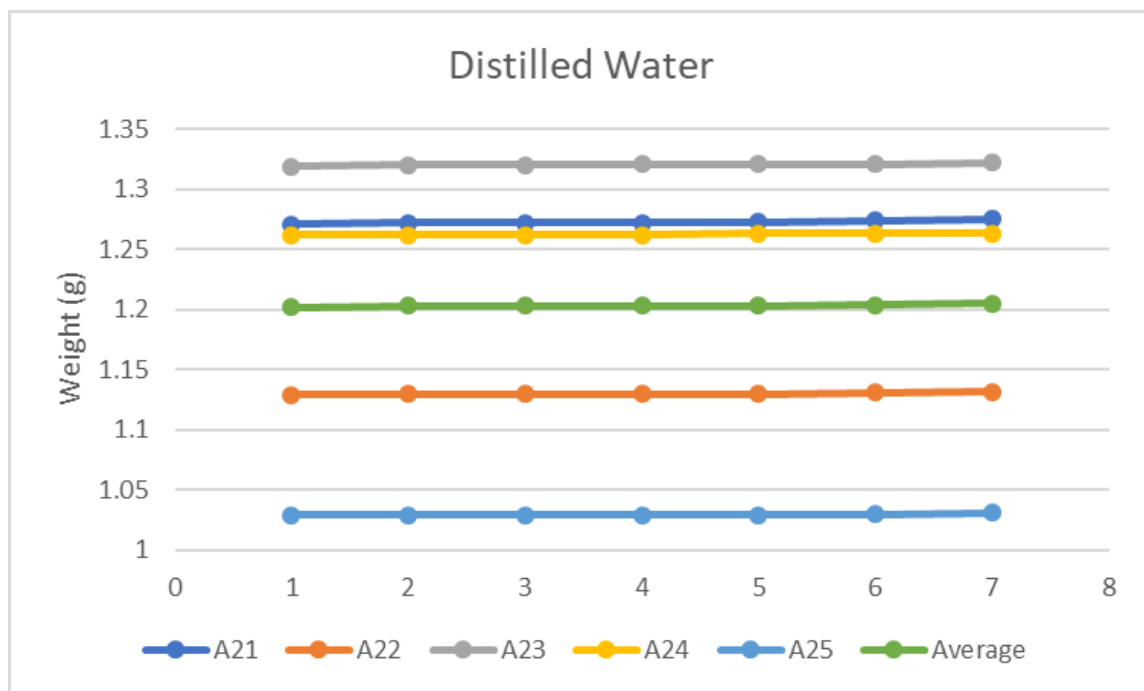
FIGURE 4.1. Weight Reading of PVDF in Distilled Water

From the results that had been collected, the samples weights were increasing. The average results had shown increment 0.003 g at 0.25%. PVDF was known for being hydrophobic fluoropolymer. This characteristic contributed to its low water absorption. Thus, the percentage of water absorption were relatively low. As results, the absorption rate of the samples was very low.

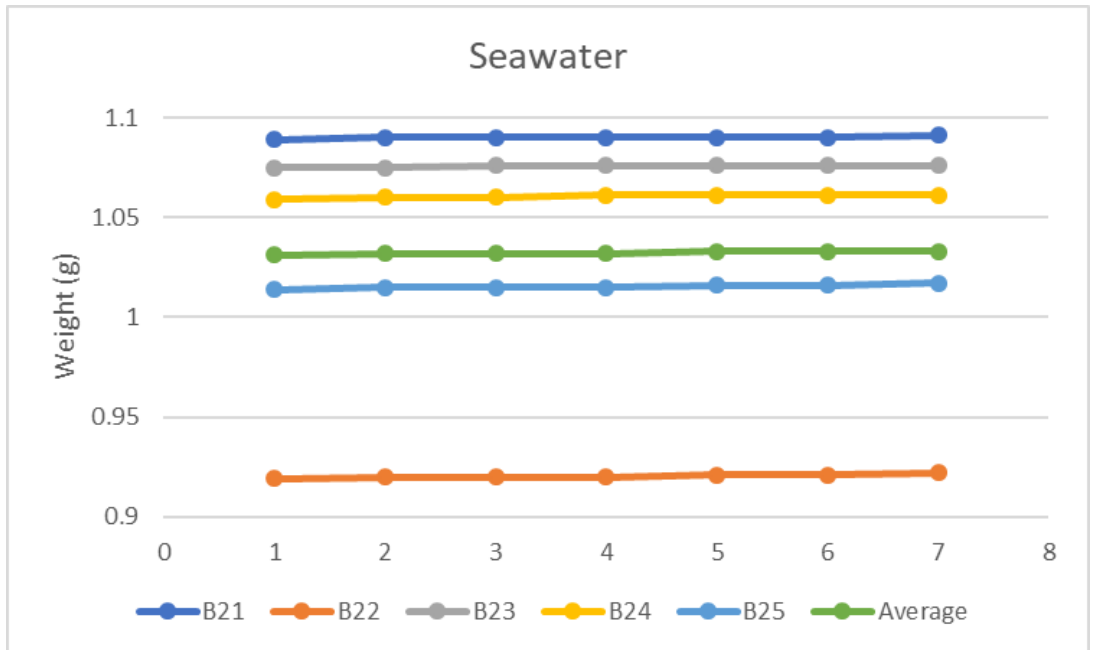
FIGURE 4.2. Weight Reading of PVDF in Seawater

From the results that had been collected, the samples weights were increasing. The average results had shown increment 0.002 g at 0.19%. Due to being hydrophobic fluoropolymer, this characteristic contributed to its low water absorption. Thus, the percentage of water absorption were relatively low. As results, the absorption rate of the samples was very low. The seawater has the pH of 8.22 as shown in Figure 4.3, thus seawater was an alkaline solution. Even though, the solution was alkaline, it did not affect the samples weight. Thus, it proved that PVDF had high resistivity to its surrounding.

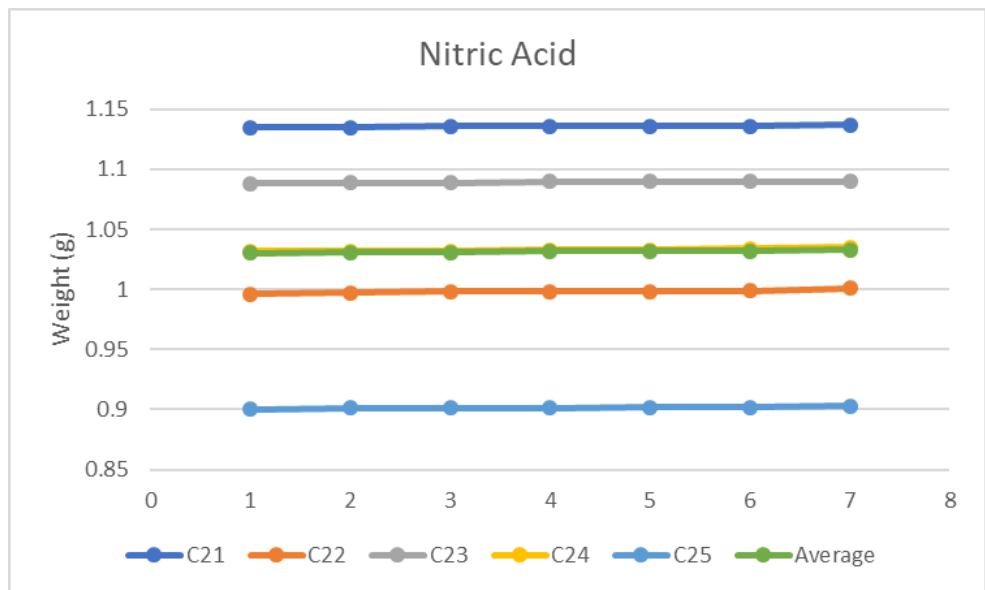
FIGURE 4.4. Weight Reading of PVDF in Nitric Acid 10% Concentration

From the results that had been collected, the samples weights were increasing. The average results had shown increment 0.003 g at 0.29%. The percentage of water absorption were relatively low due its characteristic for being hydrophobic fluoropolymer. As results, the absorption rate of the samples was very low. The nitric acid solution has the pH of 3.01, thus this solution was very acidic. It was tested with 10% concentration of nitric acid since according to Chemical Resistance Chart made by Plastic International, they recommended this concentration since it caused slight attack by absorption. Furthermore, it caused some swelling and a small reduction in mechanical likely. Even though the solution was acidic, it did not affect the samples weight by having reduction in weight due to corrosive solution. This showed that PVDF was having high resistivity due to its capability to withstand the acidity of the nitric acid solution during the study period.

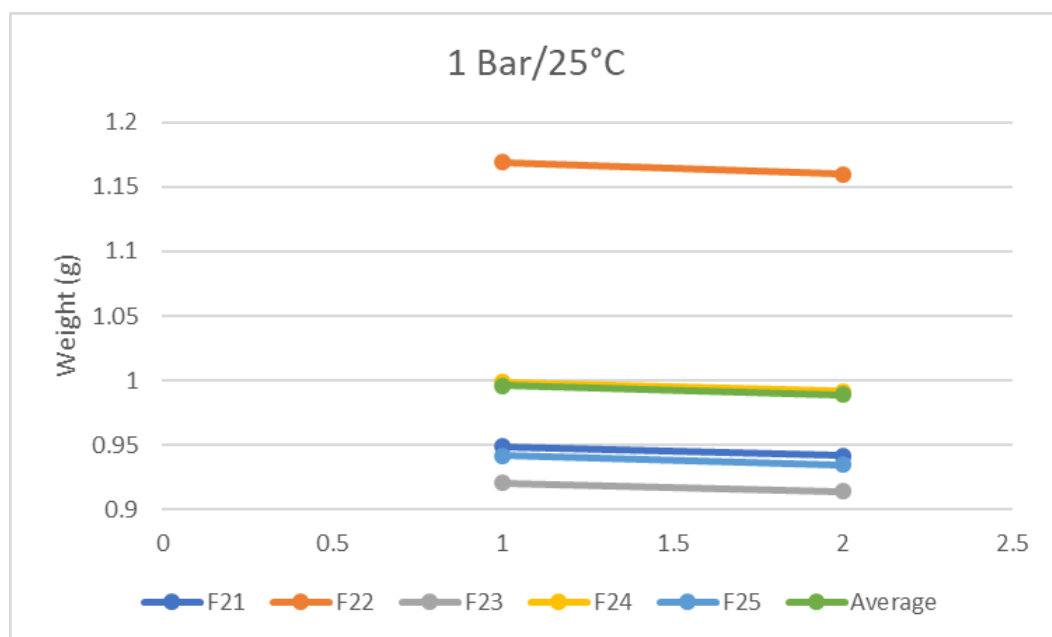
FIGURE 4.6. Weight Reading of PVDF Samples in CO₂ Exposure

From the results that had been collected, the samples weights were decreasing. The average results had shown decrement 0.007 g at -0.70%. The changes were minimal due to PVDF characteristic was chemical resistance material. During this test, there was no incident that may affect the results such as leakage. The results showed that PVDF could sustain under pressurized CO₂ environment due to little amount of loss.

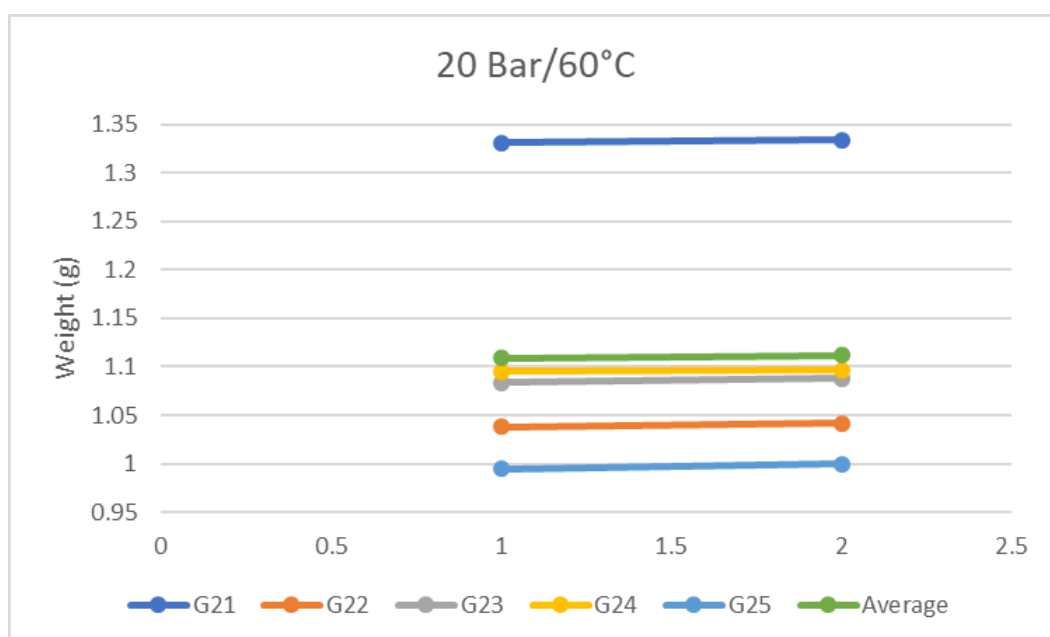
FIGURE 4.7. Weight Reading of PVDF Samples in CO₂ Exposure

From the results that had been recorded, the samples weights were increasing. The average results had shown increment 0.003 g at 0.27%. The changes were minimal as PVDF possessed chemical resistance characteristics. These results might have been affected by the technical faulty that happened in the autoclave machine during the study period of these samples. The machine had rose to 100°C before dropping to 30°C before being stable at 60°C according to the parameter given. As results, despite the weights were increasing due to exposure, but the samples melted at the edge due to the high temperature in the autoclave. The results might be unreliable for this study due to technical failure occurred.

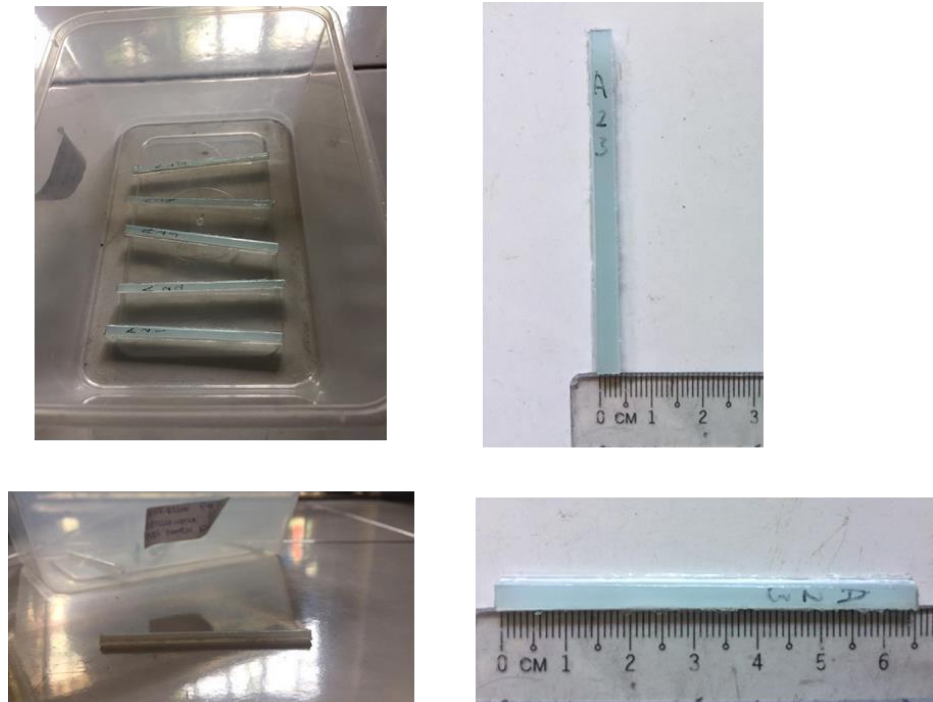
FIGURE 4.8. The Measurements of the Post Test PVDF Samples

The samples had been shown that there were no any changes in terms of sizes, shapes and angles despite underwent different parameters that caused reduction and increment in weights. All the samples still had the same 63.5 mm in length and 3.18 ± 0.5 mm in width. Moreover, no angles changed and still remained at 0° as shown in Figure 4.8.
