AUTOMATED DEFECTS DETECTION MODEL FOR IBS
ELEMENTS CONSIDERING IR 4.0 APPLICATION
ENVIRONMENT

CIVIL ENGINEERING
UNIVERSITI TEKNOLOGI PETRONAS

JANUARY 2022

Dissertation submitted in partial fulfilment of
the requirements for the
Bachelor of Civil Engineering with Honours

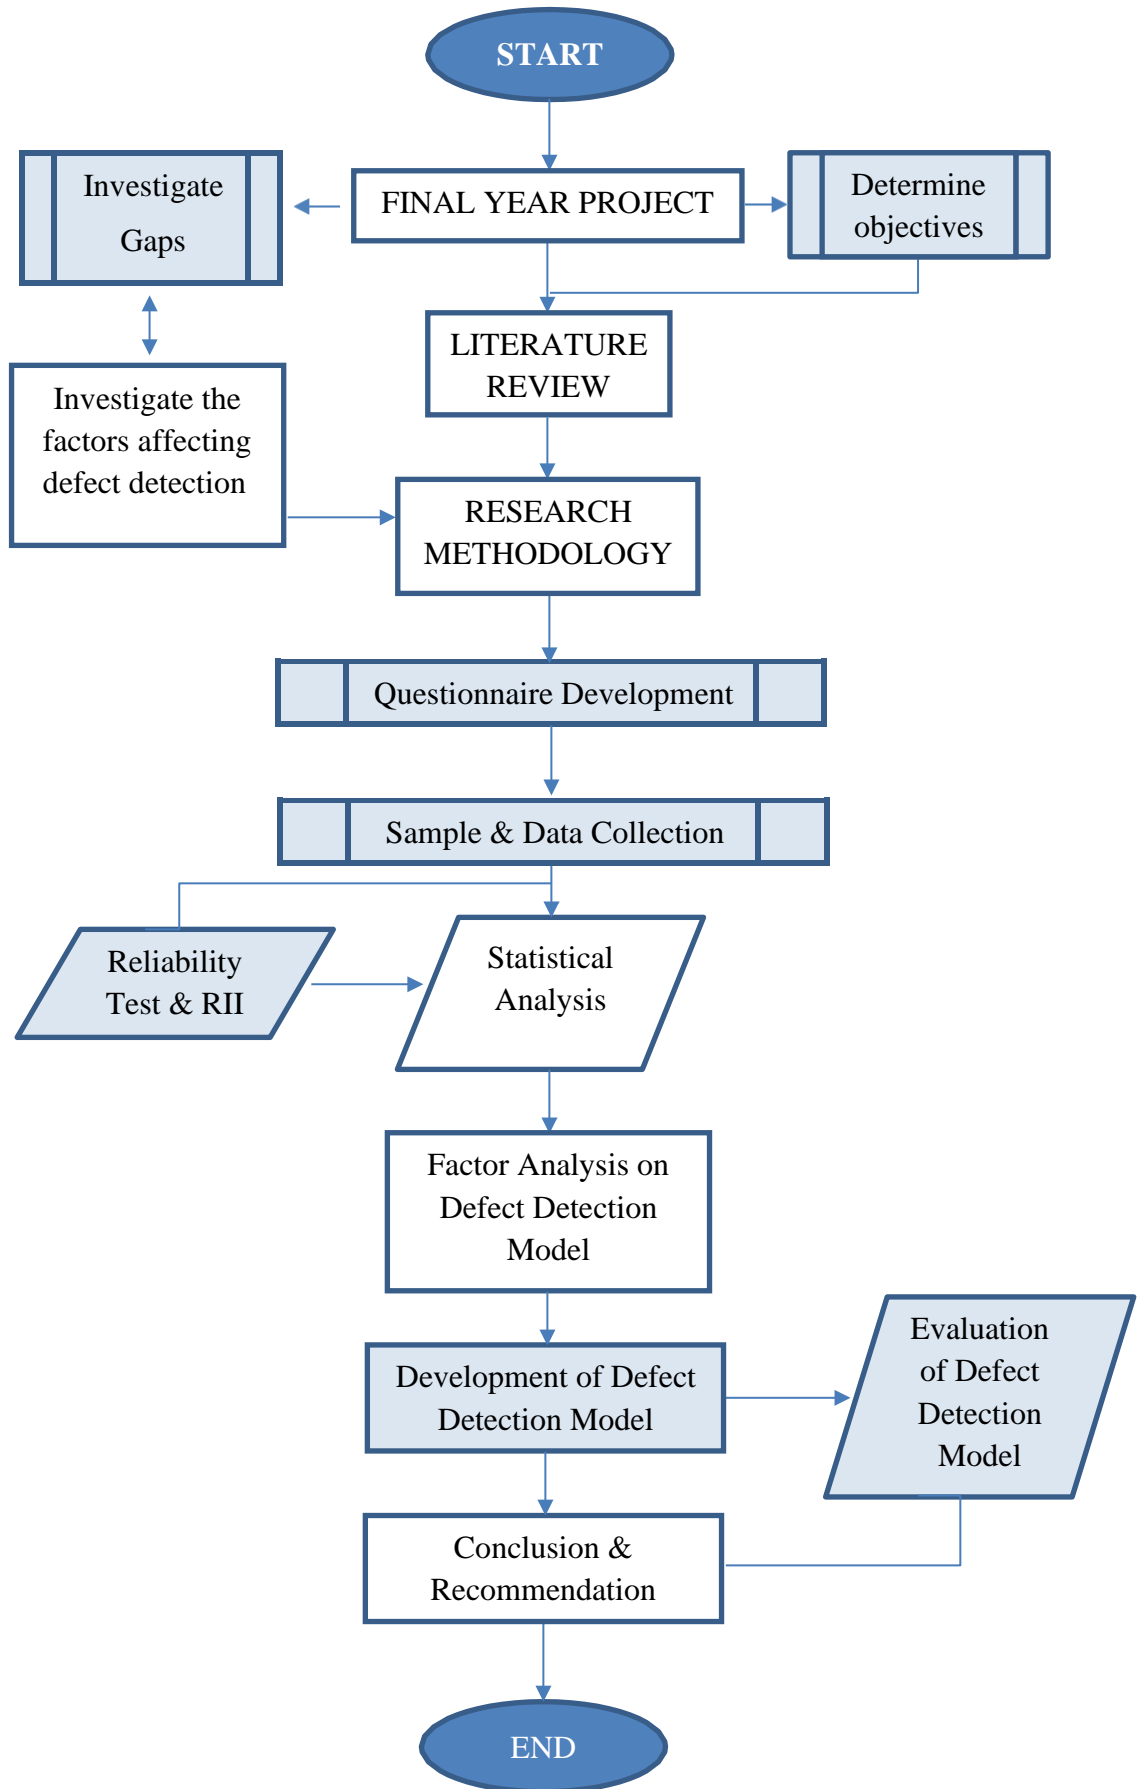
FIGURE 3.1: Project Work Flowchart

Additionally, the Figure 3.1 below illustrates the study approach using a flowchart.

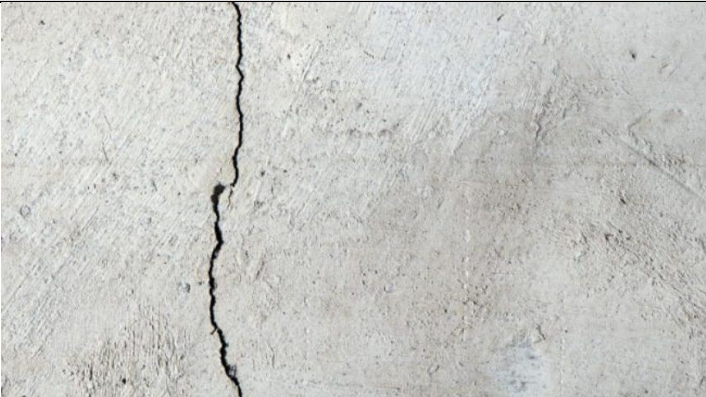
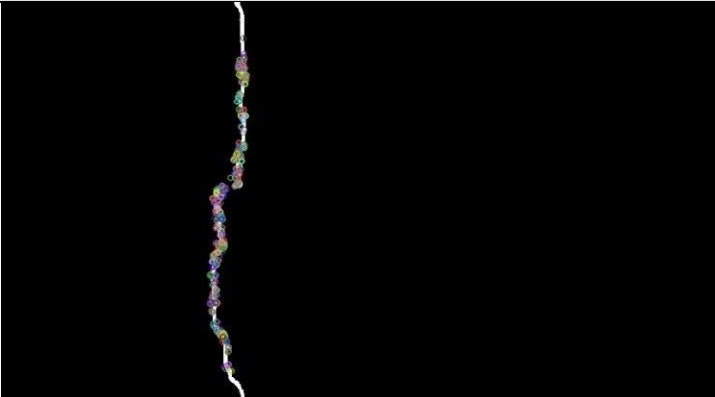
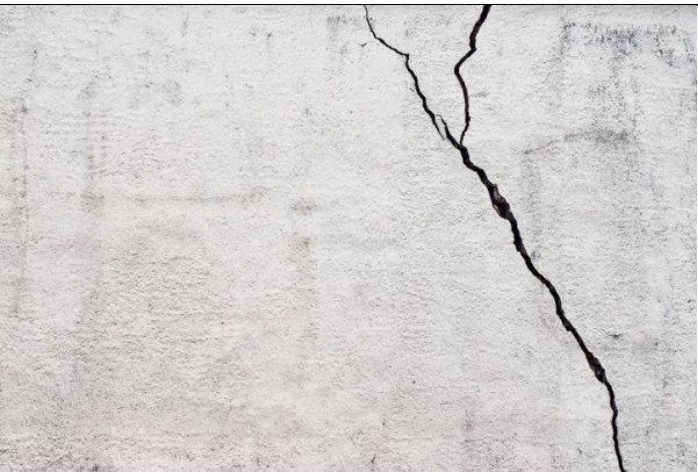
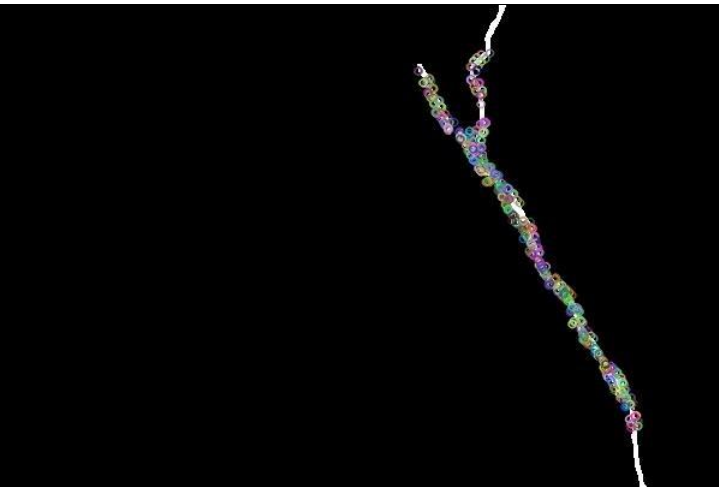
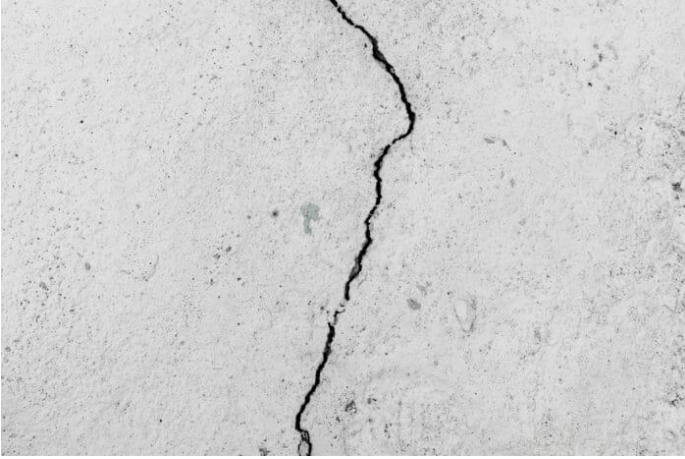
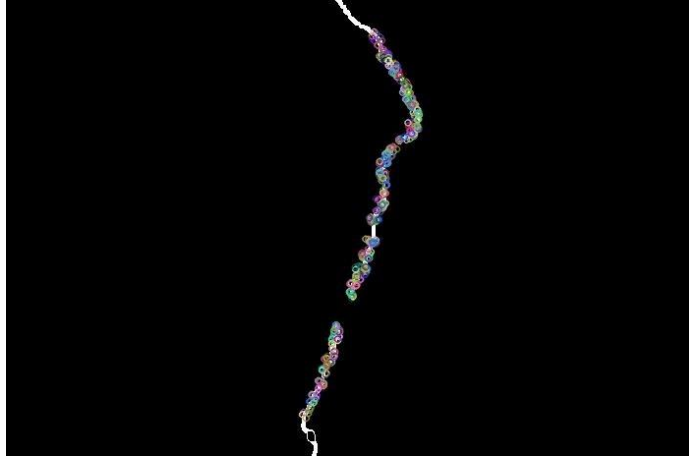
TABLE 4.6: Original and Processed Image

The Table 4.6 below shows the original image and the outcome after the defect detection process. The defect detection model can detect the cracks on the concrete surface. If high-speed camera is added to the process, the whole process can be automated. Thus, stakeholders can detect the cracks present without depending on inspectors.

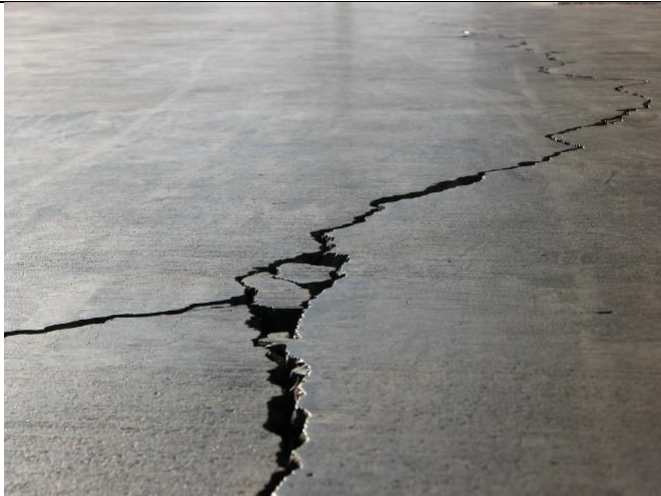
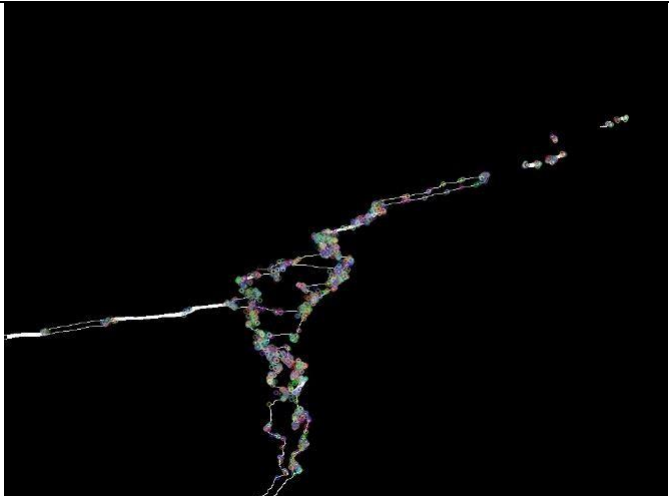
7

A photograph showing a large, irregular crack in a light-colored concrete surface. The crack starts from the left and extends towards the right, with several smaller, branching cracks. The surface appears to be a flat, outdoor area.

A 3D visualization of the crack shown in the photograph to the left. The crack is represented as a series of colored points (red, green, blue, yellow) connected by thin lines, set against a black background. The points are arranged in a pattern that matches the shape of the crack in the photograph.
8

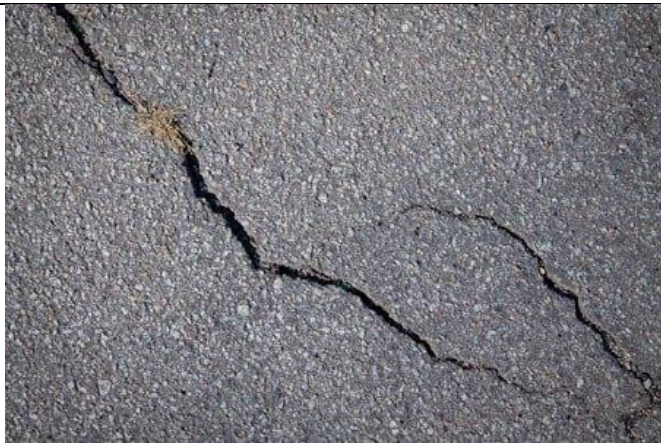
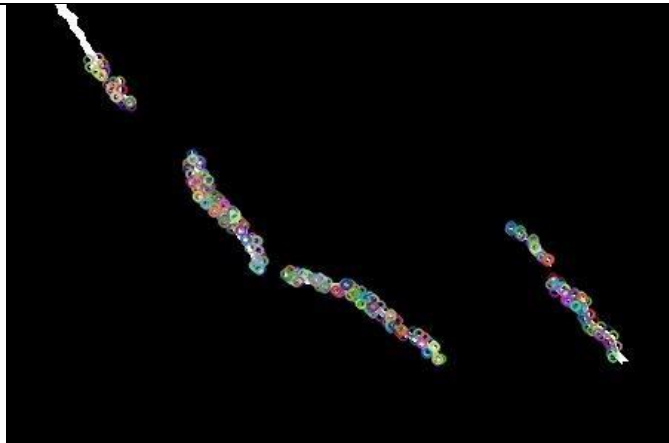
A close-up photograph of a crack in a dark, textured asphalt surface. The crack is jagged and runs diagonally across the frame. The texture of the asphalt is clearly visible.

A 3D visualization of the crack shown in the photograph to the left. The crack is represented as a series of colored points (red, green, blue, yellow) connected by thin lines, set against a black background. The points are arranged in a pattern that matches the shape of the crack in the photograph.

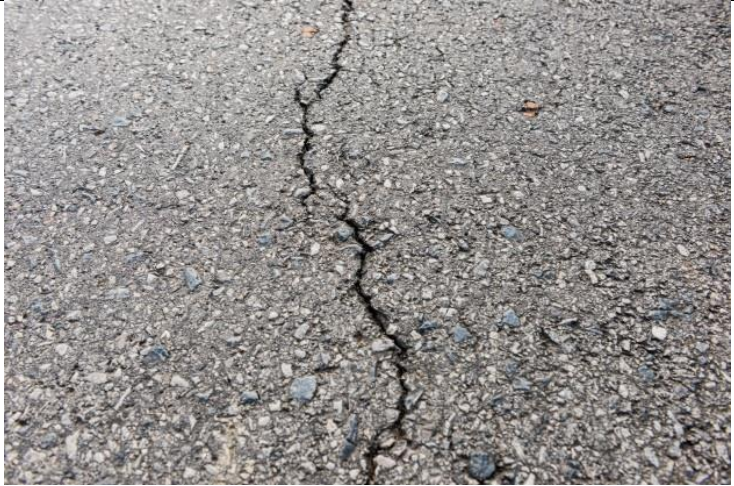
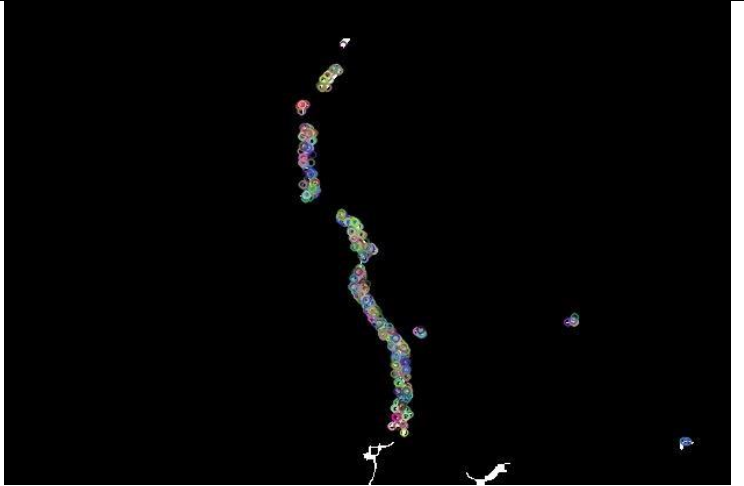
9

A close-up photograph of a grey asphalt surface with a prominent, irregular crack running vertically through the center.

A fluorescence image of the asphalt crack, showing a vertical line of multi-colored spots (red, green, blue, yellow) against a black background, indicating the presence of certain materials or contaminants.
10

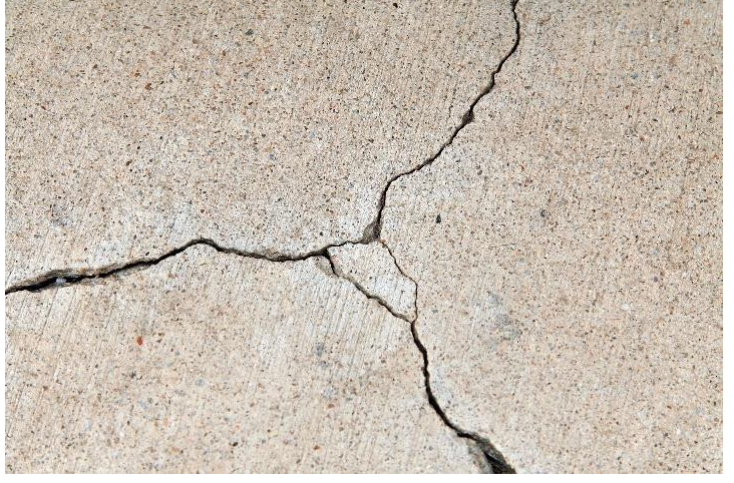
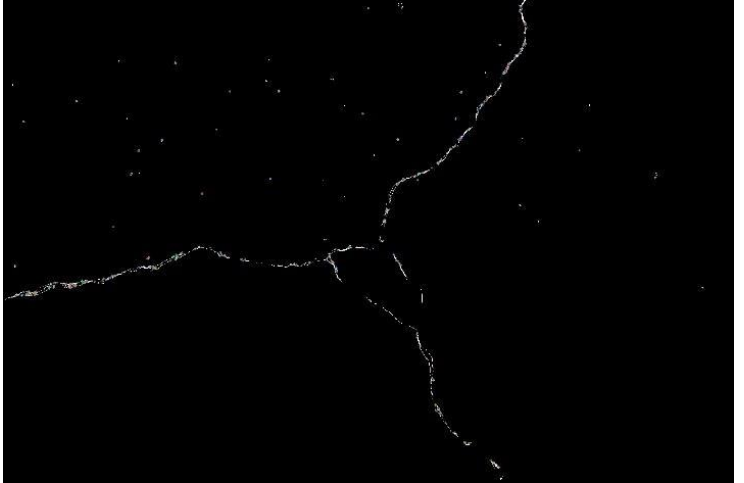
A close-up photograph of a light-colored concrete surface with a prominent, irregular crack running horizontally across the middle.

A fluorescence image of the concrete crack, showing a horizontal line of white and light-colored spots against a black background, indicating the presence of certain materials or contaminants.
