**Graphene Modified Cement
for High Performance Repair**

Dissertation submitted in partial fulfilment of
the requirements for the
Degree of Study (Hons)
Civil Engineering

Universiti Teknologi PETRONAS

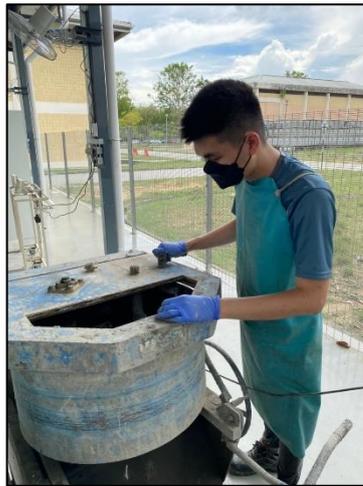
FIGURE 3.2: Mixing of 35 MPa Ordinary Concrete

This first step would be split into three days as there were 36 samples of the concrete cylinder to be made by this type of concrete. Secondly, all the 36 samples of the concrete cylinder would be cured and left for 3 days, 7 days and 28 days. Thirdly, after the curing of ordinary concrete cylinders, they would be cracked through the compression machine. The desired compression strength that is subjected to the ordinary concrete cylinders will be more than 35MPa to create the uniform concrete crack. The magnitude where the concrete specimens fail will be noted as initial compressive strength. Figure 3.2 shows the concrete mixing in the laboratory.

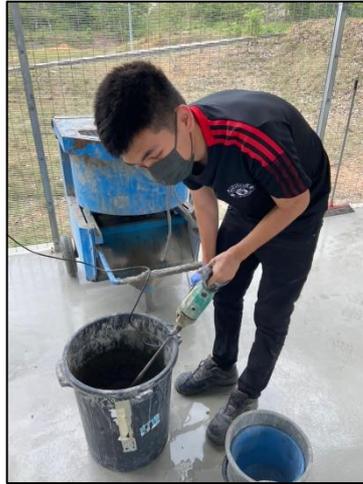
FIGURE 3.3: Mixing of GNP Cement Mortar by Portable Cement Mixer with Rod

Fourthly, it was time for the preparation and mixing of GNP cement mortar. This fourth step was divided into a few sub-steps which involved a lot of technique and skills. The first sub-step was the dispersing of GNP into the water and letting them fully dissolve into the water. Based on the study, the volume of GNP ranges from 0% to 0.1% of the total volume of cement. This range is workable and applicable in producing the excellent performance of GNP cement mortar. Therefore, the preparation and mixing of GNP cement mortar were repeated for 0 wt%, 0.02 wt%, 0.04 wt%, 0.06 wt%, 0.08wt% and 0.1 wt% of GNP to the total weight of cement. Each mix of GNP cement mortar would be used to repair 6 ordinary concrete cylinders that have cracks. Six of these ordinary concrete cylinders were equally divided into two per group which have been cured for 3 days, 7 days and 28 days respectively. At the same time, each mix of the GNP cement mortar would be cast into the dog bone shape of concrete mould.

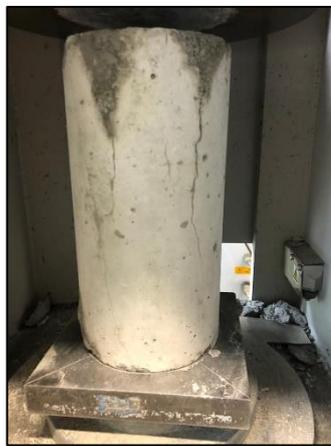
FIGURE 3.4: Testing of Compressive Strength for Post-Crack and Repaired Concrete Specimens

Fifthly, the post rectifying concrete cylinders would be then evaluated through the compression machine after strength gaining. This is to determine the enhancement or reduction of concrete cylinders in terms of compressive strength. While the dog boned shaped concrete would be evaluated to test their mechanical tensile strength after 7 days and make as the validation to the findings on the compressive strength. Figure 3.3 shows the compressive strength test for post-crack and repaired concrete specimens while figure 3.4 shows the tensile strength test for GNP cement mortar.

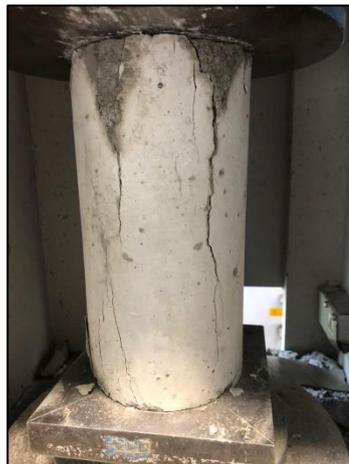
FIGURE 4.9: The Propagation of Crack from the Original Fracture Tips

Moreover, the high surface energy of GNP was used up during the mixing of cement mortar. [16] The consumption of this surface energy was to facilitate themselves to bind into the cement composite consisting of cement and water, especially during the hydration process. When this cement mortar was being used to repair the existing concrete surface, the surface energy of GNP had disappeared which made the low compatibility between the GNP cement mortar and existing concrete. Furthermore, steel reinforcement is useful and efficient in preserving concrete from the unstable crack formation. Steel reinforcement was not in use for this study. Although they were repaired with GNP cement mortar, the concrete specimens without steel reinforcement were weak in resisting the formation of cracks. According to the findings, ductile failure occurred as a result of increased loads, and the cracks propagated from the original fracture tips during compressive strength testing. It was determined that the initial compressive strength of the concrete specimens was higher than the post-crack and repaired concrete specimens as a result of this ductile failure. Figure 4.9 shows the propagation of crack from the original fracture tips.
