Study of the Microstructure of the Gas Turbine Internal Blade

Dissertation submitted in partial fulfilment of  
the requirements for the  
Bachelor of Engineering (Hons)  
(Mechanical Engineering)

SEPT 2011

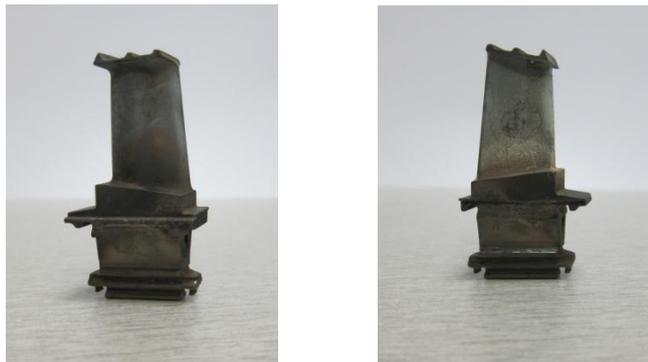
*Figure 1.1: Turbine blade 1<sup>st</sup> stage.*

Turbine blades (see Figure 1.1) are exposed to high temperature gas exiting the combustion chamber to produce mechanical work. They are also cooled down by the compressor air which flows through the blade internal passage forming an air film between the blade and the hot gas. Often the turbine blade will suffer from thermal stress failure as well as failure due to creep. Thus, it is importance if study of the turbine blade microstructure can be conducted to understand its profile with regard to the gas turbine operating temperature.

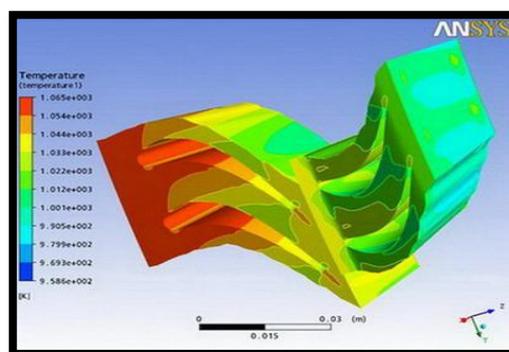
Figure 2.2: Fluid flow temperature distribution around the first stage blades.

From these researches, an improved procedure or methodology can be perform in the study of microstructure of turbine blade. First, the blade will be sectioning to several samples. The author had received specimens from PETRONAS Carigali Sdn Bhd which came from different stages of turbine engine. Examination of the blade will be made at different zones of blade: near the cracked bladetips and close to the blade platform [7]. To improve the methodology, additional zones; middle blade will be examined to get a complete profile of microstructure along blade with respect to temperature. The microstructure profile will be compare with the existing fluid flow temperature distribution as shown is Figure 2.2 [4].

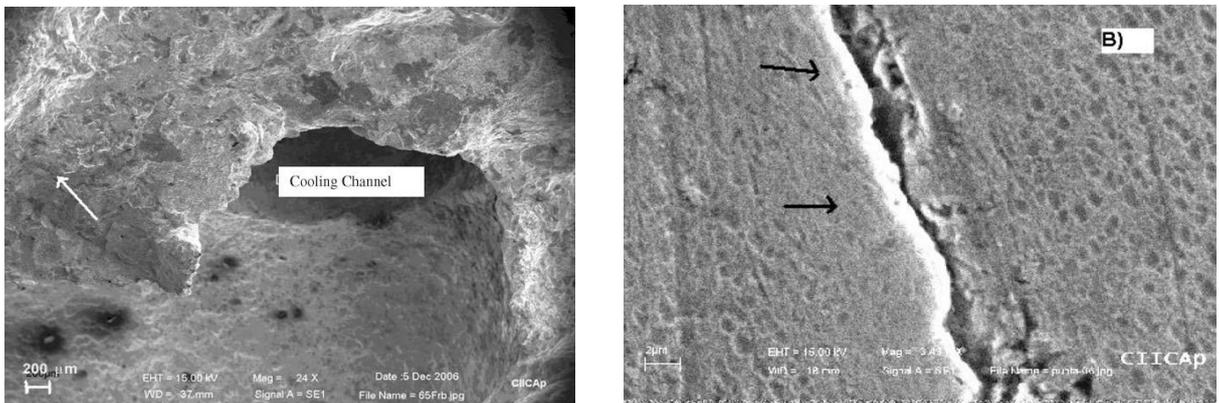
*Figure 2.3: The micrograph that shows the location where the crack started.*

From the analysis been done, several result were found indicated the existence of failure to the blade especially due to creep and thermal stress failure. On one study of failure analysis (Kubiak, et al., 2009), two cracks were identified in this blade as shown in Figure 2.3; one from the securing pin hole up to the blade base and the second one in the leading edge of the blade body, exactly at 1.5 cm from the blade base [ix]. This microstructure is hard and brittle, and leads to failures. A micro hardness profile along the blade also indicates that in the fractured zone, martensite was observed and increase of hardness was present. Carbides were also distributed in discrete form and gamma prime phase appears in the form of circle/cubic with a size between 0.5 and 1  $\mu\text{m}$ , whereas the carbides, along the grain boundaries, were 10  $\mu\text{m}$  long and the grains are nearly 100 $\mu\text{m}$  in length.

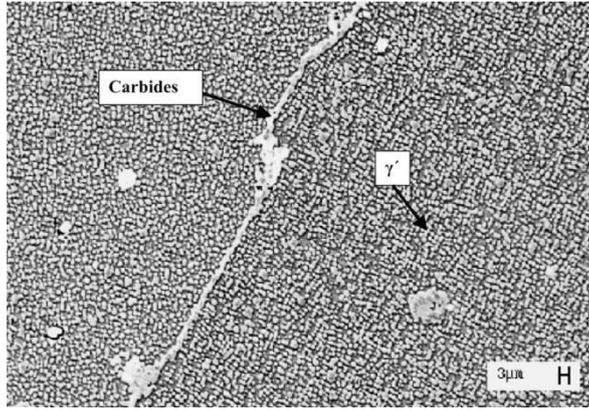
*Figure 2.4: Continuous band of grain boundary carbides and  $\gamma'$  morphology in the hottest zone.*

Meanwhile in one report of failure analysis (Mazur, Luna-Ramirez, Juarez-Islas, & Campos-Amezcu, 2004), the microstructure evaluation of different zones of the blade shown in was carried out. The microstructure of the blade hot section (airfoil) was compared to the cold reference zone (blade root) to evaluate the degree of alloy deterioration. Based on Figure 2.5 and Figure 2.5, the comparative evaluation includes the morphology change of the  $\gamma'$  particles, carbide precipitation and characterization of grain type and size [x].

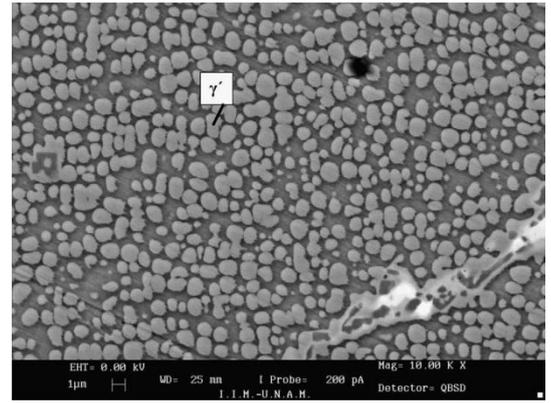
*Figure 2.5: Gamma prime  $\gamma'$  morphology in the middle zone.*

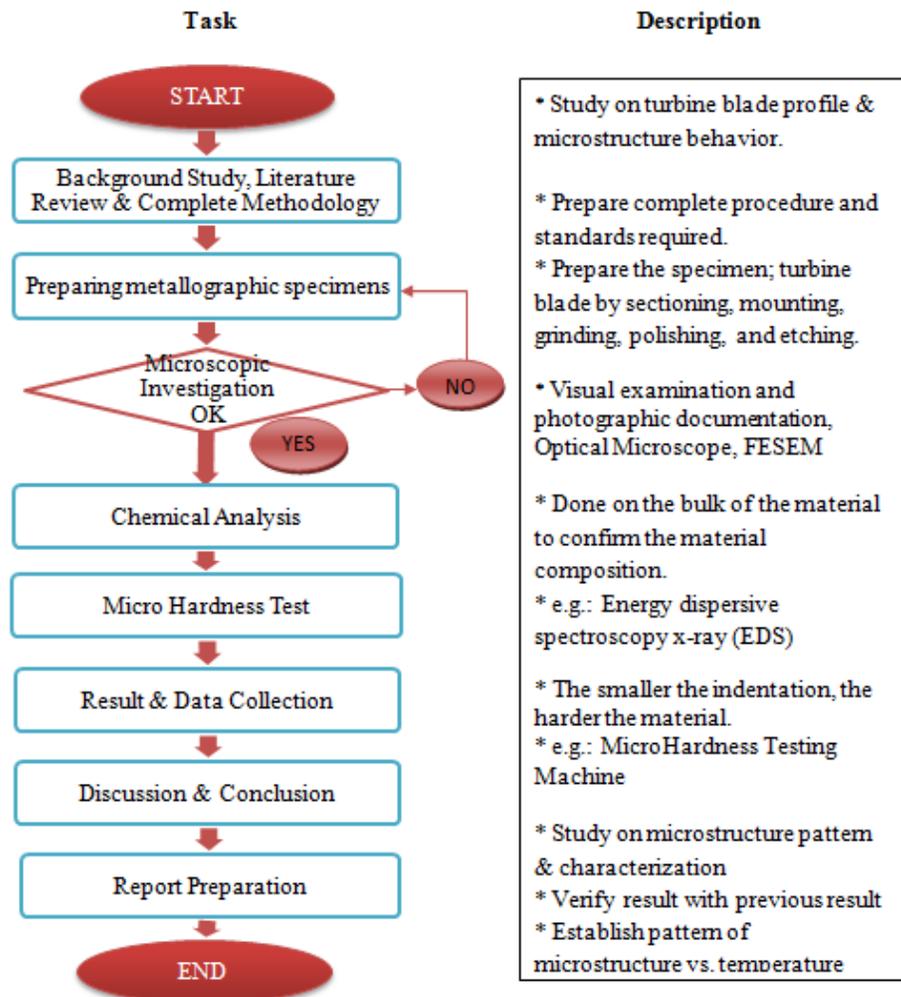
Figure 3.1: The flowchart of the project methodology and its description.

Figure 3.1 below describes the method of conducting the project.

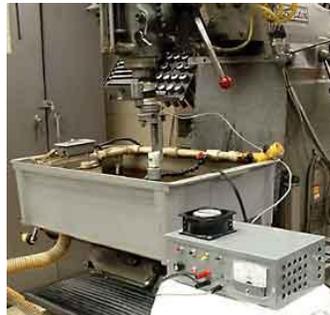
*Figure 3.2: Electrical Discharge Machining (EDM).*

In this experiment, EDM (Figure 3.2) was used to section the turbine blade into small specimens. Electric discharge machining (EDM) is a manufacturing process whereby a desired shape is obtained using electrical discharges (sparks). Material is removed from the workpiece by a series of rapidly recurring current discharges between two electrodes, separated by a dielectric liquid and subject to an electric voltage.

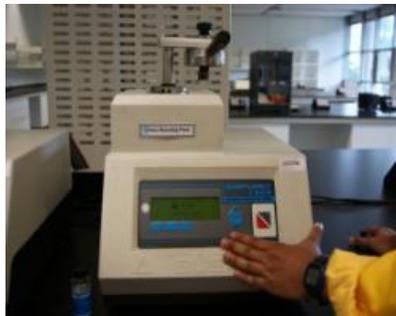
*Figure 3.3: Equipment used for hot mounting.*

The purpose of mounting is to get the flat surface of sample so that it would be easier for grinding process to take place.

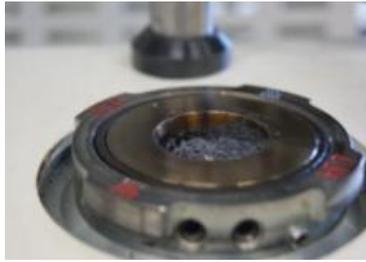
*Figure 3.4c: Phenolic powder was filled inside the mounting together with the sample.*

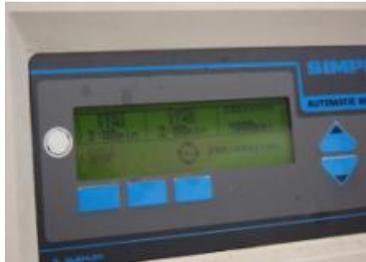
*Figure 3.4d: Once the setup has finished, it took about 10minutes for heating and cooling process.*

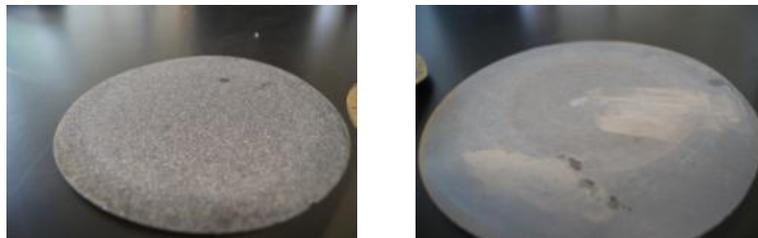
*Figure 3.5: Silicon grid paper 120 grit (left) and 1200 grit (right).*

Once the sample has been mounted, the resin block must be ground flat. Grinding process was performed by using Grinder and Polisher machine model Metaserv 2000. The samples were ground with SiC paper and running water and rotated the sample through  $90^\circ$ . The SiC paper (see Figure 3.5) used ranging from the coarsest grit paper, 60 grits to 1200 grits to eliminate the scratches from the previous grinding stage otherwise they will not be removed in polishing.

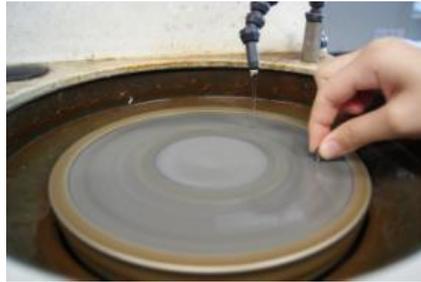
*Figure 3.6: Grind the specimen at 90 degrees.*

- (4) Finally, turning specimen 90 degrees (Figure 3.6) and repeat procedure (3) now on the 320,400,600 and 1200 Grit surface.
- (5) Close water line.

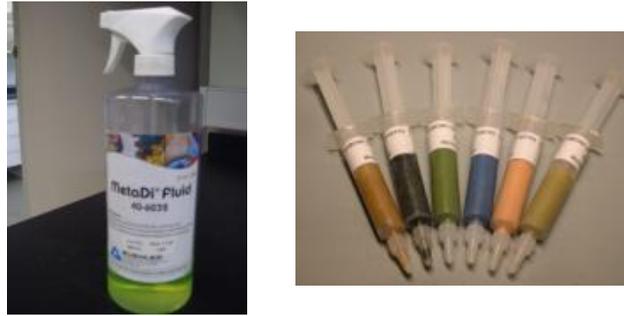
Figure 3.7: metaDi Fluid (Left) and Diamond Paste (Right).

- (1) Providing a polishing pad having at least one circular groove wherein the circular groove encircles an axis of rotation of the polishing pad.
- (2) Apply metaDi fluid ( Figure 3.7) on the polishing pad;
- (3) Apply diamond paste on the polishing pad and specimens

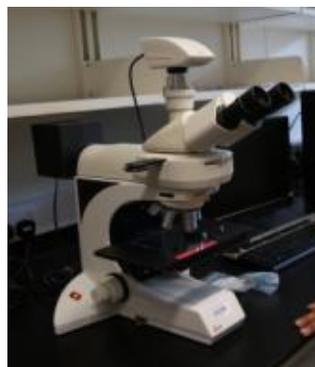
*Figure 3.8: Optical Microscope.*

The optical microscope (Figure 3.8) uses visible light and a system of lenses to magnify images of small samples. The actual power or magnification of a compound optical microscope is the product of the powers of the ocular (eyepiece) and the objective lens. The magnification employed during the experiment were 50x and 100x.

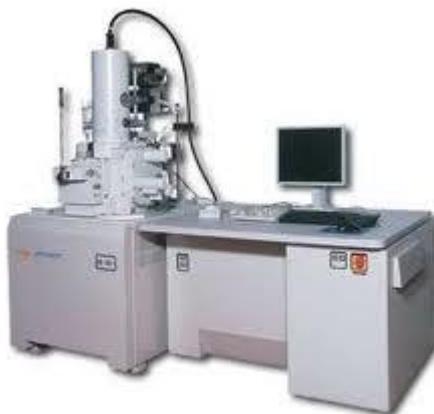
*Figure 3.9: FESEM*

FESEM (Figure 3.9) with ultra high resolution imaging is used to analyze up to nano scale surface structure and morphology of solids. EDS is embedded in this equipment to identify the different elements present in the specimen. Functions of FESEM are to analyze surface morphology and topography, point to point elemental analysis, line scan analysis and x-ray mapping. The microstructure analysis was conducted using Carl Zeiss AG with magnification up to 10K X, 5K X and 1K X with a working distance 8.0mm.

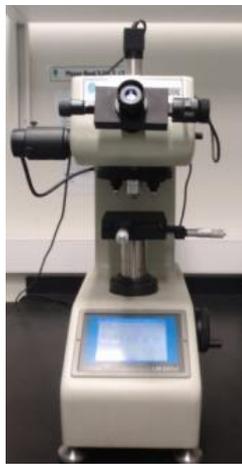
*Figure 3.10: Microhardness Testing Machine used for indentation test.*

The hardness reading for each sample was taken at three different locations of the sample's surface to get the accurate average hardness of the sample. These hardness values provided the data to estimate the yield strength properties of the Nickel based superalloy.

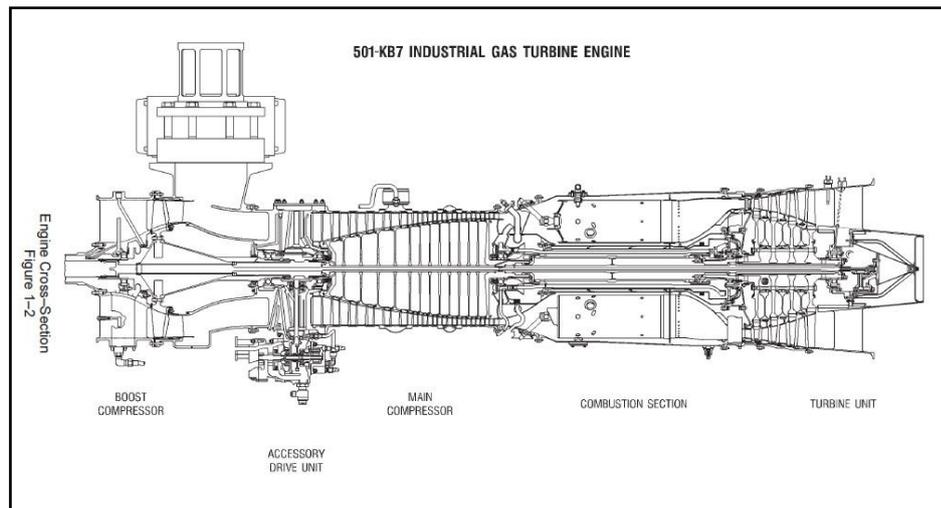
*Figure 4.1: Rolls-Royce Allison 501-KB7 Gas Generator.*

Gas turbines are extensively used for power generation and for the propulsion of aircraft and vessels. Rolls-Royce Allison 501-KB7 turbine unit (refer Figure 4.1) consist of four-stage rotor and vane assembly (stages 1, 2, 3, and 4). The 1st stage blades and vanes are air cooled. The rotor assembly absorbs the necessary energy from the expanding gases to drive the compressor rotor, the engine driven accessories, and the driven equipment through the PTO assembly. [11]

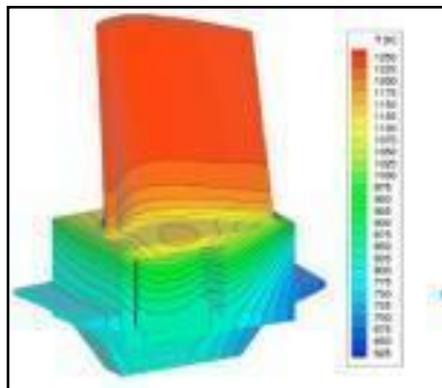
*Figure 4.2: Temperature distribution of blade without cooling channels.*

The maximum temperature experienced by the blade is along the leading edge, at about two-third of the blade height. Generally, the differential temperature along the leading edge during service results in a graded microstructure in the blade, and is a function of distance from the blade root platform [12]. The first stage turbine blade was introduced to maximum temperature (950°C -1057°C) and the temperature will gradually decreased along the blade as shown in Figure 4.2. Upper part of the blade has the maximum temperature meanwhile the temperature drop gradually until lower part of turbine blade. First stage blade was exposed to higher temperature exposure from the hot gas than second and third blade [13]. During high temperature service, the microstructure slowly degrades by a coarsening process. In the presence of stress, e.g. caused by the centrifugal load in a gas turbine blade, a severe directional coarsening, so-called rafting, of the initially cuboidal  $\gamma'$ -particles into a plate-like structure occurs.

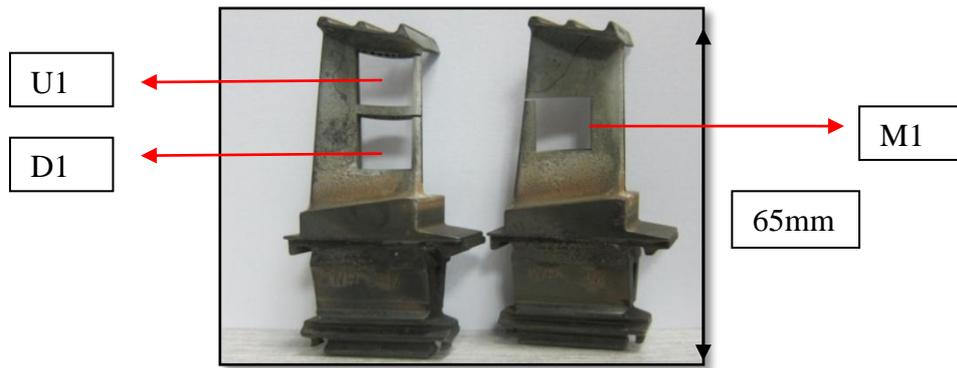
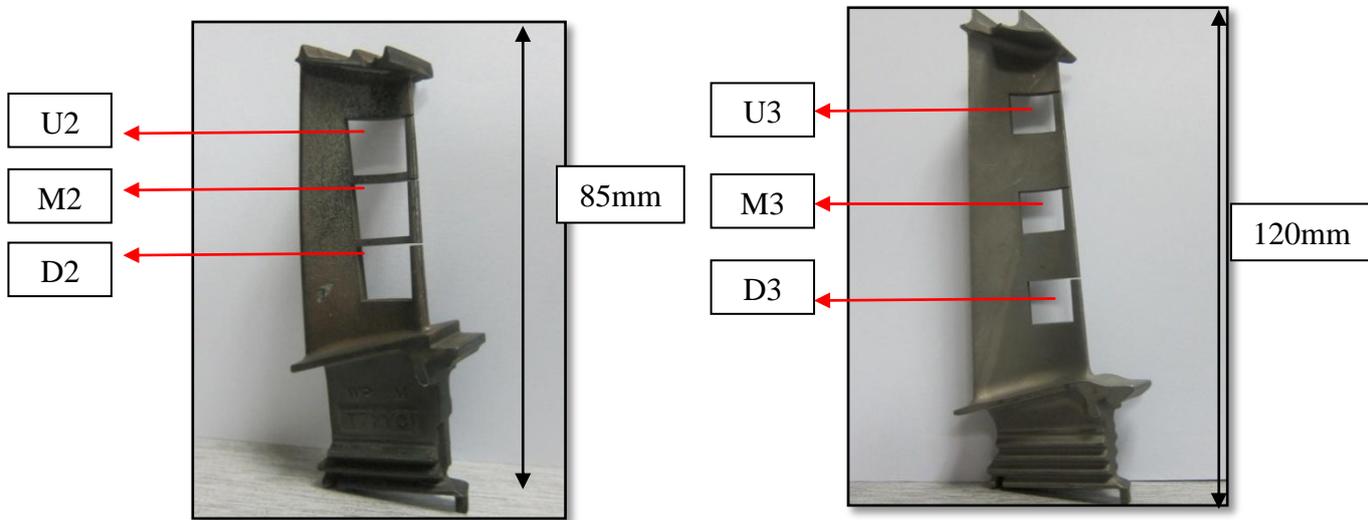
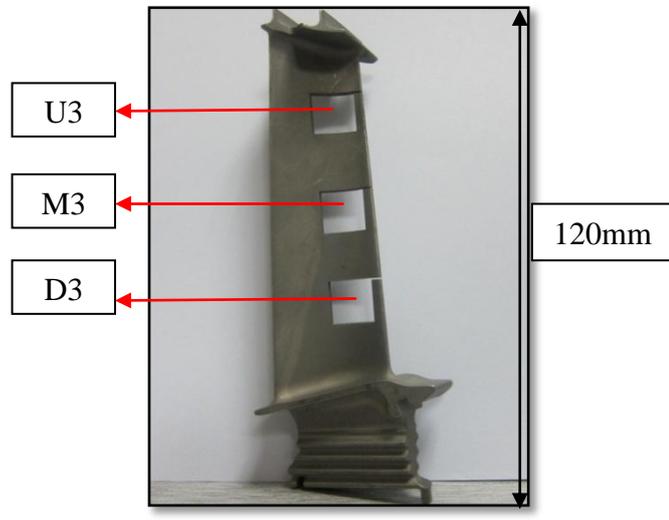
Figure 4.3a: Turbine Blade 1<sup>st</sup> Stage

Figure 4.3b: Turbine Blade 2<sup>nd</sup> Stage

Figure 4.3c: Turbine Blade 3<sup>rd</sup> Stage

Figure 4.3: Sections for each stage of turbine blade.

To study the correlation of material microstructure and creep exposure, the turbine blades were sectioned to 3 parts (1 cm x 1cm) for each blade (Figure 4.3). The samples were cut at lower part (D), middle (M) and upper part (U).

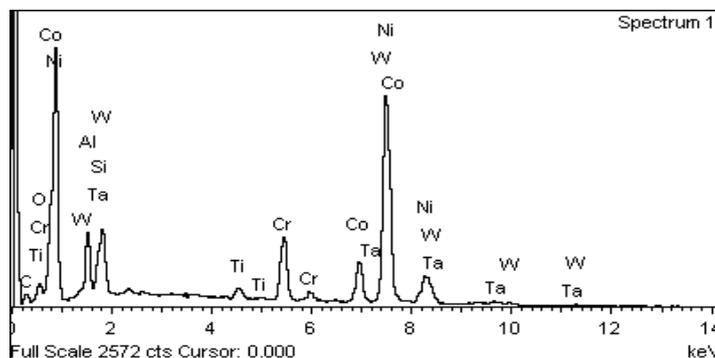
Figure 4.4: Chemical composition for sample M2.

Based on Figure 4.4, Ti amount is in the range between 0.8 to 1.0 wt% and Ta has the highest amount, 7.35wt%. The element Ti and Ta strengthens the  $\gamma'$  precipitates by substituting to Al in Ni<sub>3</sub>Al. Al also plays a fundamental role in promoting the formation of a stable Al<sub>2</sub>O<sub>3</sub> alumina surface scale which protects the alloy against further oxidation. Several elements are added in small quantities for control of grain structure and mechanical properties that are strongly influenced by grain boundaries. Minor additions of C tend to result in the formation of carbides, often located at the grain boundaries.

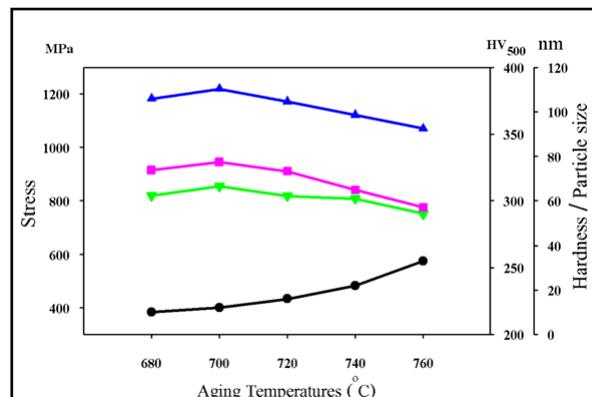
Figure 4.5: The relationship between mechanical properties and gamma prime particle size.

A relationship between the particle size and temperature of turbine blade SRR99 was constructed referring to the studies been done before. Figure 4.5 show the relationship between aging temperature and gamma prime particle size on the wrought nickel based superalloy [17] and Figure 4.6 shows the relationship between grain size and temperature when strain rate is  $0.01 \text{ s}^{-1}$ , holding time is 30 minutes. Both graphs show that when temperature increases, the particle size will be increased exponentially.

Figure 4.5 also shows that when temperature increased, hardness, yield strength and ultimate tensile strength (UTS) behaviors have the same trend which initially increase with the particle size and then continuously decreased with temperature. It could be noted that all mechanical properties are obviously related to the size of precipitate  $\gamma'$  particles in matrix.

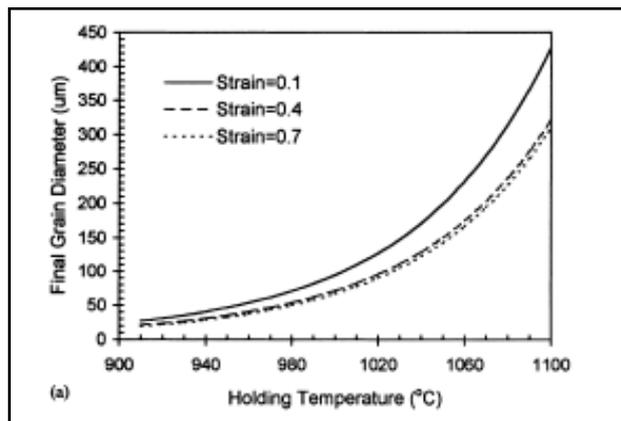
*Figure 4.6: The relationship between grain size and temperature when strain rate is  $0.01\text{ s}^{-1}$ , holding time is 30 min.*

The relationship between particle size and temperature can also be predicted on the previous work [18] as shown in Figure 4.6. From this work, the final grain size of IN718 is related to the holding and deformation temperature and also strain and strain rate prior to the holding period. The higher is the temperature, the larger is the final grain size. At a higher temperature, a dynamically recrystallized grain grows more easily than that at a lower temperature during a hot deformation process because atoms diffuse and move more easily.

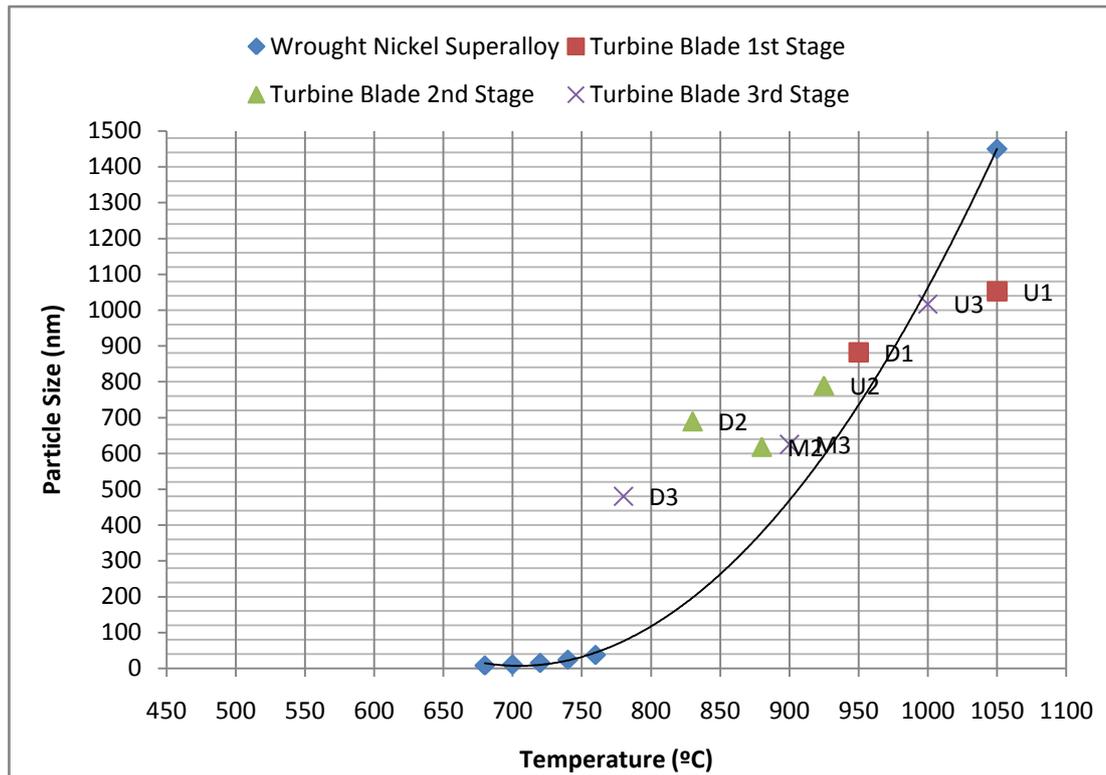
Figure 4.7: Relationship of particle size of gas turbine blade and temperature.

Results were tabulated in Table 4.3. In this table, the temperatures of each blade were estimated first according to the initial value of temperature come from combustor part which is 950 – 1057 °C. Graph in Figure 4.7 were extrapolated exponentially until the maximum temperature and maximum grain size. The maximum of grain size were estimated from previous work [19], the microstructure periodicity also depends strongly on the temperature, showing values from 750–1450 nm. The grain size calculated before (refer Table 4.2) were plotted on the trend line to obtain the temperature value.

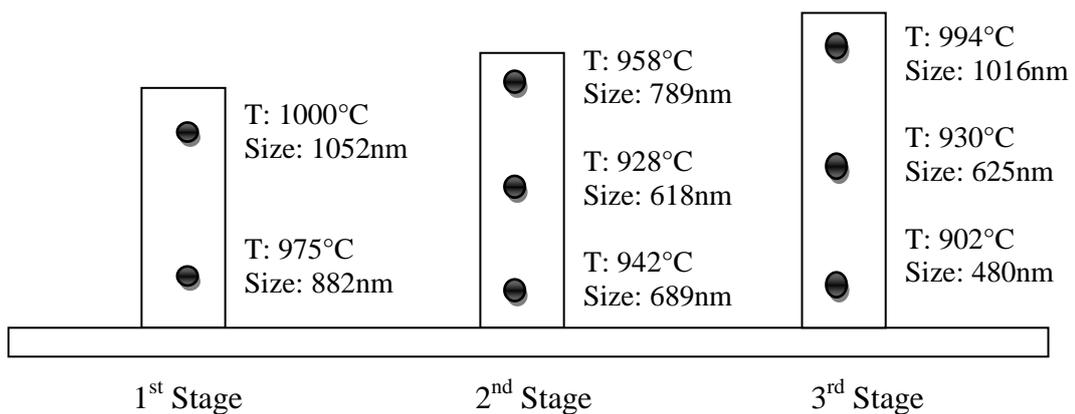
Figure 4.8: Temperature and particle size relationship on the blade arrangement.

The correlation between temperature and microstructure on every stage of turbine blade can also be performed. From Figure 4.8, an increment on particle size can be seen when the temperature are higher at upper part (U1, U2 and U3) of turbine blade. The particle size was smaller when the temperature drops from 1<sup>st</sup> stage blade to 3<sup>rd</sup> stage blade. This relationship also is applied on the middle and lower section on the blade. At lower section (D1, D2 and D3, the temperature drop from 975°C to 902°C. At D1, the microstructures were fully rafted with angular shape while the microstructures in D3 were very fine and in cuboidal  $\gamma'$  shape. The evolution of particle size and shape can be concluded due to high temperature and stress applied from turbine.

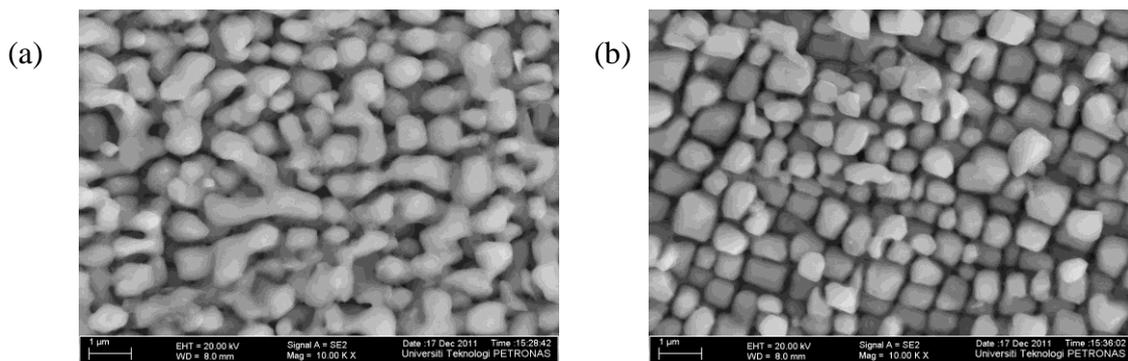
Figure 4.9:  $\gamma'$  morphology (a) rafted particle size  $1.053\mu\text{m}$  for sample U1 and (b) with particle size  $0.882\mu\text{m}$  for sample D1.

Significant changes occurred in the microstructure of the base alloy of first stage blade during service aging 24000 hrs at the highest operating temperature, 950 °C - 1050 °C hot gas coming from combustor part. The blade was subjected to hot gas temperature from combustor to first stage vane. Figure 4.9a show a rafted  $\gamma'$  resulting from exposure to stress at high temperature.

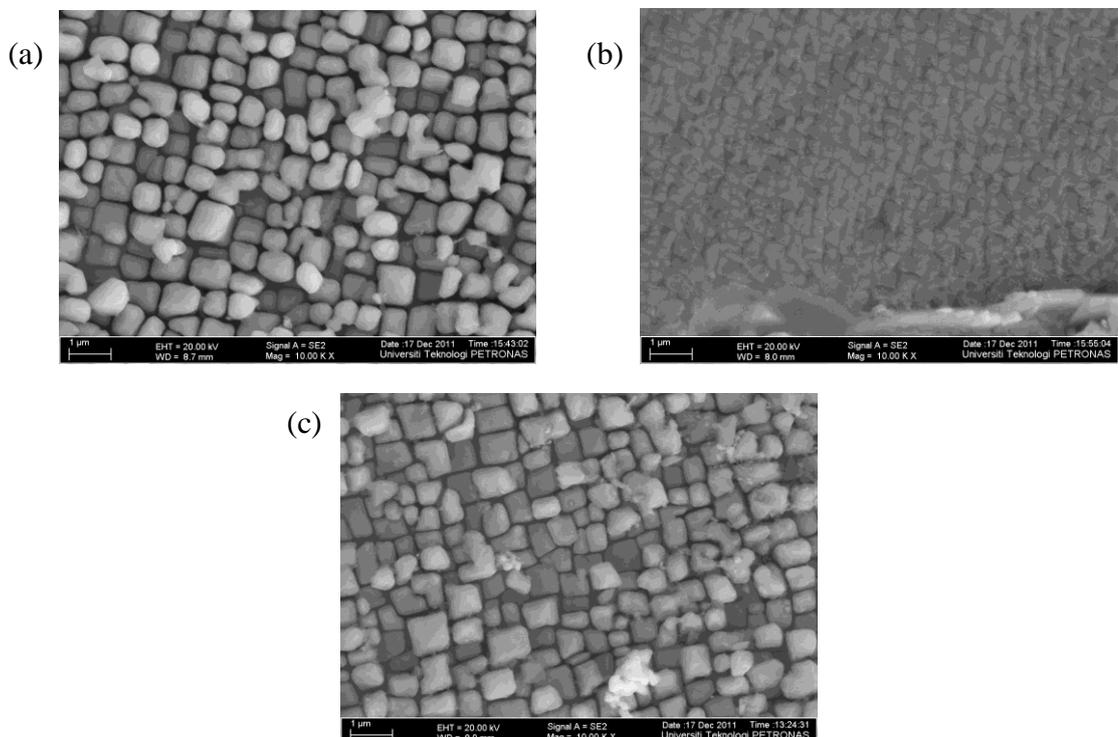
*Figure 4.10:  $\gamma'$  morphology (a) of particle size 0.789  $\mu\text{m}$  for sample U2 and (b) of particle size 0.619  $\mu\text{m}$  for sample M2 and (c) of particle size 0.69  $\mu\text{m}$  for sample D2.*

The degree of degradation, as evaluated by the gamma prime particle size, increases with exposed time and service temperature. The primary gamma prime particle size varied from 0.789  $\mu\text{m}$ , 0.619  $\mu\text{m}$  to 0.69  $\mu\text{m}$ , as shown in Figure 4.10. The microstructure shows significant degradation in service. The primary gamma prime particles have been spheroidized and secondary gamma prime coarsened in the sample [21]. From the reducing  $\gamma'$  volume fraction and increasing size of particle size, it can be concluded the temperature increased alongside the blade from lower part to upper part.

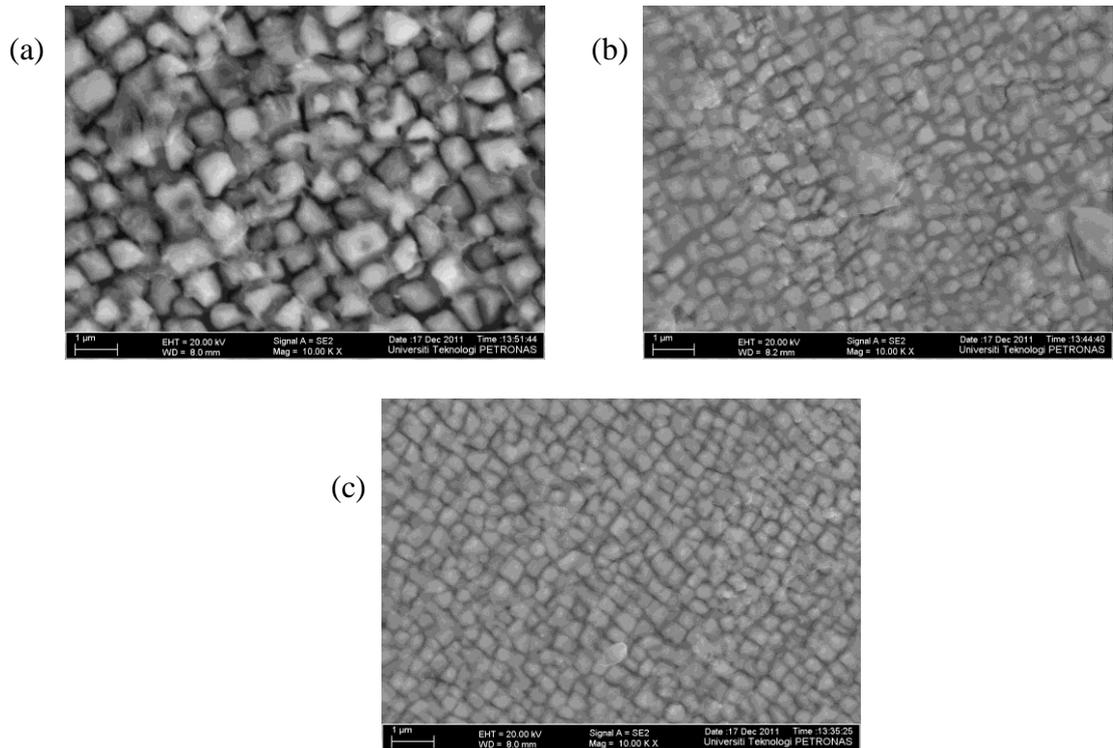
*Figure 4.11:  $\gamma'$  morphology (a) of particle size  $1.016\ \mu\text{m}$  for sample U3 and (b) of particle size  $0.625\ \mu\text{m}$  for sample M3 and (c) of particle size  $0.48\ \mu\text{m}$  for sample D3*

As shown in Figure 4.11, the precipitates  $\gamma'$  morphology which were  $0.48\ \mu\text{m}$  in size (D3) in the form of circle/cubic at third stage blade have coarsened during service aging to  $0.625\ \mu\text{m}$  (M3) and  $1.016\ \mu\text{m}$  (D3) [22]. The blade was subjected to hot gas temperature from second stage blade at around  $900\text{--}1000\text{ }^\circ\text{C}$ .

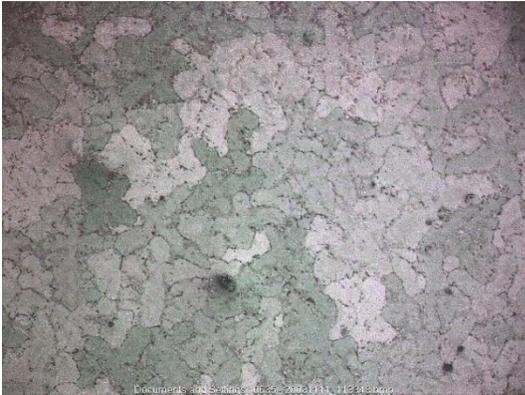
<p>Sample : U3</p> <p>Microstructure of SRR99 with a fine grain size, considerable delta and large primary MC carbides revealed using glyceresia.</p>
2

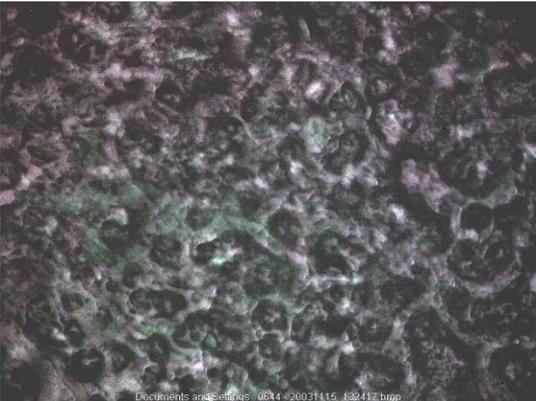
<p>Sample: U3</p> <p>Microscope image of nickel superalloy with smaller grain boundaries by using Marble Reagent. This region was exposed to high temperature of hot gas.</p>

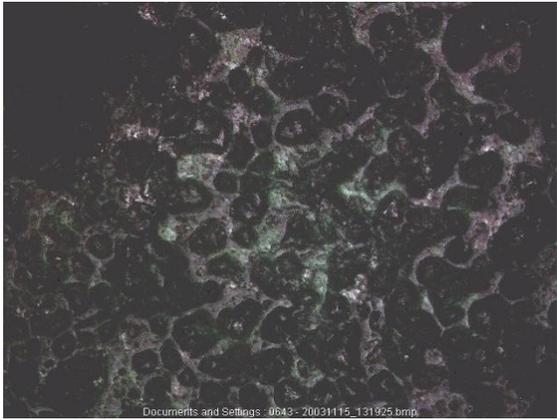
<p style="font-size: small; text-align: center;">Documents and Settings\0643-20031115_131925.bmp</p>	<p>Sample : M3</p> <p>Microscope image of nickel superalloy with bigger grain boundaries than Sample-U3 by using Marble Reagent. This region was exposed to high temperature of hot gas but was cooled down from cooling air.</p>
5

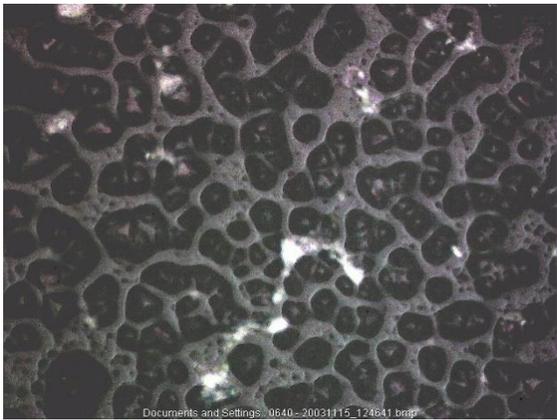
<p style="font-size: small; text-align: center;">Documents and Settings\0640-20031115_174641.bmp</p>	<p>Sample : D3</p> <p>Microscope image of nickel superalloy with bigger grain boundaries than Sample-U3 and Sample-M3 by using Marble Reagent. This region which is the trailing edge was exposed to high temperature of hot gas but was cooled down from cooling air.</p>
