Development of a Failure Prediction Model for Heat Exchanger Tube

Dissertation submitted in partial fulfillment of
the requirements for the
Bachelor of Engineering (Hons)
(Mechanical Engineering)

JANUARY 2008

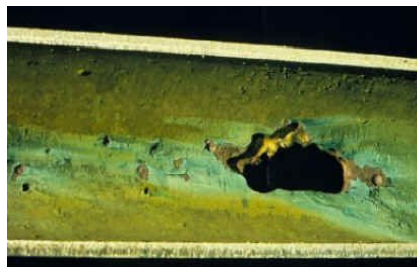
Figure 2.6: Inner surface having Erosion Corrosion

Corrosion of a metal which is caused or accelerated by the relative motion of the environment and the metal surface[18]. It is characterized by surface features with a directional pattern which are a direct result of the flowing product. Erosion corrosion is most occurring in soft alloys (i.e. copper, aluminum and lead alloys)

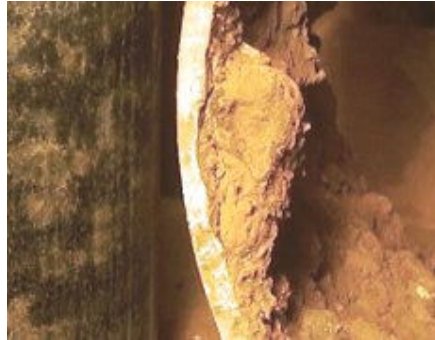
Figure 2.7: Deposit at inner surface of tube

A condition often indicated ultrasonically by some areas showing at near original specification, and adjacent areas of high wall loss. It is more prevalent at the bottom of horizontal lines, on lower floors, and where flow rates are slowest[17].

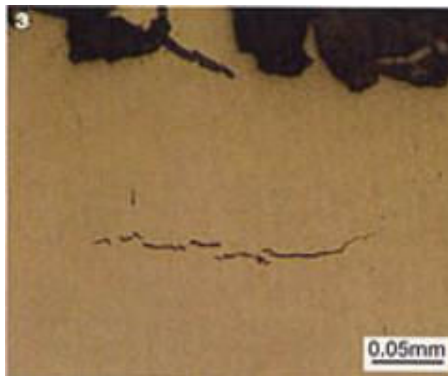
Figure 2.8: HIC at tube surface

Brittle mechanical fracture caused by penetration and diffusion of atomic hydrogen into the crystal structure of an alloy and also referred to as hydrogen embrittlement[19]. This can occur during elevated-temperature thermal treatments and in service during electroplating, contact with maintenance chemicals, corrosion reactions, cathodic protection, and operating in high-pressure hydrogen.

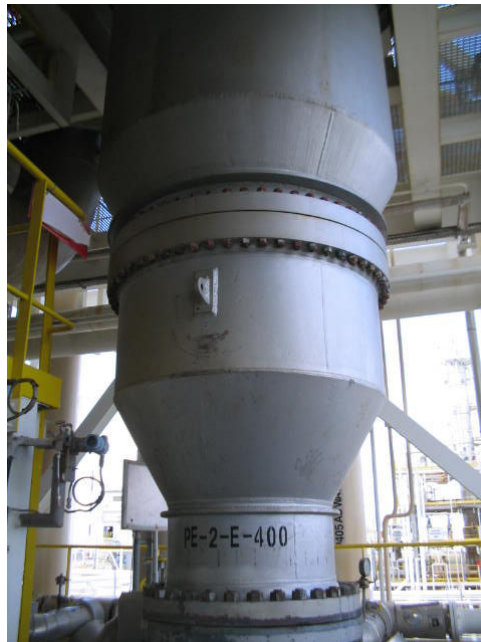
Figure 2.10: PE-2-E-400 Heat Exchanger in EPMSB

Tubes (original) were supplied by M/S. Benteler, Germany in normalized condition and confirm to the Chemical composition, mechanical properties, hardness (from 64 to 75 HRB \leq 85 HRB), hydraulic test (1500 PSI) as per ASTM A 334gr1 .Outer diameter and thickness of original supplied tubes were 25.4mmX 2.23mm respectively

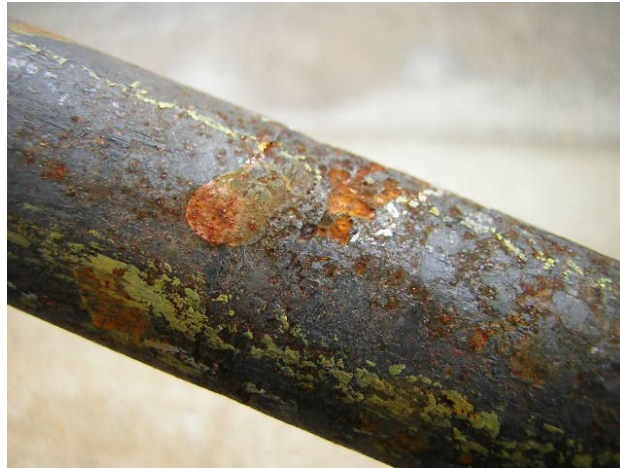
Figure 2.12: Tube sheet having deep pitting

Thin layer of deposit (light blackish in color) was observed throughout the length of the tube. Deep pitting corrosion was found just above the bottom tube sheet having a length of about 200mm. Corrosion was noticed under the baffle plate. No appreciable corrosion was observed on other area.

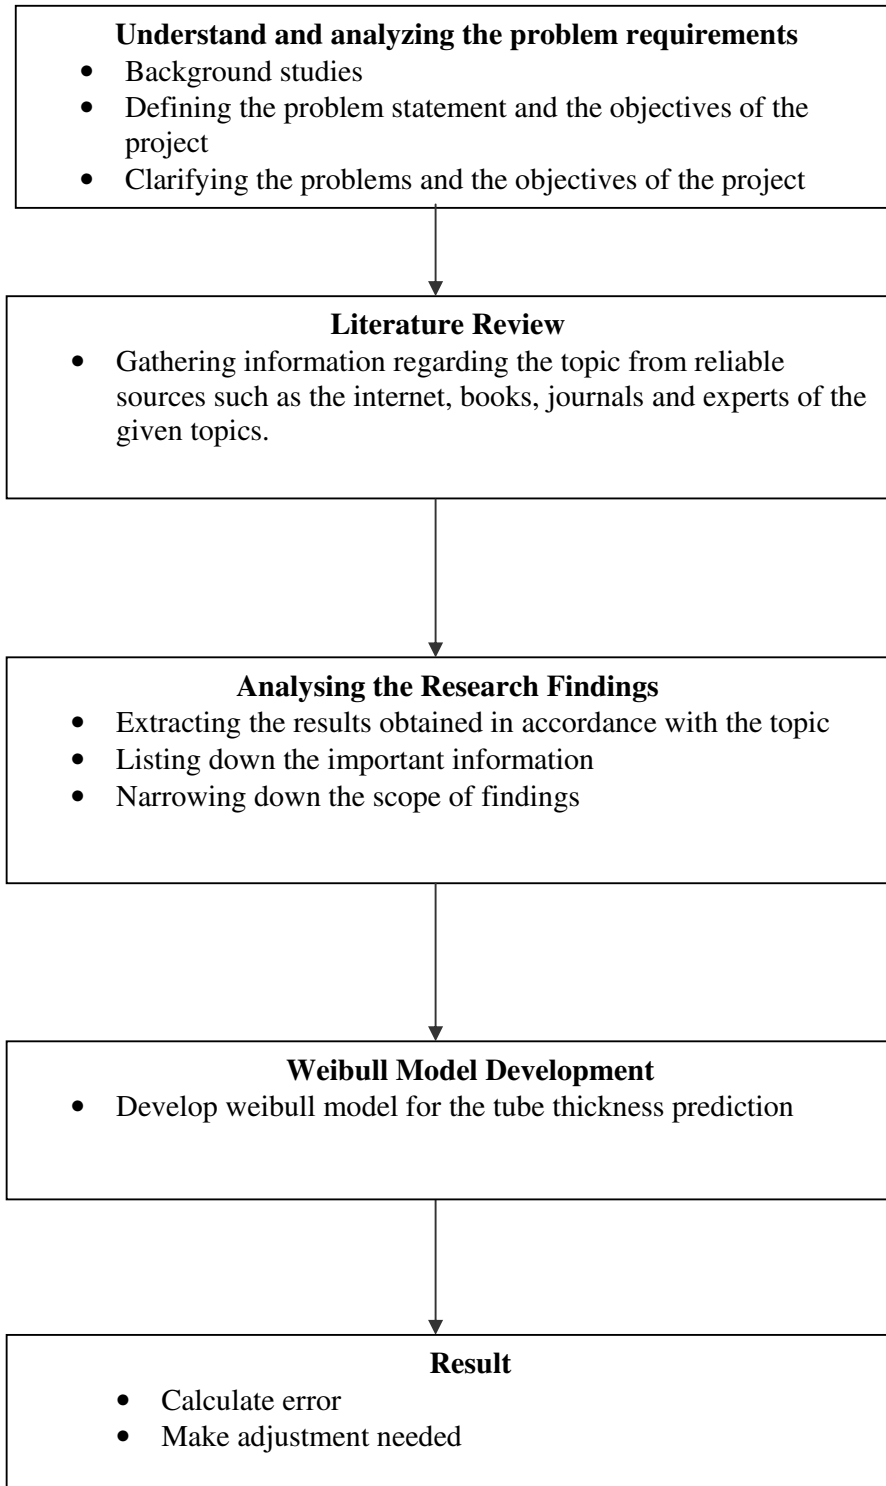
To get clear view of the methodology of this project, below is the simplified methodology using flow chart.

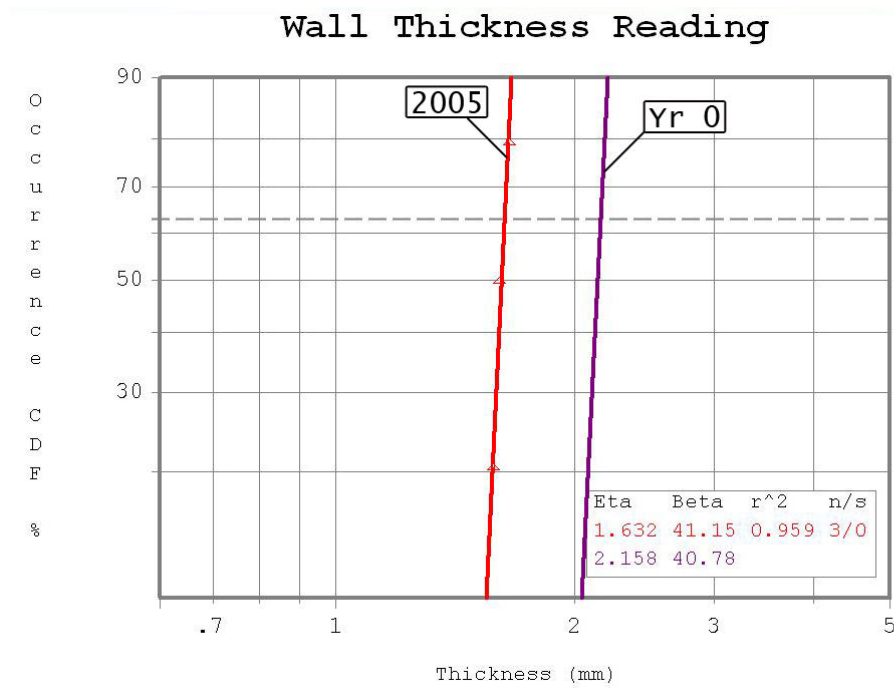
Wall thickness data for year 2005 and year 1991(year zero) was plotted as in Figure 4.1. Dash line represented the rule of thumb practice value when the tube thickness has reduced thickness by 1/3 or almost 66.67% of the tube thickness.

Figure 4.1: Wall thickness reading of Year 2005 and Year 0

A set of data as shown in Figure 4.1 with the large number of data input all the same values. This suggests the use of the “Inspection” option for analysis[10]. The inspection option regresses the trend line through the top point in the data stacks. The coefficient of determinations r^2 says this straight line explained 95.9% of scatter in the data.

That mean data obtain from EPMSB plant were increasing failure rate with respect to time ($\beta = 41.15$) Notice that the line slope (Beta) for year 0 was about the same as year 2005 (year 14). Look at the Eta values for the lines where for year 1991(Eta = 2.158) and year 2005 (Eta= 1.632)[20]

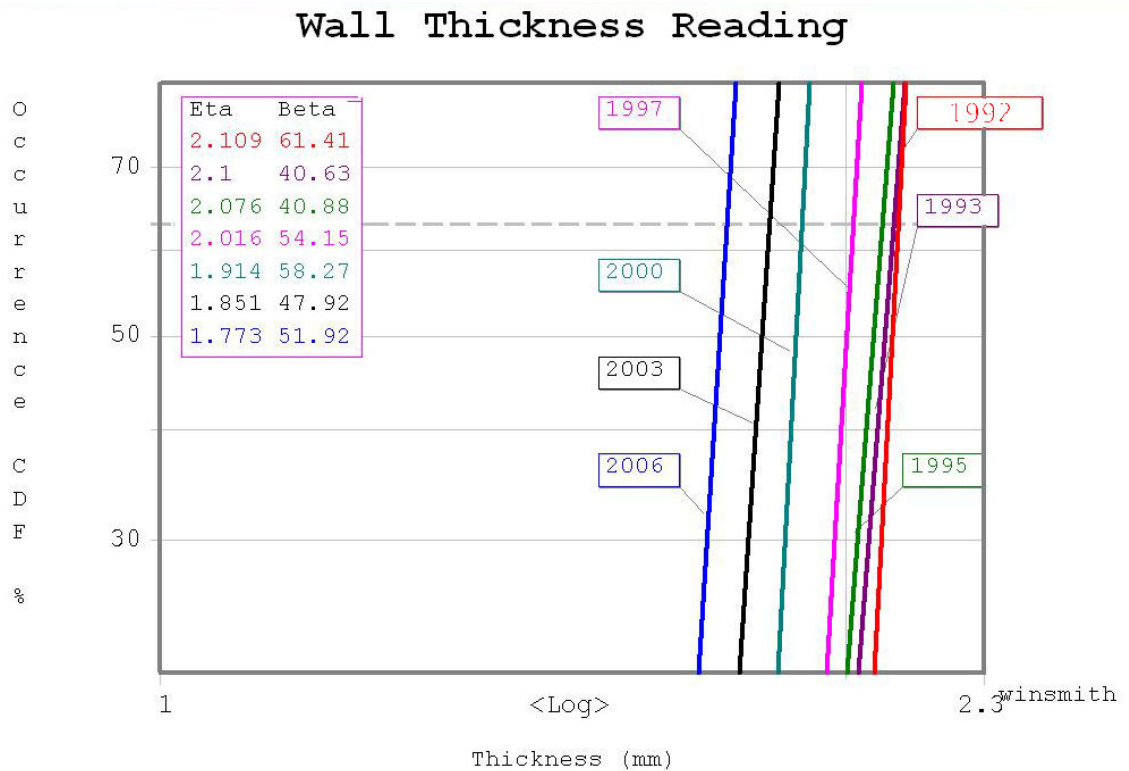
Figure 4.2: Wall thickness reading of Actual Data

In order to compare predicted data and actual data, actual data in Table 4.1 also was plotted using Weibull WinSmith software. By obtain the ETA (characteristic thickness) of the tube in actual data; comparison was made by calculate the error.

From figure 4.2, Beta value was slightly same between others that could conclude that corrosion rate was uniform and Eta value decreased as it shows the characteristic thickness of the tube. Beta value for year 1992 was the highest between all data show that high thinning rate due to plant running at lower performance.

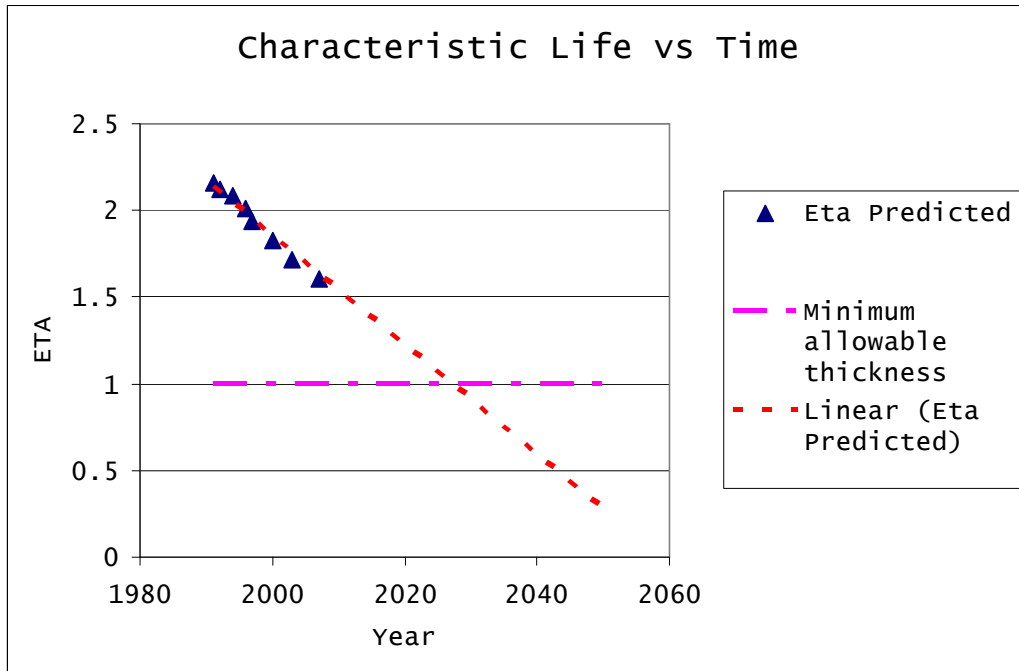
A method was described for finding the projected end of life using the characteristic wall thickness values and plotted the characteristic thickness values on a trend chart[9]. The trend chart included the critical wall thickness value determined from the Weibull plot. When the trend line of decreasing characteristic thickness values intersected with the critical minimum wall thickness, the maximum failure risk was reached which resulted in maximum failure. This technique helped predict end of life[21].

Figure 4.3: Characteristic Life (ETA) vs Time

Characteristic wall thickness values from Figure 4.3 provide a clearer signal for projecting the end of useful life as shown in Figure 4.2. The minimum line was established in Figure 4.3 by using the slope of wall thickness lines and passed the minimum wall thickness line through the maximum allowed failure, the minimum allowed value or Eta as 1 mm. This minimum value for Eta became the lower limit value for Figure 4.2. The regression trend line for Eta values versus time was projected from year 15 through the minimum Eta and they intersected at 2028 years
