**Experimental Study on Spur Gear Vibration Characteristics under Various  
Loading Conditions**

Dissertation submitted in partial fulfillment of  
the requirements for the  
Bachelor of Engineering (Hons)  
Mechanical Engineering

MAY 2012

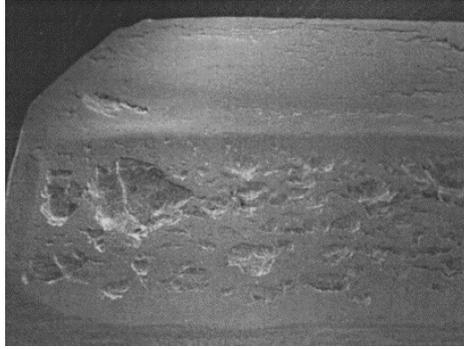
Fig. 1.3 Pitting formation on a gear tooth (*obtained from S. Glodez et al. (2003)*)

There are several types of gear fault that occur in the machine environment, which include pitting and bending fatigue breakage (cracking). Pitting, as shown in Fig 1.3, is characterized by a small cavity forming on the tooth of a gear. This type of fault usually occurs in localized parts of a gear tooth and is caused by over stressing. Pitting is sometimes known as corrective pitting due to the load redistribution done by the fault itself by removal of high contact spots.

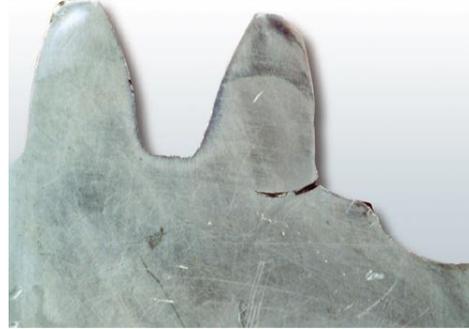
Fig. 1.4 Bending fatigue failure or cracking (*Retrieved from [www.machinerylubrication.com](http://www.machinerylubrication.com)*)

Bending fatigue failure, or cracking, as shown in Fig 1.4, occurs in the root section of a gear tooth. This fault will keep on propagate until breakage of the tooth. Cracking is caused by excessive tooth loads that causes repeated root stresses which will ultimately exceed the endurance limit.

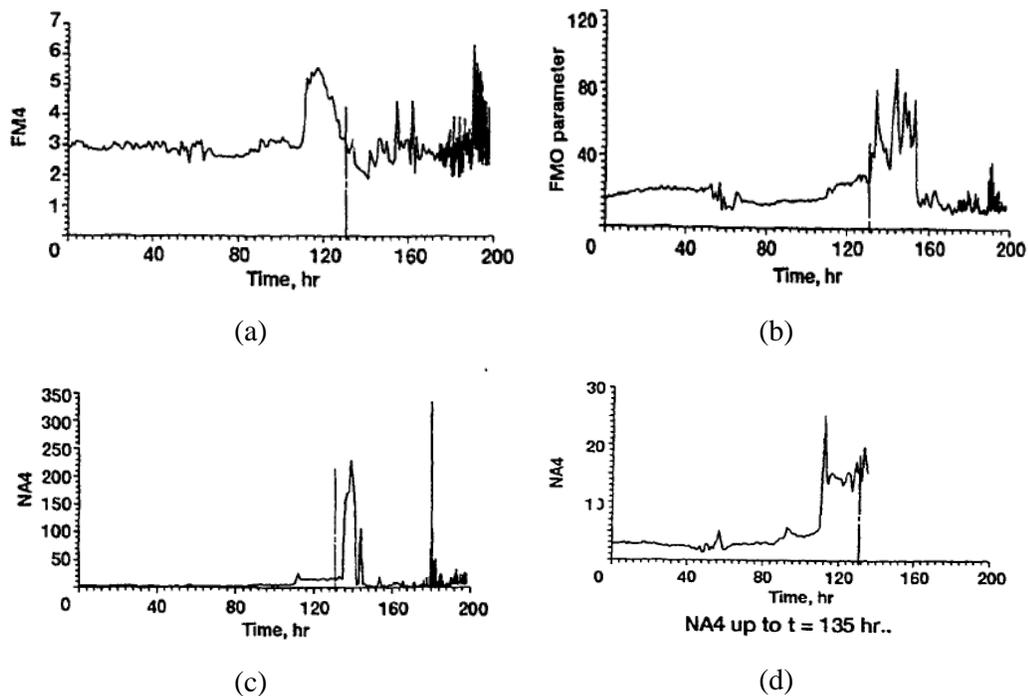
Fig. 2.1 Zakrajsek's observation of different parameters and results (obtained from Zakrajsek et al (1993))

In Fig. 2.1(a), the parameter detected the tooth damage at  $t=110$  hours, 21 hours before the rig was stopped and damage was recorded ( $t=131$ h). The FM4 peaked at a value of 5.4, and then dropped to the nominal value of 3. The parameter in Fig.

2.1(b), which is FMO, detected the damage at the time the rig was stopped for damage recording. During this time, the FMO increased three times its nominal value. In Fig. 2.1(c), the parameter detected the damage at the same time as FMO. In the expanded scale in of up until 135 hours in Fig. 2.1(d), the NA4 showed robust reaction to damage, increasing to 25 at the start of damage, and remained steady at 15 after that, despite other parameters dropping down to their nominal values.

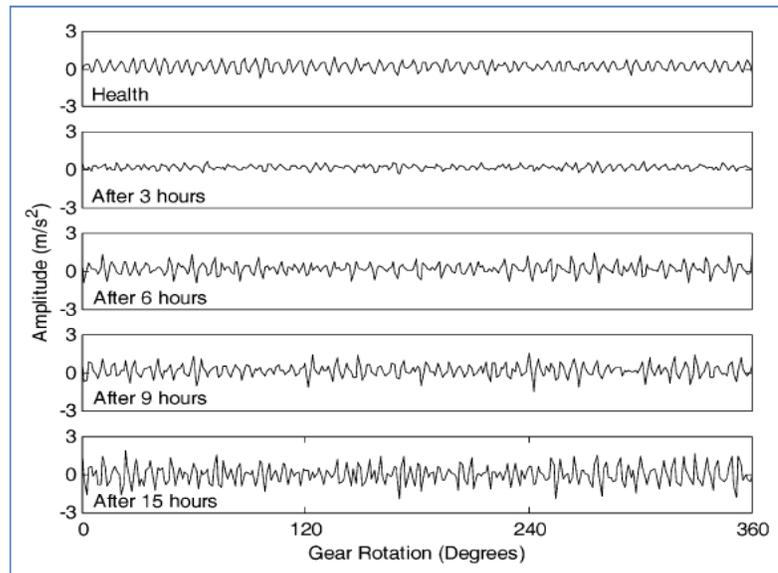
Fig. 2.2 Time-degree representation (obtained from Yesilyurt et al. (2003))

From Fig. 2.2, it is indicated that the healthy gear vibration yields a uniform sinusoidal waveform in the time-degree representation. However, after 3 hours, the amplitude of the time-degree representation was reduced. At hours 6, 9 and 15, the appearance of the time-degree representation becomes random and the amplitude of vibration also increased.

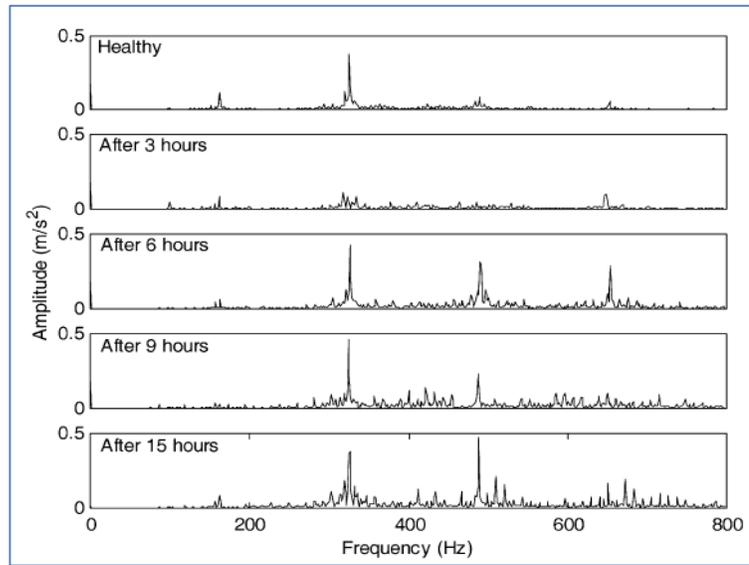
Fig. 2.3 Vibration spectra representation (obtained from Yesilyurt et al. (2003))

In Fig. 2.3, it can be seen that the second tooth-meshing harmonic located at 325Hz was the strongest component of a healthy gear vibration. However, after 3 hours, the amplitudes of the first three tooth-meshing harmonics were reduced, but the fourth toothmeshing harmonic was increased slightly. Yesilyurt commented that this is due to the small deviations in the involute tooth form. At hours 6, 9 and 15, the second, third and less significantly, fourth tooth-meshing harmonic yielded larger amplitudes.

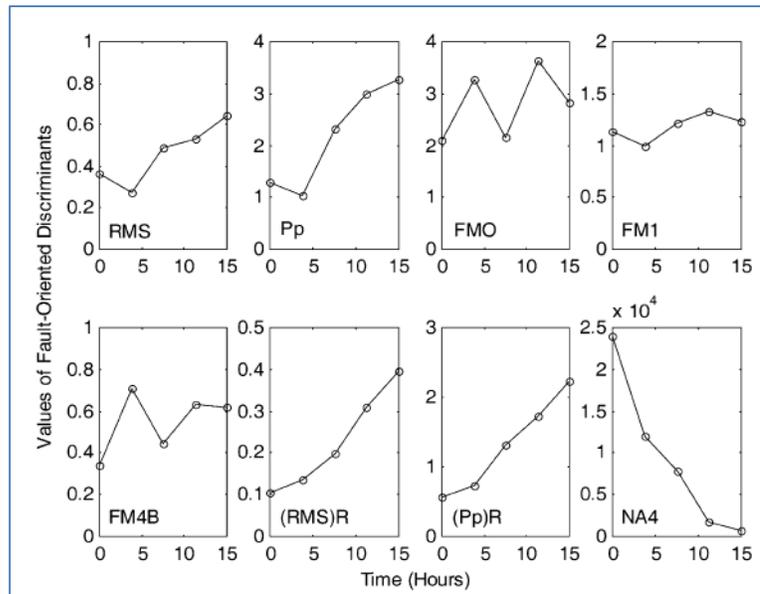
Fig. 2.4 Residual signal based parameters' reaction to vibration damage (obtained from Yesilyurt et al. (2003))

In the representation of the residual signal based parameters' reaction to vibration damage as shown in Fig. 2.4, it is observed that only two of the parameters: RMS and Peak to Peak reflected the progression of damage, where the two parameters decreased slightly at the beginning, but increased with the progression of damage. The other parameters did not exhibit a clear representation of vibration damage progression. NA4 also showed a trend in the progression of damage, but with a decreasing trend.

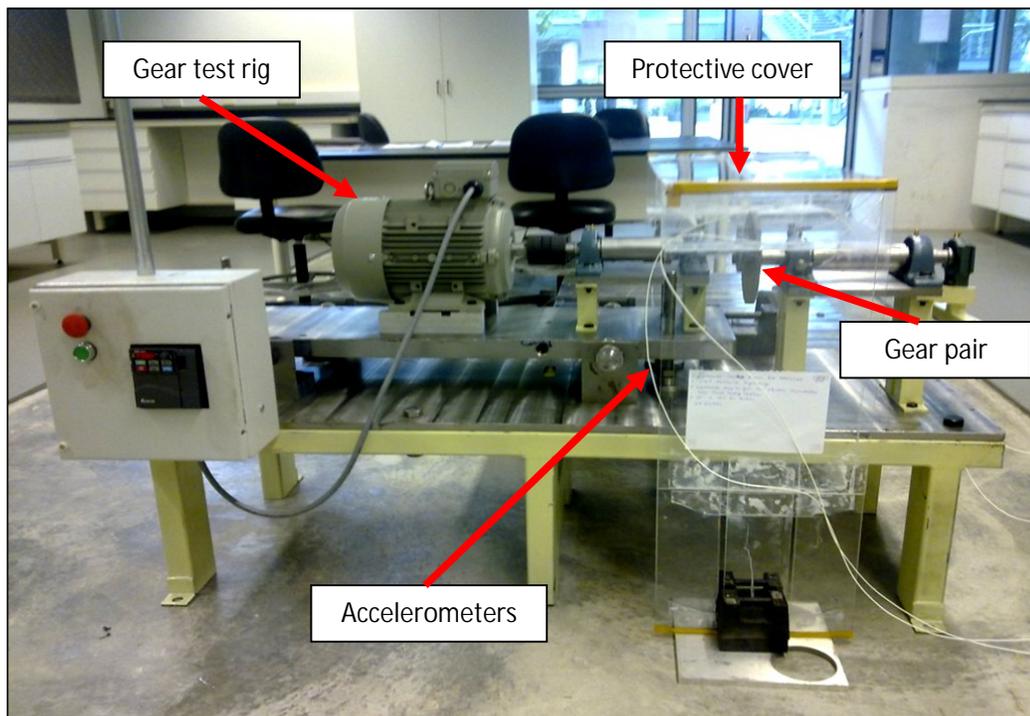
Fig. 3.2 Experimental setup

1. The gear test rig consists of two shafts, of which one of them is connected to a 3-phase electric motor. This is the driving side of the test rig. The other shaft is the driven shaft, where a hooking appendage is located at the other end for the loadings to be applied. Available loadings are 1kg, 2kg, 3kg and 5kg. Figure 3.2 shows the experimental setup.

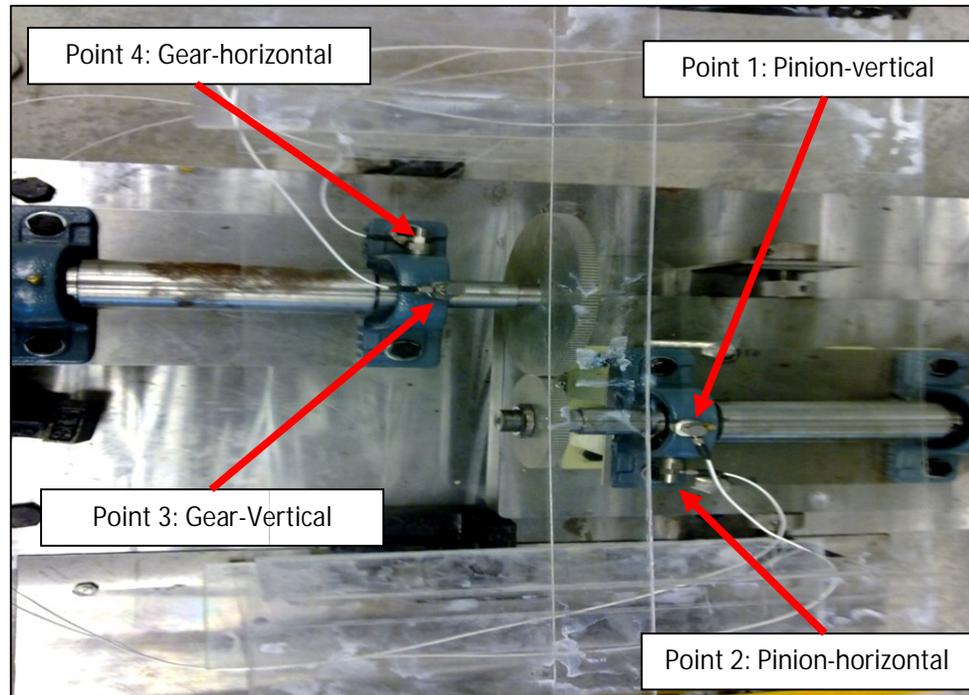
Fig. 3.3 Placement of accelerometers

1. A gear set is installed on the test rig.
2. Both of the shafts are ensured to be parallel. This is set to be the datum.
3. Four accelerometers are mounted onto four points on the test rig (refer to Fig. 3.3):
  - I. Pinion – Vertical
  - II. Pinion – Horizontal
  - III. Gear – Vertical
  - IV. Gear - Horizontal
4. The test rig is switched on and run initially at 500rpm for 10minutes. The acceleration graph is recorded and observed.
5. The procedure is repeated at a speed of 1250rpm.

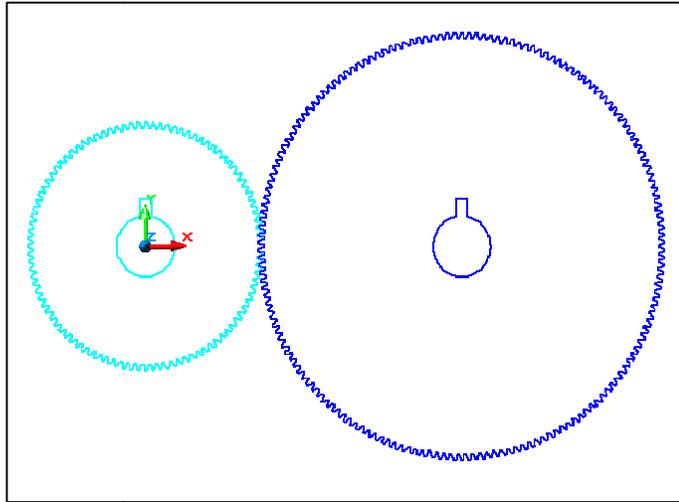
Fig. 4.1 AutoCAD drawing of the gear and pinion

The gears were first designed by using AutoCAD. Figure 4.1 shows the complete design of the gears.

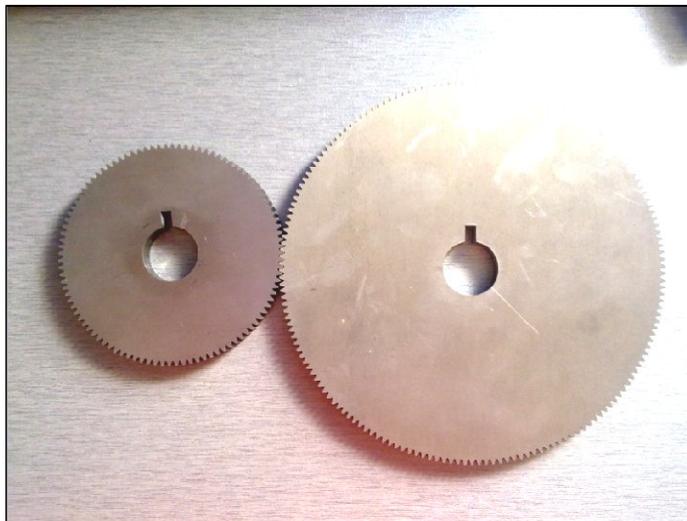
Fig. 4.2 Fabricated pinion (left) and gear (right)

The gears were fabricated by employing an EDM Wire Cut machine. Figure 4.2 shows the fabricated gears.

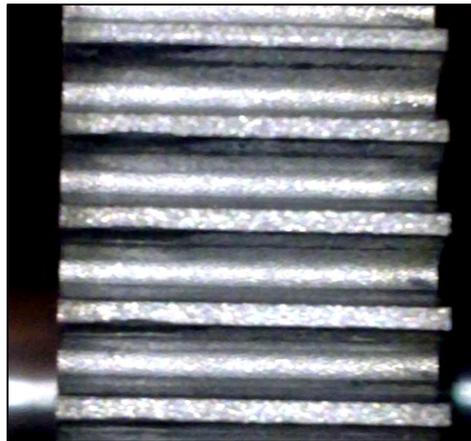
Fig. 4.3 Gear condition after 45 minutes

- 15 minutes: Some darkened spots at the edge of gear teeth, while no change in condition for pinion.
- 45 minutes: Increasing intensity of the darkened spots. Scuffing exhibited on both gears, along with some obvious scratches on some of the teeth. These observations are shown in Figure 4.3 below.

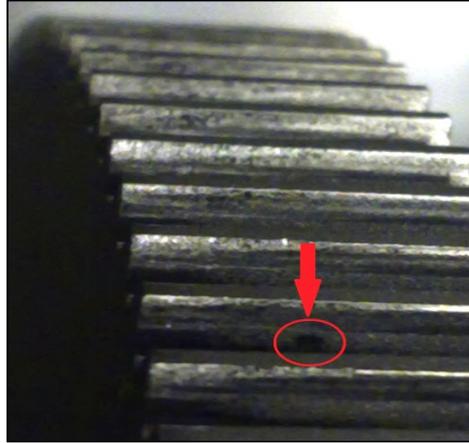
Fig. 4.4 Gear condition after 2 hours

- 2 hours: As shown in Figure 4.4, small pit-like formations can be seen on some of the tooth. These formations were increasing in size. The addendum of the gears exhibited severe scratch marks and wear.

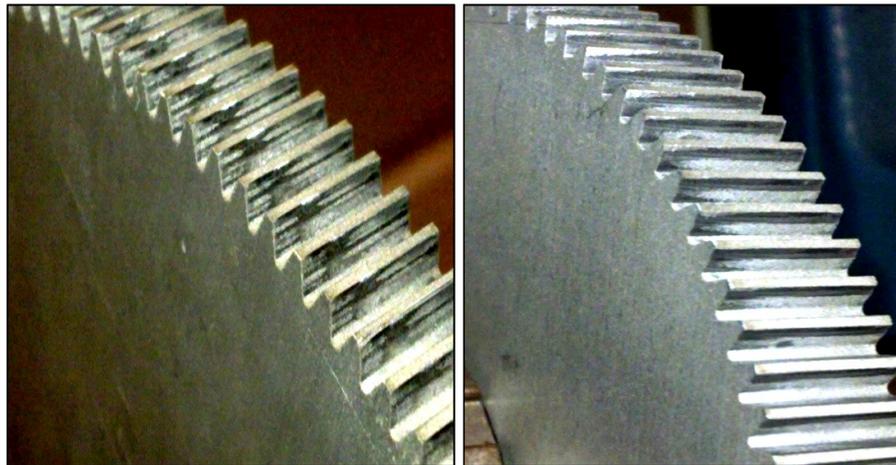
Fig. 4.5 The conditions of the gear (left) and pinion (right) after 3 hours of run

- 3 hours 30 minutes: All of the teeth for both gears were completely covered with scratch marks and darkened spots on the addendum. Dark lines begin to form at the bottom of the gear teeth. These observations are shown in Figure 4.5.

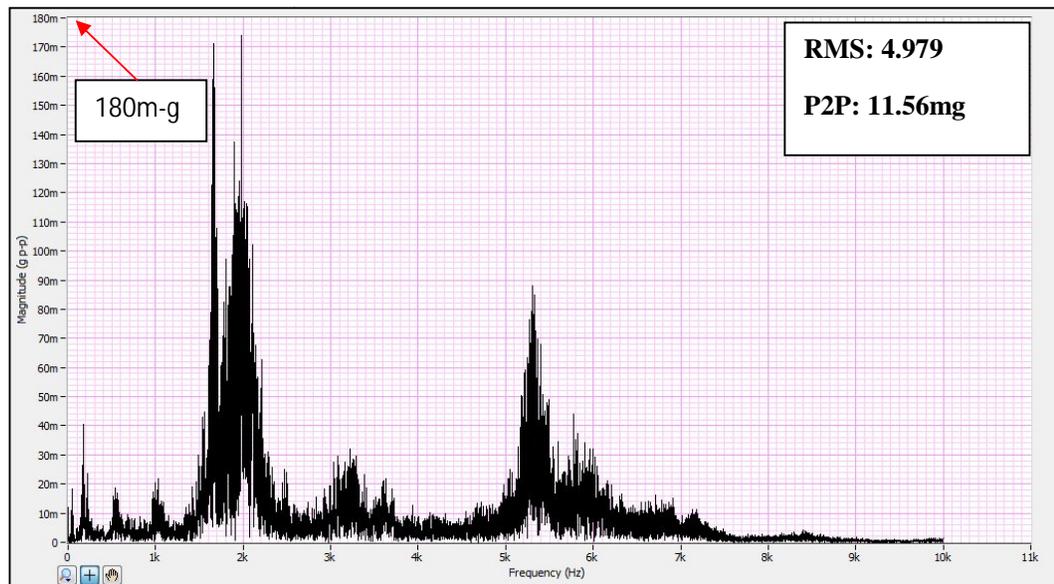
Figure 4.6 Frequency spectrum for baseline data of 500rpm

Figures 4.6 and 4.7 show the FS for speeds 500rpm and 1250rpm without any loading conditions. As evidenced by the peak value of each of the spectrum, the setup with the higher speed exhibited a higher peak value compared to the lower speed. This result infers that at the same time interval, in this case 10 minutes, a higher speed would cause more vibration. This inference is supported by the values of RMS and P2P, which are 4.979mg and 11.56mg for 500rpm and 6.144mg and 11.47mg for 1250rpm respectively. The increase in the RMS and P2P are not significant as at the start of the experiment, the test rig is still in good condition as it was newly purchased. It should be noted that the fundamental tooth-meshing frequency – in this case, 2083Hz, possesses the highest peak due to the inherent vibration by the gear itself. (Shreve, 1994)

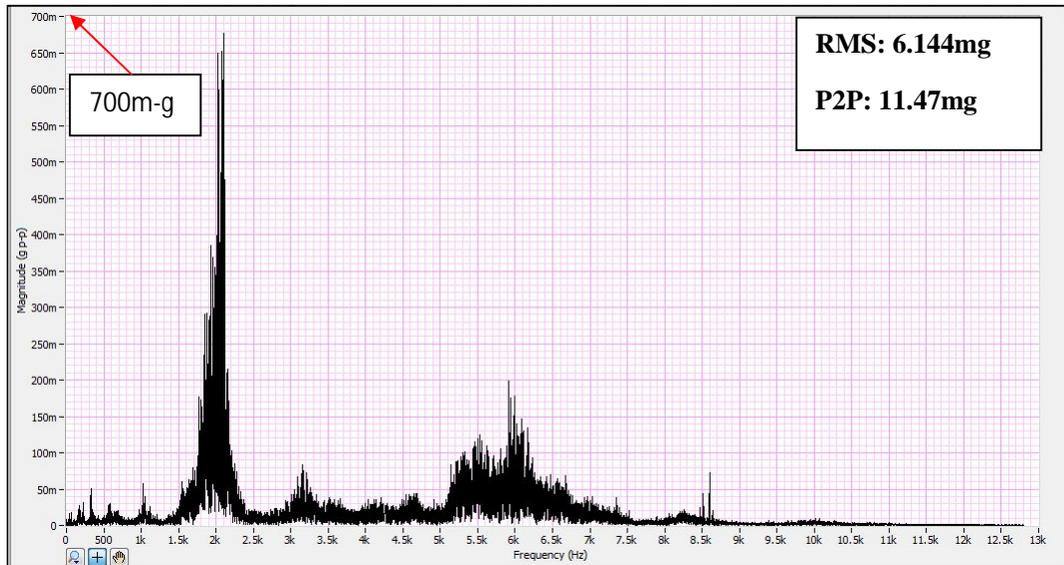
Fig. 4.7 Frequency spectrum for baseline data of 1250rpm

When the resulting frequency spectrum in Figure 4.7 is compared with that of Figure 4.8, it can be seen that higher amplitudes are reached at the first and especially nearing the second harmonics (6249Hz). This is attributed to the misalignment between the shafts, which caused complete contact between the gears without any clearances. This inference is supported by an excerpt from the vibration troubleshooting guideline chart as shown in Table 4.1.

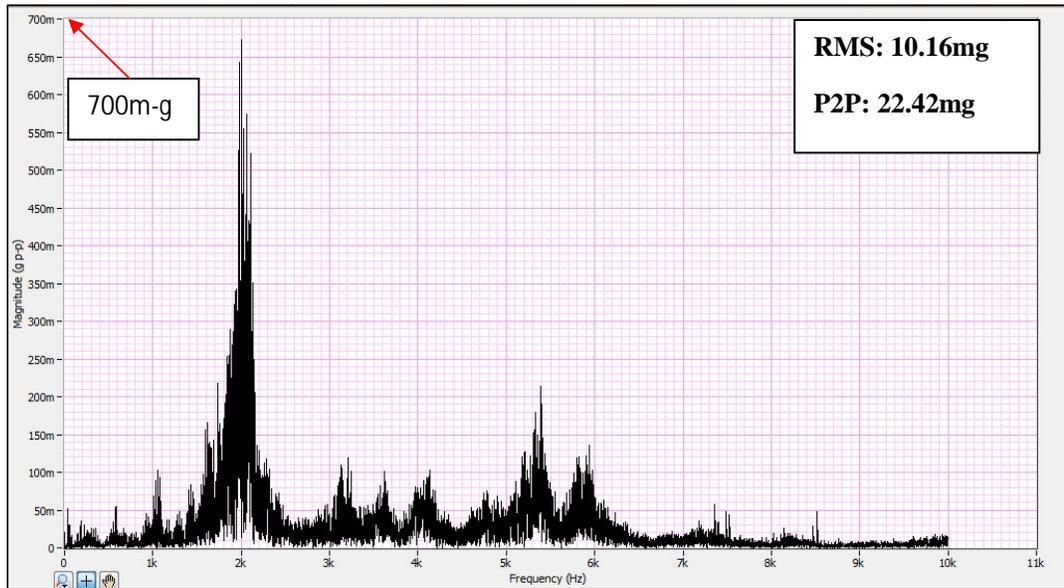
Fig. 4.8 Frequency spectrum for deviated shaft

Additionally, the RMS and P2P values for this setup are 10.16mg and 22.42mg respectively, indicating an almost two-fold increase from the baseline data, further implying that misalignment causes severe vibration within a vibrating body.

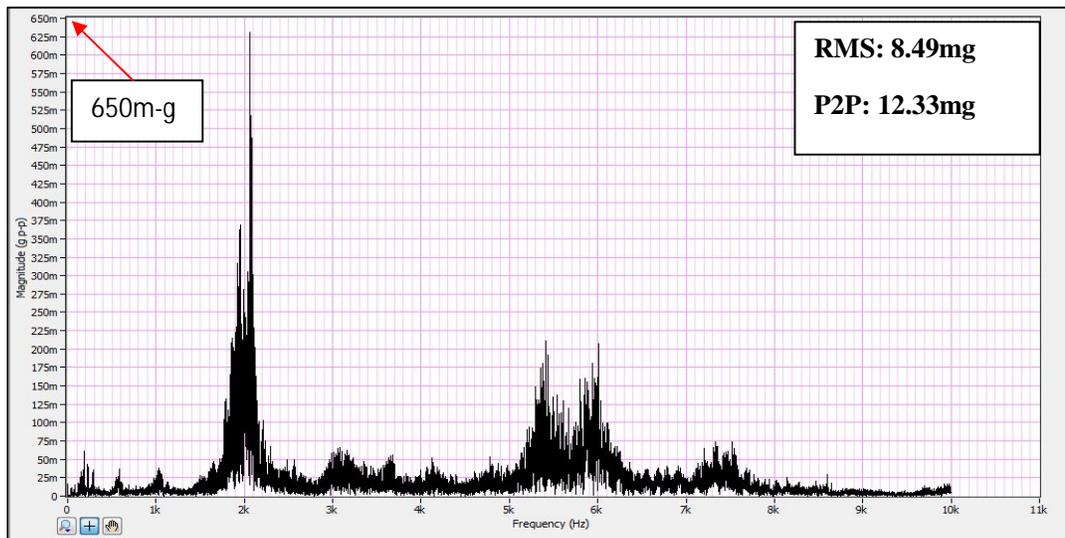
Fig 4.9 Frequency spectrum for 2kg loading

In comparison with the second setup, where the misalignment was introduced to the system, the resulting frequency spectrum for the bending moment setup do not differ as much as one would expect, where only the peak values are different, albeit a small amount. However, a significant difference between the two setups is noticeable in the values of the RMS and P2P. For the 2kg weight, the RMS and P2P values are 8.49mg and 12.33mg, while for the 5kg weight, the RMS and P2P values are 9.59mg and 14.20mg. The values are much lower – almost half than that of the second setup. From here, it can be inferred that both setups cause misalignment, as evidenced by the similar amplitude increment in the second harmonic. However, a bending moment in a system would result in a lower vibration energy compared to a deviated shaft.

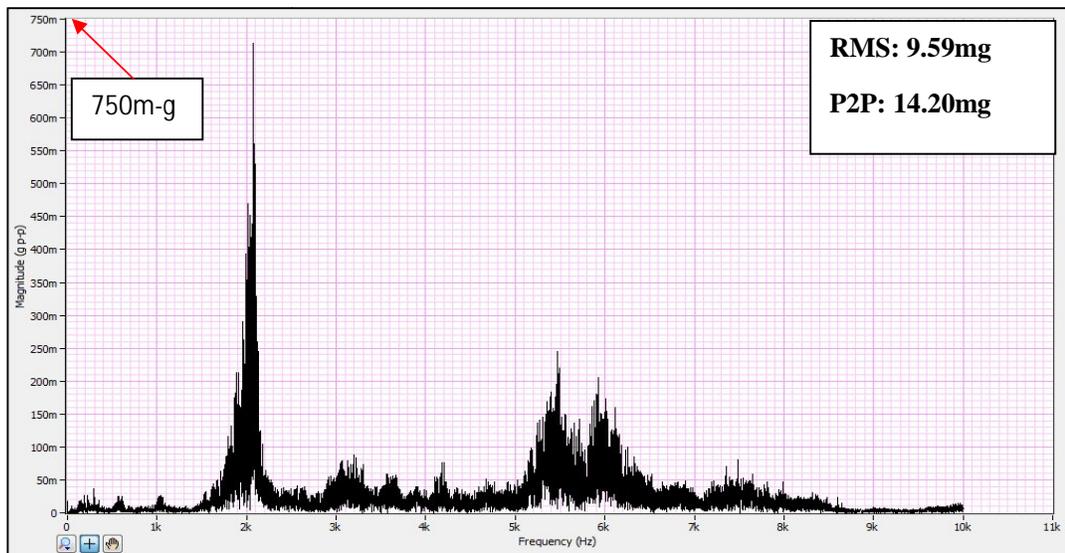
Fig. 4.10 Frequency Spectrum for 5kg loading

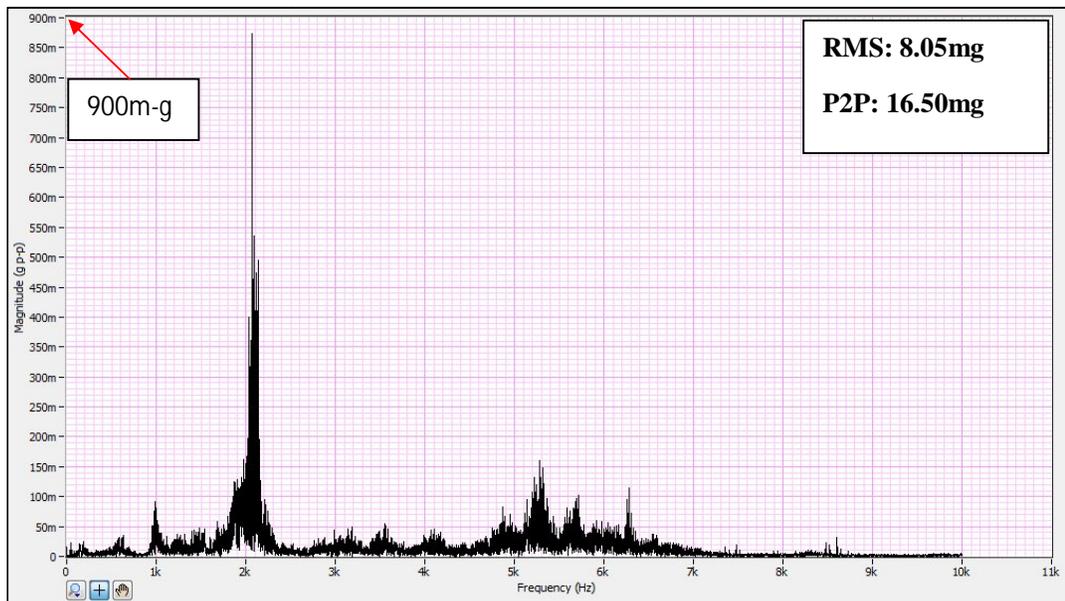
Fig. 4.11 Frequency spectrum after 2 hours of continuous run

The result was taken after 2 hours of run, as it was after this time interval that severe deterioration started to manifest. From the frequency spectrum in Figure 4.11, it is shown that the peak value is higher than the previous setups (900m-g.) As no loading condition was applied for this setup, it is best to compare with the baseline data of 1250rpm. There is a large difference between the RMS and P2P values for both of the setups. For this setup, the RMS and P2P values are 8.05mg and 16.50mg respectively, both almost twice the baseline value. From this result, it can be inferred

that when subjected to long operation periods, a system would exhibit high vibration energy, and the increase in P2P value shows increasing radial displacement of the shafts. It was at this period that pit-like formations are observed. Also, as no loading conditions are applied in this setup, no significant increase in amplitude is observed at the second harmonic.
