**The Enhancement of Non-Destructive Testing (NDT) through Active Thermal
Infrared Thermography to Identify Internal Piping Failure**

Dissertation submitted is partial fulfillment of
the requirements for the
Bachelor of Engineering (Hons)
(Petroleum Engineering)

SEPTEMBER 2012

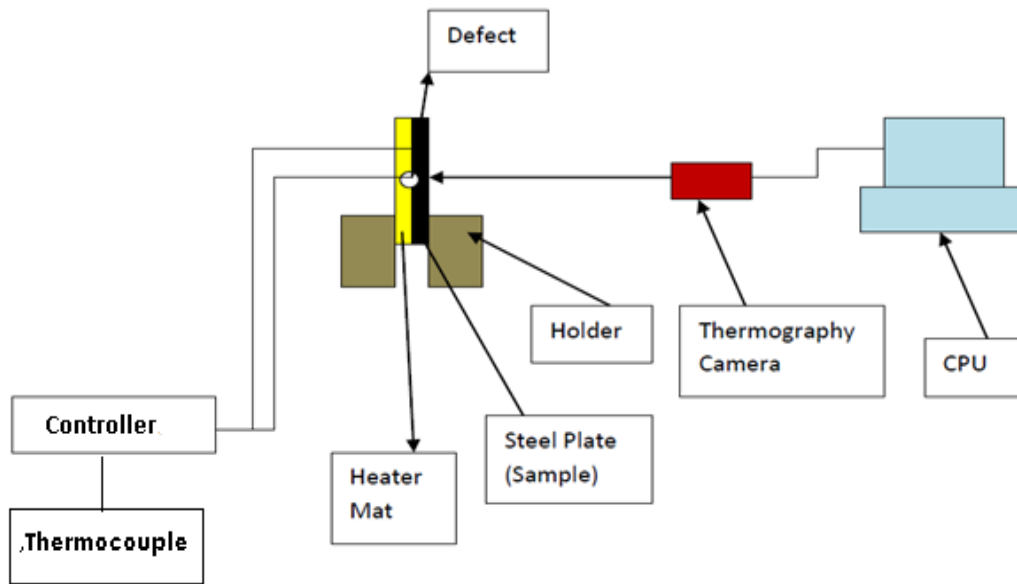
The setup of the experiment is as shown Figure 3-1

Figure 3-1 Experiment Setup

The controller was connected with heater mat and the sample. The connection between sample and controller will show the temperature of the sample. The sensor that is used in this experiment is Thermocouple Type K. This sensor was connected to controller and heater mat. The sensor was used in order to detect the heater if the heater is exceeding the temperature range that is set between 119^oC to 120^oC. If the temperature of the sample exceeds 120^oC, the sensor will turn of the controller until the temperature of the sample reach 119^oC. This will kept the sample at high temperature.

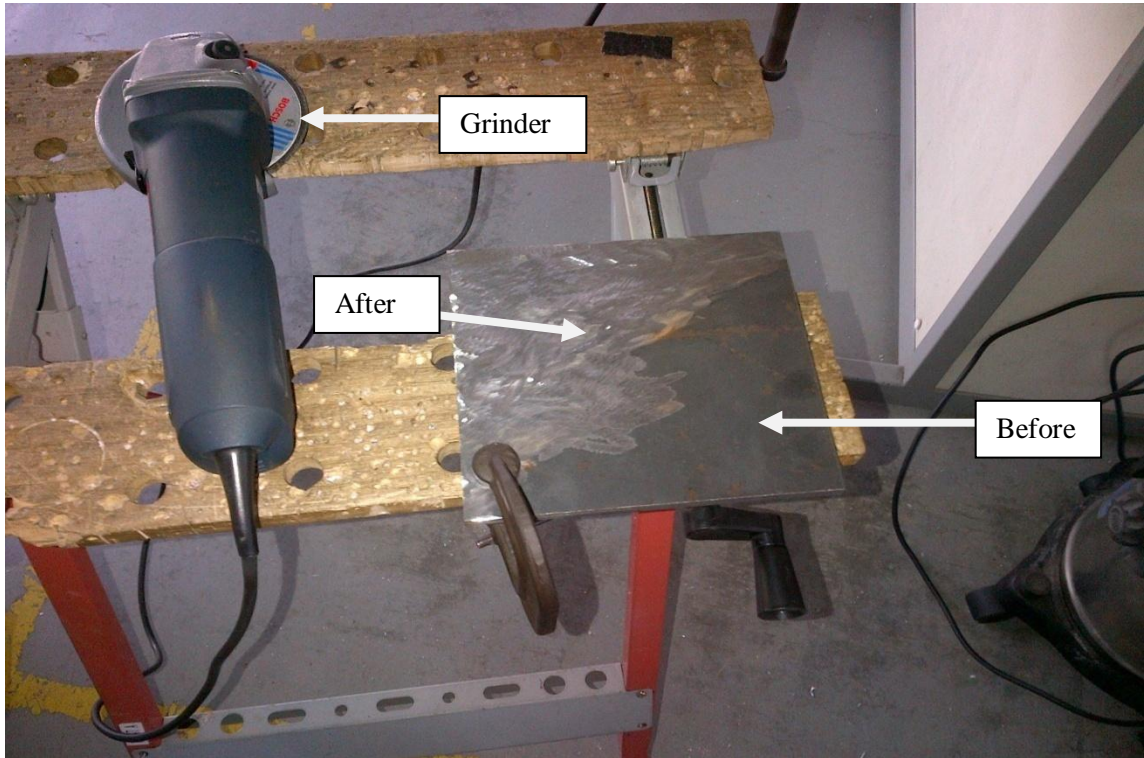
Figure 3-10 Before and After Grinding

The surface has been grinded to remove the rusting from the sample and to make the surface smoother. This is because, after first trial of the experiment, the roughness and the rusty on the surface of the sample are disturbing the thermal images. The rusty and rough sample can be seen at Figure 3-7.

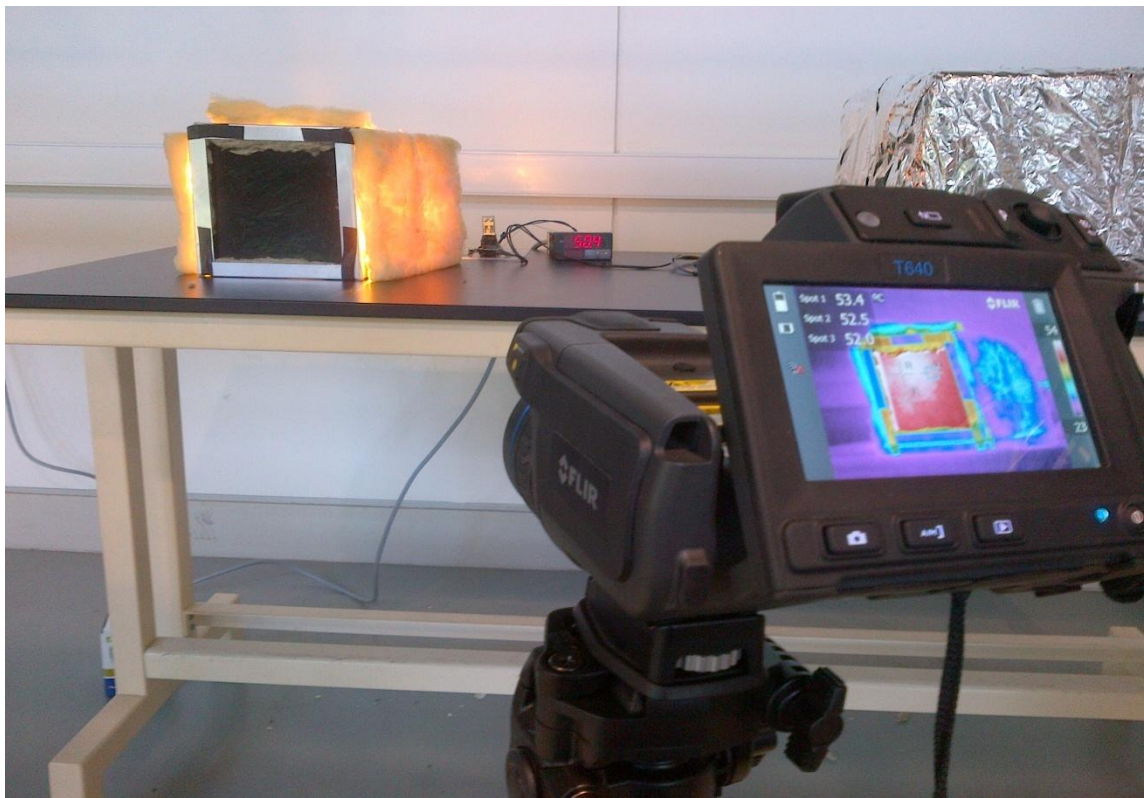
Figure 3-14 Infrared Camera Recorded Thermal Image of the Sample

Based on the Figure 3-14, the Infrared camera is recording the thermal image of the sample. By using “Spot” from Infrared Camera, the temperature reading of Defect can be recorded. The spot is placed at each defect area but at the front side of the sample (defect is at the backside of the sample).

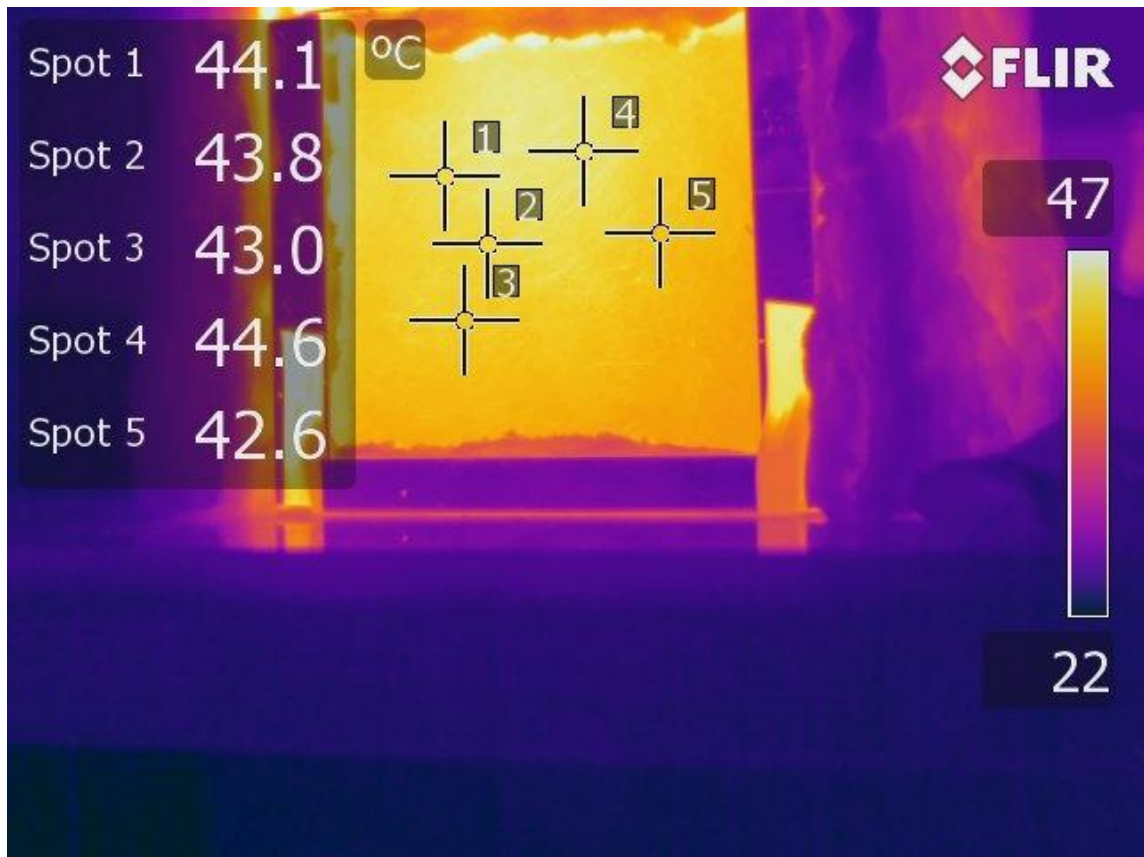
Figure 3-15 Example of Spot Temperature

Figure 3-15 shows the “Lava” type thermal image. There are five spots that have been placed on the sample tested. Each of the spot shows the temperature of their location.

In the experiment, three spots have been placed on the defect in order to identify the temperature of the defect and will be compared with temperature of the sample (detected by the controller)

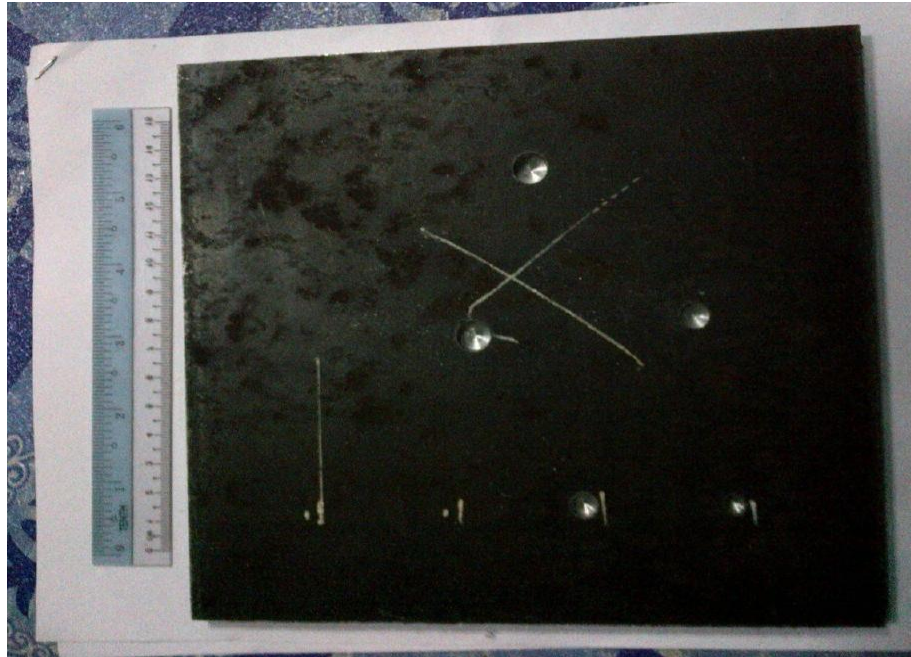
Figure 3-16 Sample Dimension (this picture is taken before grinding and defect making process)

1. Infrared Camera
2. Steel Plate (Dimension = 200mm x 187mm x 10mm)

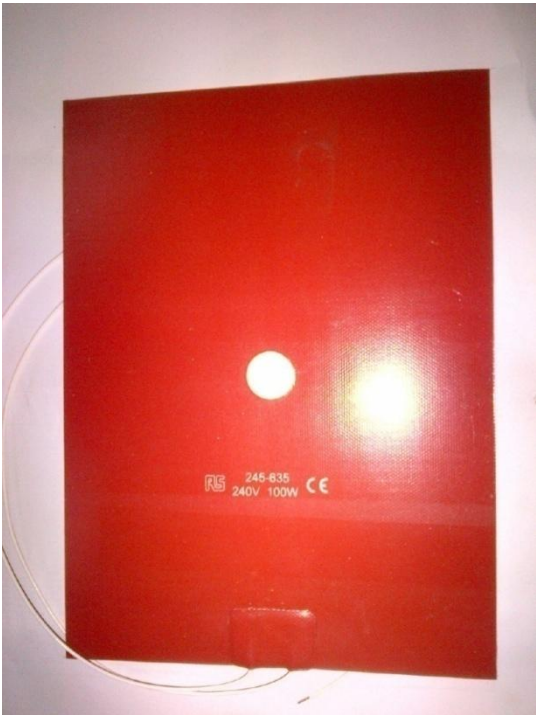
Figure 3-17 Heater Mat

3. Heater Mat with dimension 200 mm x 150 mm (240 V, 100 W)
4. Halogen Lamp as an alternative to replace heater mat (240 V, 80 W)
5. Controller
6. Thermocouple Type K
7. Rock Wool
8. Glass Wool
9. Drilling Machine
10. Black Paint
11. Grinder

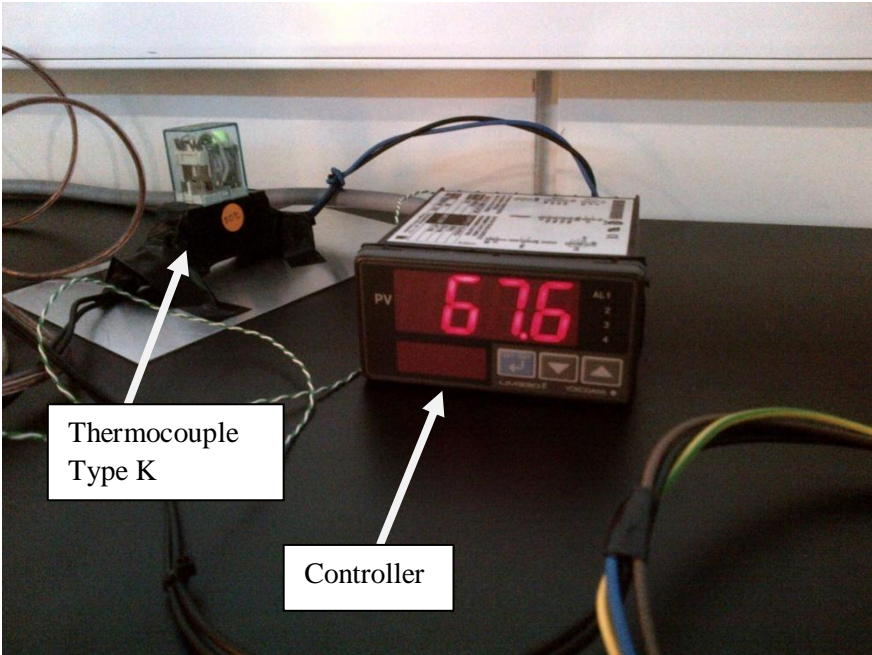
Figure 3-18 Controller and Thermocouple Type K

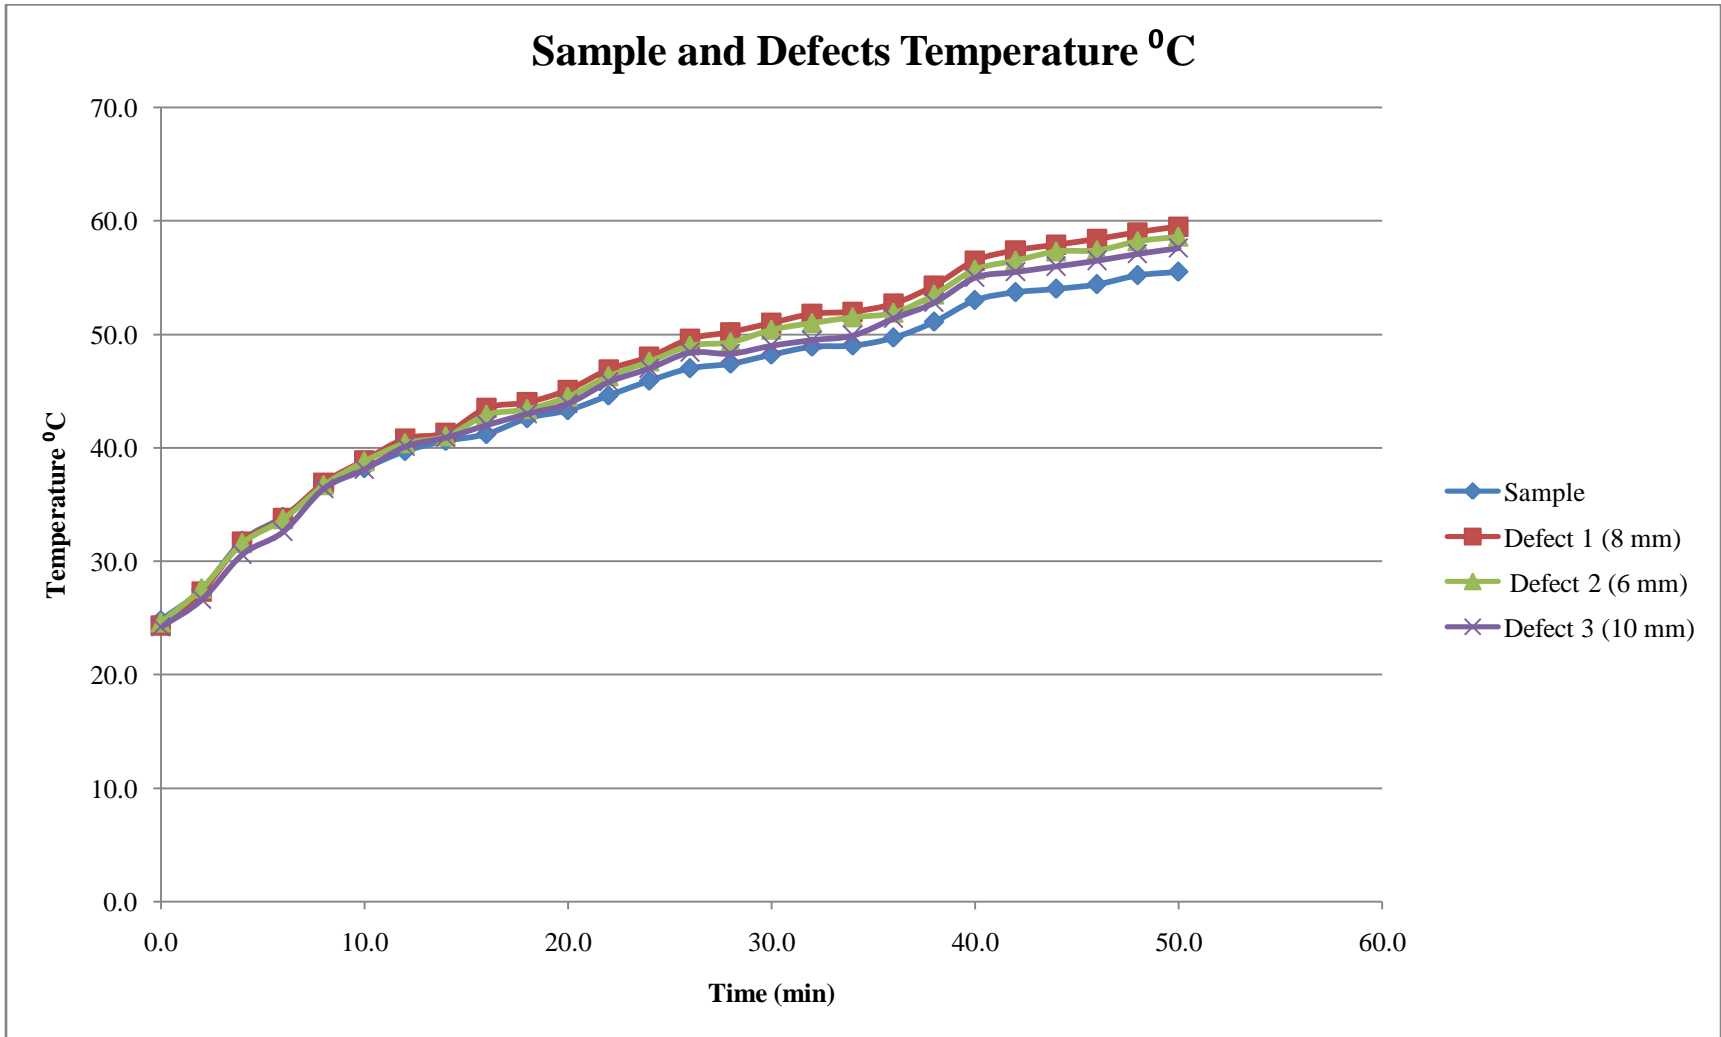
Figure 4-4 Graph of Temperature of Defects and Sample

By using Infrared Camera and Controller, the temperature of the Sample/Host and defects were recorded. Based on the thermal image, the even though the thermal image cannot distinguish the colour of the defect and the sample, but by using “Spot” from the Infrared Camera, the temperature of the defect can be read at the surface from the front side of the sample. This result shows that the infrared camera still can detect the defect because of the different temperature but cannot distinguish the colour of the defect and the sample because the temperature different might be low. The temperature differences are increasing from time to time. But because of heat loss to surrounding and low heat source (if the experiment was done by using heater mat, the temperature and temperature difference will be higher because the mat is attached directly on the sample and supply more heat because it has higher current compared to halogen lamp), the temperature difference does not increase anymore.

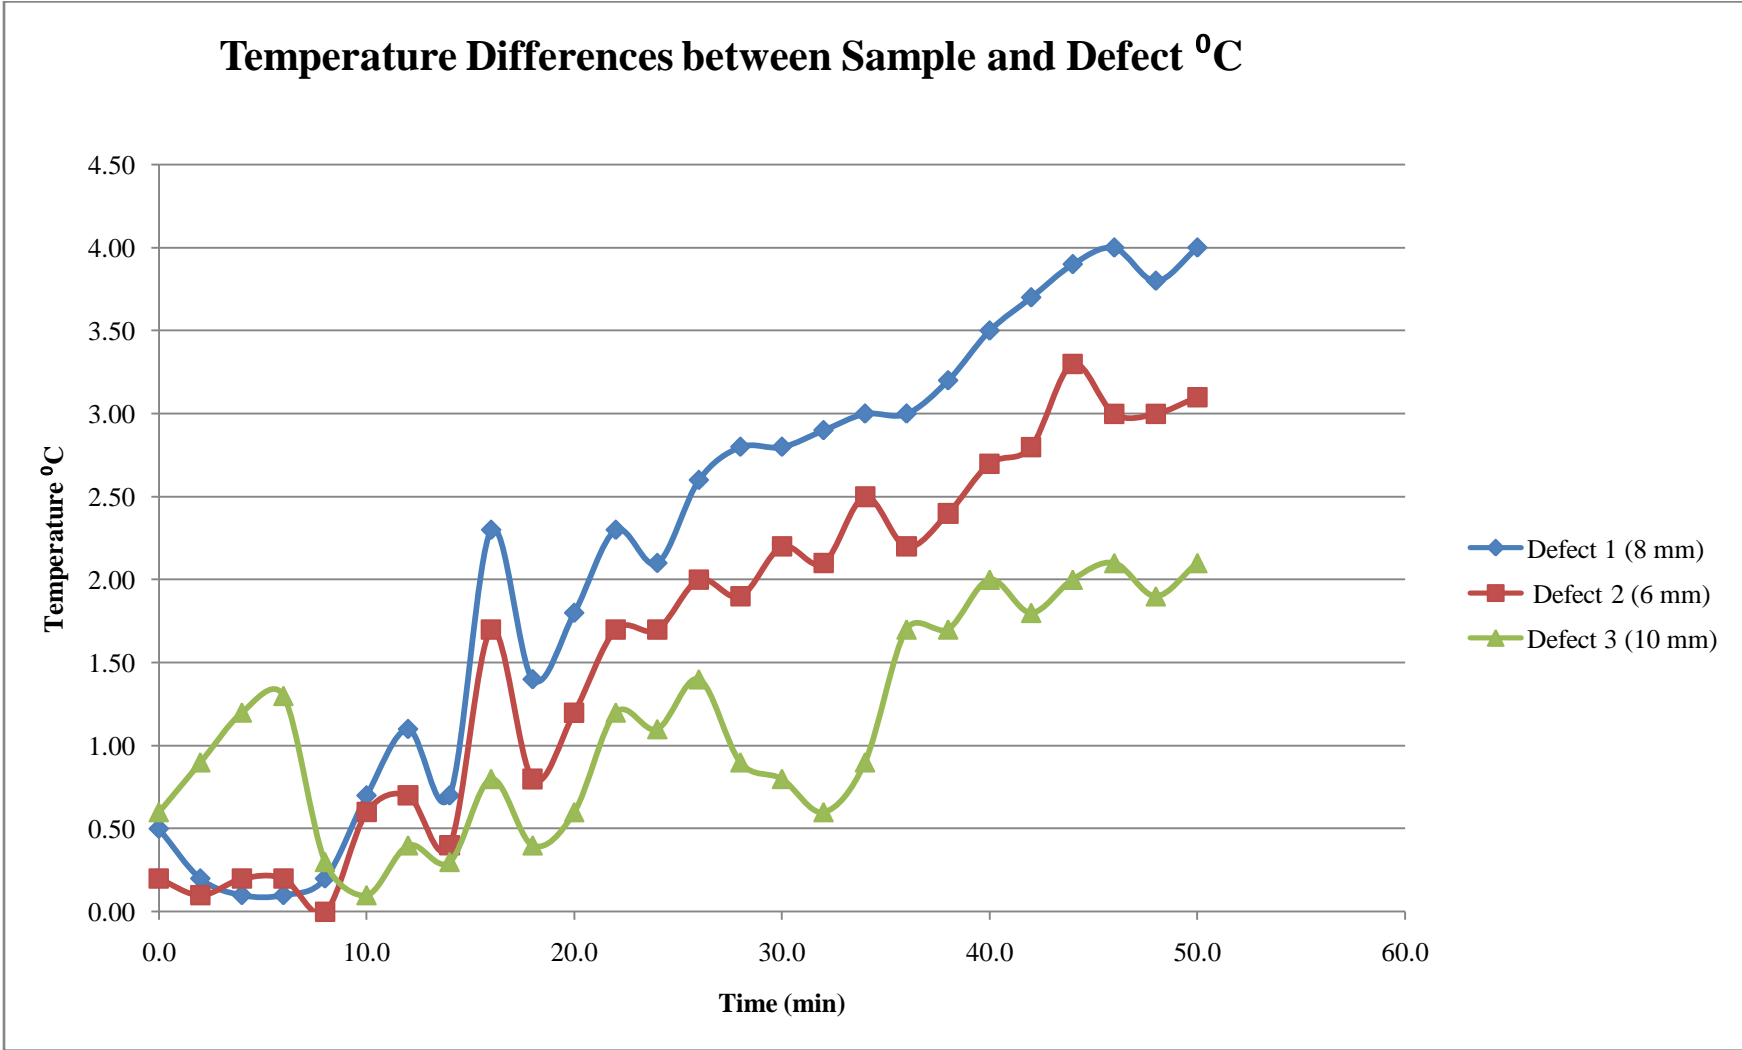
Figure 4-5 Graph of Temperature Difference between Defect and Sample

Based on the Figure 4-5, each of the defect temperature is different with the sample. The defect that has the highest temperature difference is Defect 1 which is 8 mm. The defect with the lowest temperature difference is Defect 3 which is 10 mm. The average temperature difference of the Defect 1 is 2.18°C, Defect 2 is 1.64°C and Defect 3 is 1.12°C. The main reason why the temperature difference of Defect 1 and 2 are higher is the light and heat from halogen lamp was focused on these two defects. These defects were received a lot of heat compared to the other. This will increase the rate of heat transfer at that area. The temperature differences for all the defects are increasing from time to time. If the experiment continued for a longer time or if the experiment has been done by using heater mat, the temperature differences might be higher and there is a possibility for the defect to visible at the thermal image because the temperature difference is higher.
