**EVALUATION OF COATING PERFORMANCE FOR CORROSION UNDER
INSULATION (CUI) PREVENTION**

Wan Muhammad Faris bin Wan Sohaimi

Bachelor of Engineering (Hons)

(Mechanical Engineering)

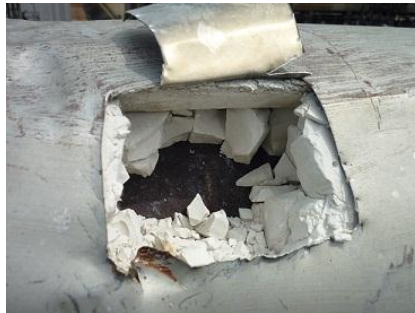
Figure 2.1: Corrosion Under Insulation [1]

Corrosion under insulation occur in-between metal pipe and insulation. This type of corrosion is difficult to detect and can be very dangerous compared to other types of corrosion as the corrosion is occurred underneath the insulation. Detection of corrosion under insulation is very expensive and complicated.

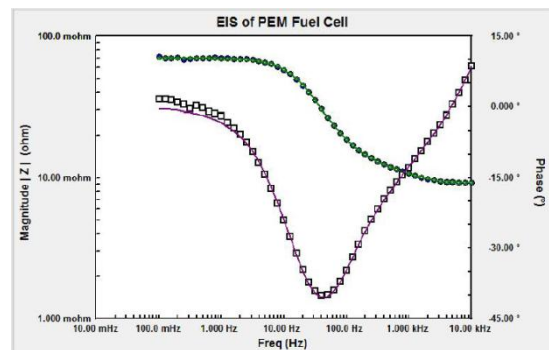
Figure 2.3: Bode Plot [8]

Another popular presentation method is the Bode Plot. The impedance is plotted with log frequency on the X-axis and both the absolute values of the impedance ($|Z|=Z_0$) or the phase-shift on the Y-axis. Unlike the Nyquist Plot, the Bode Plot does show frequency information.

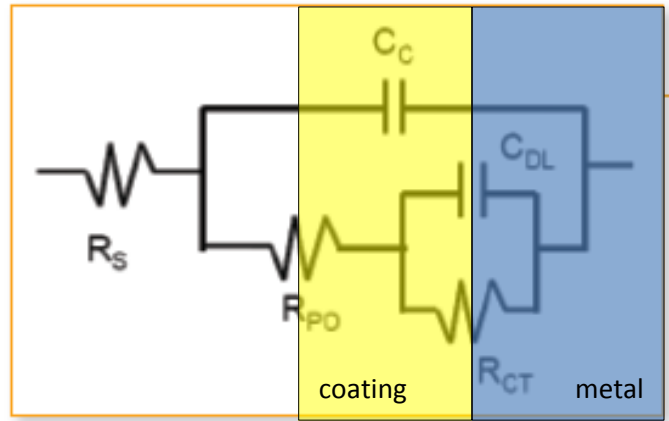
Figure 2.4: Electrochemical Cell of Coating Metal [8]

Electrochemical cells are usually be modelled using a single electrical circuit element. Most of the circuit elements in the model are common electrical elements such as resistors, capacitors, and inductors. In this project, the coating sandwiched between the coated metal and the electrolyte can be represented by an electrical circuit [9].

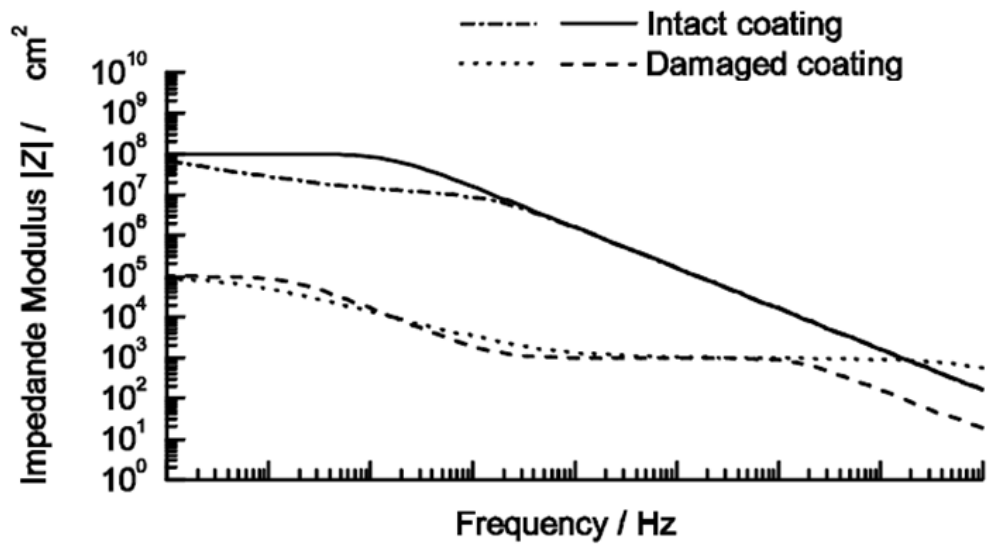
Figure 2.6: Impedance results for intact coating and damaged

Figure 2.6 shows two distinctive Bode plots of a good, smooth and intact coating and another two plots equivalent to a damaged coating where the electrolyte reaches the metal interface (one of them modelled using pure capacitors and the other using constant phase elements, CPE).

The damage coating sample shows low value of impedance compare to intact coating. The results show that the damaged coating has reducing the strength of bonding between the coating particles. It means the pore resistance of the coating is weak and the water can easily penetrate through the coating thus lead to rusting on metal.

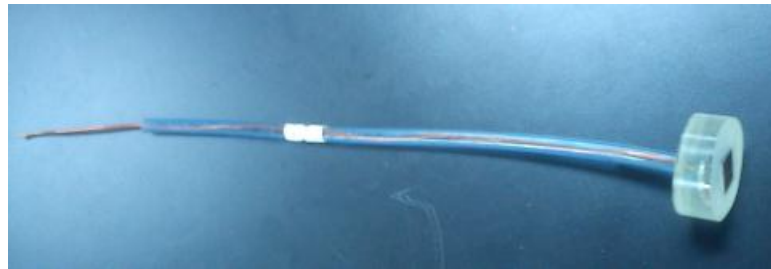
The project activities were started after all the research about corrosion under insulation is done to avoid any mistakes during the activities. The samples are made from carbon steel scrap pipeline that is available at UTP Centre for Corrosion Research. The sample is a combination of scrap pipe mounted with hose and copper wire as picture below.

Figure 3.2.1: Pipe sample

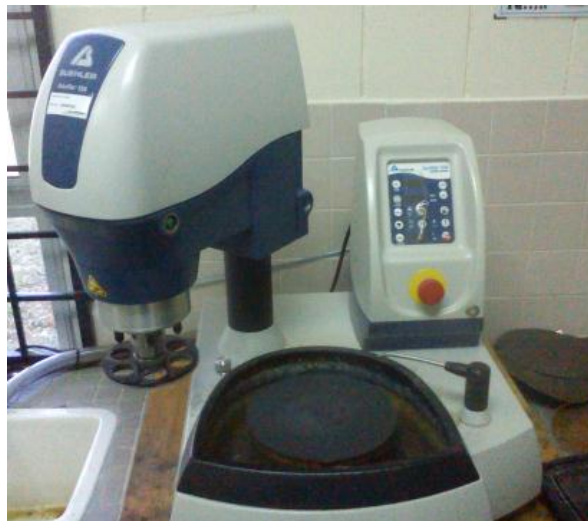
The surface grinding is done on samples to clean its surface from dirt and rust before it goes through spray coating process. There are two ways to clear the rust; surface grinding and grit blasting. The author used surface grinding method with grade 180 of grinding paper to grind the samples.

Figure 3.2.2: Surface grinding machine

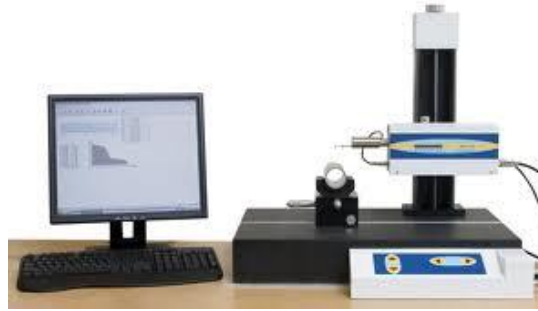
After the samples were grinded, the roughness average of samples was measured using profilometer. Profilometer is a measuring instrument used to measure a surface's profile, in order to quantify its roughness.

Figure 3.2.3: Profilometer

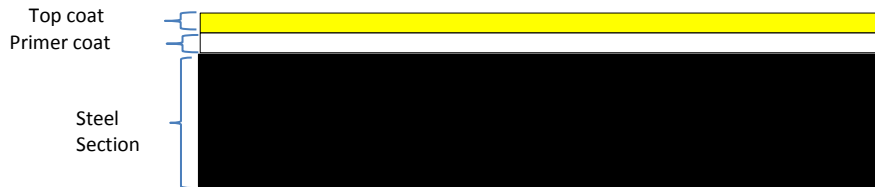
Figure 3.2.7: Sample 3 – Thinner off spec coating sample

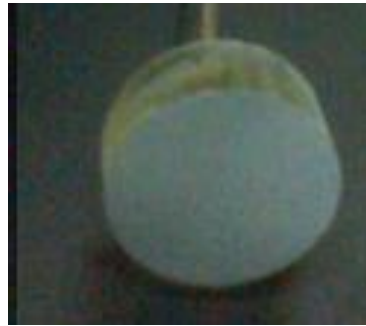
Figure 3.2.8: Drying process in dry box result

The samples that were placed in dry box had shown good quality of coating surface. However the scrap samples that were placed in normal room had shown surface crack. The result shows the importance of stable temperature and cleanliness of air during the drying process in order to get high quality of surface coating.

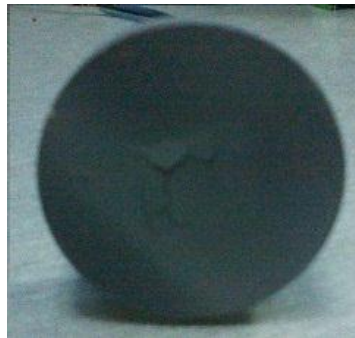
Figure 3.2.9: Drying process in normal room result

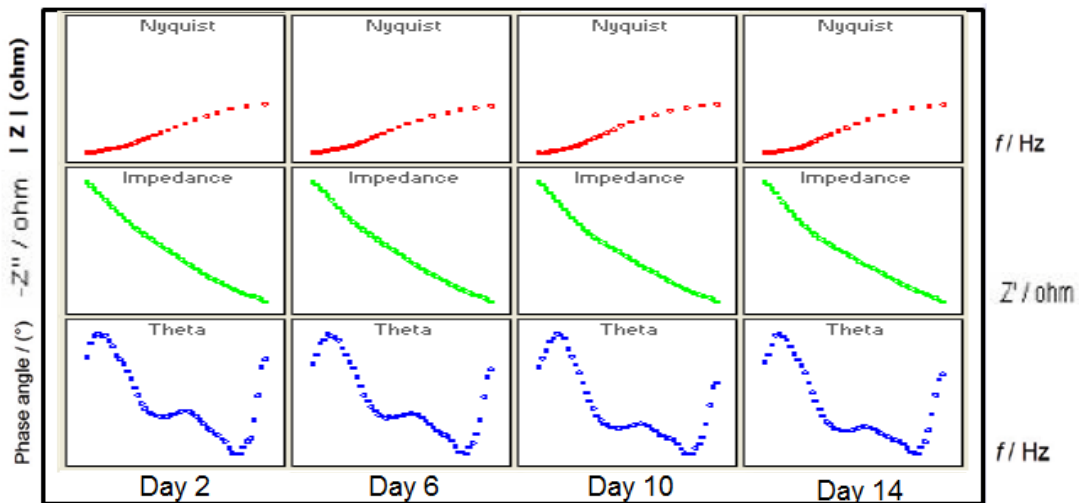
Appendix B: EIS graph result for good coating condition sample
