A Review on the Incident of Flexible Pavement Defects in Malaysian Road

Dissertation submitted in partial fulfillment of the requirements for the Bachelor of Engineering (Hons) (Civil Engineering)

Ipoh – Lumut highway has been chosen as the typical asphalt pavement with moderate traffic to study pavement defects. The research will be focusing on identifying

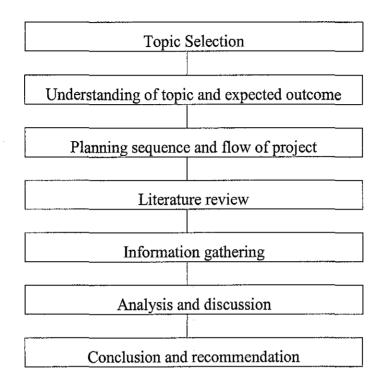
Figure 1: Flow of methodology

On-site information gathering will be carried out after the literature review is done. On-site information gathering involved interviewing the relevant authorities, visual inspection on the road surface condition, data collection and also photo taking of any relevant object.

After on-site inspection is carried out, all the information and data gathered will be tabled and perform in a proper way, such as graph and flow chart. This information will be discussed in details and will be elaborated. Finally, conclusion and recommendations will be done. Conclusion will be made based on the information and data gathered, and analysis performed. Recommendation will be suggested if there is any.

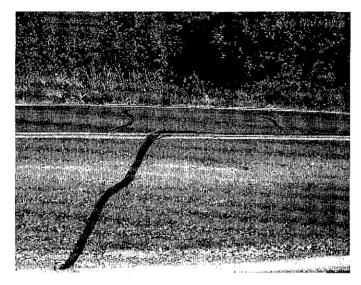
Figure 2: Crack Sealing

Crack seal products are used to fill individual pavement cracks to prevent entry of water or other non-compressible substances such as sand, dirt, rocks or weeds. Crack sealant is typically used on early stage longitudinal cracks, transverse crack, reflection cracks and block cracks. Fatigue cracks are most often too extensive to warrant filling with crack sealer; they usually require an area treatment such as a patch or reconstruction. $^{(6)}$

Crack sealing is best done in moderate temperatures (spring or fall) and is most effective if performed immediately after cracks develop. Before applying crack sealant, cracks should be routed out and cleaned

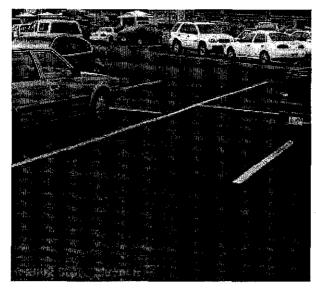
Figure 3: Fog Seal on the Right Hand Side

A fog seal (see Figure 3) is a light application of a diluted slow-setting asphalt emulsion the surface of an aged (oxidized) pavement surface. Fog seals are low-cost and are used to restore flexibility to an existing HMA pavement surface. They may be able to temporarily postpone the need for a BST or non-structural overlay.

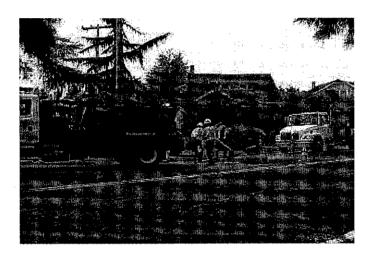
Figure 4: Semi Permanent Potholes Repair

Although it may seem that the semi-permanent technique would produce a higher quality patch than the throw-and-roll technique, the FHWA's Long Term Pavement Performance (LTPP) Study found that the "throw-and-roll technique proved just as effective as the semi-permanent procedure for those materials for which the two procedures were compared directly" (FHWA, 1998). Since the semi-permanent technique is more labor and material intensive, the throw-and-roll technique will effective if generally prove more cost quality materials are used.

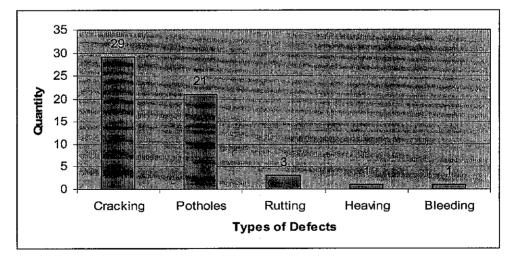
Figure 6: Type and Frequency of occurrence for pavement defects along Ipoh – Lumut Highway

From the inspection carried out, 55 defects were found. These defects can be categorized into cracking, potholes, rutting, heaving and bleeding type. Figure 6 show the frequency of the defects occurs along the stretch.

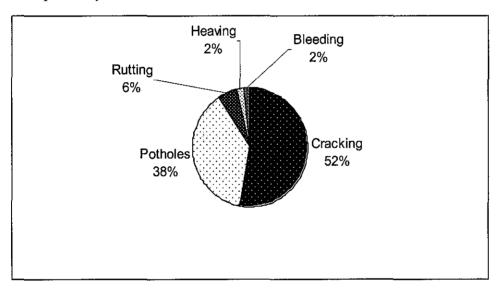
Figure 7: Percent of Defects Corresponding to Defect Type

It shows that cracking is the most frequent defect found on the Ipoh – Lumut highway where which is 29 spot. The second highest in the rank is found to be potholes which is 21 spot. While for rutting, heaving and bleeding, it is 3 spots, 1 spot and 1 spot, respectively. From these data collected, it can be concluded that 52.7% of defect found on Ipoh – Lumut highway is cracking, 38.2% is potholes, 5.5% is rutting and 1.8% is heaving and bleeding respectively. The results are shown in Figure 7.

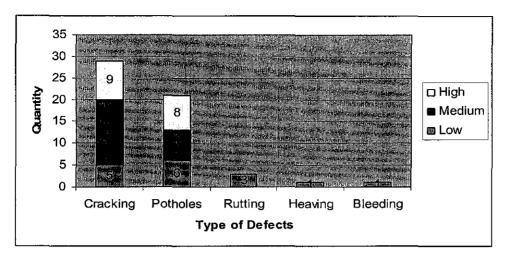
Figure 8: Type, Amount and Severity of Defects Found

The defects found on the Ipoh – Lumut road were classified according to their severity and affected area. There are 3 classes of severities for cracking, potholes and rutting respectively. For cracking, crack width smaller than 3mm is considered low severity, crack width more than 3mm is considered medium severity and cracks with several spalled cracks is considered as high severity⁽⁶⁾. As for potholes and rutting, depth which is less than 1 inch is considered as low severity, 1 inch – 2 inches depth is considered as medium severity and if the depth is more than 2 inches, it is considered as high severity ⁽¹¹⁾. For heaving and bleeding, the severity is classified as how large is the area affected. Affected area less than $0.5m^2$ is considered low severity, affected area between $0.5m^2$ and $1m^2$ is considered medium and if it is more than $1m^2$, it is considered as high severity.

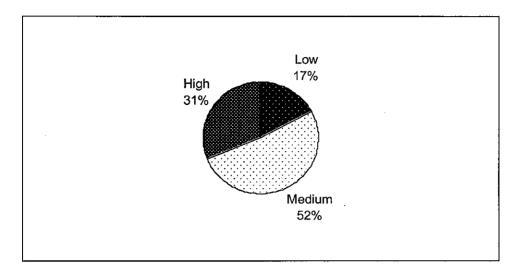
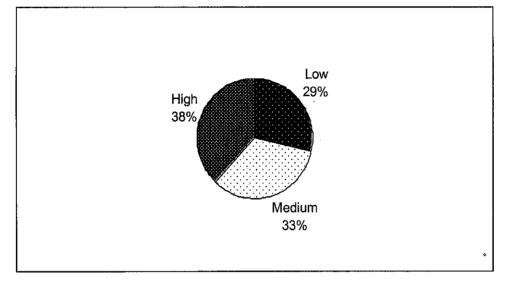
Figures 10 and 11 show the percentage on level of severity for cracking and potholes, respectively. From figure 10, it shows that 31% of cracking is a high severity stage, 52% at medium severity stage, and 17% of cracks is at low severity stage. As for potholes, most of it is at high severity stage (38%), 33% is at medium severity stage and 29% is at low severity stage. Rutting, heaving and bleeding are all having low severity.

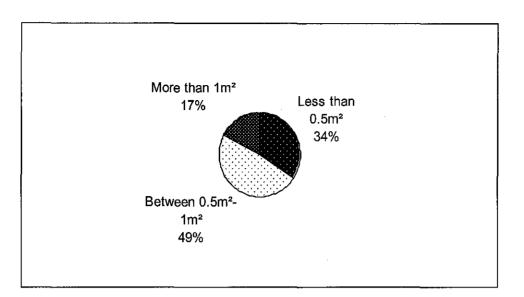
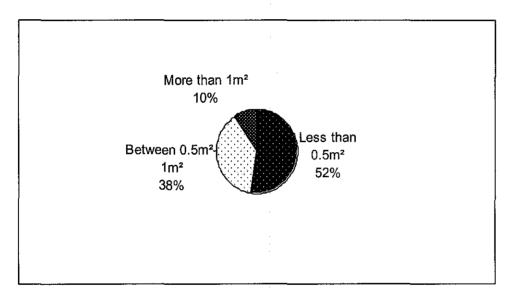
Figures 12 and 13 reflect the percentage of affected area for cracking and potholes, respectively. As shown in Figure 7, most of the cracking are only affecting small area (34%), 49% of it affecting medium area and 17% of cracking is affecting large area. Figure 13 shows the percentage of affected area for potholes. 52% of the potholes are found occurring in small area, 38% are in medium area and only 10% of it is affecting large area.

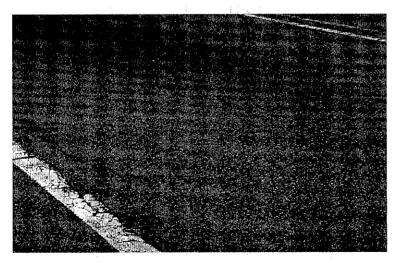
Figure 15: Cracks with High Severity

Ipoh – Lumut road is a busy road. Lots of heavy vehicles, such as concrete mixer lorry, lorry and truck, travel along the road every day. The loads resulted from these heavy vehicles caused the pavements to deteriorate faster than its design life. Cracking is one of the sign that showing this road is deteriorating. Most of the cracks found on this road are already at their critical stage that if no immediate remedy action is taken, pothole will occur. Figure 15 shows cracks with high severity found near UTP area.
