# **Simplified Creep Assessment of Catalyst Tube**

Dissertation submitted in partial fulfillment of

**Bachelor of Engineering (Hons)**

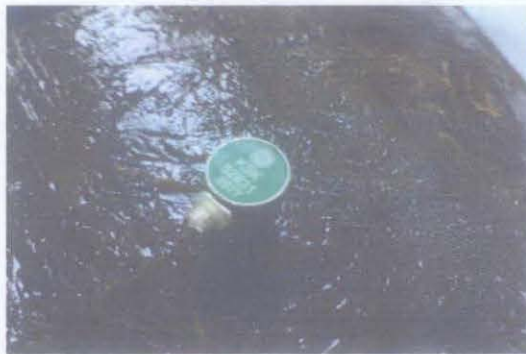
Figure 6: 5 Mhz probe

Ultrasonic equipments used to develop weld or material flaw detection and sizing, need to be calibrated prior to the inspection, so one of the mandatory calibrations is the well known time base calibration that can be defined as the process developed to establish a correspondence between the time spend by the wave to go and come (time of flight) from a known reflector and the distance traveled. First, suitable probe need to be selected. For this study, 5 Mhz probe has been used to do the calibration. The diameter for this probe is 4 cm.

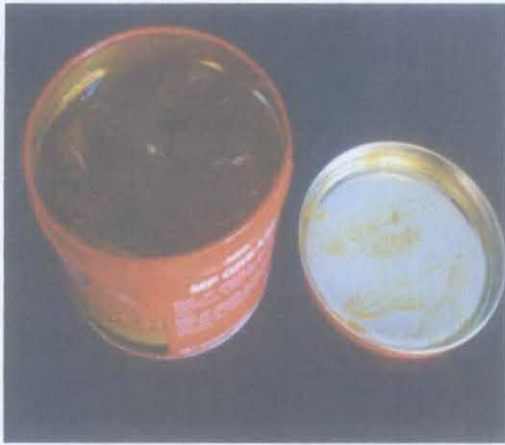
Ultrasonic testing is performed on the reformer tube. The tube is inspected using pulse-echo testing method. The tube has been lathed to three layers of thickness, 7.8 mm, 9.7 mm and 12 mm. The coating is removed from the tube because it produced so much scattering while doing the measurement. The testing on the catalyst tube been done using 5 Mhz probe. Grease has been used as a couplant to be applied on tube's surface.

Figure 8: Grease as a couplant

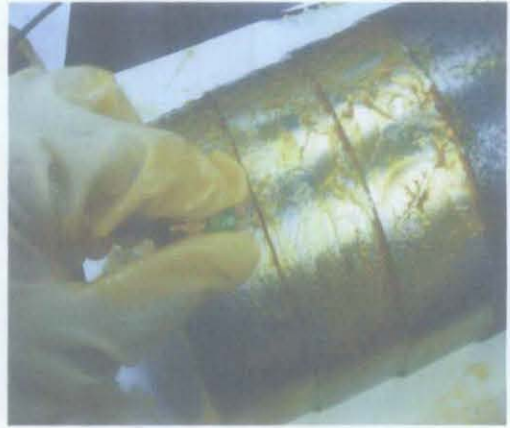
Figure 9: UT been performed on the tube

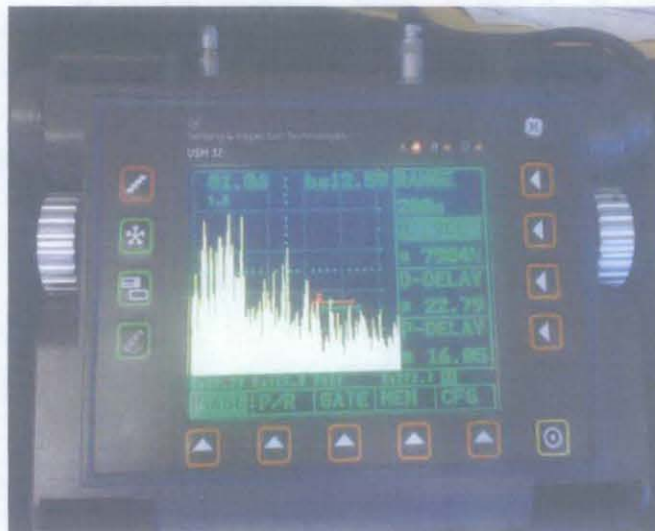
The equipment used in this ultrasonic testing is called ultrasonic flaw detector. The diagnostic machine display the result in the form of signal with an amplitude representing the intensity of reflection and the distance, representing the arrival time of the reflection. Firstly, the range value is set-up to ensure the measurement is easy to read. Usually the range is set-up two times larger than the thickness. For this study, the sound velocity of the material is unknown. By using the known distance, the sound velocity is determined by adjusting the value of velocity to get the right signal.

Figure 10: Ultrasonic flaw detector

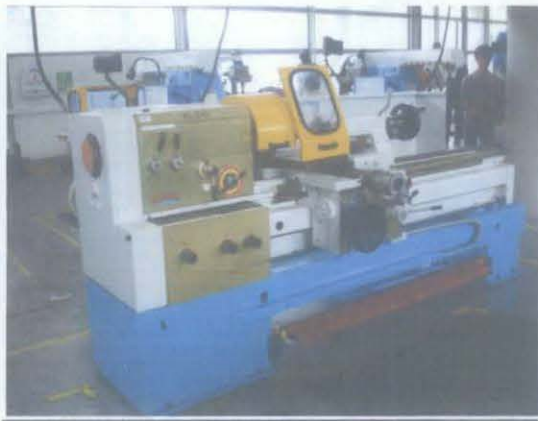
**Cutting the sample** - For microstructure study, the optical microscope cannot detect the microstructure of the outside coating of the tube. So, it is necessary to remove the coating. The tube has been turning to three layer of thickness which is 8 mm, 10 mm, and 12 mm. The coating at the tube surface also been removed using lathe machine.

Figure 11: Lathe machine

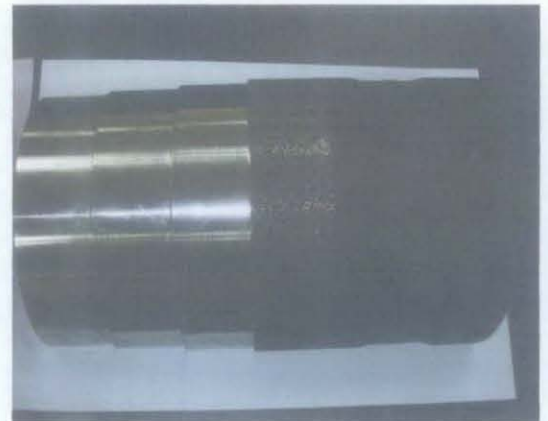
Figure 12: Tube after the turning process

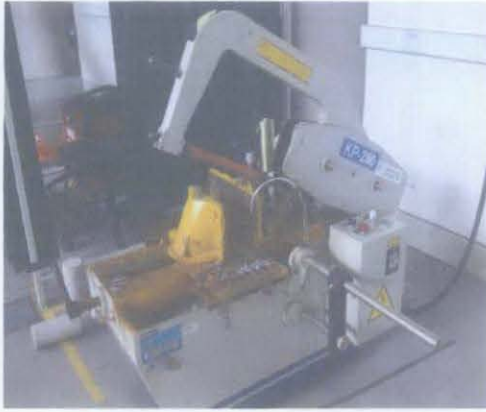
The tube has been cut into 2 part which is half part will use for metallography study and another half will be used for ultrasonic testing inspection. The cutting of the tube been conducted using linear hacksaw machine. After been cut to half, a piece of the nickel alloy tube was cut from the each layer of the tube using electric discharge machining. The samples size was cut around 10mm x 10 mm for convenience during grinding and polishing.

Figure 13: Linear hacksaw machine

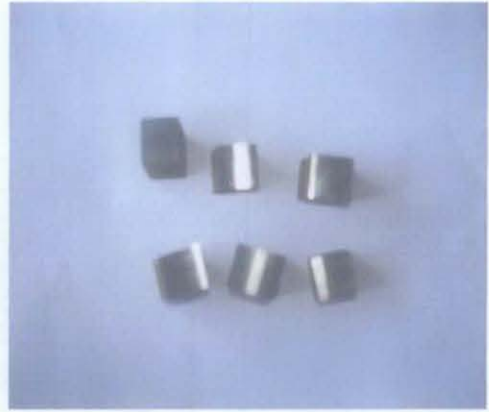
Figure 14: 10mm x 10 mm samples

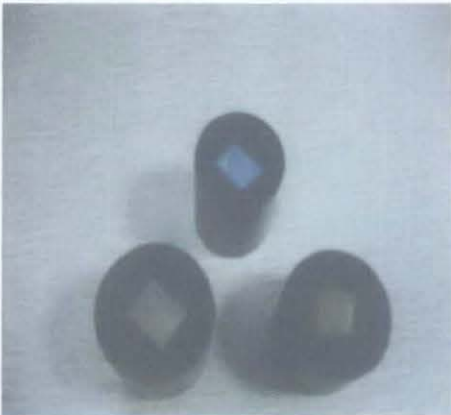
**Mounting of the sample** – Mounting is necessary because the samples are small and it is hard to do polishing and grinding job without mounting. Hot mounting is chosen for this study and this type of mounting uses heat generation in compression mounting. Black powder is used as the mounting material. The advantage of mounting is that the edges of the specimen will be reasonably well polished and not “bevelled” by the preparation process.

Figure 15: Mounting's samples

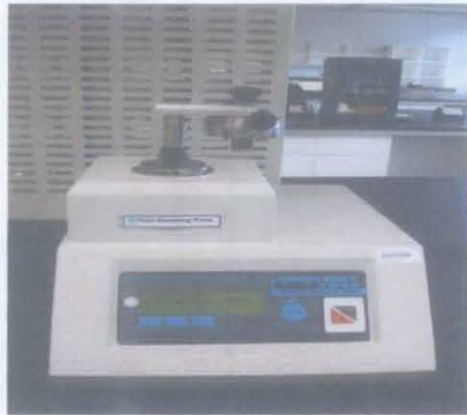
Figure 16: Hot mounting machine

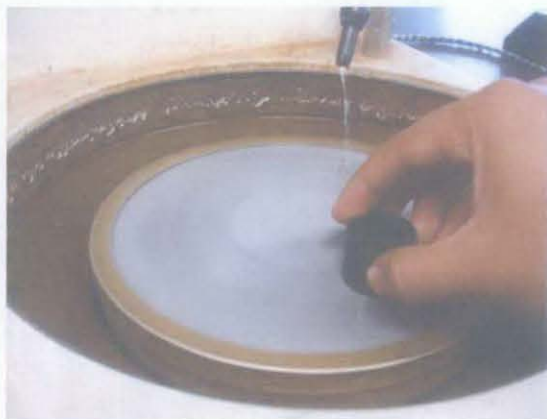
**Grinding** - The samples are ground on progressively finer SiC waterproof papers from 300 to 4000 grit, the reason for using different grit papers is to produce a reasonably flat surface; then the samples are lubricated with water to keep it cool and to remove the grinding products. If the samples are not flat, they might be necessary to remove some material on the lathe or grinding machine first. The sample should be moved forward

and backward on the paper until the whole surface is covered with unidirectional scratches. It is then washed with running water to remove debris associated with the grade of paper used. It is then ground on the next finer paper such that the scratches produced are at right angles to those formed by the previous paper.

Figure 17: Grinding

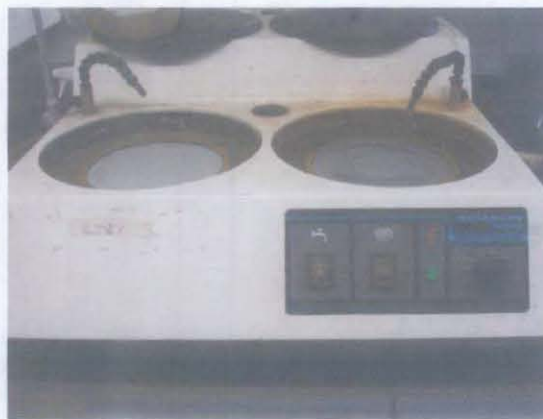
Figure 18: Grinder/polisher

**Polishing** – After finished with grinding, the next step is to do polishing on the samples. The purpose of polishing is to remove or disperse the scratch finely on the samples so that true structure can be observed. Polishing also is done using same rotating wheel like grinding but it used a cloth impregnated with a very fine abrasive compound. The compounds used are diamond. The samples are grounded on the on the lubricated rotating wheel and it is important not to press the sample on one orientation for a long time because it can cause the dragging of some microstructural components on the sample's surface. After 20-30 seconds the specimen is removed and rotated through 90° in the hand, placed back on the wheel and then again oscillated. The process of polishing is continued until the scratches is removed or dispersed finely.

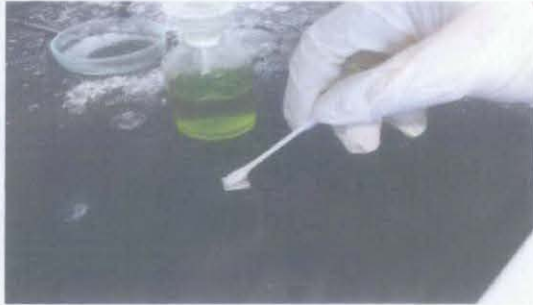
**Etching** – For 34%Nickel 20% Chromium alloy, fry's reagent is used as the etchant material. Fry's reagent consisted of 30ml H<sub>2</sub>O, 25ml of ethanol, 40ml of HCl and 5g of copper chloride. The purpose of etching is to reveal the grain boundary and the microstructure of the sample. Firstly, the samples were cleaned using alcohol and water and then being dried on the dryer. The purpose of this cleaning is to remove any impurities on the sample's surface. After that, fry's reagent was applied at the surface of

the specimen for 5 to 10 seconds. Then the samples were washed using water and alcohol. Lastly, the samples were dried and ready for microstructure examination.

Figure 19: Etching process

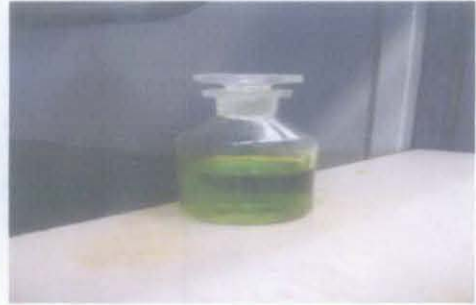
Figure 20: Fry's reagent

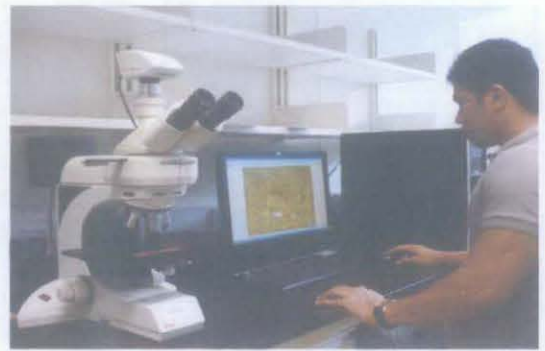
**Microstructure Examination** - The next step after etching is to do a microstructure examination on the samples using optical microscope. Firstly, the sample been put on the lens and then it been adjusted till the monitor come out with a good microstructure view. The brightness of the microscope also is adjusted until a fine picture of microstructure can be seen. The pictures of the microstructure were taken by using 500 x magnifications.

Figure 22: Microstructure examination

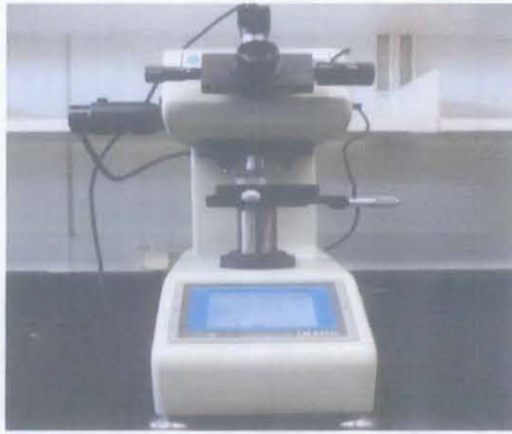
**Hardness test** – Surface hardness of the samples is measured by using microstructure Vickers hardness. The measurement of the samples was taken for four times for each thickness's samples. The average samples were determined.

Figure 23: Microstructure Vickers hardness

Vickers hardness test were performed on each reformer tube sample at 100 gf. Four reading for each sample surface were taken, in order to detect, an increase due to massive carbide precipitation. The means value from these readings for each samples are reported in Table 5. The hardness value of material in as-cast condition is  $179 \pm 7$ . The external surface layer of 12mm has the highest value which is 324.8 Hv while inner layer of 7.8 mm has smallest value which is 230.4 Hv. The results of hardness test are summarized in Table 5 and Figure 33.

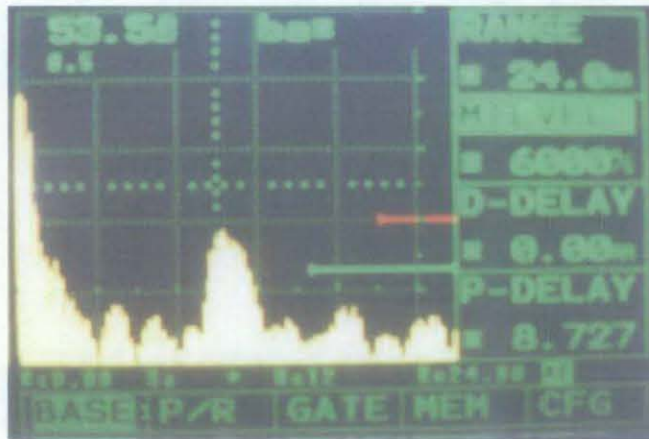
The ultrasonic testing of the external surface of the tube with the thickness of 12.0 mm is shown in Figure 25. The sound velocity for the sample was measured to be 6000 m/s.

Figure 25: UT on Nickel Chromium alloy  $t=12\text{mm}$

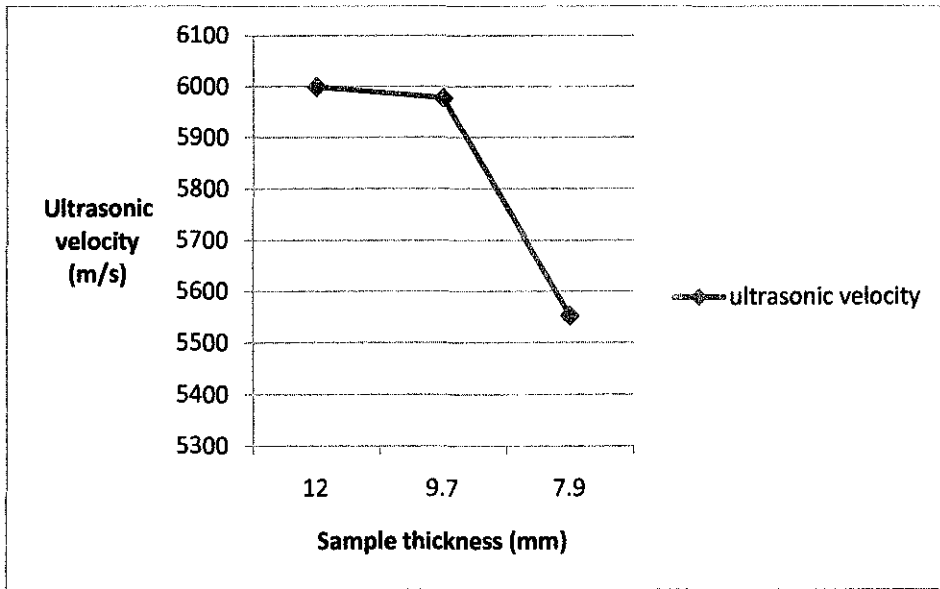
Figure 28: Ultrasonic velocity versus sample thickness

The ultrasonic velocity values are observed to decrease with thickness, particularly for the inner layer. The values of sound velocity are influenced by the condition of the tube. The external tube and subsurface were in the same condition while the inner tube represented different conditions. The condition of the tube can be determined by metallography study.

The results of the ultrasonic velocity on the different layer of thickness are summarized in Table 3 and Figure 28.
