**EVALUATION OF EFFECT OF OPERATING TEMPERATURE TO
CORROSION UNDER INSULATION (CUI)**

Dissertation submitted in partial fulfillment of
the requirements for the
Bachelor of Engineering (Hons)
(Mechanical Engineering)

MAY 2014

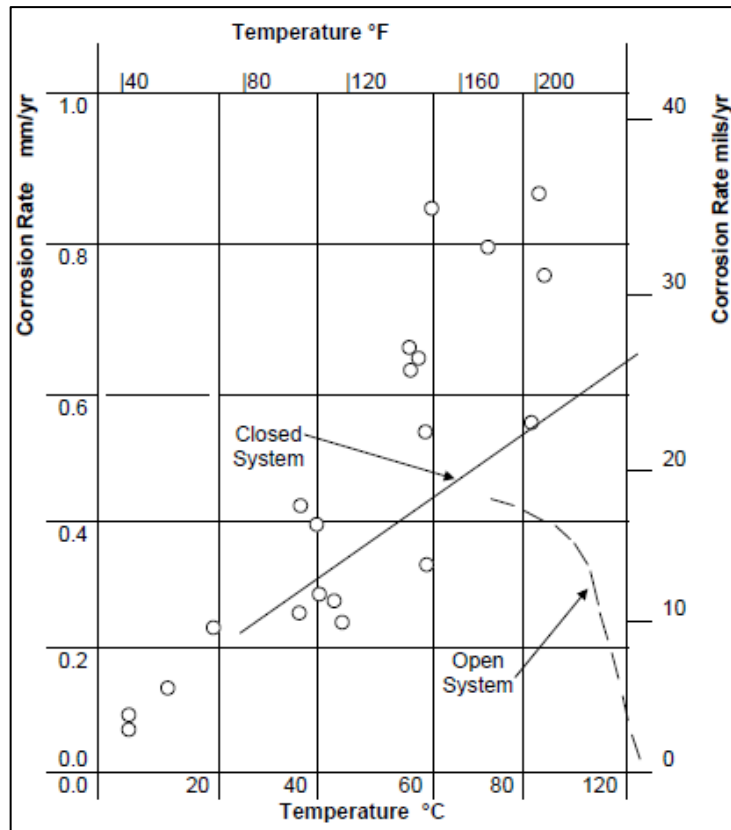
The effect of operating temperature on corrosion of steel in water is shown in **Figure 2-3**. In an open system, the concentration of oxygen in water decreases with increasing temperature, thus decreasing the corrosion rate. In contrast, the corrosion rate in a closed system increases with increasing temperature.

FIGURE 2-3: Comparison of Actual Plant CUI Corrosion Rates Measurements (Open Data Points Shown is for Plant CUI) with Laboratory Corrosion Data Obtained in Open and Closed Systems_[10, 11].

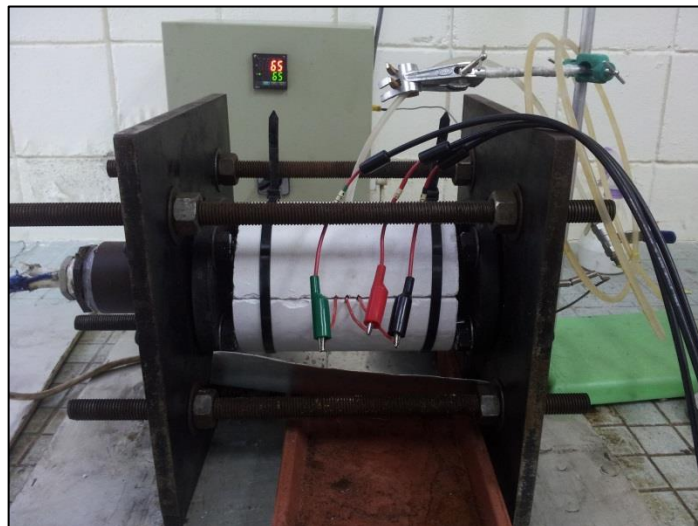
FIGURE 3-4: CUI-Cell Experimental Setup.

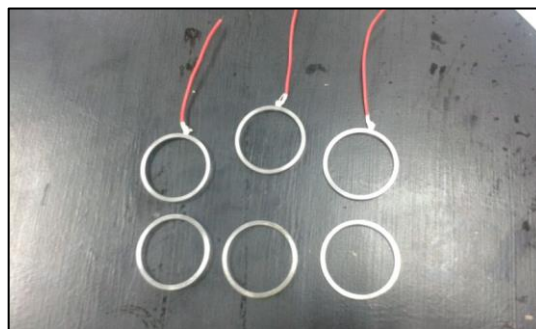
1. The ring specimens is machined from the pipe material and prepared to the surface finish.
2. The CUI-Cell is assembled by placing alternate specimens and nonconductive spacers.

FIGURE 3-6: Sample of Specimens.

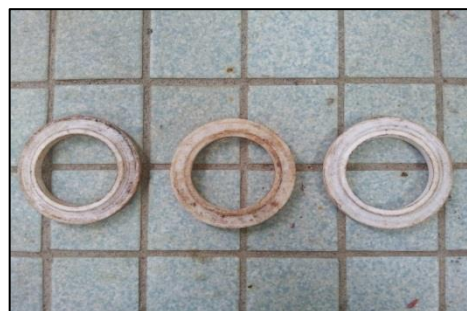
FIGURE 3-7: Sample of Nonconductive Spacers

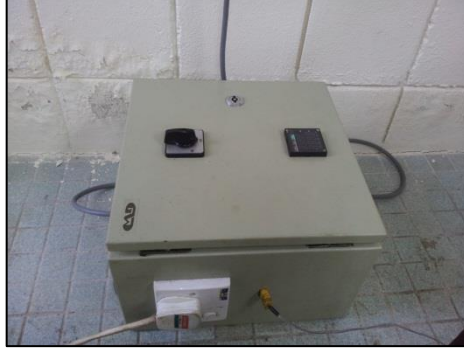
3. The immersion heater, thermocouple and the extension tube to the oil reservoir is attached to the CUI-Cell. The internal volume of the CUI-Cell is filled with suitable heat transfer oil for the condition used, heated and checked for leaks.

FIGURE 3-8: *Immersion Heater.*

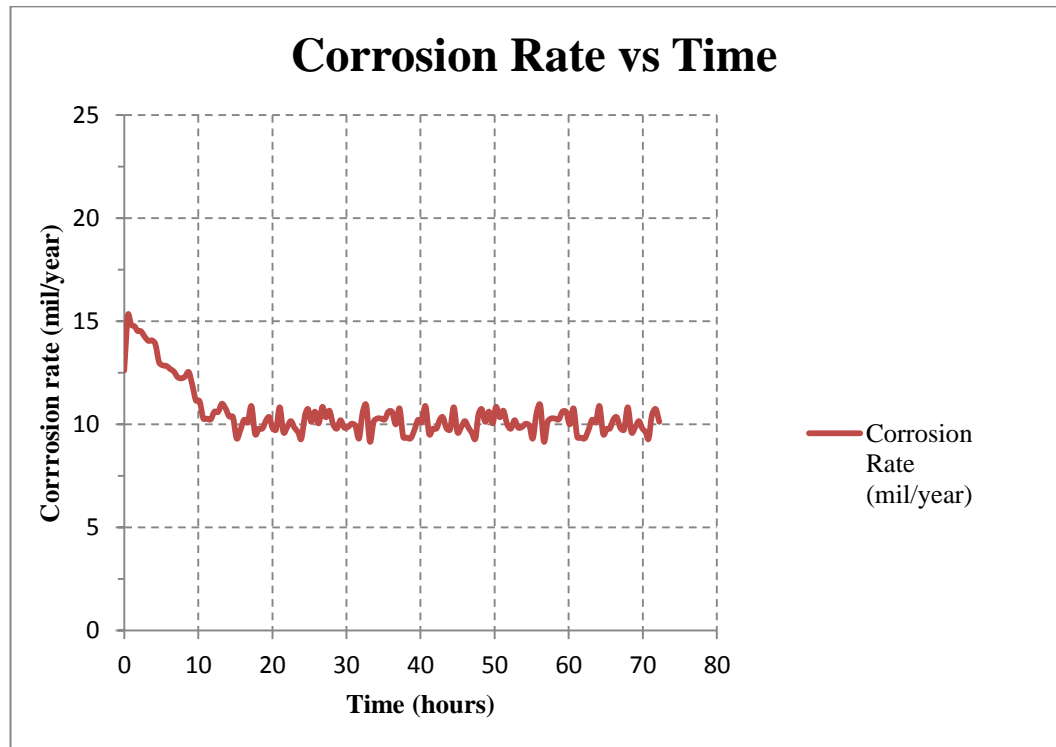
FIGURE 4-3: Corrosion Rate versus Time at temperature 65°C.

Based on **Figure 4-3**, the highest corrosion rate observed was at about the first hour which was about 15 mil/year mpy. The corrosion rate then decrease until about tenth hour and the corrosion rate is constant at range about 10 mpy. The corrosion rate obtained from potentiodynamic polarization resistance test is 10 mpy.

The same result was obtained by Abvarathna et al. in their experiment which was 10 mpy_[10]. However, based on **Table 2-2** and **Table 2-3**, the corrosion rate based on the experiment environment which is a coastal and coastal environment is 18.57 mpy after interpolation used since the temperature used 65°C is the intermediate value_[13].

The value obtained from experimental was lower than value in API Recommended Practice 581_[13] might be due to the solution used in the experiment to represent the environment was not the same on several conditions such as pH, chloride content,

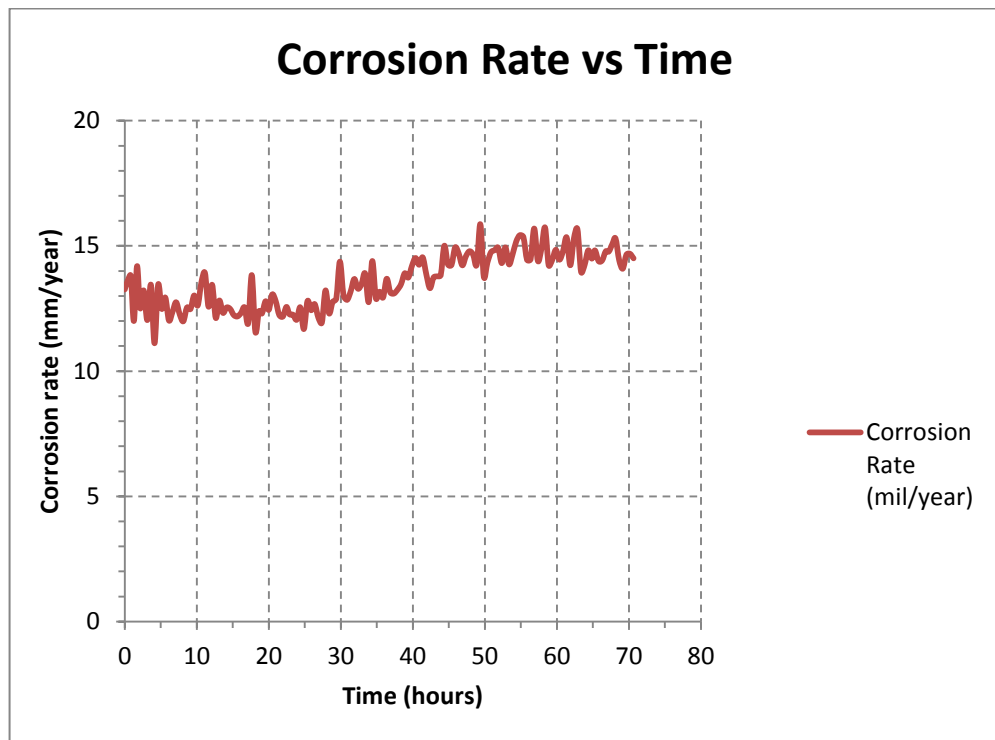
FIGURE 4-4: Corrosion Rate versus Time at temperature 121°C

Based on **Figure 4-4**, the trend for the corrosion observed was in the range between 13 to 15 mpy. Thus, the average value of corrosion rate observed at 121°C was about 13.5 mpy.

Based on **Table 2-2** and **Table 2-3**, the corrosion rate based on the experiment environment which is a coastal and coastal environment is found to be 10mpy after interpolation used since the temperature used 121°C is the intermediate value_[13].

The value obtained from experimental was higher than value in API Recommended Practice 581_[13] might be because of the solution used in the experiment to represent the environment was not the same on several conditions such as pH, chloride content, iron content, and other chemical species that may be present even though the environment condition is the same which is a severe environmental condition.

Based on the result obtained from the experiment, it was found that at higher operating temperature (121°C), the corrosion rate obtained was higher which is 13.5mpy compared to 10mpy corrosion rate at lower operating temperature (65°C). The result obtained from the experimental work done is corresponding with several references [9, 10, 12]. Several references[2, 12, 13] also states that CUI occurs at temperature in the range of -4°C to 175°C. API Recommended Practice 571 states that at metal temperature between the boiling point (100°C) and 121°C where water is less likely to vaporize and insulation stays wet longer, the corrosion becomes more severe[9].
