**Experiment Investigation on Pull-Off Strength between Fiber Reinforced
Polymer (FRP)-Concrete Interface under Marine Condition**

CIVIL ENGINEERING PROGRAMME

Universiti Teknologi PETRONAS

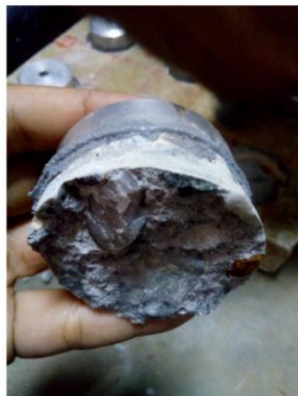
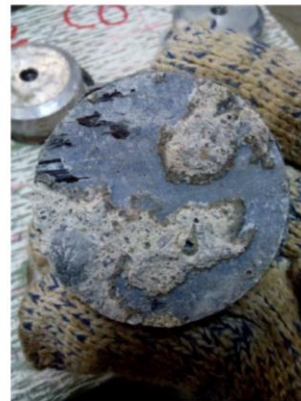
TYPE B

TYPE A/B

Figure 4 Failure Mode based on EN 1542

Looking to the type of failure in Figure 4 (Type B), an effect of microcracking is clearly visible where the failure happened in the superficial zone of substrate. For polishing, all failures appeared at the interface (type A/B, Figure 4), probably due to insufficient mechanical interlocking between substrate and repair layer and lower effective surface of contact.

Generally, a failure mode type B is desirable as it means that the bond between the substrate and repair material is so good that it surpasses the strength of the origin material. However, it is important to analyze the failure mode together with the value of bond strength.

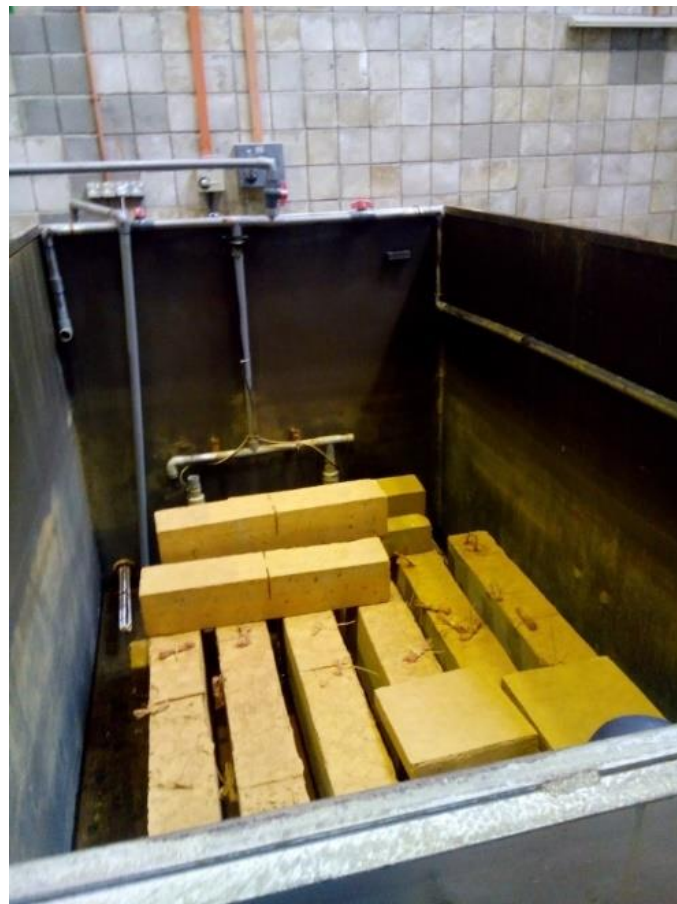
Figure 6 Specimens in Water Tank during Dry-Cyclic

The specimens are to be removed from tanks after 3, and 6 months during wet-dry cycles where the system loops between 3 days of fully-immersion in salt water and 3 days dry in the room temperature. In order to circulate the water, two pumps are installed for the first and the second tanks. However, the third tank is used for continuous condition of immersion in salt water.

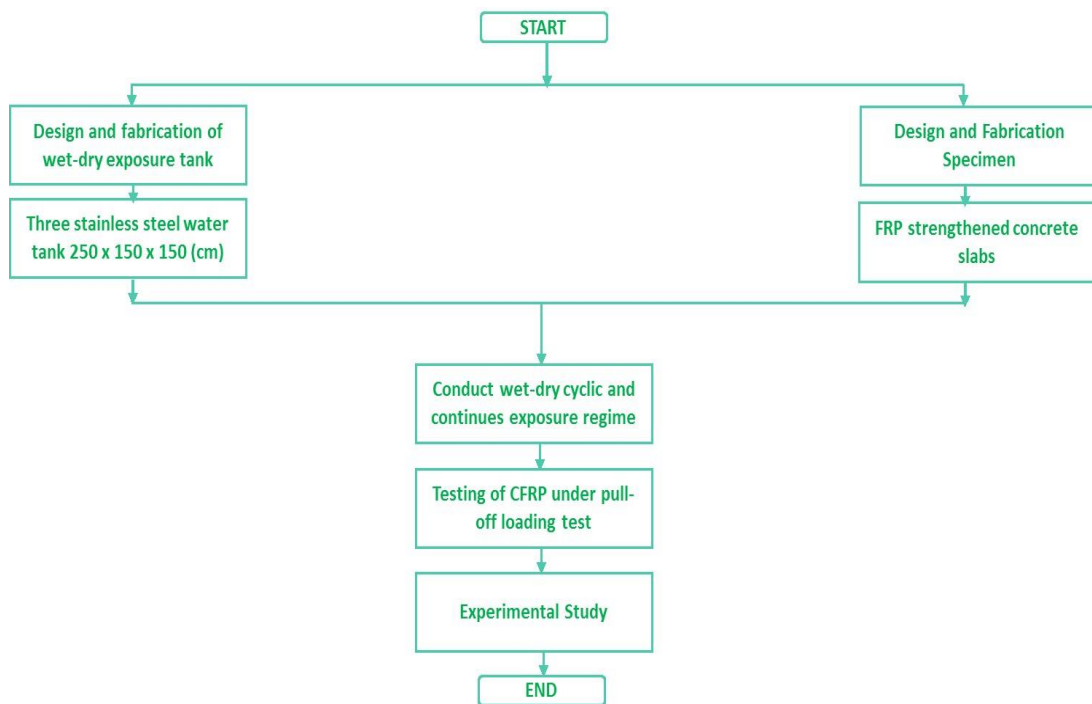
Figure 7 Flow Diagram on Environment Condition Procedure

Figure 7 above summarises that the design and fabrication of water tanks and specimens are conducted simultaneously.

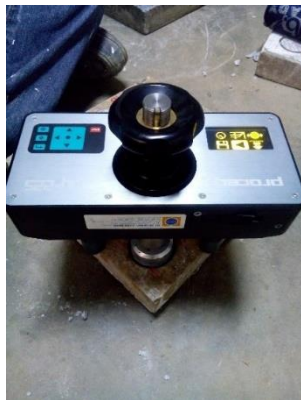
Figure 8 Proceq® DY-225, an Automated Pull-Off

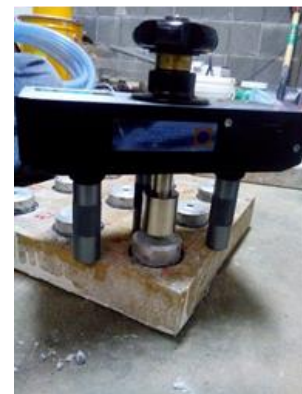
Figure 9 Measuring the Adhesive Strength of Applied Coatings

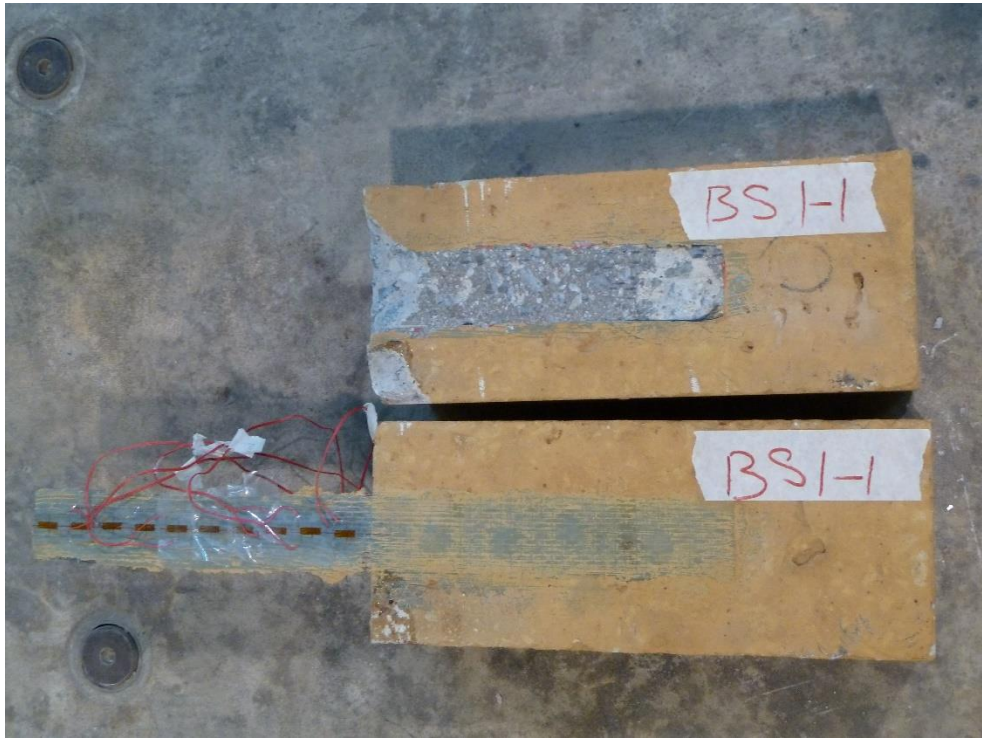
Figure 15 CFRP installed with strain gauges, debonded from substrate

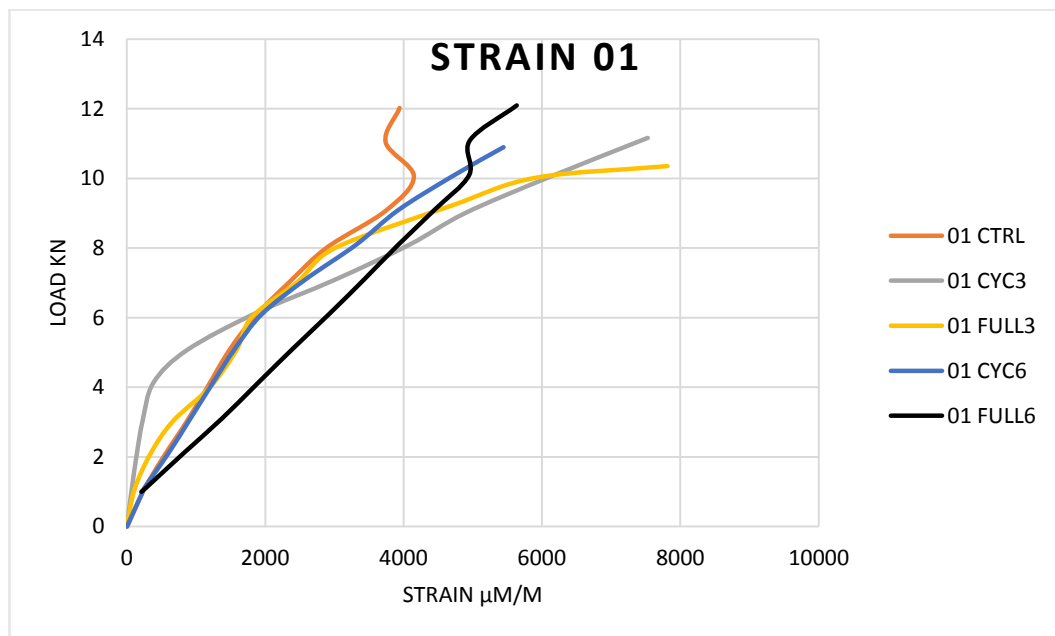
Graph 4-3

From the graph above, it shows the relationship on Strain 01 readings of control, 3 months and 6 months aging. Based on load versus strain graph, specimen FULL6, which has been aging continuously for 6 month-period; has strained linearly

subjected to the loading in the test. CYC3 indicates rapid straining until 4.2 kN loading and it strains linearly throughout the bending test.

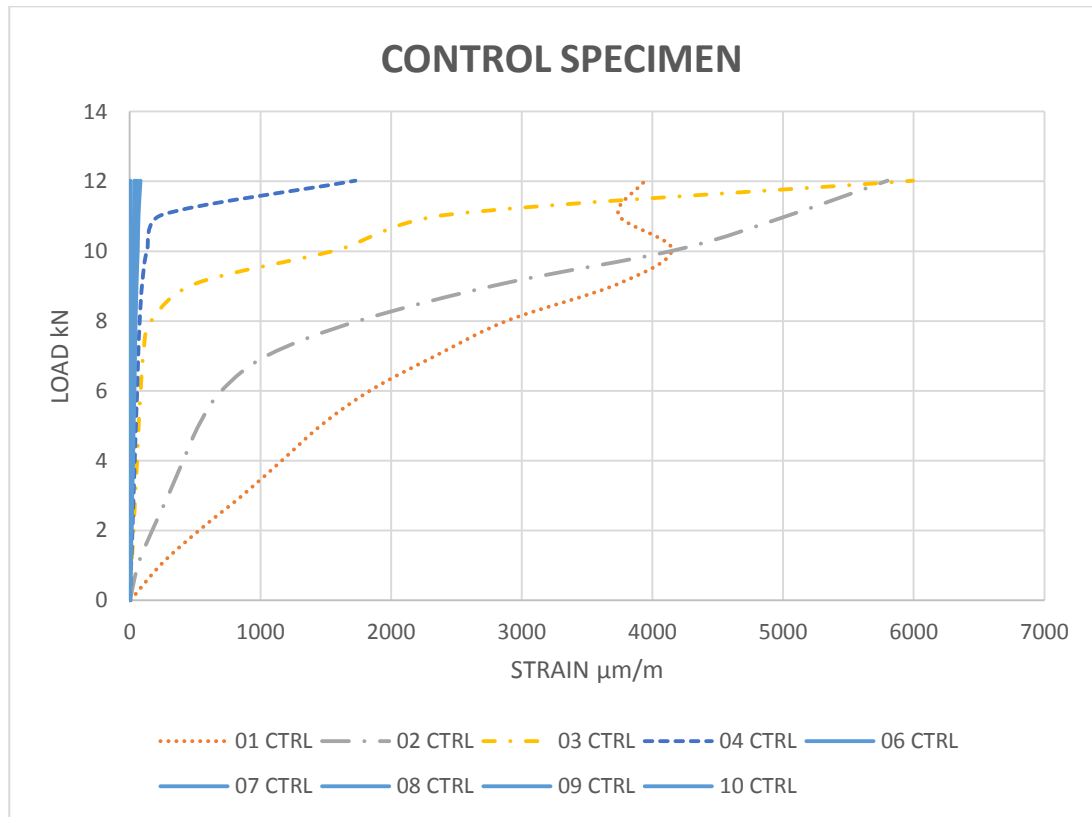
Graph 4-13

Based on the graphs above, Strain 01 indicates the strain gauges which is the furthest away from the support, in other words situated at the mid span of the beam whilst Strain 10 is the strain gauge which is the nearest to the support. As discussed in previous sections, the de-bonding between the CFRP rod and the epoxy starts at midspan then extends towards the supports situated on the end of beams. [13]

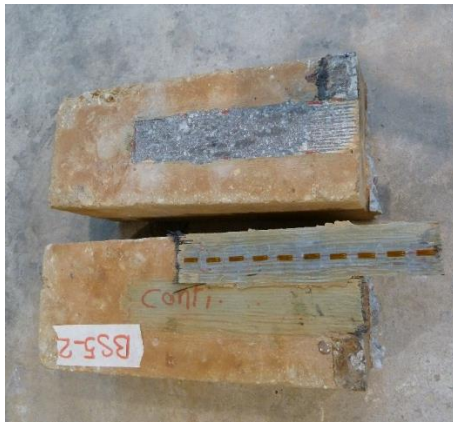
Figure 19 Continuous 3 month-exposure

After 3 months of aging process taking place, the debonding of CFRP starts to occur at greater rate compare to control specimen. However, comparison between 3 month cyclic (Graph 4-13) and 3 month fully immersion (Graph 4-14) specimens in salt water, shows that Strain 01 of FULL3 specimen strains with 1206 $\mu\text{m/m}$ at 4 kN whilst CYC3 strains at 386 $\mu\text{m/m}$ which is lower. These results show on bond strength on each beam subjected to the aging process. Saltwater degradation effects on the interface mechanisms of FRP-concrete member and reduce the mechanical bonding properties. Either in cyclic or continuous aging process, both procedure cause the higher rate in moisture diffusion. The durability of the bond in moist presence is mainly controlled by rate at which water and the deleterious ions move through the system. [12]

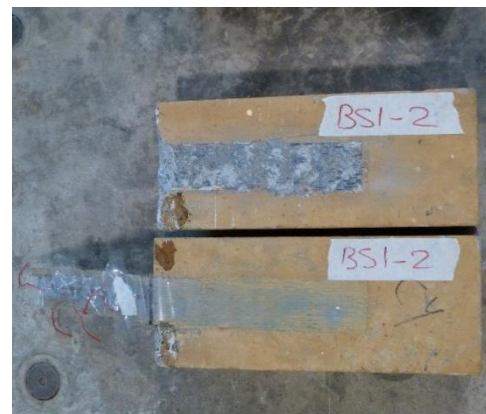
Figure 20 Wet-dry cyclic 3 month-exposure

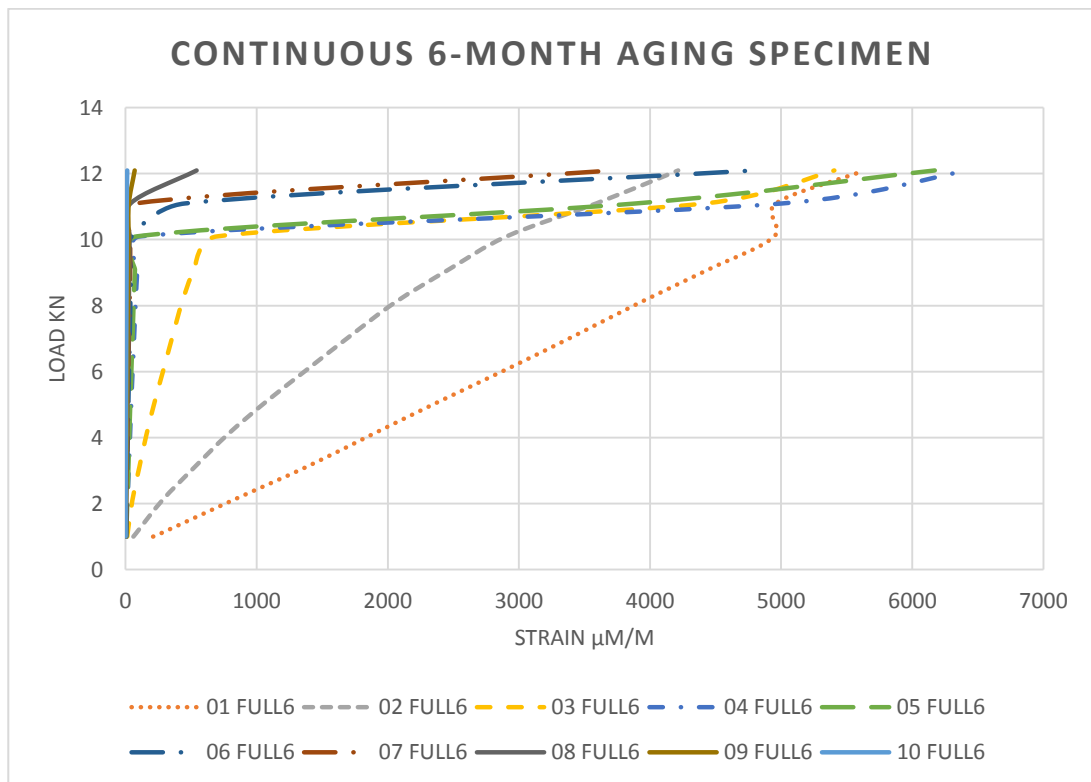
Based on the two graphs in Graph 4-15 and 4-16, where both graphs curve are almost identical and exhibit same pattern. Based on the author observations, the straining reading on the FRP sheet shows on intersection between loading and the strain. On wet dry cyclic ageing condition, the graph lines are converged at the straining ranged of 5000 $\mu\text{m}/\text{m}$ and 6000 $\mu\text{m}/\text{m}$ whilst the continuous aging of 6 months exposure results converged between 4000 $\mu\text{m}/\text{m}$ to 5000 $\mu\text{m}/\text{m}$. Failure loads ranged from 11.0 kN and 11.6 kN on both conditions. On average, as expecting from previous tests, the control specimens showed the highest strength. All beams showed a similar failure mode, wherein a single flexural crack is started at the top of the saw cut and shear failure debonding on one of the FRP-concrete interfaces is witnessed.

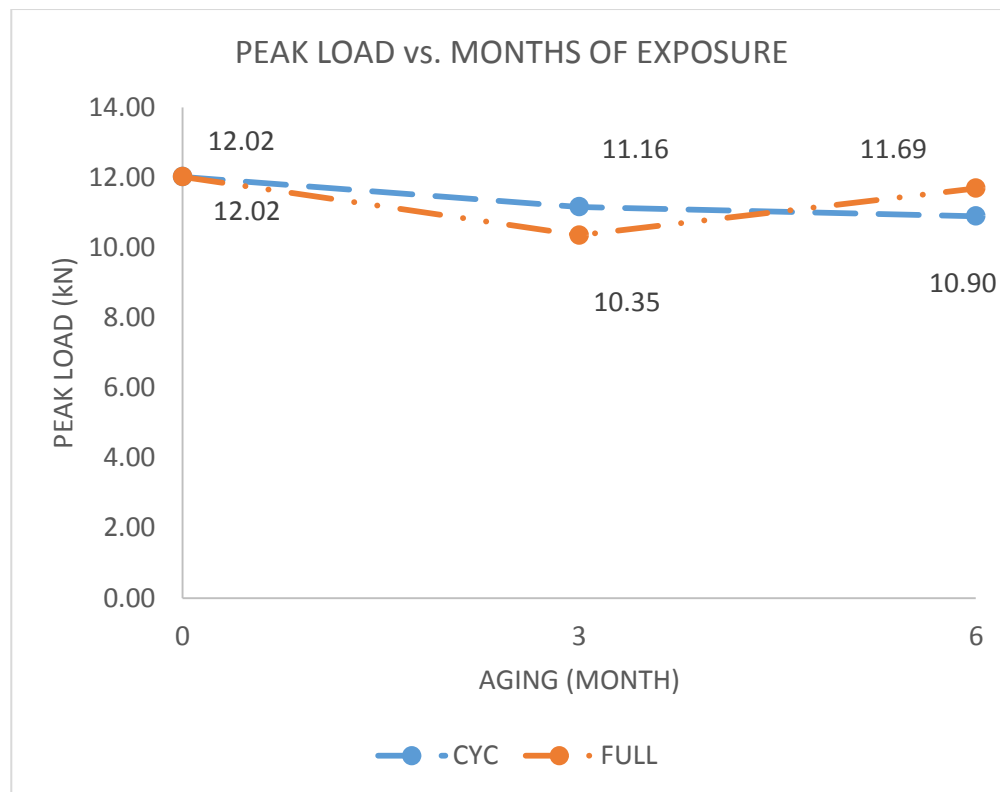
Graph 4-18 Average beam results for the 3-month and 6-month exposure

Graph above presents on a comparison plot of the beams tested at all aging stages process. As estimated, the dry (control) beams are the strongest ones throughout the entire durability study. In addition, a decrease in strength was witnessed in the wet dry cyclic environmental exposure. However, for unknown reason there was

an increase in strength during the last three months of exposure for the full continuous exposure specimen beam.
