# **Failure Mode Effect Analysis (FMEA) on Heat Recovery Steam Generator (HRSG): Water Tube Boiler**

Dissertation submitted in partial fulfillment of the requirement for the

Bachelor of Engineering (Hons)

Universiti Teknologi PETRONAS

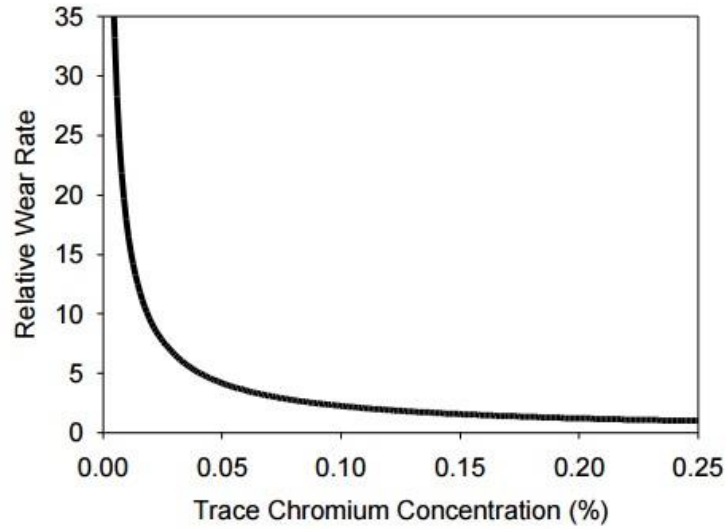
Figure 2.11: FAC-Chromium Concentration Relationship (F.C Anderson, 2003)

In the LP region of the HRSG, the equipments are mostly made up of carbon steel materials and these carbon steels contain minute amount of trace elements such as chromium. The rate of FAC is affected by the amount of chromium present in the carbon steel tubes which amounts normally from 0.15% to 0.25%. As according to F.C Anderson et al. (2003), the higher the concentration of chromium in the carbon steel tubes, the lower the rate of FAC attacks. As shown in Figure 2.11.

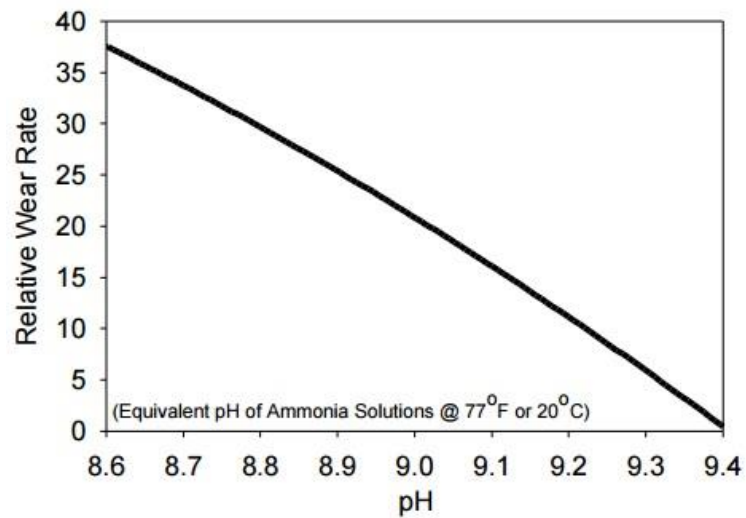
Figure 2.12: Relationship of FAC attacks and pH level (F.C Anderson, 2003)

The boiler feed water pH level also plays an important role in contributing to the rate of FAC attacks. In LP evaporators, there are significant amount of ammonia concentration that may affect FAC as stated by F.C Anderson et al. (2003). He also went on further to state that the lower the pH level of the boiler feed water the higher the rate of FAC as represented by the graph in Figure 2.12. Boiler feed waters are meant to be in a basic state, having a pH level normally between 8.7 to 9.4. If there happens to be a drop of pH level in the boiler feed water, it could contribute to an increasing rate of FAC.

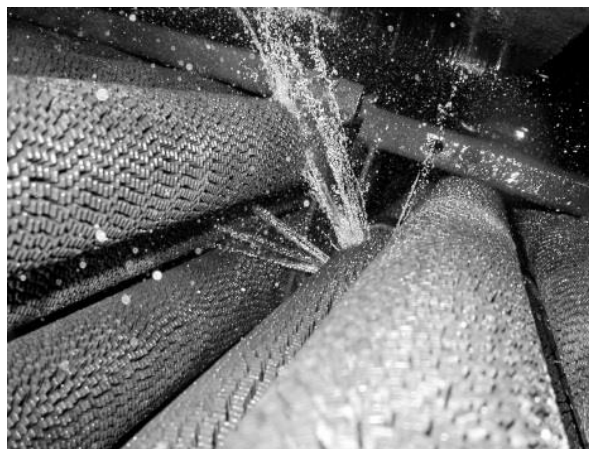
Figure 2.13: Leaking Evaporator Tubes (F.C Anderson, 2003)

F.C. Anderson et al. (2003) also conducted an investigation on an HRSG with failed evaporator tubes which have operated for the past 6 years (52,560 hours). It was discovered that the failed tube, after thorough examination, had suffered FAC attack. The main reason to the tube's failure was due to the low concentration of the trace element, chromium. It only contains 0.01% of chromium. It was proven that a higher concentration of chromium would not had to deal with FAC problems as another neighboring tube was also removed for examination and was discovered that it had 0.10% chromium and suffered no FAC attacks. An image of the failed tube can be observed in Figure 2.13 below.

To detect a tube suffering from FAC is a little difficult, especially with finned tubes as according to F.C. Anderson et al. (2003) conventional methods in detecting FAC such as the usage of eddy current and ultrasonic testing would provide little result as the fins would disrupt the signals significantly. Other methods that could prove a little useful is the laser profilometry, which measures the inner diameter of the tube of interest with rotating laser probe.

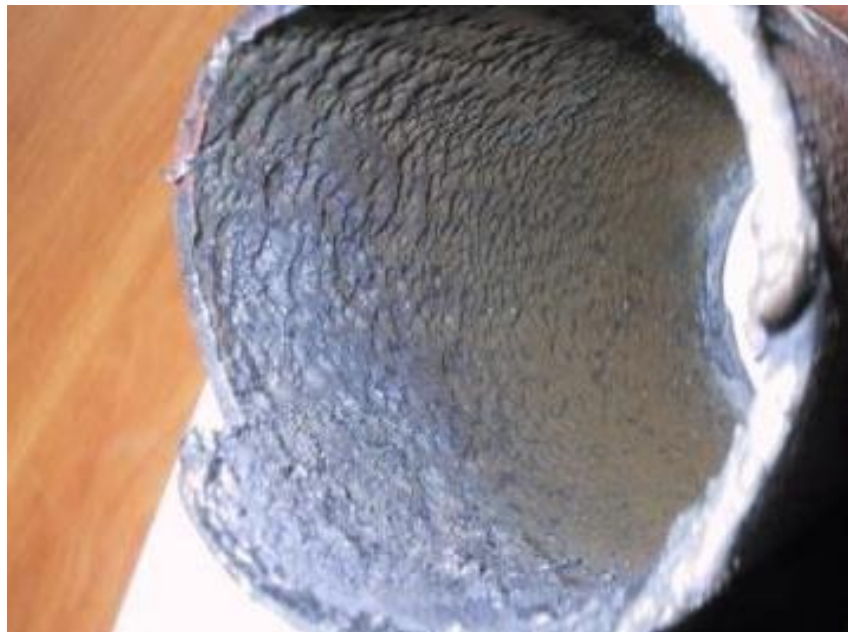
Figure 2.14: FAC attack on tube wall (R.M Sharip,2007)

According to R.M. Sharip et al (2007), several factors may contribute for FAC, such as boiler feedwater pH, temperature, turbulence and concentration of oxygen. An example of a FAC attack is as shown in Figure 2.14 below.

He also states that combined with a specific temperature window and an unsuitable water chemistry may lead to FAC (R.M. Sharip, 2007). R.M Sharip (2007) added on that FAC generally occurs at operating temperature range of 80-230 °C. Table 2.6 below shows recorded failures in the economizer section.

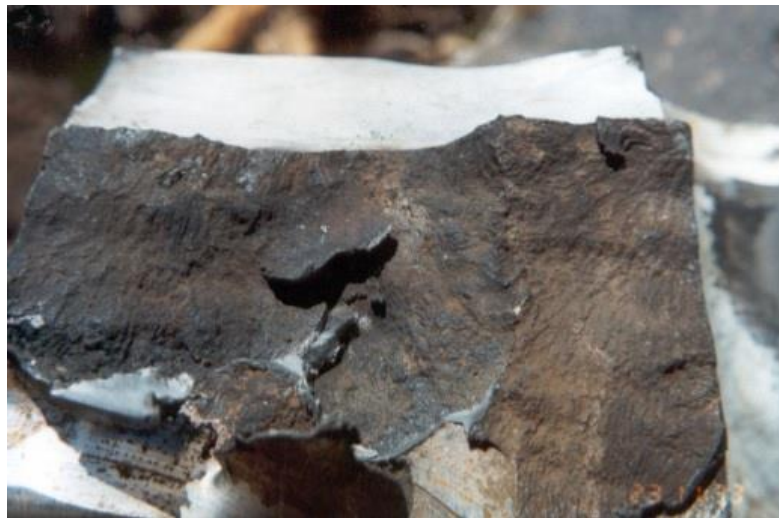
Figure 2.16: Corrosion Fatigue on a Steam Drum, (K.B. McIntyre, 2002)

Another prominent type of failure that has occurred in HRSGs that have been identified over the past years is corrosion fatigue. Corrosion fatigue by definition according to K.B. McIntyre (2002) is a combination of fluctuating stress and the presence of a corrosive environment will lead up to cracking. Furthermore, he states that in water tube boilers, this failure tends to occur at the higher pressure region of the boiler, such as the steam drum. As shown in Figure 2.16 below, a steam drum suffered a corrosion fatigue attack as it was discovered during an inspection after 16 years in operation. If allowed to continue, this failure could lead to a boiler explosion. This steam drum underwent an engineering redesign to prevent such failure. Corrosion fatigue failure tends to happen when corrosion is allowed to happen and there is a lot of start and stop cycle.

F.C. Anderson et al. (2003) states that corrosion fatigue tends to happen to locations associated with trapping corrosive impurities which lead to high stress factors such as socket welded joints and partial penetration joints. He went on further to state that one of the causes that contributed to the occurrence of this type of failure could be rooted from inadequate quality control during fabrication. Another evidence of a corrosion fatigue failure that has occurred in HRSG can be seen in another study conducted by F.C. Anderson et al. (2003) where in his study shows that several tubes to header joints

According to F.C Anderson et al. (2003), the joints are done in accordance to the ASME Code, where partial penetration weld was utilized and through visual inspection, cracks have been found to form in these areas that were highly associated with high stress. The remedial method to reduce corrosion fatigue attacks on these tubes as proposed by F.C. Anderson et al. (2003) is to modify the geometry design of the components or change the mode of operation as to reduce the cyclic stress on the component of interest.

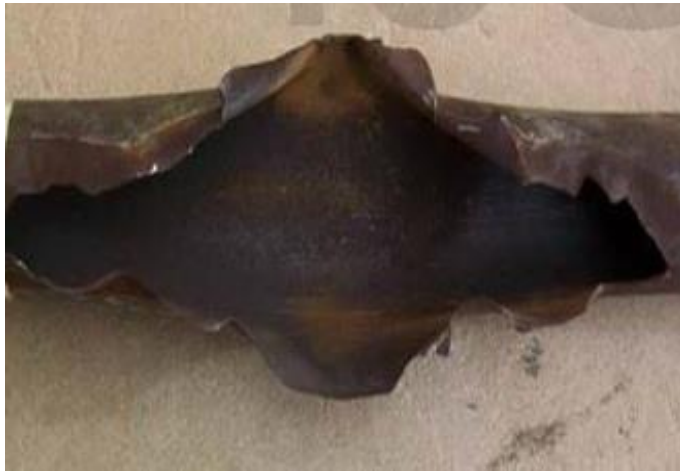
Figure 2.17: A ruptured Economizer Tube due to Fireside Corrosion (A.U. Malik, 2013)

One such case of fire side corrosion can be seen in a study conducted by A.U. Malik et al. (2013) on a cogeneration plant in Saline Water Conversion Corporation (SWCC), where failed economizer tubes caused a boiler to be tripped. The tubes had experienced a fish-mouthed rupture as wide as 0.28 cm as shown in Figure 2.18 after precisely 4 years of operation. By chemical analysis through EDX profiling on the tube, as shown in Figure 2.19, it was found out that the fireside of the tube had high content of Magnesium, Sulfur and Magnesium. These findings show that the flue gas had high ash content and the plant was using high ash oils.

A.U. Malik et al. (2013) concluded that the tubes had experienced ruptured due to its inability to withstand the pressure inside the tube. The reason being is that the tube had suffered severe corrosion on the external surface due to the condensation of sulfuric acid at dew point and thus contributed to the metal thinning of the tube which ultimately resulted in the rupturing of the tube.

A.U. Malik et al. (2013) proposed a solution to counteract the problem of fireside corrosion by installing a high powered soot blowing system which could minimize the chances of acid dew-point corrosion taking place. He also went on further to add that by dwindling the amount of sulfur content would highly reduce the chances of a fire side corrosion by opting for low ash oils.

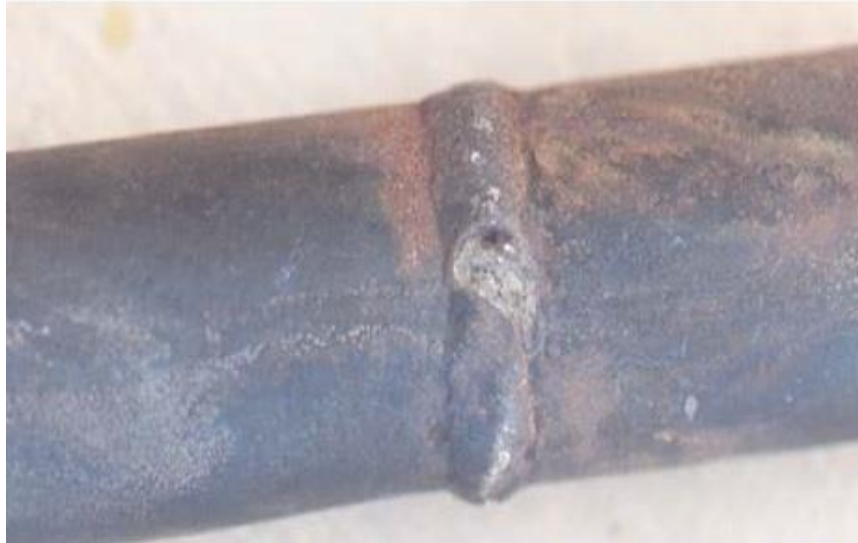
Figure 2.19: Formation of Hole Around Weld Area (A.U. Malik, 2013)

Temperature plays an important role in preventing tube failure. Tubes might encounter failure such as dew-point corrosion if poor temperature management was taking place. Dew-point corrosion as according to A.U. Malik et al. (2013) is the product of a lowered flue gas temperature below the dew-point of acid condensation. In his study, A.U. Malik et al. (2013) have identified several economizer tubes that were reported of exhibiting leakages in SWCC also after 4 years. Upon visual inspection, it was discovered that the tube had formation of small holes around the weld area as seen in Figure 2.20. Through chemical analysis by using EDX profiling on the tube as shown in Figure 2.21, it was found out that the high Sulfur content. A.U. Malik et al. (2013) stated that, the condensation of Sulfuric acid is in the temperature range of 120 to 150 °C.

The remedial method in fighting dew point corrosion as proposed by A.U. Malik et al. (2013), is that by fixing the economizer's temperature well above the dew-point of acid condensation is highly recommended. A.U. Malik et al.(2013) also went on further to add that installing a proper temperature monitoring device to monitor the temperature of the economizer tube would prove useful as well.

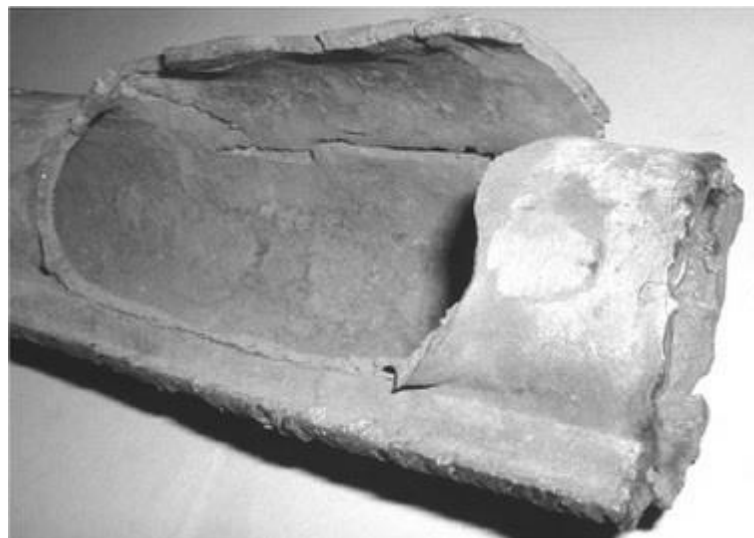
Figure 2.24: Evaporator Tube Window Fracture (M.Djukic, 2005)

Next, the failure that shall be discussed is hydrogen attack. According to M. Djukic et al. (2005), hydrogen attack is a problem faced by engineers frequently. By definition as stated by M. Djukic et al. (2005), hydrogen attack is basically when methane gas is formed along ferrite grain boundaries due to the presence of high pressure and temperature in its surrounding which forces the carbon element present in steel to react with hydrogen atoms. The attack decarburizes the tube and thus lead weakened the tube's structure. In an investigation conducted on a thermal fossil fuel power plant boiler, several evaporator tubes have been found to be in an extensive damage after a boiler trip. The tubes suffered failure in the form of a window fracture as seen in figure below after 73,000 hours of operation. The tubes had to be replaced.

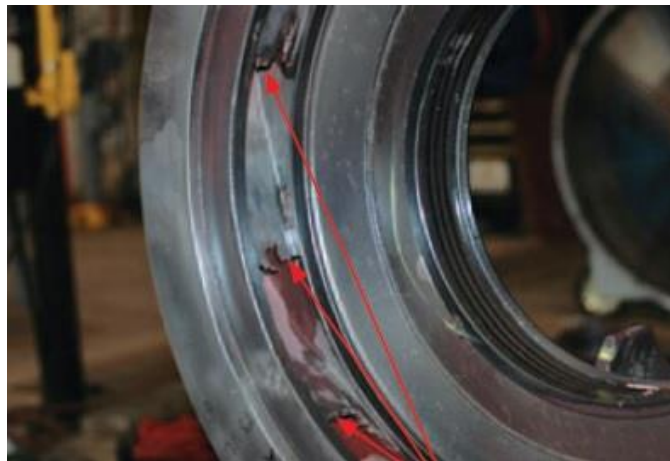
Figure 2.25: Cavitation Signs on Pump's Diffuser (Flowserve, 2010)

An example of cavitation in pump can be seen in a case study by Flowserve (2010) where a boiler feed water pump for a coal fired power plant had suffered severe cavitation. The pump had operated for every 3000 hours and for the first 15,000 hours, after being reported of producing loud noise and excessive vibration the pump had exhibit signs of cavitation as pointed out by the red arrows in Figure 2.26.

Flow instability was discovered to be the main contributor the pump's failure. This is because the pump had operated below the pump's best efficiency point (BEP). According to Flowserve (2010), the solution to overcome this problem was to adjust the parameters of operation so that the pump could operate at BEP.
