Structural Integrity Re-Use Assessment for Fixed Structures

Dissertation submitted in partial fulfilment of

Bachelor of Engineering (Hons)

(Civil)

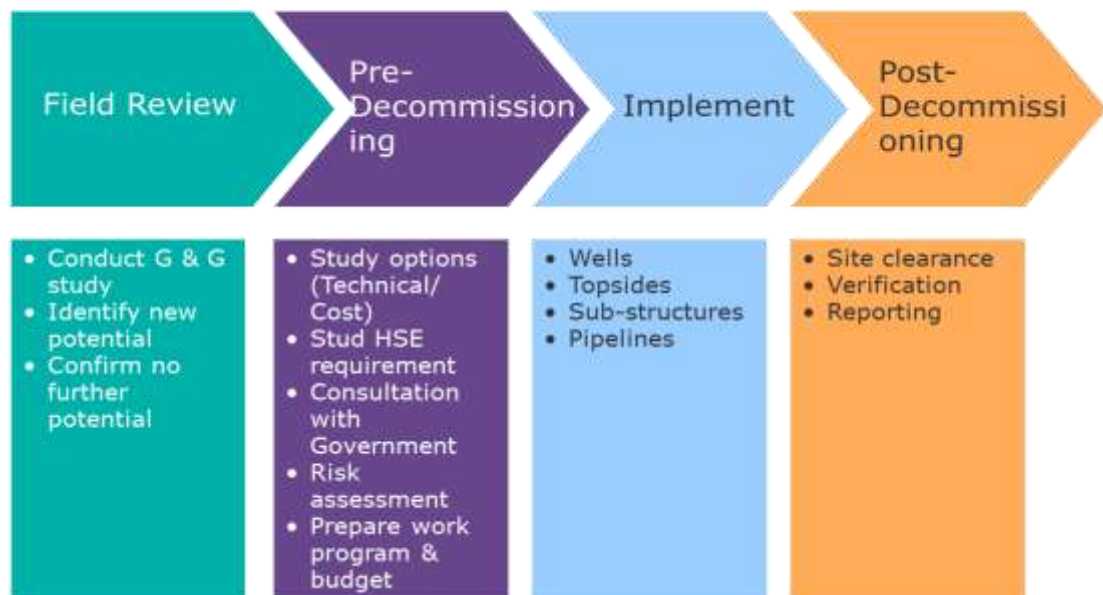
Figure 1. Decommissioning Process (Roslina Misman & Salamah Saad, 2004)

The decommissioning process involves closing down operations at the end of field life including permanently abandoning wells, properly disposing of hydrocarbons and chemicals, making the platform safe, and removing some or all of the facilities and reusing or disposing of them as appropriate (API, 2014). PETRONAS “Guideline for Decommission of Oil and Gas Installation” had identified four main phases: field review, pre-decommissioning and implementation and post-decommissioning.

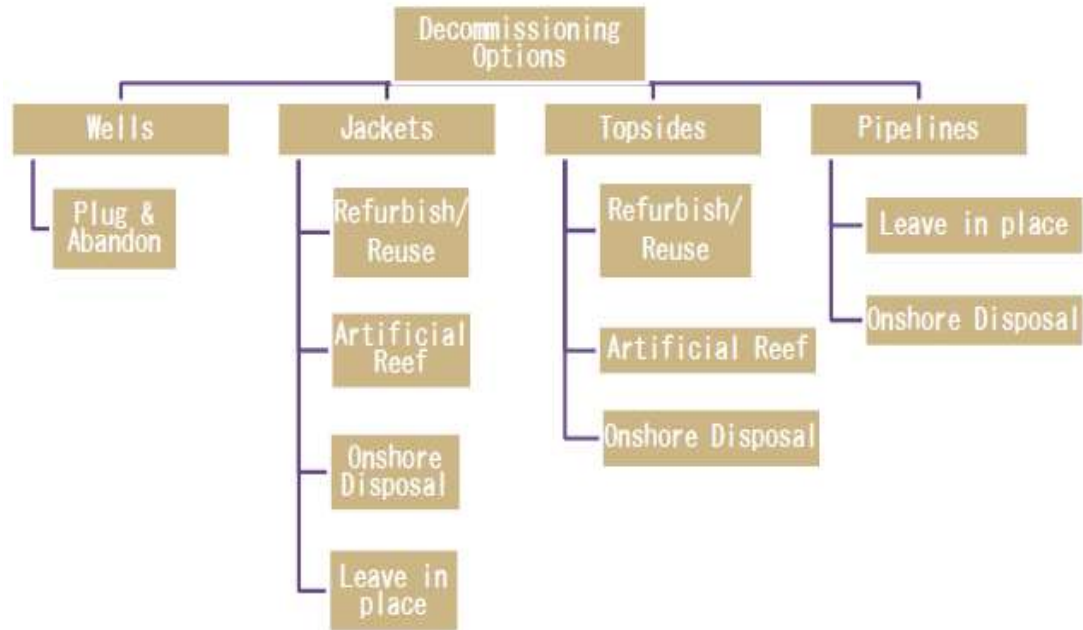
Figure 2. Decommissioning Options (Beheshti, 2014)

or as artificial reefs), and reusing. According to International Maritime Organization (IMO) Guideline (1989), all structure installations require total removal with the exception of partial removal for some cases. More than 97% of Malaysia Platforms require total removal (R. Misman & S. Saad, 2004)The options for decommissioning of the various components of the offshore structure is show in Figure 2.

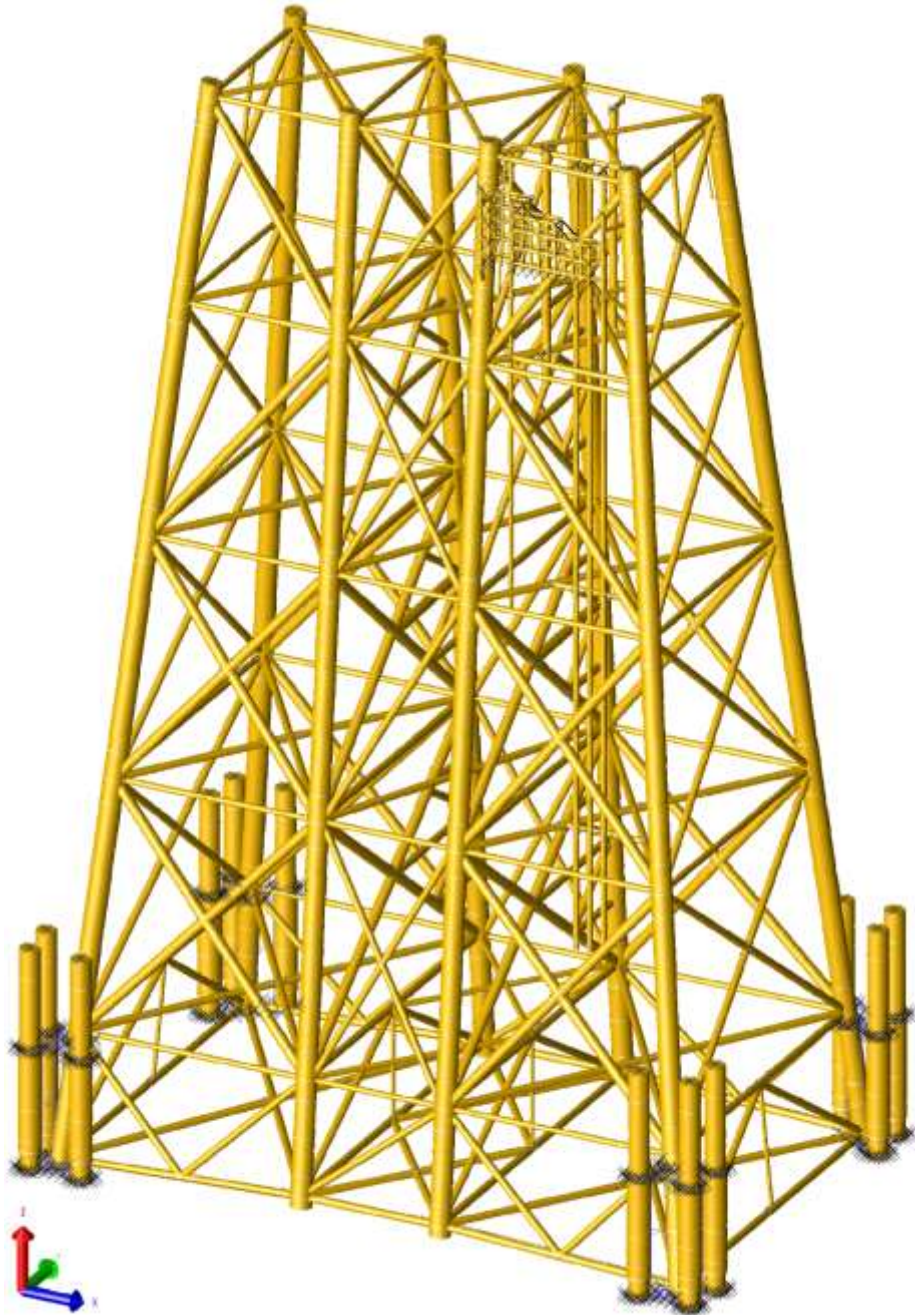
Figure 5 SACS 3D Model View - Yetagun B Jacket
