**Electrochemical Impedance Evaluation Of Coating Under Simulated Splash
Zone Condition**

Dissertation submitted in partial fulfilment of
the requirements for the
Bachelor of Engineering (Hons)
(Mechanical)

January 2020

Universiti Teknologi PETRONAS
32610 Seri Iskandar
Perak Darul Ridzuan

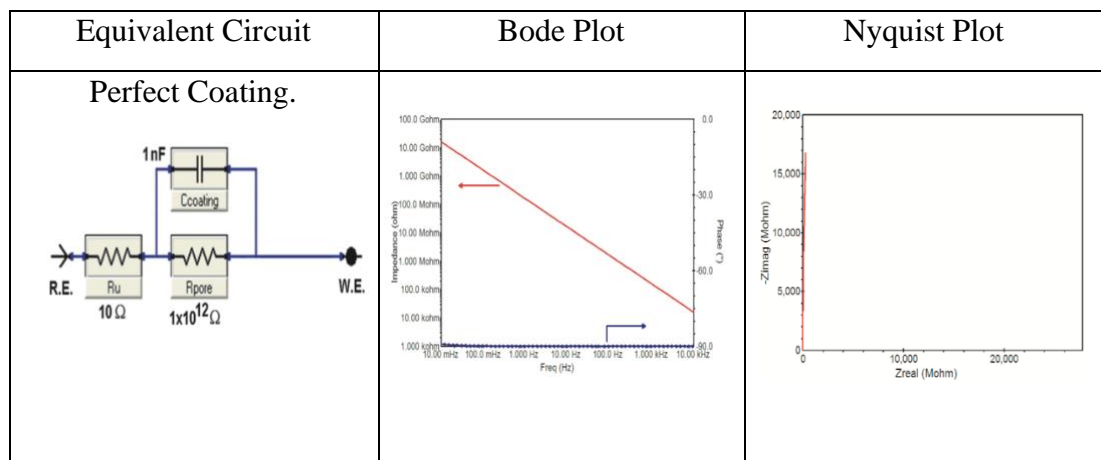
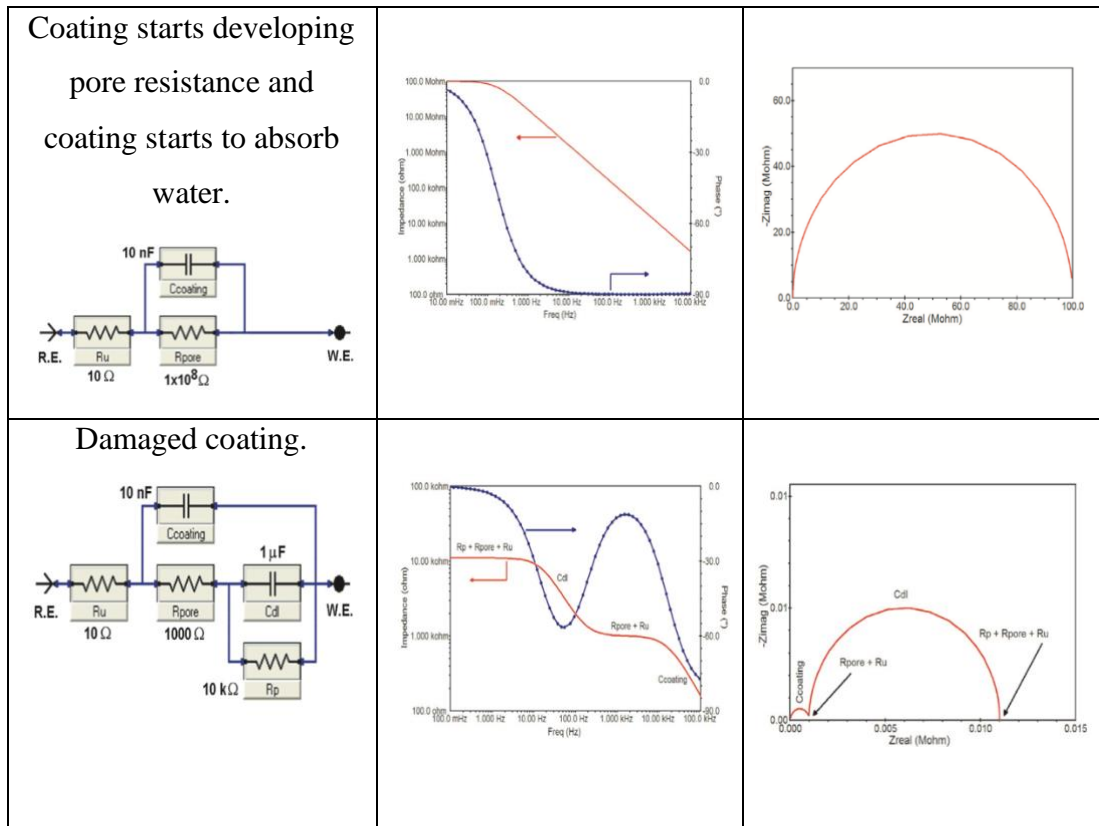
Table 2.2 Equivalent circuit model. Retrieved from Gamry Instruments

In summary, high impedance indicates high resistance towards corrosion. Moreover, the Nyquist plot will show a distinctive patterns and shapes, which shows the state of the coating. With ‘semi-circled’ Nyquist plot, the coating is experiencing water absorption, meaning there is a potential for the metal to experience corrosion. With two ‘semi-circle’ shape at the Nyquist plot means the coating have been damaged.

To have more credible result, it is recommended that the ageing test should be extended until result for impedance and Nyquist plot are categorized as damaged coating as per Table 2.2. Once the coating are categorized as damaged coating, it should then be compared visually through blistering and rusting.

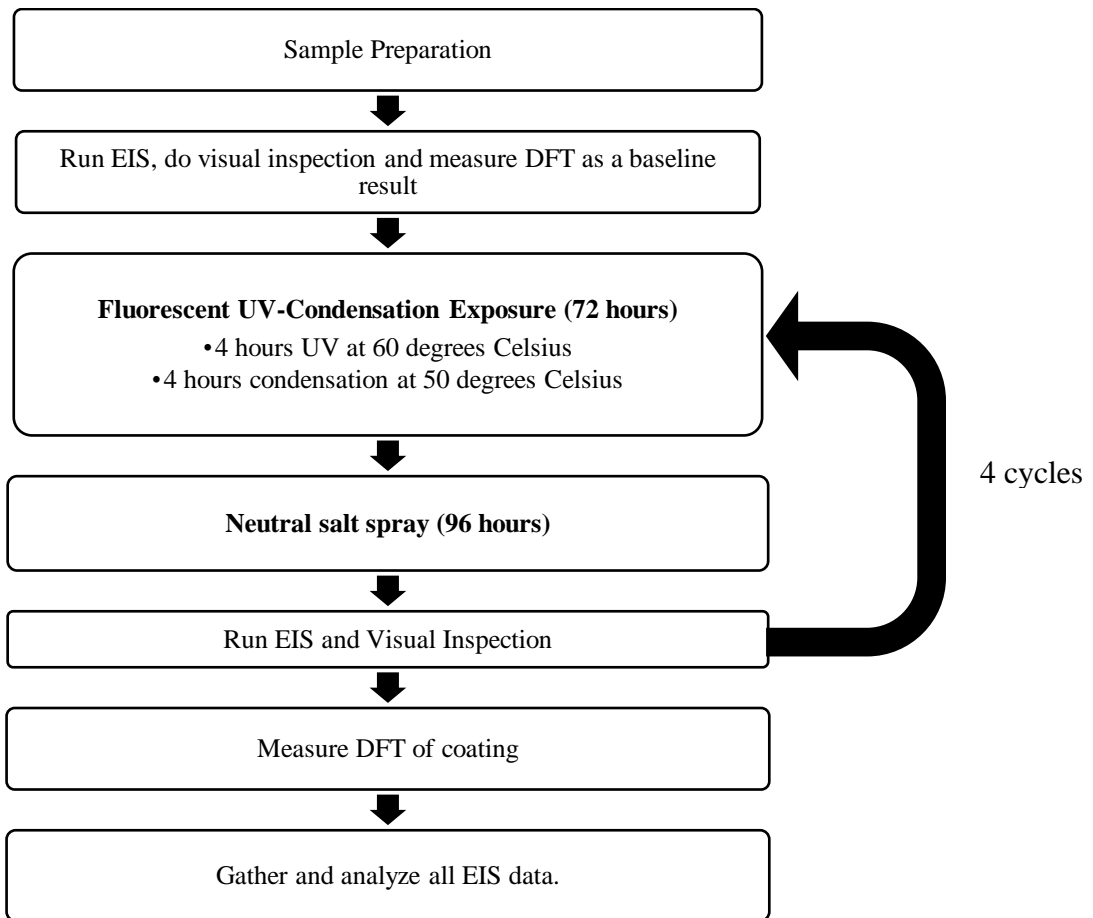
Below is the flow chart of the experiment:

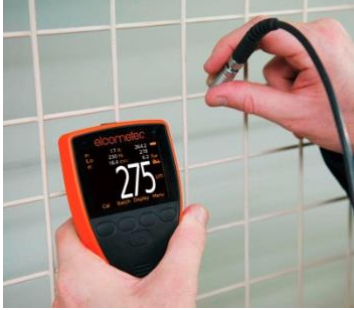
Measure the dry-film thickness of coating.
2	Salt spray chamber

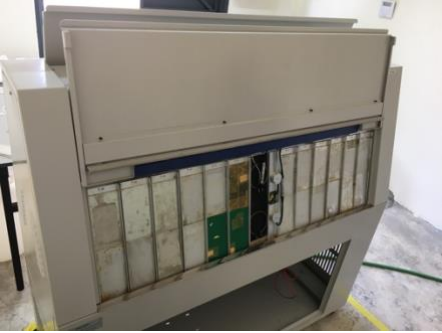
Produce damage caused by UV and humidity.

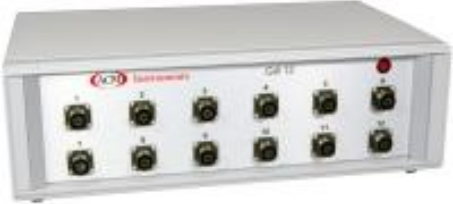
<p>Characterize the coating through measurement of impedance.</p>
5	<p>EIS Cell</p>

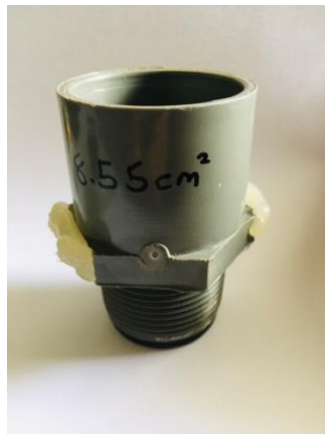
Figure 3.2 EIS Cell

EIS cell is a place where electrolyte solution is poured to ensure connectivity of the EIS test. There are certain criteria must be met when constructing the EIS's cell as per stated in ISO 16773: Electrochemical Impedance Spectroscopy on coated and uncoated metallic specimens [15], which are:

- I. The EIS cell's material must not react to the electrolyte to prevent error.
- II. The EIS cell must be leak-proof to ensure the exposed area is constant because capacitance depends on the exposed area. Hence, the use of O-ring is recommended.
- III. The compression of O-ring must be adequate, until no leakage is seen.

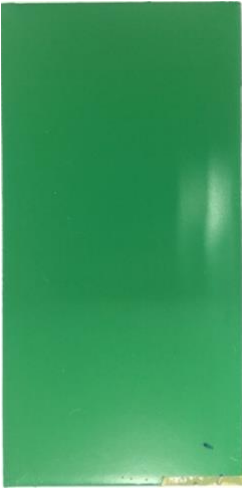
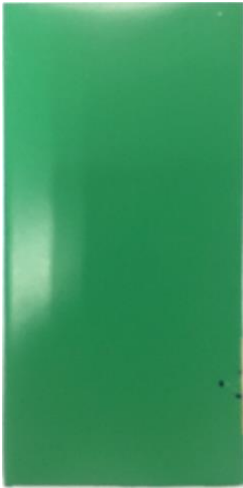
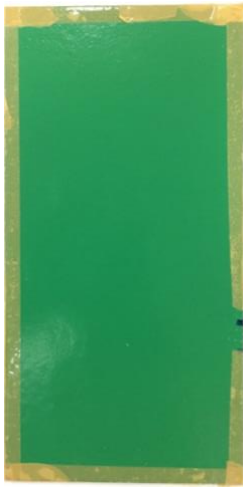
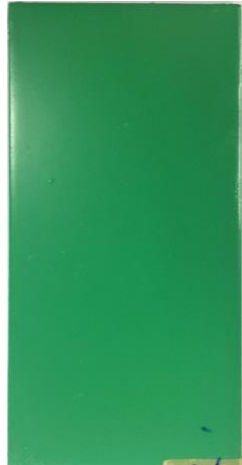
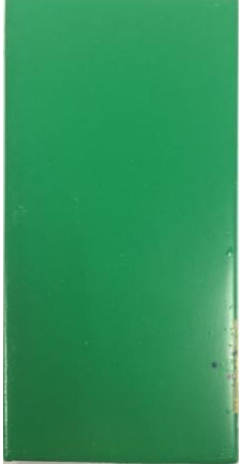
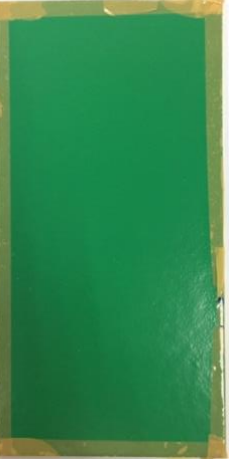
Table 4.1 Photographic result

To determine the degree of blistering, ASTM D714: Standard Test Method for Evaluation of Blistering of Paints is referred [17]. From the result obtained (Table 4.1), there are no blistering or rusting seen on all samples. Hence, all samples have a rating of 10.

Rust is a yellowish-brown flaking coating of iron oxide that is formed on iron or steel by oxidation. To determine the degree of rusting, ASTM D610: Standard Practice for Evaluating Degree of Rusting on Painted Steel Surfaces is referred [16]. From the result obtained (Table 4.1), there are no rusting seen on all samples. Hence, all samples have a rust grade of rating 10.

Firstly, for the measurement of DFT (before and after the ageing test), all of the sample have decreased approximately by 1% from its initial thickness. Hence, the coating may have experienced degradation when the experiment is running. As for the degree of blistering and degree of rusting, all the samples have a rating of 10, meaning no blister or rust is visually seen.

All samples have a rating of 10 for both degree of blistering and degree of rusting since it does not have any blistering or rusting seen on the coating.

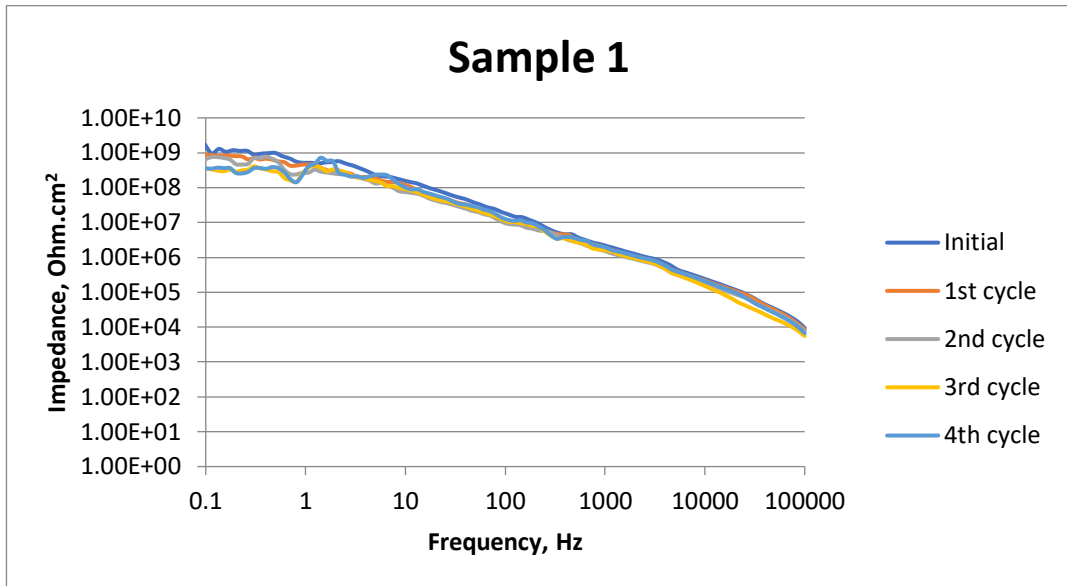
Sample 1

To conclude the bode plot result, sample 1 shows a quite significant of decrease in its impedance, while sample 2 and sample 3 shows a slight decrease of impedance. At cycle 4, all three sample have a impedance value of 3.2×10^8 to 3.7×10^8 , which is still categorized as a good quality of coating as per stated by Gamry Instruments [18].
