**Electrochemical Impedance Spectroscopy Evaluation of
Non-Metallic Pipe (NMP) Degradation in CO₂ Environment**

Dissertation submitted in partial fulfilment of
the requirements for the
Bachelor of Mechanical Engineering
With Honours

FYP II
JANUARY 2020

Universiti Teknologi PETRONAS
32610 Seri Iskandar
Perak Darul Ridzuan

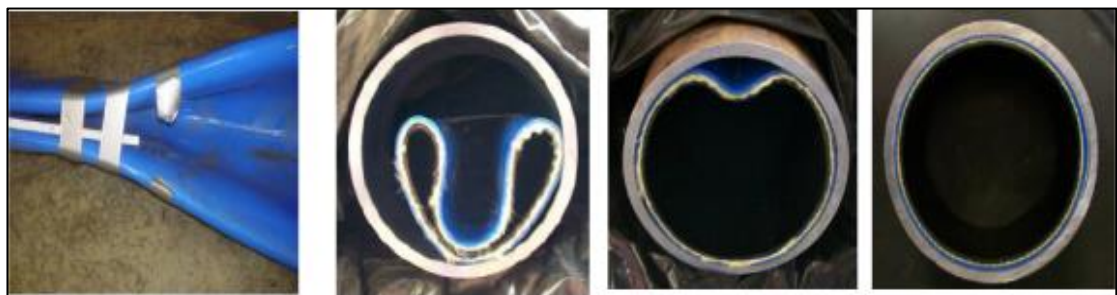
Figure 2.3: IFL installation in a metallic pipe [15].

According to the research by Baron, et al. [11], they are evaluating plastic liner which made of High-density polyethylene (HDPE) and Polyamide – 11 (PA-11). However, the current material that been used as plastic liner is Polyvinylidene fluoride (PVDF) since the researcher are seeking for a material that can handle extremely aggressive, hot and sour hydrocarbon, and high operating temperature up to 110°C [12]. The critical factors in applying plastic liner are exposure time for the plastic to handle the fluid and temperature of the environment. HDPE was built with C-H bond while fluoropolymer such as PVDF was built with C-F bond which is a stronger bond with a stable crystalline structure compared to C-H bond [21]. An illustration on the installation of IFL inside a metallic pipe are shown in Figure 2.3.

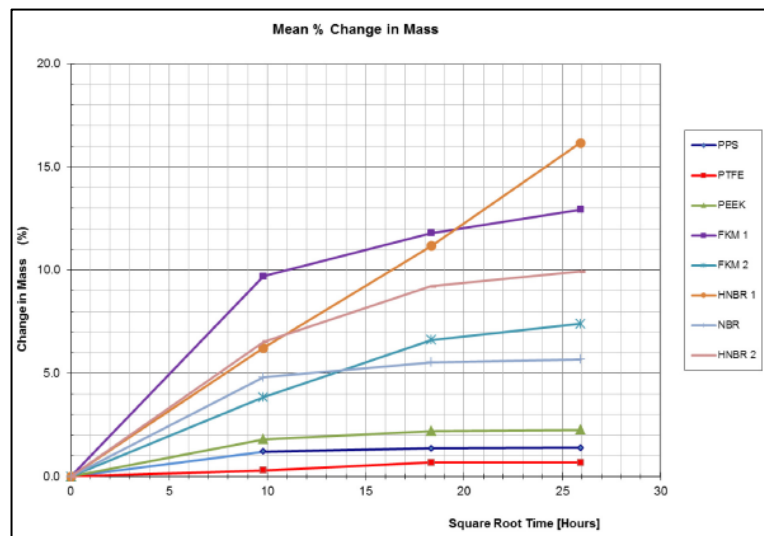
Figure 2.7: Percent change in mass versus exposure time at HP&HT [19]

The driving force for fluid to permeate into the material is usually quantified by the concentration gradient [18]. For gas or vapour service such as natural gas and condensate, the concentration gradient will depend on the partial pressure of the fluid. According to Maxwell, et al. [6], the water absorption will result in swelling, reduction of glass transition temperature, T_g and reduction of mechanical and physical properties. In many cases, the fluid that permeate into the material will react with the polymer matrix and resulting in irreversible chemical changes and reduce the material performance. As a result, the change in mass and volume of the elastomer and thermoplastic can be significantly observed from time to time. Those correlation also mentioned by Waterton in Figure 2.7 and 2.8 below [19].

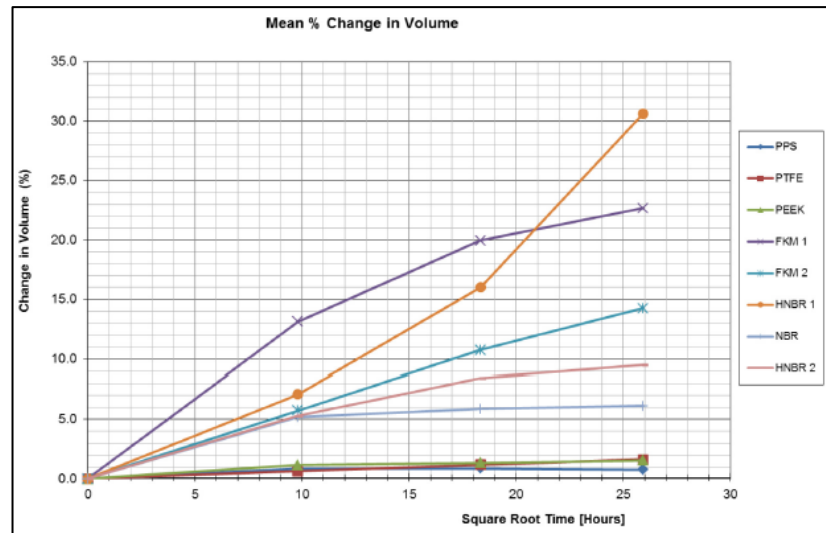
Figure 2.8: Percent change in volume versus exposure time at HP&HT [19]

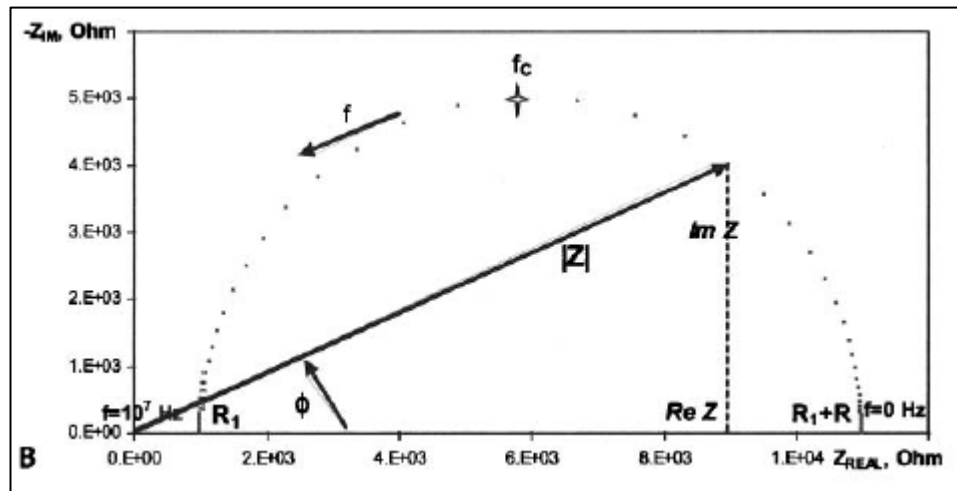
Figure 2.10: Example of Nyquist plot [20]

In general, the EIS results are represented in two graphical approach namely Nyquist and Bode Plot. In Nyquist plot, the imaginary impedance, Z_{img} is plotted against the real impedance, Z_{real} . Every point that plotted in the graph is representing the impedance value at one frequency. The impedance magnitude and phase angle also can be obtained from Nyquist plot as in Figure 2.10. After that, for Bode plot as in

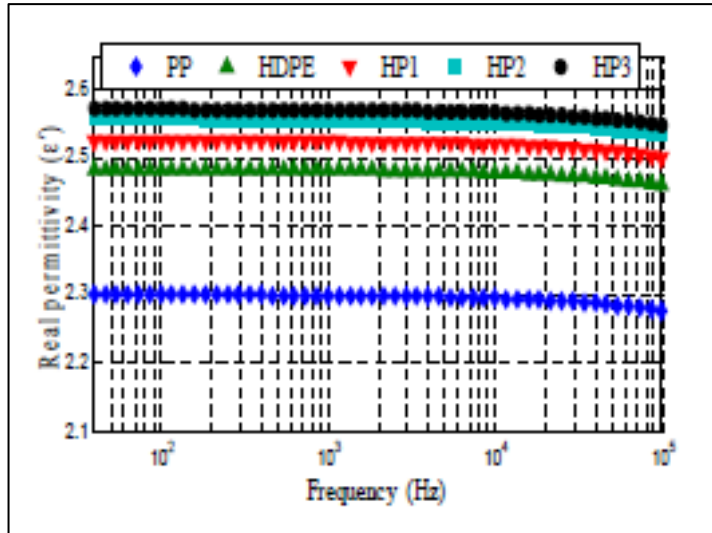
Figure 2.12: Permittivity real component of HDPE [21]

Dielectric is a non-conducting medium or material such as polymer coating and pipelining. However, the electron may diffuse through the material when placed in an electric field and this so-called electric polarization. There are two parameters needed to scrutinise the abilities of any material to store electrical energy and transmit electron charge which are permittivity and conductivity. In dielectric analysis, those parameters are measured as a function of time, temperature and AC radial frequency, w [20]. For this project, the author was using HDPE as the dielectric material. The permittivity value of HDPE was evaluated and tabulated in Figure 2.9.

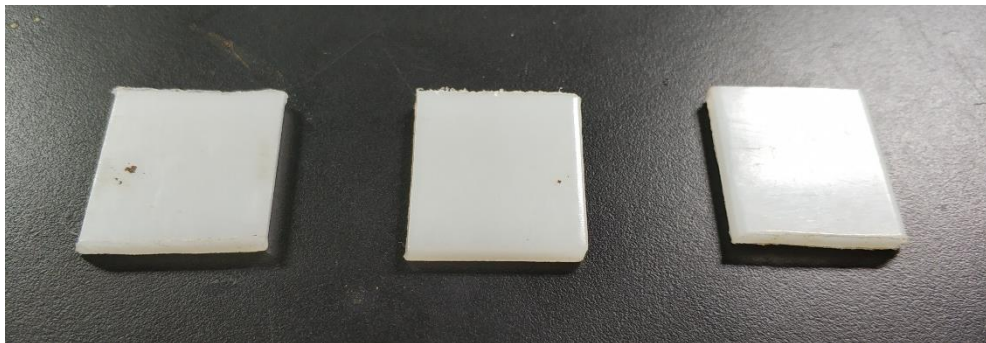
Figure 3.2: Polymer samples

For sample preparation, the polymer was cut into 6 pieces with the dimension of 25mm X 25mm X 3mm. Then, the author chose to use 10 small low alloy steel plates with the dimension of 20mm X 20mm X 3mm as conductive material for EIS evaluation. Three of the metal plates were applied with commercial epoxy adhesive on one of its side and maintained the thickness between 100 – 120 microns. Another three metal plates were coupled with the polymer samples by the same commercial epoxy adhesive in between. Before applying the epoxy, the author made some profile on the metal surface by using a coarse hand file since the epoxy will peel off easily when applied on a smooth surface. The metal plates also been grinded to remove the corroded surface before putting under EIS machine.

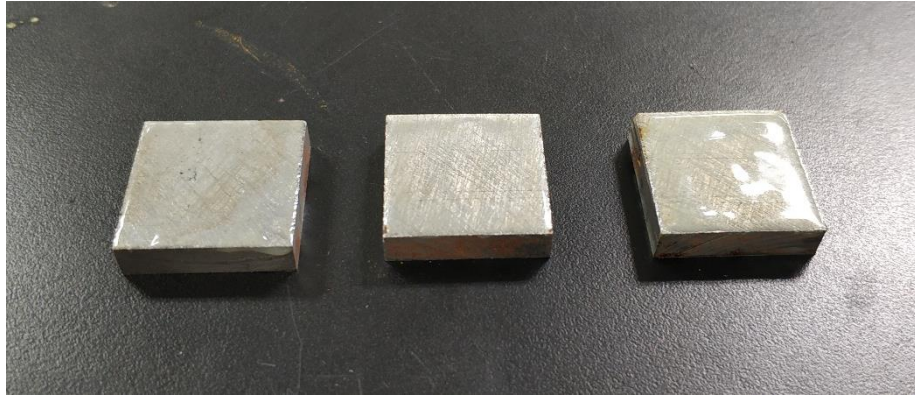
Figure 3.4: Metal plate applied with epoxy

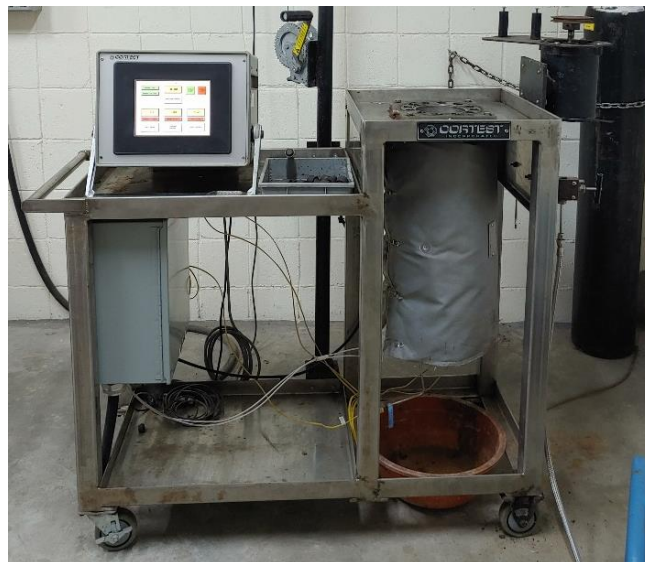
Figure 3.7: The autoclave machine

As for accelerated study purposes, the samples were immersed in the solution and put into the autoclave machine at 20 bar and 60°C for 72 hours. Then, the exposed polymer sample were measure for its dimension and mass changes. The autoclave machine that been used was as in Figure 3.7.

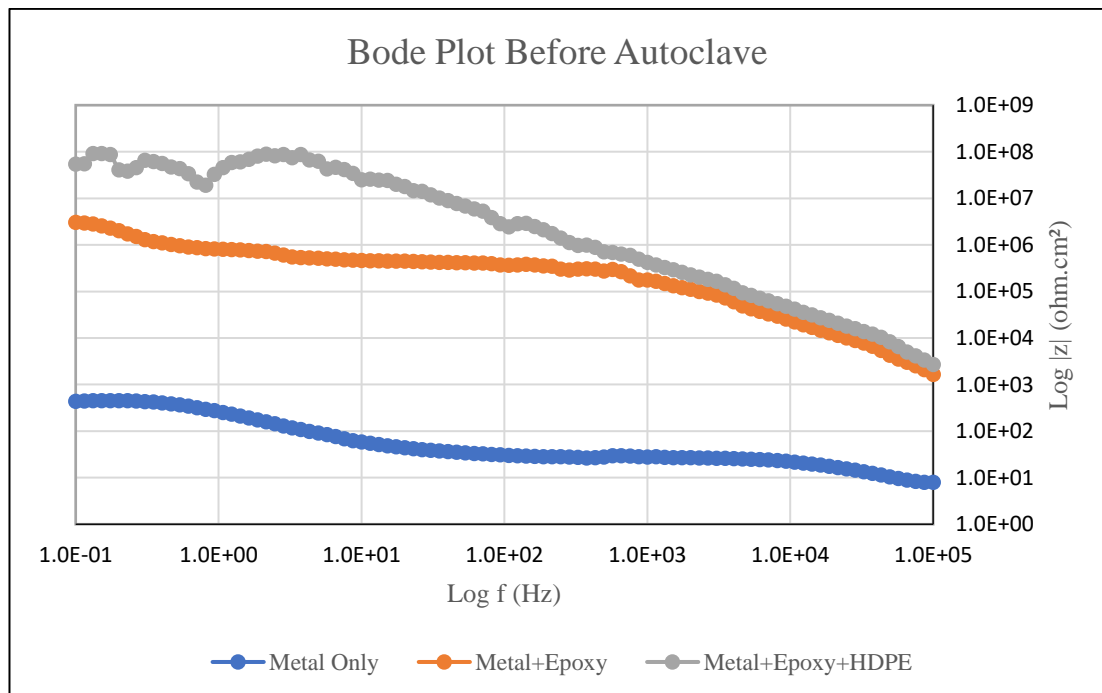
Figure 4.1: Bode plot for initial impedance reading

From the bode plot shown in Figure 4.1, the impedance of the samples were inversely proportional to the frequency. When the frequency decrease, the sample impedance will increase and vice versa. The impedance patterns and measurements for each type of samples also difference due to the present of additional capacitance and resistance into their system. This also indicates that there are some additional surface or material added on the metal plate. For example for this project, the appliances of epoxy and polymer had increased the capacitive element into the system's circuit element.

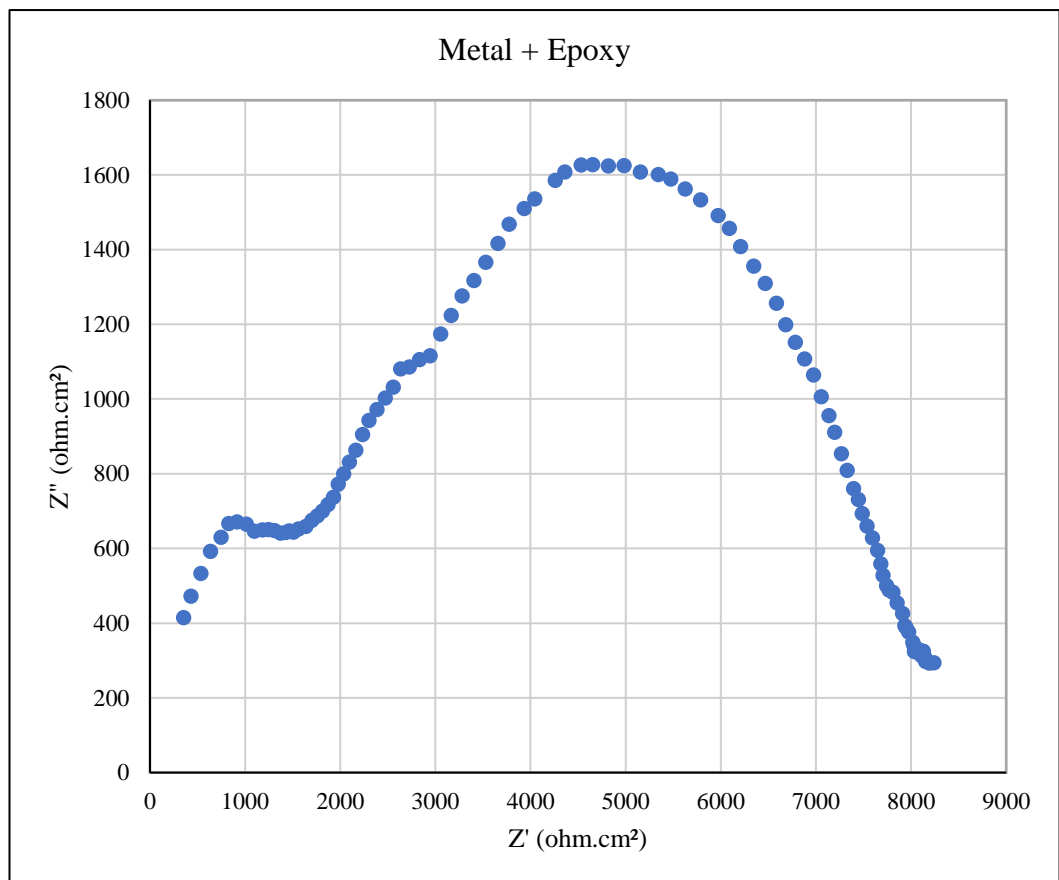
Figure 4.3: Initial Nyquist plot for metal plate and applied epoxy

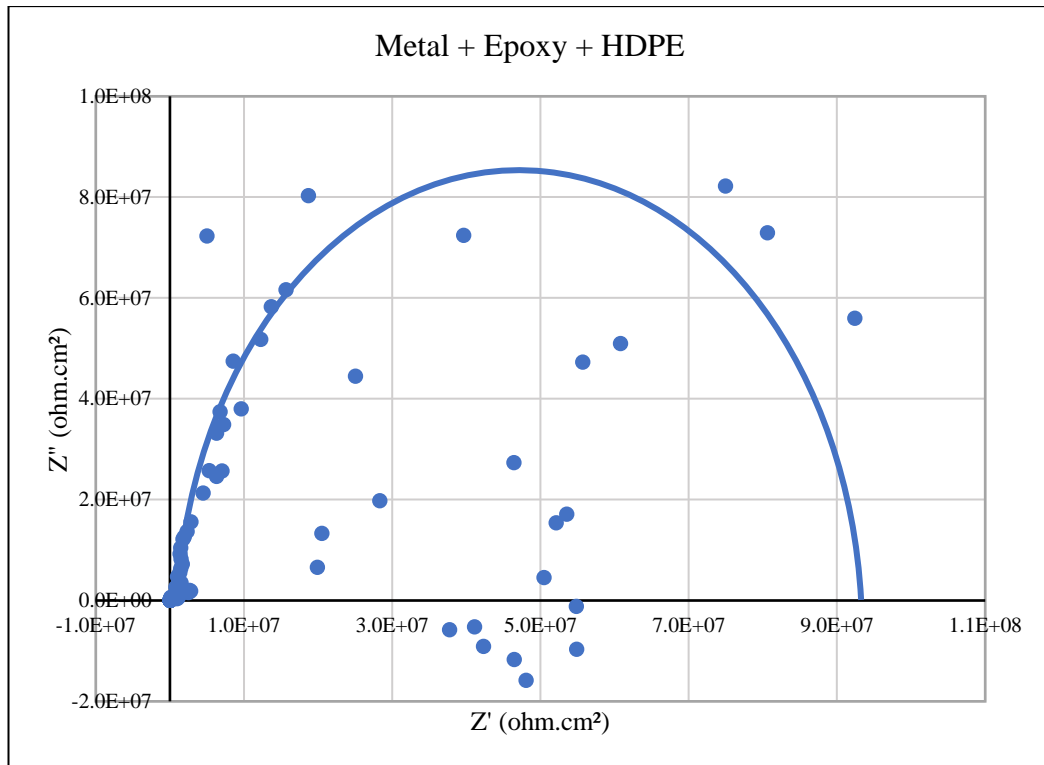
Figure 4.4: Initial Nyquist plot for metal plate and HDPE with epoxy adhesive

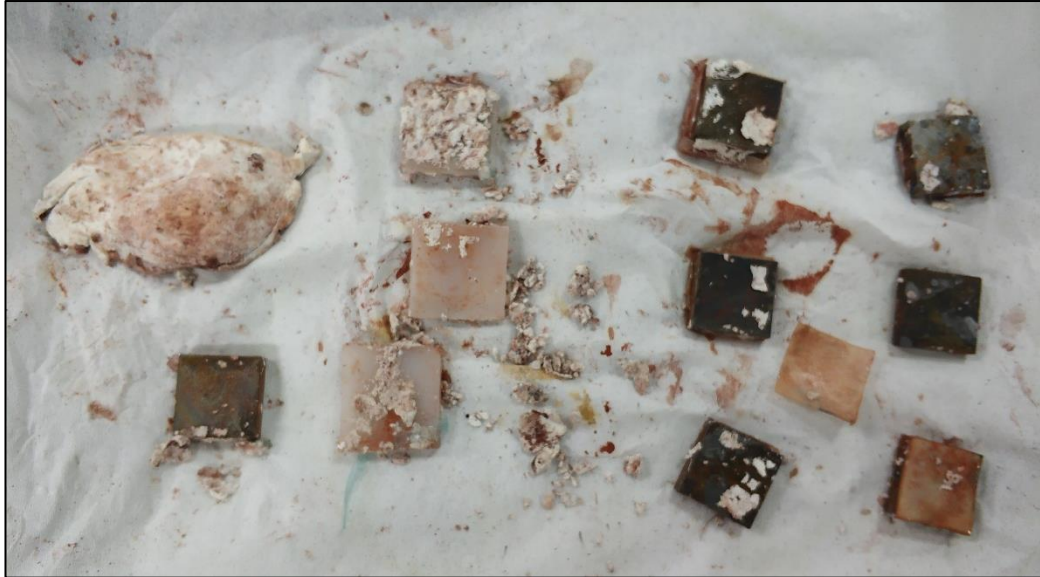
Figure 4.5: The samples after putting into autoclave machine

As shown in Figure 4.5, all of the epoxy adhesive which applied on the metal surface and used to attach the HDPE were peeled off. Two of the HDPE sample were melted. The metal specimens were lightly corroded. This incident occur due to the machine's malfunction. The temperature of the solution was increased up to 100°C by the machine. The event occur not during working hour and the author just realised the changes in the next morning. After some adjustment, the temperature goes down to 30-35°C and maintained until the end of 72 hours even the setting temperature is 60°C. The author believes that the experiment can be repeated by reducing the temperature and increase the exposure time. However, the heater on the autoclave was broken and need to go through some repair work.

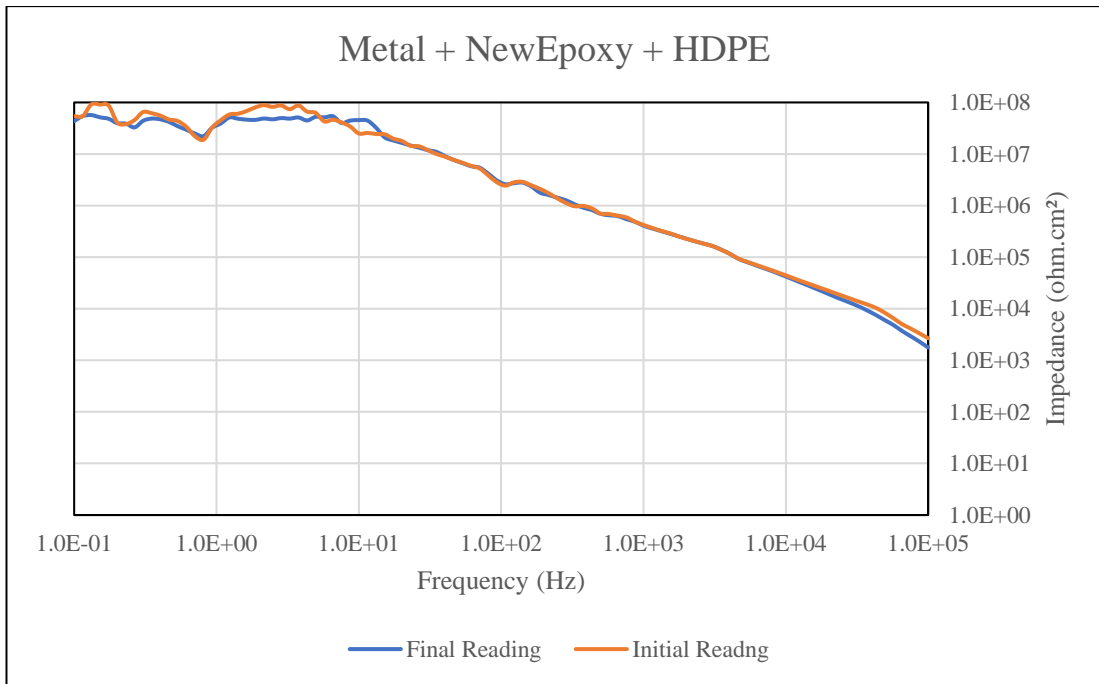
Figure 4.6: Bode plot for final impedance reading

Firstly, from the Bode plot in Figure 4.6 above, the author observed some impedance reduction at the lower frequency reading. As mentioned by Lvovich [20], the determined polarization can be ionic or displacement of the ions with respect to each other when the frequency was from Hz to kHz. However in the metal plate, the impedance remained the same. This is because the resistance in the metallic plate was remained the same, since the exposure time of 72 hours was not adequate to reduce its thickness or changing other properties. Secondly, in Figure 4.8 and 4.9, the Nyquist plots shows two semicircles which intercepted on the Z' axis. These can be interpreted such that some air gap or disbondment were present between the epoxy and metal plates. This might be due to action taken by the author which slipped on the exposed epoxy in between the samples. Lastly, the Nyquist plot in Figure 4.10 was showing a semi-circular pattern since new epoxy layer was applied on the exposed samples even the plotting was not certain and scattered due to some noises, etc. Unfortunately, for mass and volume changes, the author could proceed the analysis since the samples were melted and the labelling for the samples are wiped out in the autoclave machine.

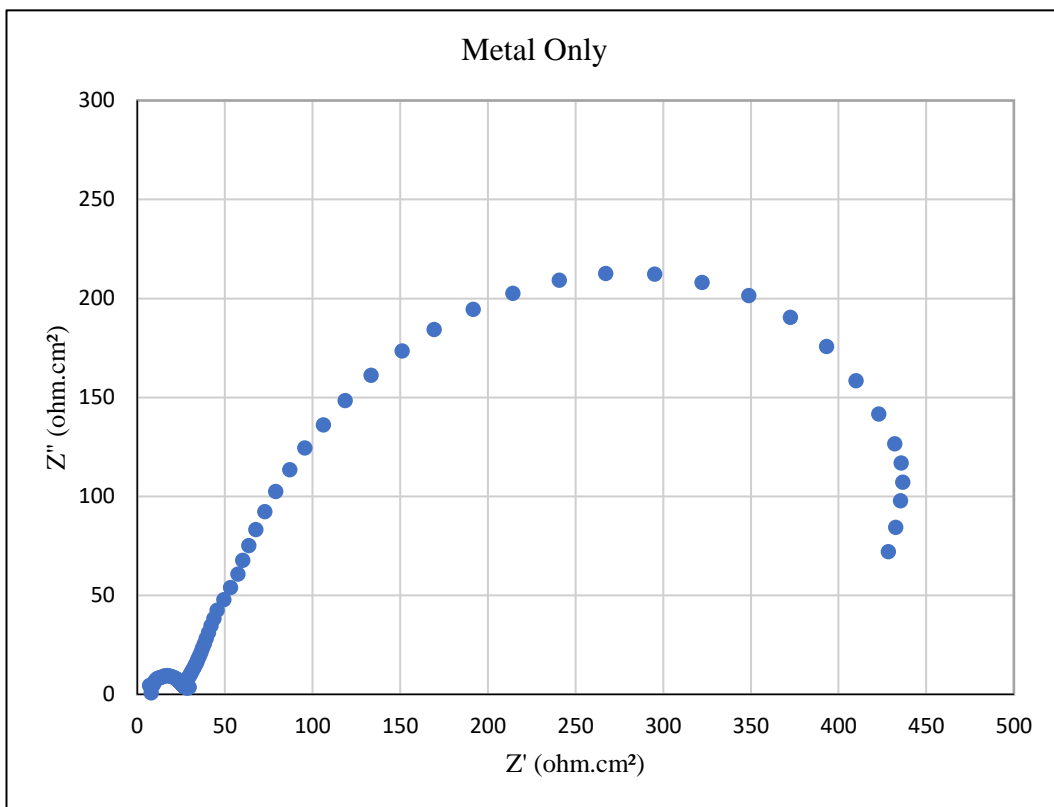
Figure 4.7: Final Nyquist plot for exposed metal plate

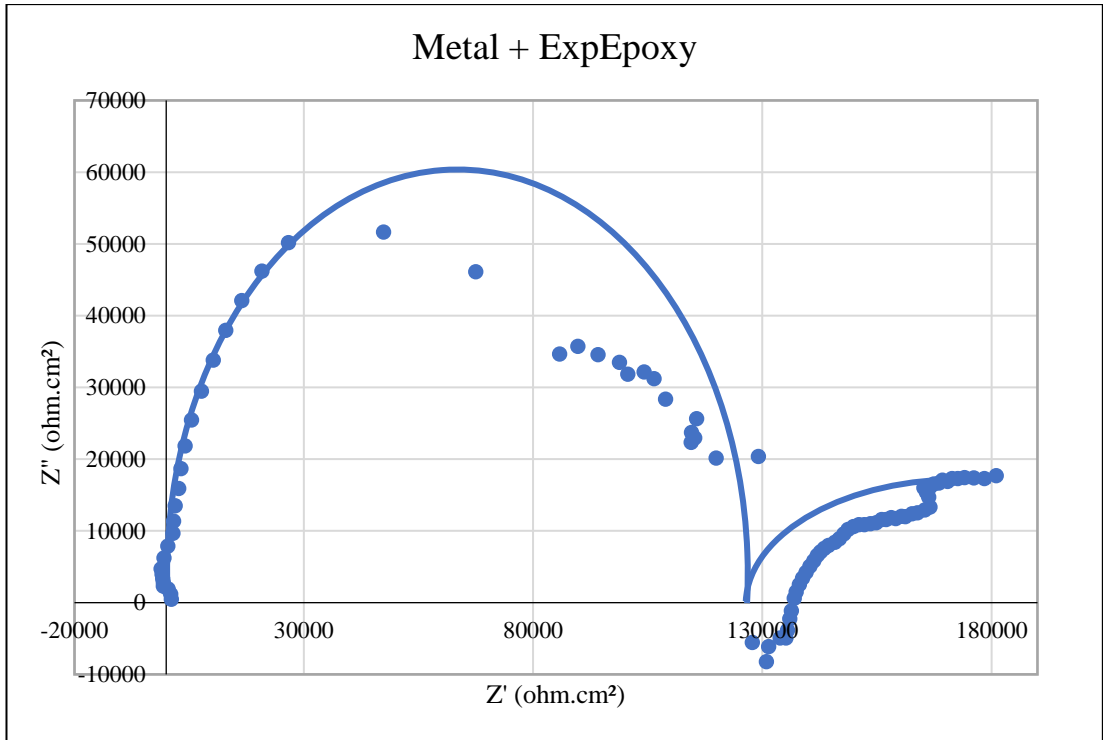
Figure 4.8: Final Nyquist plot for exposed metal plate and epoxy

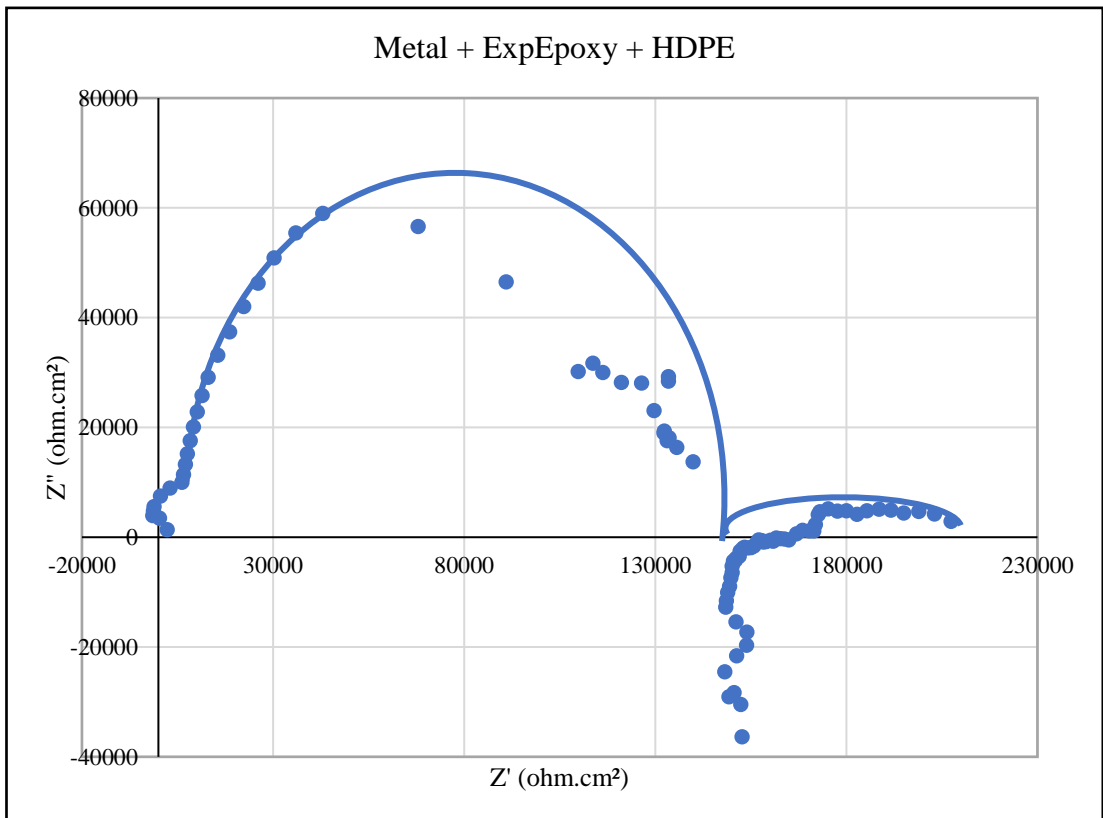
Figure 4.9: Final Nyquist plot for exposed metal plate and HDPE with exposed epoxy adhesive

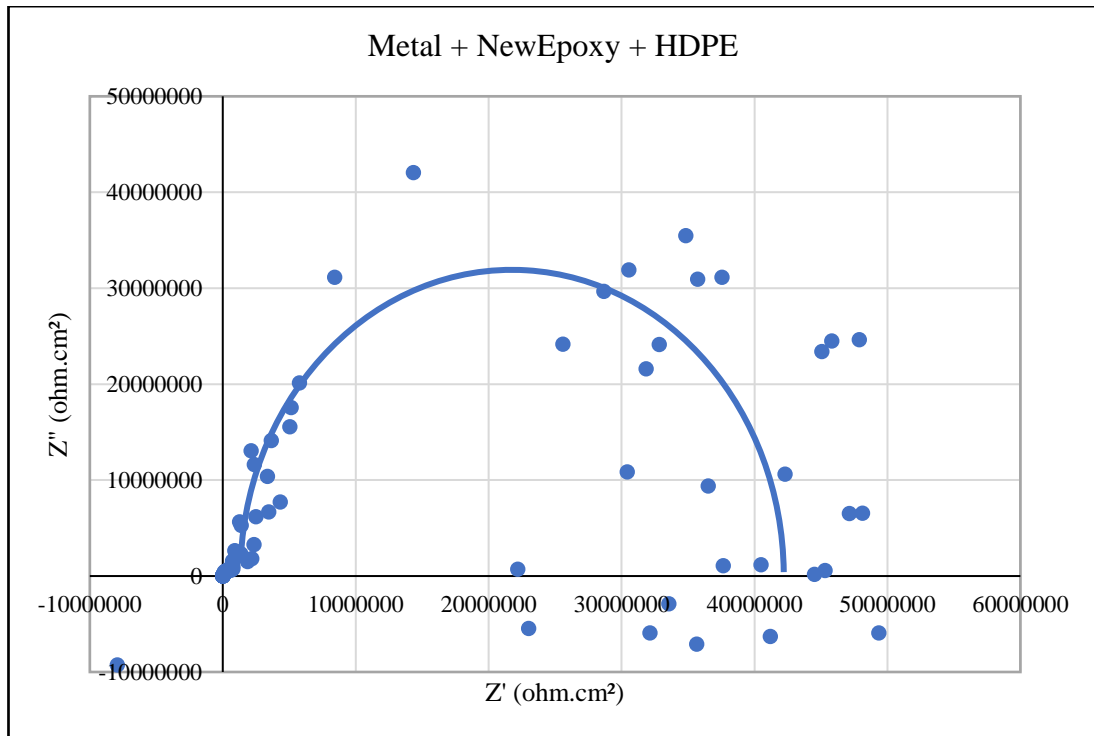
Figure 4.10: Final Nyquist plot for exposed metal plate and HDPE with new epoxy adhesive
