UNIVERSITI  
TEKNOLOGI  
PETRONAS

## FINAL EXAMINATION MAY 2024 SEMESTER

**COURSE : AAB3033 - CORROSION AND DEGRADATION OF MATERIALS**

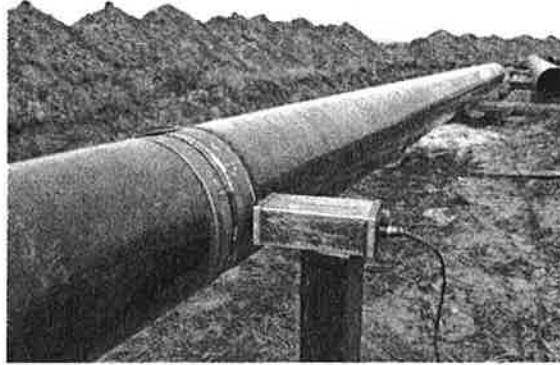
**FIGURE Q4: UNDERGROUND PIPELINE**

4. As a corrosion engineer, your responsibility is to safeguard long-distance underground pipelines, aiming to ensure a minimum lifespan of 20 years, as illustrated in **FIGURE Q4**.

- a. Propose a corrosion prevention method to protect the long-distance underground pipelines. Provide justification for the principle mechanisms, supported by sketches.

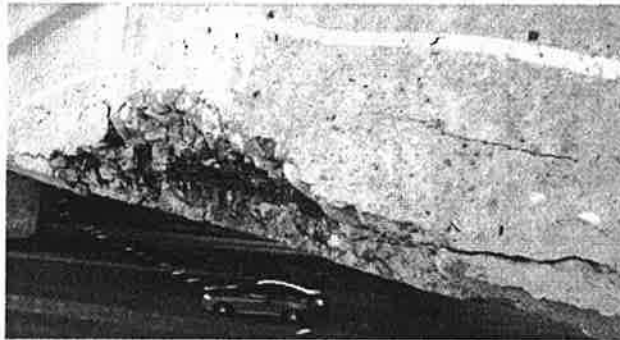
**FIGURE Q4: DEGRADED CONCRETE**

4. Reinforced concrete is crucial in modern construction for its strength and durability, especially in bridges. However, it degrades over time due to corrosion, swelling, and cracking, as shown in **FIGURE Q4**.

- a. Explain **TWO (2)** primary causes for swelling damage in bridge structures.  
[6 marks]
- b. Discuss the carbonation process towards the corrosion damage in the reinforced concrete. Justify the answer.  
[6 marks]
- c. Steel bars embedded in reinforced concrete are subject to corrosion. Explain the underlying mechanism and provide a sketch to support your answer.  
[8 marks]
- d. A 2-meter-long with 0.02-meter diameter steel bar in reinforced concrete was exposed to corrosion for 10 years. Its weight decreased from 3000 grams to 2950 grams. With a steel density of  $7.85 \text{ g/cm}^3$  and an exposed surface area of  $200 \text{ cm}^2$ , calculate the corrosion rate in mm/year.  
[5 marks]
