# **Infrared Thermography Inspection on Potential Failures of Rotating Equipment**

Bachelor of Engineering (Hons)  
(Mechanical Engineering)

A project dissertation submitted to the  
Mechanical Engineering Programme  
Universiti Teknologi PETRONAS  
in partial fulfillment of the requirement for the  
BACHELOR OF ENGINEERING (Hons)  
(MECHANICAL ENGINEERING)

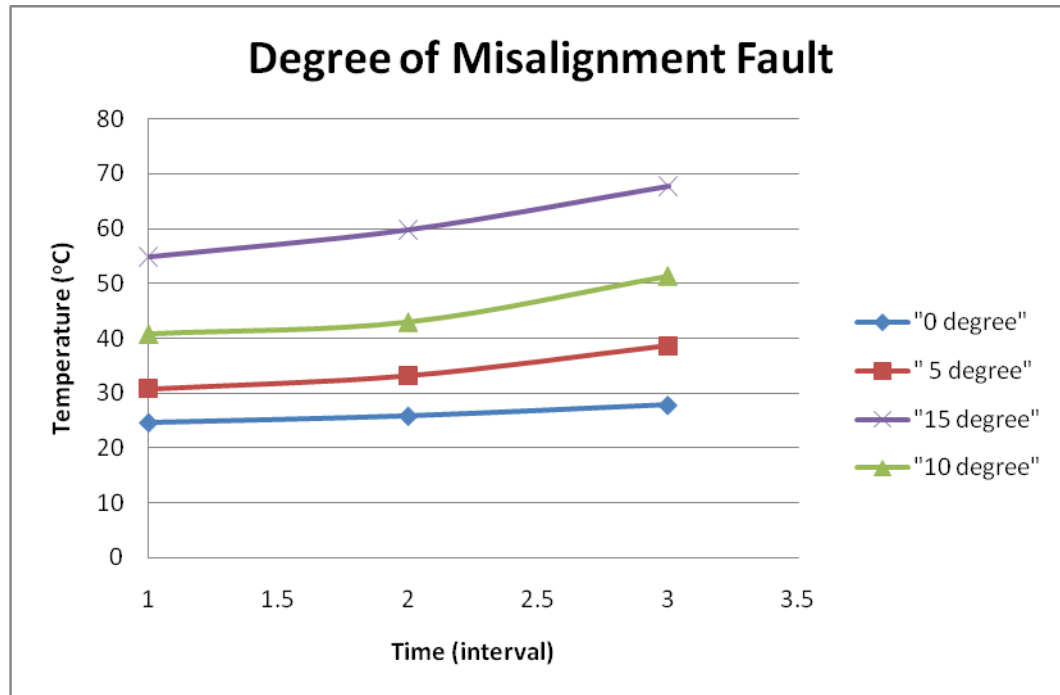
**Figure 17: Temperature affected by the Degree of Misalignment Fault**

The figure 17 shows, the temperature of the motor depending on the degree of the angular misalignment under the time interval. From the graph, the line represent the angular misalignment at 15 degree has experience the highest different change in temperature compare to the others degree of angular misalignment. It can be determined by analyze the slope of the line graph. From all of the lines, the highest value of the slope is temperature different on the misalignment at 15 degree. Thus, it can be concluded, the higher the degree of the misalignment, the bigger the temperature increased from the first time interval to the third time interval.

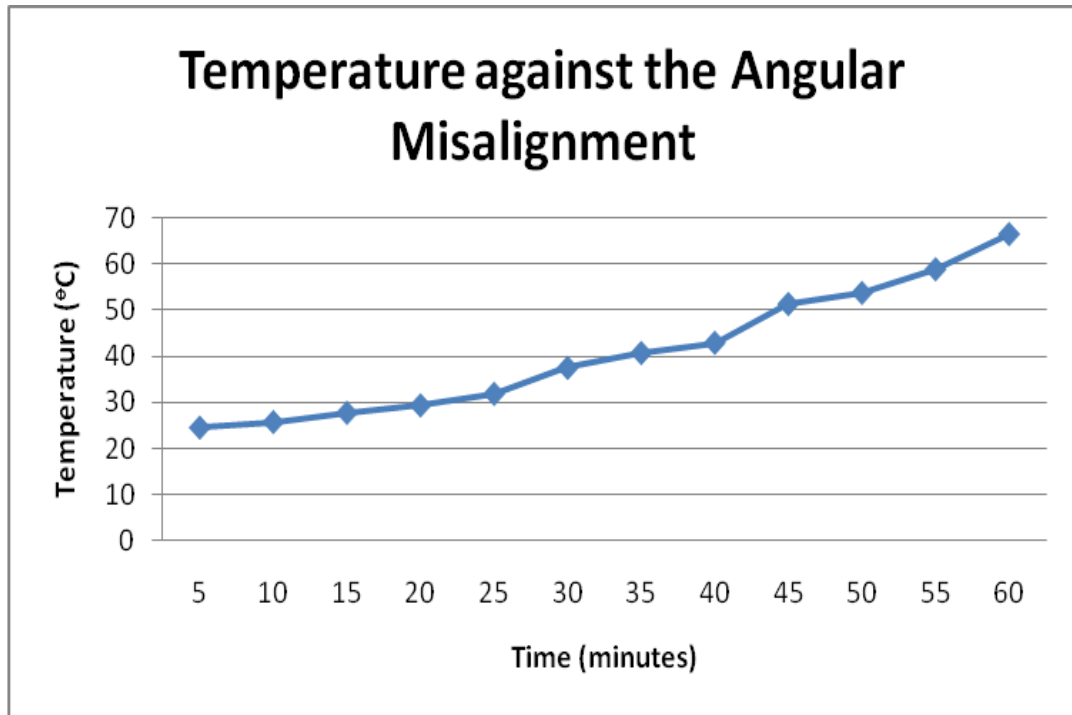
**Figure 18: Graph of Temperature against the Angular Misalignment**

The figure 18 above is from the previous data graph that shows the entire angular misalignment fault at every degree. The angular misalignment is increased for every 15 minutes and the reading is taken for every 5 minutes. From the result gather and the discussion, as the misalignment developed, it will cause the increasing in friction and hence, the temperature increased.

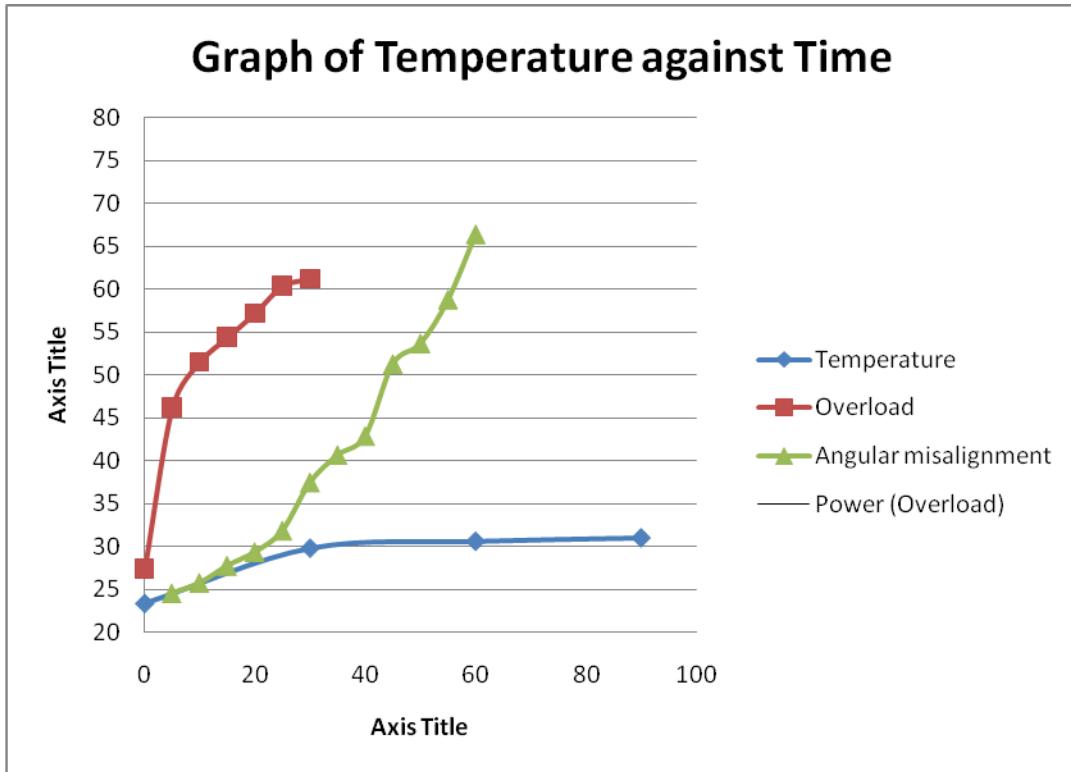
**Figure 19: Comparison of Temperature of Motor between the Normal Condition and under Abnormally**

From the data and analysis made, both faults which are the overload and misalignment had show the expected result as the temperature is increased when the fault occur on the motor. The figure 19 above shows the comparison between the temperature under overload and angular misalignment condition with the reference temperature or known as working temperature. From the graph, it can be interpreted; the motor is subjected to the friction force due to the faults created and affect the temperature of the motor.
