CHAPTER 1

1.1 Background of Study

- a) to carry out failure analysis for the failed seal used at the condensate booster pump

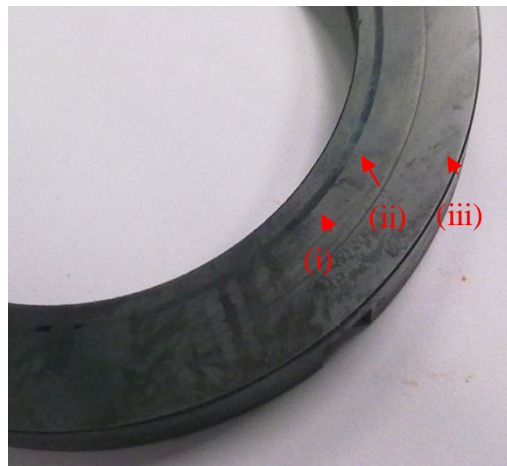
Figure 3.3: Failed stationary face seal (sample)

- i) Along the groove line for about 2mm
- ii) 5mm distance (intersect along the groove line)
- iii) Non-groove area (2mm distance)

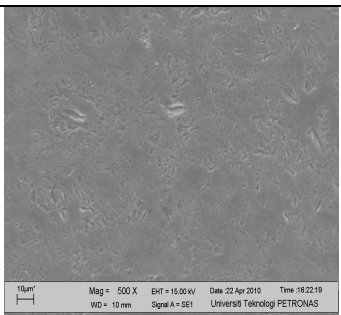
<p>Figure 4.21:500X Magnification</p>

Basically, the SEM magnification profile can be used in differentiating the microstructure profile of the seal accurately. However, due to limited sources that can be the comparative profile that can be used in determine the profile changes, the discussion of the result still can be improved in the future analysis. In addition, material composition analysis can also be carried out using the SEM application. This experiment can determine the different percentage of material composition in ones material.
