Furnaces at Ethylene (M) Sdn Bhd is ethane cracking heater which are used to crack ethane to produce ethylene gas and other useful byproduct which is mainly fuel hydrogen gas. The cracking heater is gas fired and the fuel gas is hydrogen and methane-off gas. ^[1]

Furnace tube prematurely failed after 1 years of operation. Total replacement of furnace tubes are scheduled after 6 years of operation. The last total replacement of the tubes was done in June 2008. The tube experienced bulging and cracks, suspected due to overheating. Failure analysis to identify the causes of failure is to be done.

General Information		
Plant	Ethylene (M) Sdn Bhd	
Tag Number	ET-O-F-105 (Coil 6)	
Design Code	API 530/ ASME VIII Div 1	
Design Parameters		
Material	Nickel based alloy (25-35 CrNi)	
Design Life	100,000 hours	
Design Operating Temperature	1100°C	
Operating Temperature	692 °C (Outlet), 841°C (Inlet)	
Tube thickness	6.55 mm	
Manufacturing Information		
Manufacturer	Schmidt-Clemens	
Manufacturing process	Casting	
Failure Information		
Component maintenance history	major	Total radiant tubes replacement conducted in 2003 and 2008. Replacement of furnace linings carried out in 2006.
Date of failur

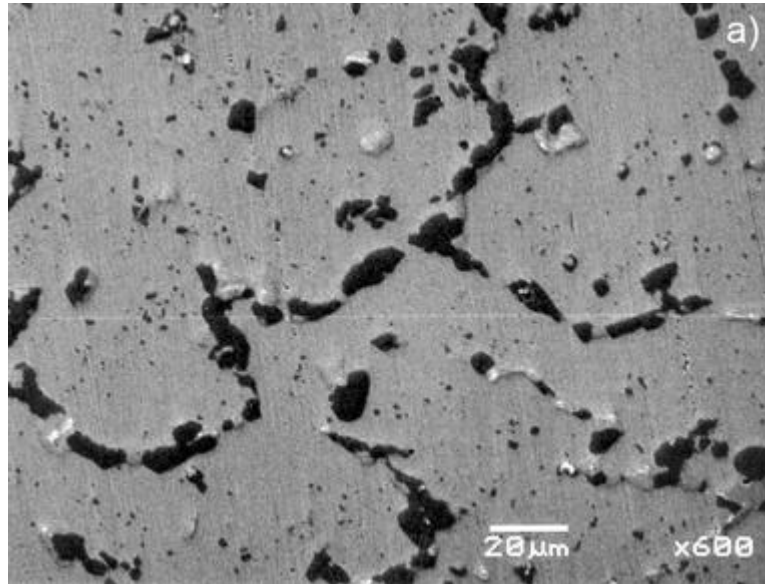
Figure 4.10: SEM image for uncarburized Nickel-Chromium alloy

From literature ⁽⁴⁾, SEM image for uncarburized Nickel-Chromium alloy is shown in Figure 4.10. Compared to the result obtained, it can be observed that chromium precipitates less coarse in uncarburized Nickel-Chromium alloy compared to the image obtained from the sample.

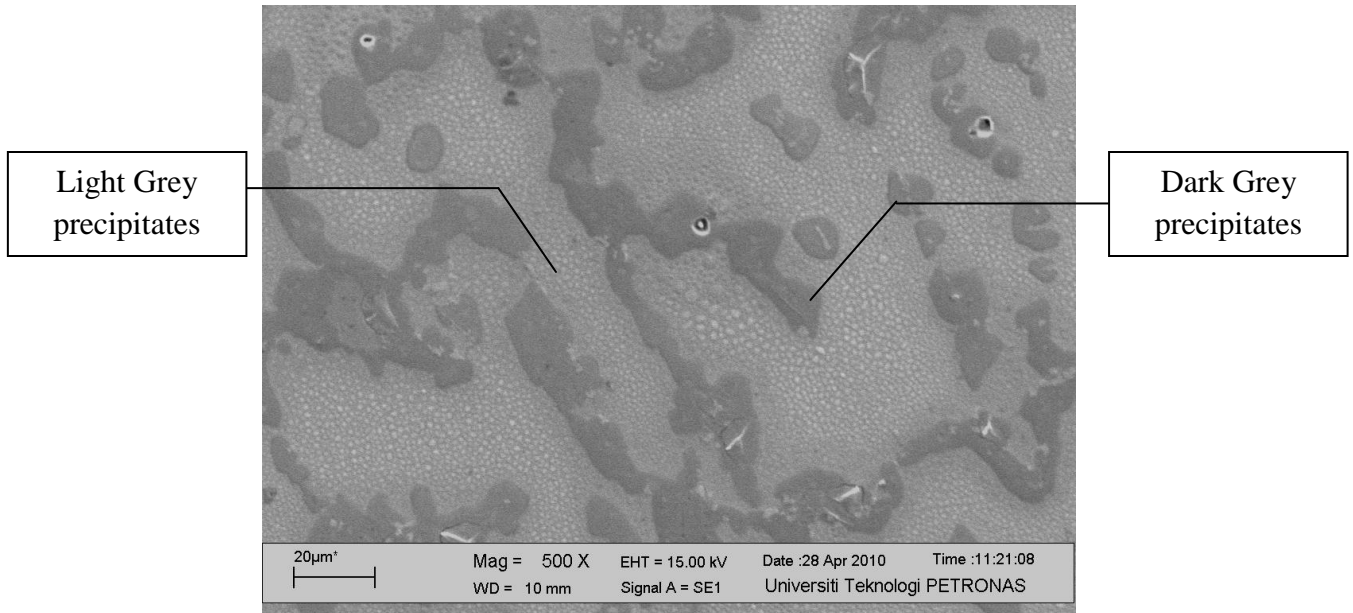
Figure 4.11: SEM image for EDX test

Energy dispersive X-Ray (EDX) spectra obtained from the dark grey region of the microscopy is as follows:

Figure 4.11 and Figure 4.12 present the fractography of the crack. The fracture mode was found to be intergranular crack.

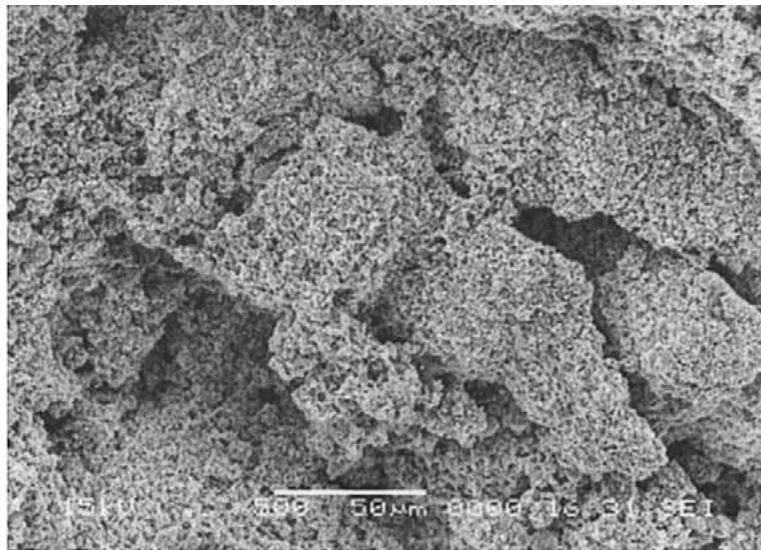
Figure 4.17: SEM image of intergranular crack

From literature ⁽³⁾, the intergranular crack is shown in Figure 4.17. Comparing with SEM image of the crack, the result is confirmed to be intergranular crack.
