CHARACTERIZATION AND PROPERTIES INVESTIGATION
OF AUTOMOTIVE STEEL EXHAUST PIPING FAILURE

MUHAMAD FIKRI BIN KHAIRDDIN

MECHANICAL ENGINEERING
UNIVERSITI TEKNOLOGI PETRONAS
JANUARY 2017

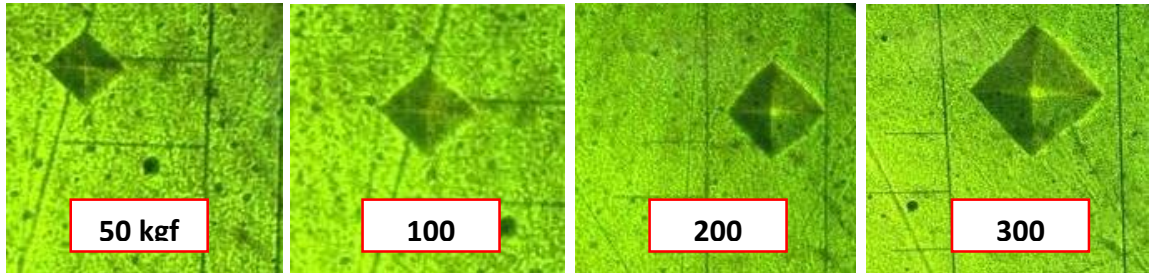
Figure 4.3: Different size of imprint diameters

Vickers diamond utilized to test the sample hardness at various locations as shown in Figure 4.3. The imprints of symmetric square shape after the Vickers indentation tests were measured using an optical microscope and the Vickers hardness values were calculated and tabulated.

Figure 4.3 shows indentation with different diameter for Vickers indentation test for different load applied on the surface of the samples. Formula constructed below illustrates that Vickers indentation obeys Meyer law. The correlation between the applied load P and indentation diameter d is as follows:

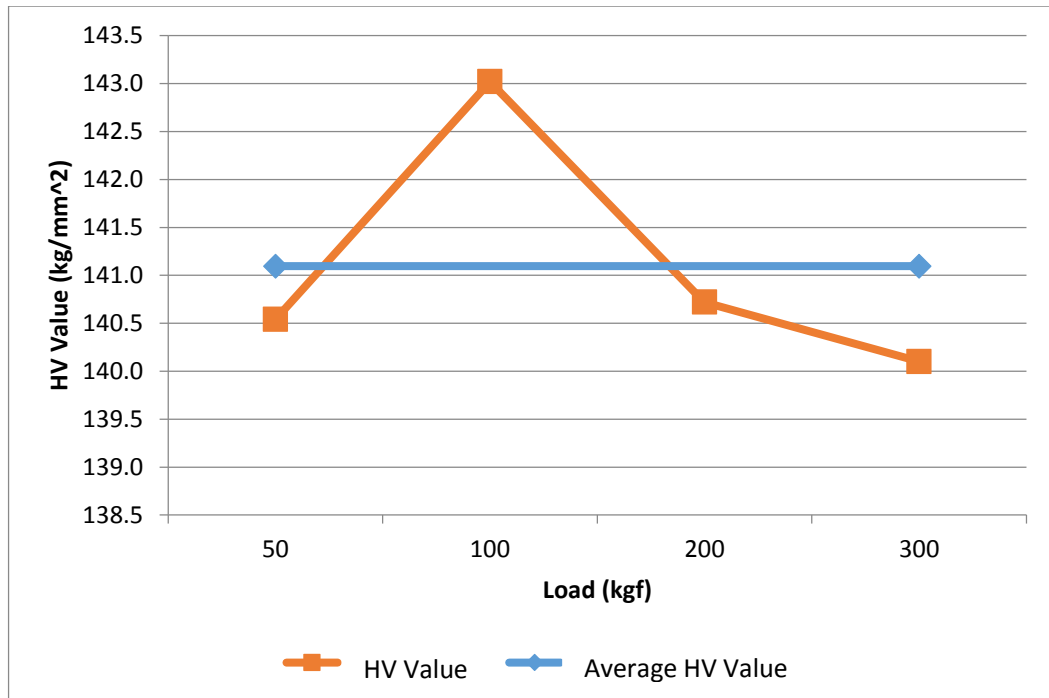
Figure 4.4: Load vs HV values graph

The hardness value calculated using Meyer Law equation as in Equation 3.5 and graph of the applied load against the Vickers Hardness (HV) is shown in Figure 4.4. Throughout the test, rough surface finish of the sample that makes two diagonals of the indentation is difficult to be measure, leading to some significant inconsistency in the hardness calculation. Therefore, the hardness test was repeated in order to obtain an average Vickers Hardness (HV) value thus reduces random errors.

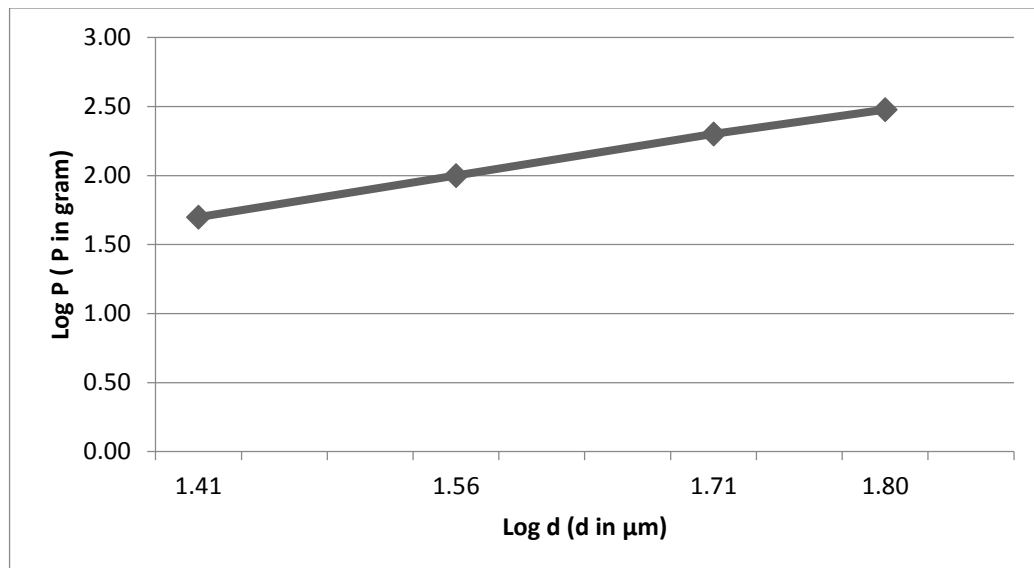
Figure 4.5: Log d vs Log P graph

In the study, it was found out the value of m was 2 and the average of Vickers hardness value was 141.1. According to Onitsch, the value of m for hard materials range from 1 to 1.6, and for soft materials it is more than 1.6. Therefore, it can be concluded that the samples tested in this research can be classified as soft materials [29].

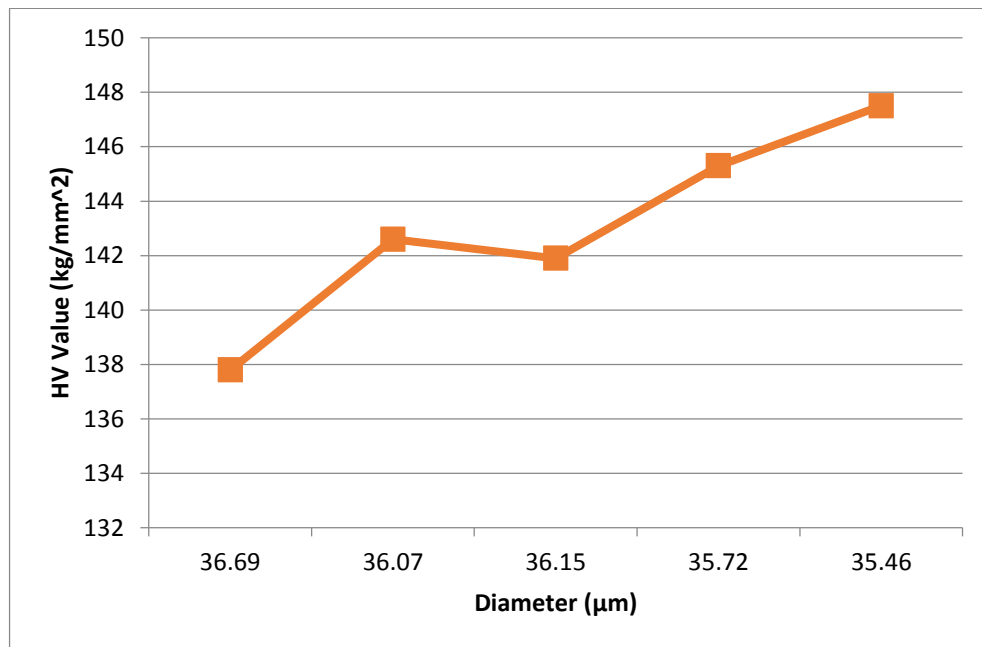
Figure 4.6: Diameter vs HV Values graph

Applied force of 100kgf was selected considering 8mm thickness of the specimen and to reduce the error during determination of imprint diameter. Figure 4.6 shows the Vickers Hardness (HV) values calculated based on imprint diameter formed on the specimen using Equation 3.5.

From the result obtained, it was found out that the Vickers hardness values increased as the diameter of imprints increased. In the study, we found that the average diameter of indenter imprints was 36.02 μ m. However data recorded shown inconsistency in Vickers hardness values due to systematic error and random errors. Systematic error donated by various position of eye during determination of imprints diameters. During Vickers hardness testing individual tend to measure an indent diameter is slightly undersized or oversized. Besides, low quality of polish, poor surface finish, and low reflectivity reduce the feasibility of conducting Vickers hardness test producing rough surface finish contribute to random error.

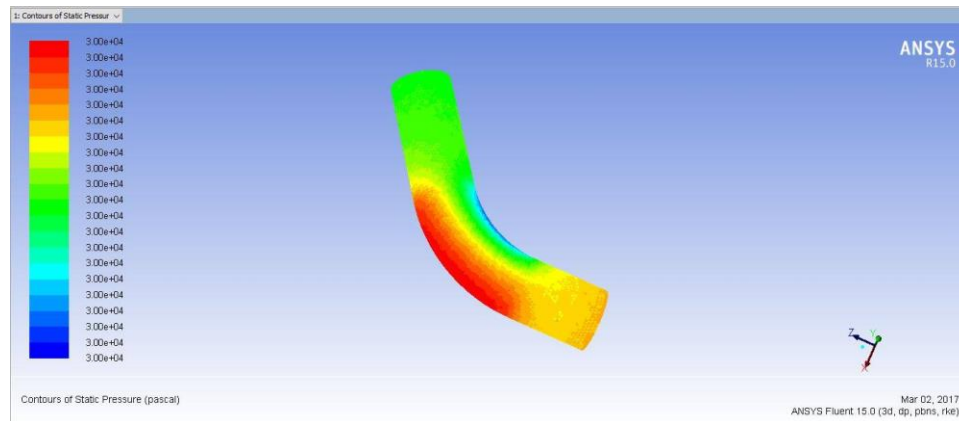
Figure 4.16: Pressure contour

Figure 4.16 demonstrates the pressure gradient in the radial direction is large, showing a small pressure value near the region of the inner wall surface of the pipe with larger distribution high pressure at the outer wall surface area. This is due to the bend curvature of the fluid as the gas exhaust flow contributes centrifugal effect to the radius of curvature larger near the outer wall of the pipe thus leads to plurality of fluid due to push the outer wall surface. In addition, the outer bend exhaust pipe experienced high pressure compare to inner exhaust pipe due to viscous fluid along the pipe wall along the secondary flow and losses arising out of the loss.
