# LANDSLIDE ASSESSMENT ON UTP CUT SLOPE

NUR AMIRA BINTI ABDUL RASHID

Bachelor Of Engineering (Hons)

Universiti Teknologi PETRONAS

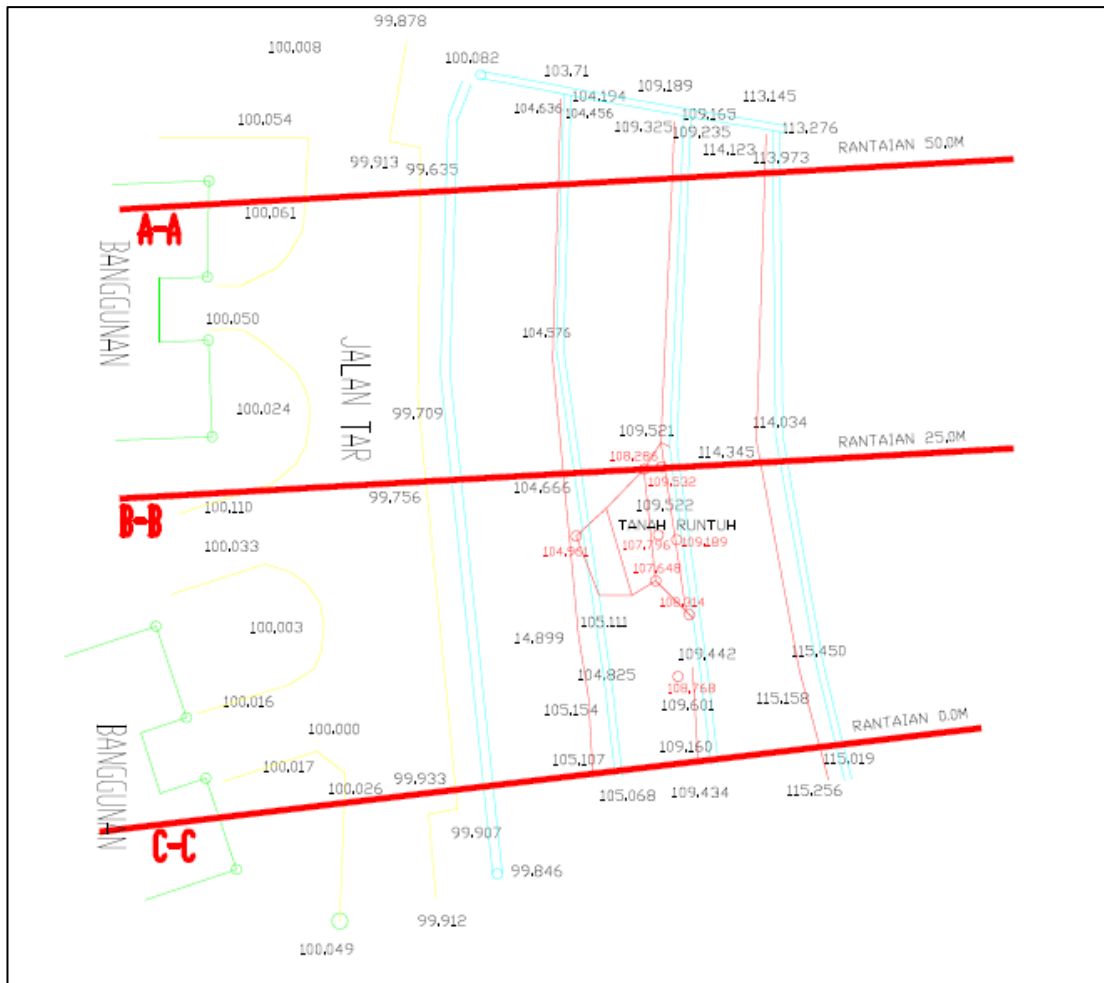
Figure 4-5: Survey Plan View of the Block 14 Slope Failure

The site survey has been carried out on 20<sup>th</sup> May 2017 by the certified experience surveyor which covers the approximate 50m (L) x 12m (W) x 15m (H) and the specified area of landslide of 76.5m<sup>2</sup>. The survey works details includes of taking EGL of each berm height, road level, drainage and specified the localised slope failure. The slope failure extends from second berm drain to first berm drain which covers at approximate 20 m length as shown in *Figure 4-5*. *Figure 4-6* shows the cross section of the slope zone with specifies the horizontal distance of each berm.

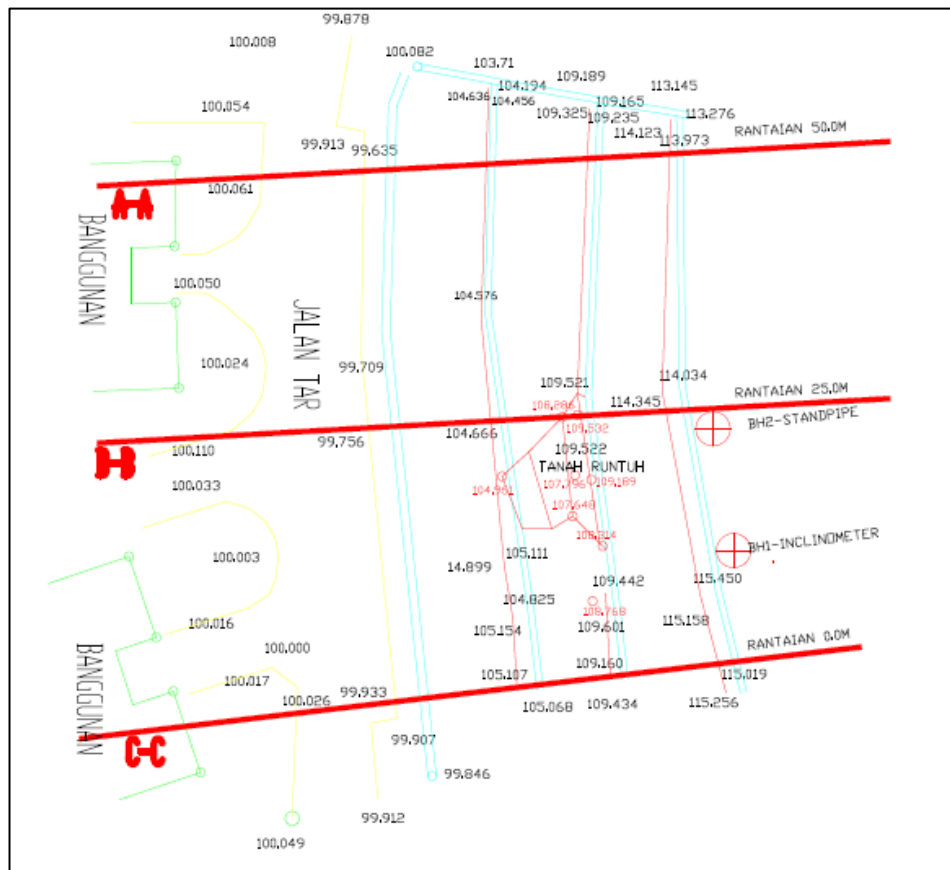
**Figure 4-7: Location of Boreholes**

The soil investigation is carried out using Rotary Wash Boring (Toho D2K) and two boreholes have been made which used for setting up standpipe and inclinometer. The distance between two boreholes is 20 m and the location is at the top of the slope as shown in *Figure 4-7*.

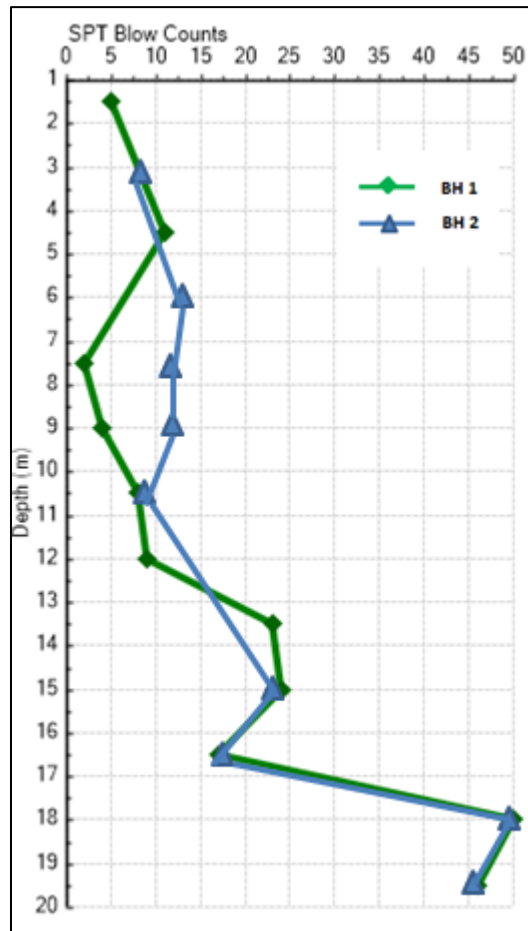
**Figure 4- 8: Graph of Depth against SPT Blow Counts**

From the site investigation boreholes data, *Figure 4- 8* shows the SPT blow count for each depth of boreholes and the SPT value at depth of 6 m to 15 m is slightly different. For borehole 1, the depth of boring at 7 m has the same depth of the failure occur with the SPT value of 2 which means the soil bearing capacity is weak. The SPT blow counts are not consistent increasing until the depth of 2 m such at the depth of 16.5 m, the SPT value decrease from 24 to 16. The soil type at the cut slope is not residual soil but it's originally soil formed. Basically, after the depth of boring achieved 19.5 m, no bedrocks were found and the boring was ended at 20 m depth.

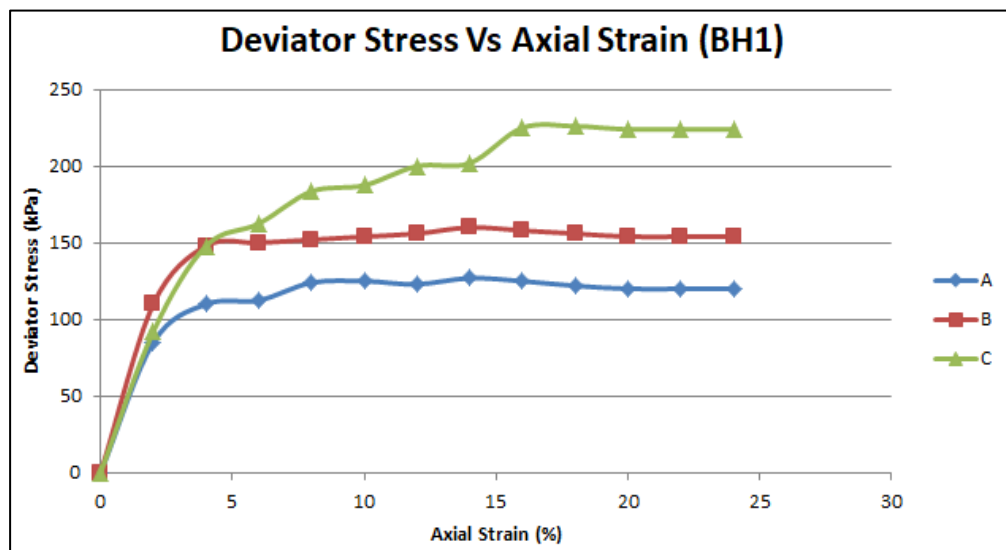
**Figure 4-10: Graph of Deviator Stress vs Axial Strain for BH 1**

There are three samples being tested for this CIU test and *Figure 4-10* shows the graph of deviator stress against axial strain for borehole 1 which at 24% of axial strain, it shows the critical state of strength. At 24% of axial strain, the values of deviator stress for each sample are 120kPa, 154kPa, and 224kPa respectively. The critical state pore pressure is also at 24% as shown in *Figure 4- 11*. As stated in *Table 4-6*, the Mohr-circle in critical condition is shown in *Figure 4-12* and the value friction angle is calculated using Equation 4.1 while cohesion value is obtained from the intersection of the y-axis and effective stress failure line. Thus, the value of critical friction angle is 19.36° and cohesion is 22 kPa.

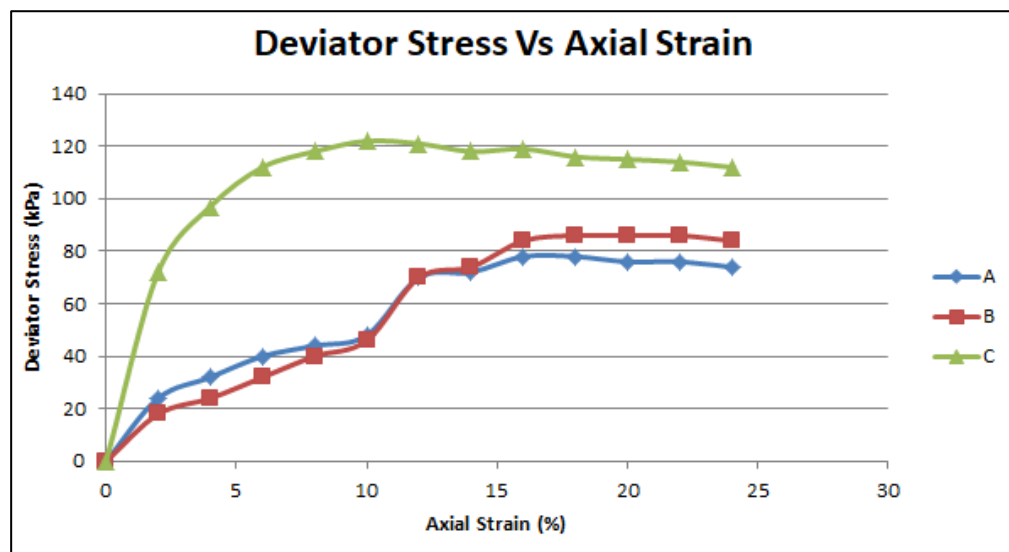
**Figure 4-13: Graph of Deviator Stress vs Axial Strain for BH 2**

For borehole 2, the calculation of the friction angle and cohesion is same as borehole 1. *Figure 4-13* shows the graph of deviator stress against axial strain which at 24% of axial strain as it shows the critical state of strength. At 24% of axial strain, the values of deviator stress for each sample are 74kPa, 84kPa, and 112kPa respectively. The critical state pore pressure is also at 24% as shown in *Figure 4-14*. As stated in *Table 4-7* the Mohr-circle in critical condition is shown in *Figure 4-15* and the value friction angle is calculated using Equation 4.1 while cohesion value is obtained from the intersection of the y-axis and effective stress failure line. Thus, the value of critical friction angle is  $7.36^\circ$  and cohesion is 8 kPa.

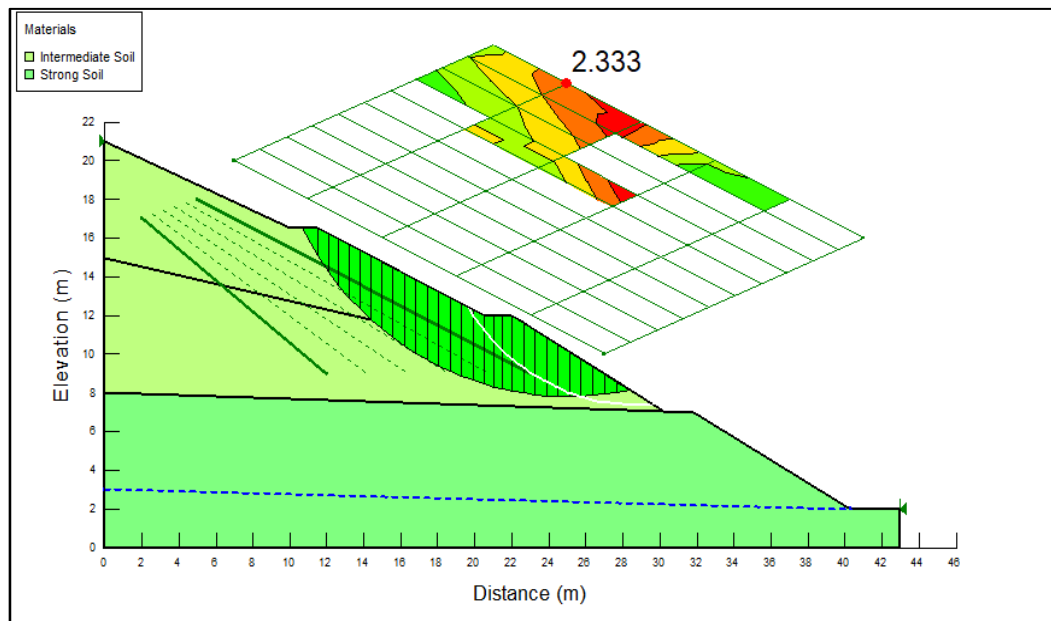
**Figure 4-16: FOS of the Cut Slope using Lab Test Parameter which in Morgenstern Analyse Method**

Based on *Figure 4-16*, it shows the value of FOS by using Morgenstern analysis method which 375 of slip surface has been analyzed. The soil parameter in *Table 4-8* is utilized in the numerical modeling and basically the soil parameter is obtained from laboratory result. The following are the value of FOS from the two other methods;

By using the soil parameter in *Table 4-8*, the values of FOS of the three methods shows the slope is in good condition as the FOS value is greater than 1. The slip is located at the failure area with depth about 4 m. Unfortunately, in reality the slope failure had occurred at the second berm of the cut slope and this has caused re-analysis of the soil parameter is made.
