# **CHAPTER 1**

The objective of this project is to do Failure Analysis on the hot water piping system at Resak Living Quarter (LQ). The Failure Analysis processes conducted in this project is the macroscopic examination which involved the surface examination of the sample under optical microscope and the examination of microstructure of the sample under SEM (Scanning Electron Microscope). The XRF Analysis also is conducted to support the result. Data and result will be collected and further analysis will be conducted using these results to find the cause of this failure. The scope of the study focused on the microstructure analysis of the sample and how to interpret data collected from the experiment and analysis. This hot water piping system is made from copper and has been used since year 2000. All the lines are insulated with aluminium cladding to maintain the temperature of the water within the pipe. Due to the long time service, there some leaking occurs at the tube and most of the leaks are located at the distribution line along the corridor. The header and main line is still in good condition. From the survey, the leaks are due to the pitting occurring mainly at the joints

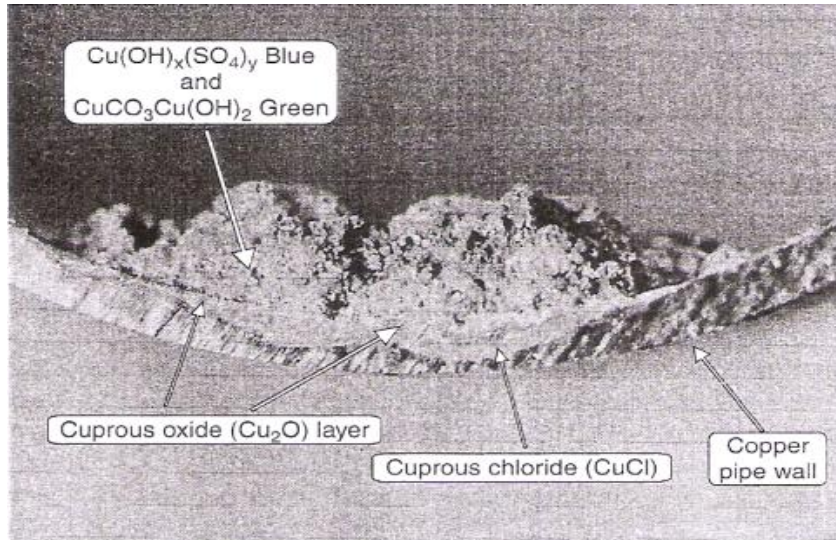
**Type I** pitting is associated with hard or moderately hard waters with a pH between 7 and 7.8, and it is most likely to occur in cold water. The pitting is deep and narrow, and results in pipe failure.

**Figure 2.1** Type I copper pitting corrosion[4].

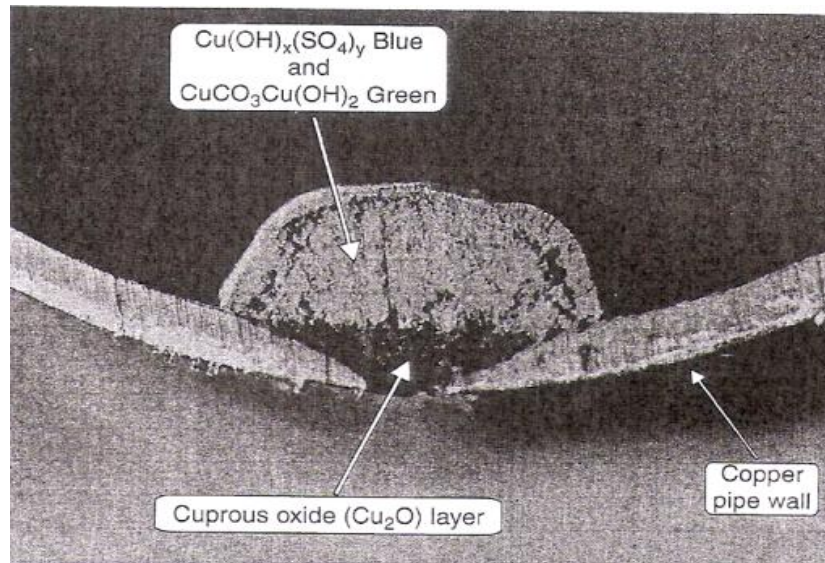
**Type II** pitting occurs only in certain soft waters, with a pH below 7.2 and occurs rarely in temperatures below 140° F. The pitting that occurs is narrower than in Type I, but still results in pipe failure.

**Figure 2.2** Type II copper pitting corrosion[4].

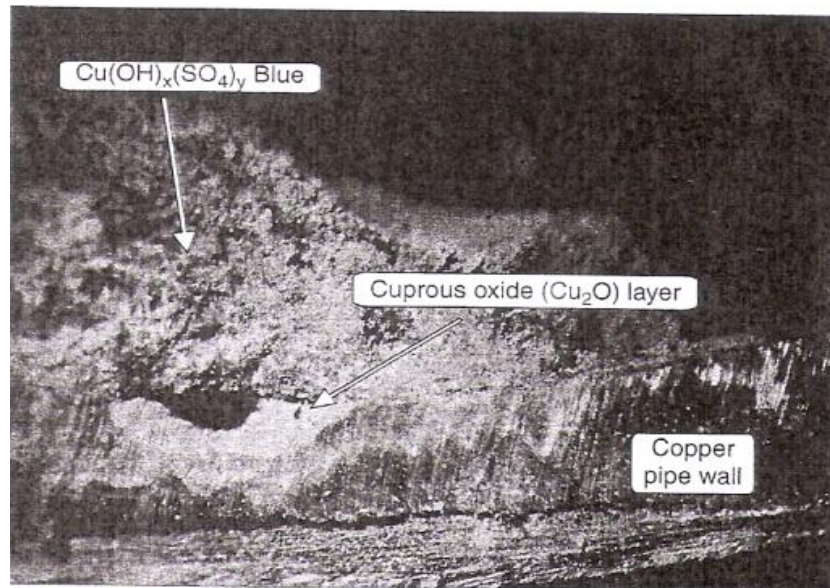
**Type III** pitting occurs in cold soft waters having a pH above 8.0. It is a more generalized form of pitting, which tends to be wide and shallow and results in blue water, byproduct releases, or pipe blockage.

**Figure 2.3** Type III copper pitting corrosion[4]
