Corrosion Characterization of Salvaged Subsea Pipeline

A project dissertation submitted to the
Mechanical Engineering Programme
Universiti Teknologi PETRONAS
In partial fulfillment of requirement for the
BACHELOR OF ENGINEERING (Hons)
(MECHANICAL ENGINEERING)

MAY 2012

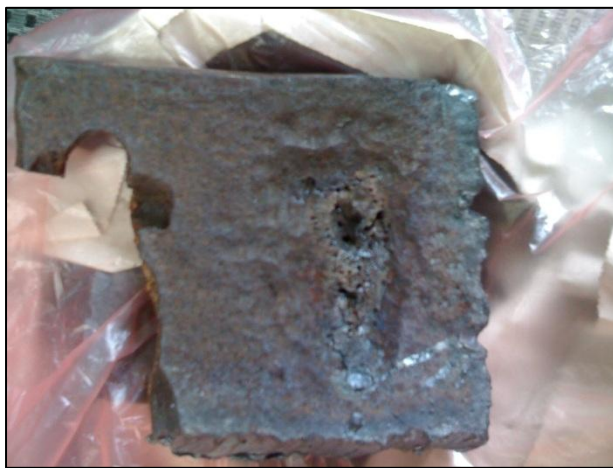
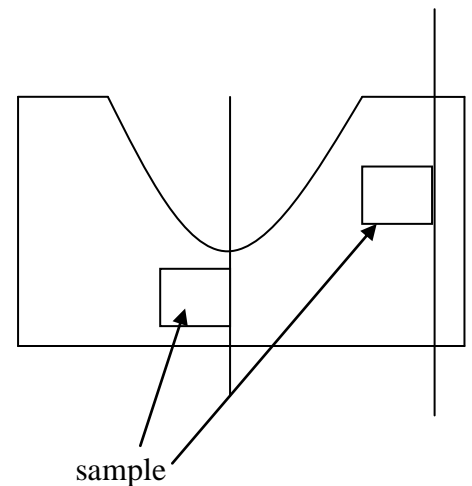
Figure 7: Localize corrosion sample and area of sample taken

Abrasive cutting offers the best solution to get the manageable size from larger parts of the samples because the resultant surface is smooth, the sectioning task is quickly accomplished and can withstand the stresses imposed by clamping vises and the action of the abrasive wheel. Low-speed cut-off wheels are utilized in cases where the heat created by standard abrasive cutters must be avoided. Ample coolant and proper speed control are essential in all sectioning operations. Figure 7 shows a localize corrosion and area of the sample taken by using EDM wire cut.

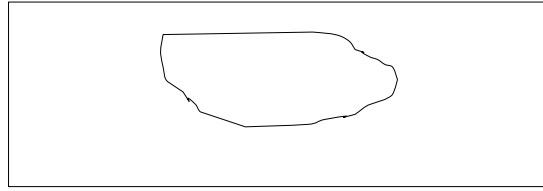
Figure 25–Inclusion

Figure 25 illustrates how the pitting happens because of the inclusion. The general corrosion will take place on the metal surface and when the metal losses reach to the inclusion, the pit will be initiated. On the other hand, in Figure 26, the pitting occurrence on a metal surface is due to some environmental difference between one area on that surface and deposit. These differences will create anodic and cathodic areas, setting up a basic corrosion cell. The anode is the area at which the metal is lost. The electrons move by the metal flow to the cathode to be consumed in a reduction reaction. The pitting caused by inclusion and deposit will occur at different area and this parallel with the visual inspection record.
